# Inspection Report

1234 Main Street  
Acworth GA 30301

**Marion Hodges Home Inspection Services**

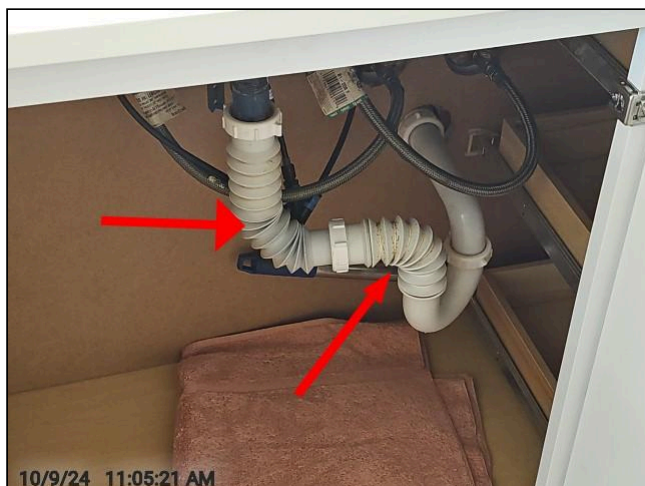
- 🏠 (1) The sink drain has been retrofitted with flexible drain pipe. All drainage pipes and fittings should be smooth wall material with no ridges, ledges, or bends that will slow down or stop the flow. Flexible pipe has the tendency to clog. A licensed plumbing contractor needs to replace flexible pipe with smooth wall pipe. Location(s): basement bath

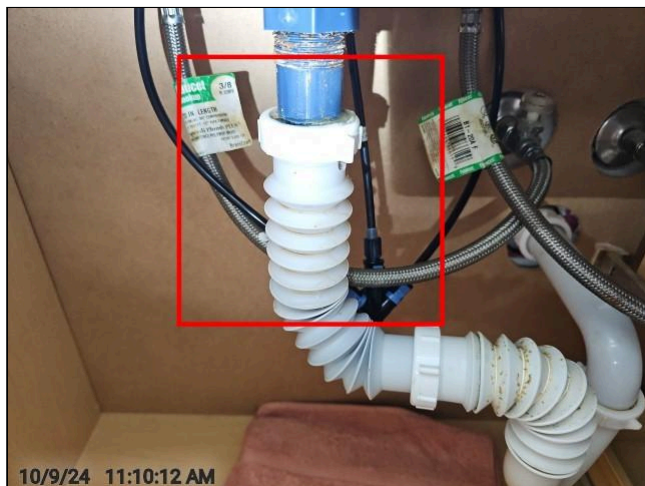
- 🏠 (2) The sink drain leaks. A licensed plumbing contractor needs to repair. Location(s): basement bath

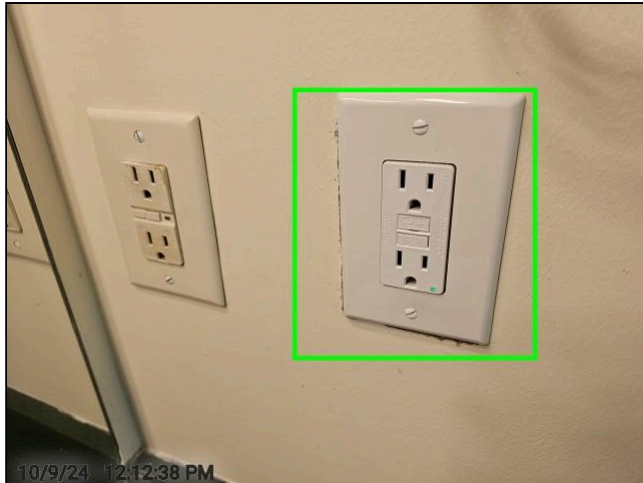
(1) FYI, GFCI reset for the whirlpool circulation pump. The GFCI should be tested periodically to verify the GFCI will trip and turn circulation pump off.

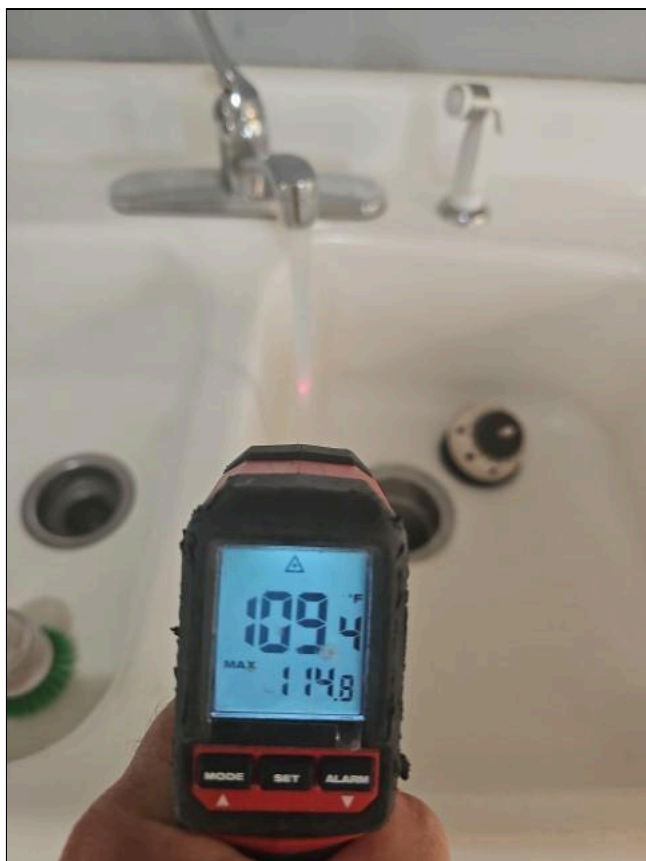
Water Heater Delivering Heated Water

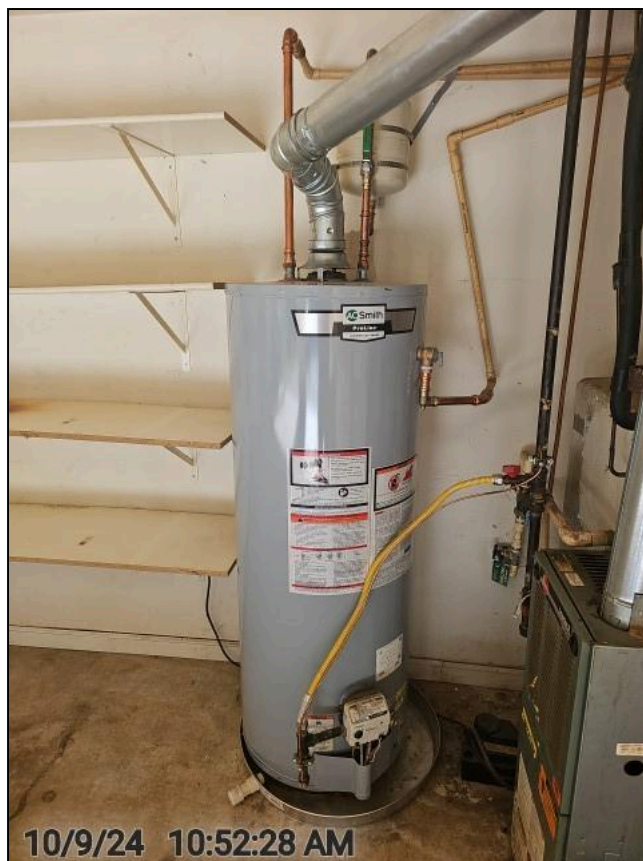
Water Heater and Thermal Expansion Tank

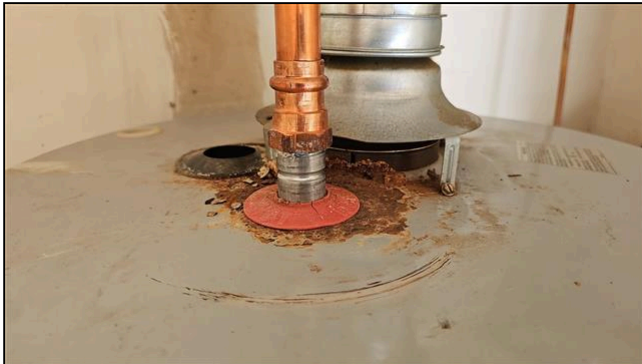
Signs of a past leak on the water heater. Appears to be from pipe connections. At the time of the inspection there was no leakage. Check with the seller about repairs that were made.

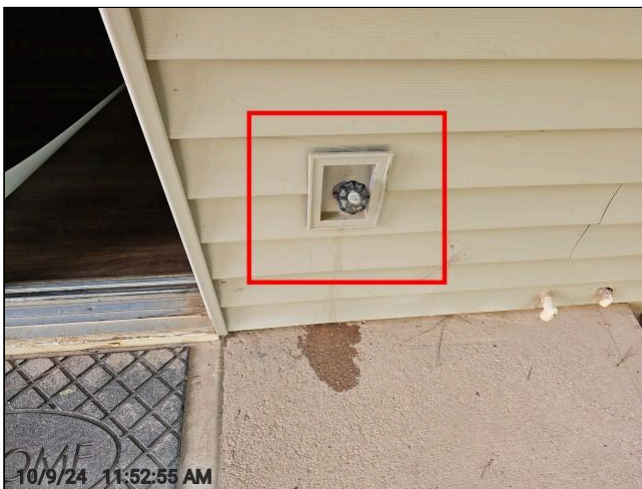
The back hose bibb is turned off at main cut off valve. Fixtures that are turned off are not turned on by the inspector. The seller should turn on the hose bibb prior to closing to verify there are no leaks or broken pipes. Repairs made if needed.

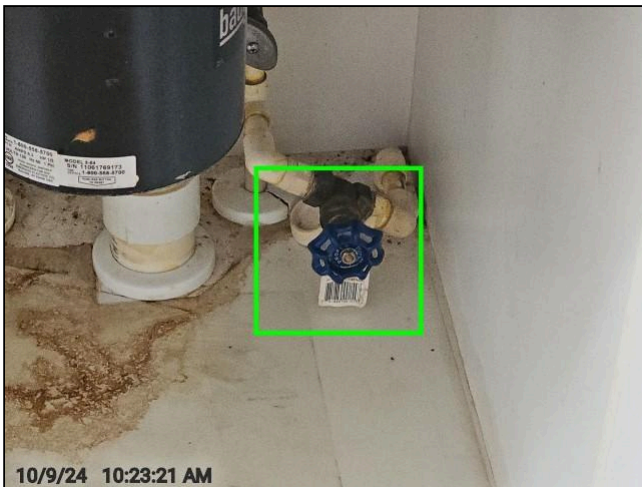
In Kitchen Sink Cabinet

FYI, Location of exterior water faucet shutoff. (See Photo). In the winter time, a good practice is to turn off the water to the exterior faucets and drain exterior faucet to prevent pipe from freezing. This is for your information.

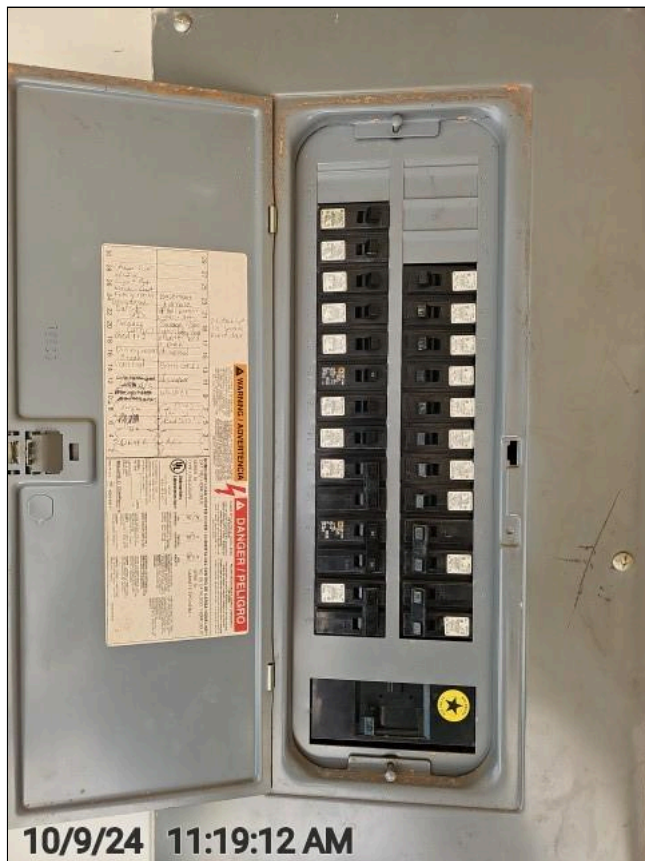
Main Service Disconnect Breaker and Labeled Panel Front

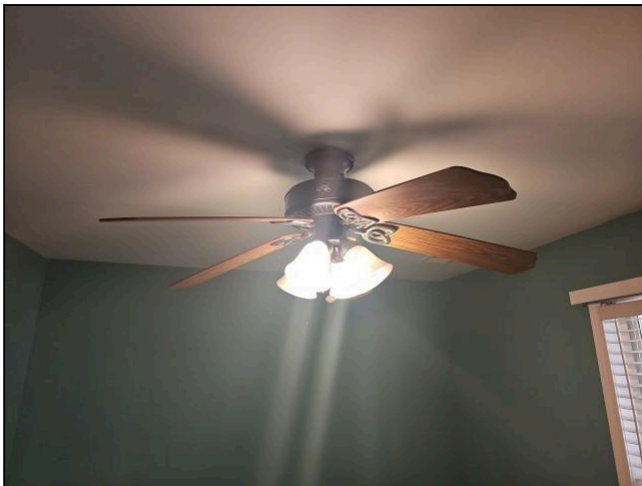
(2) Ceiling fan did not turn on. A licensed electrician needs to put fan in working order. Location(s): basement office

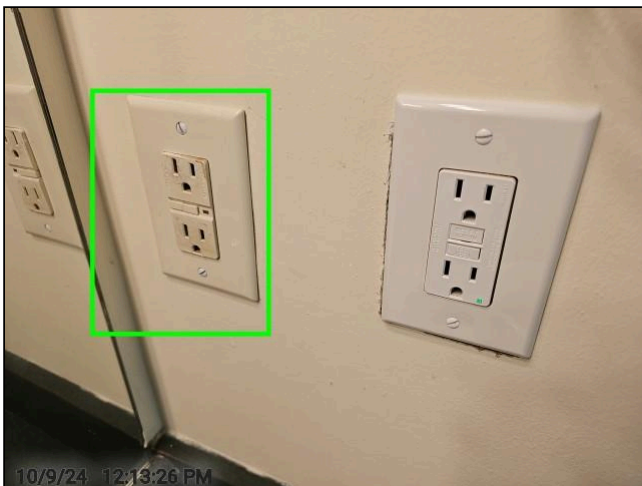
(1) Receptacles are not GFCI protected. A licensed electrician needs to put the receptacle(s) on a GFCI protected circuit. Location(s): basement bath both receptacles

(2) FYI, The GFCI re-set for the hall bath receptacles is in the primary bath.

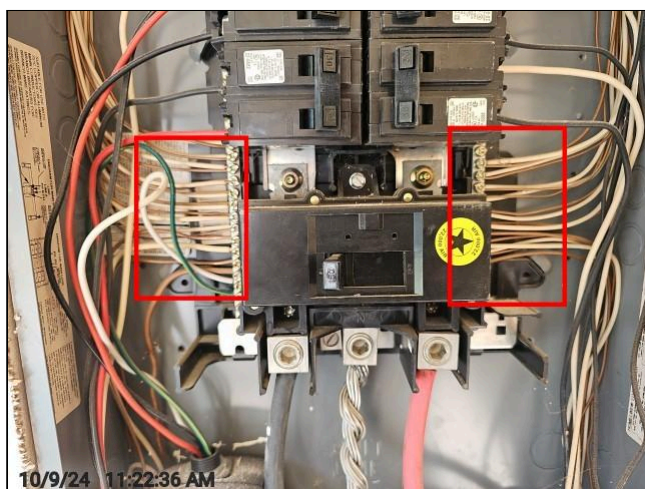
- 🏠 Double tapped neutrals and grounds were observed in the electrical panel on the same bus bar. If the house was built prior to 2002, this was the standard at the time. Current standards are for the neutrals and grounds to be terminated separately on the bus bar. Only one wire should be connected to each terminal. A licensed electrician needs to inspect further and repair.

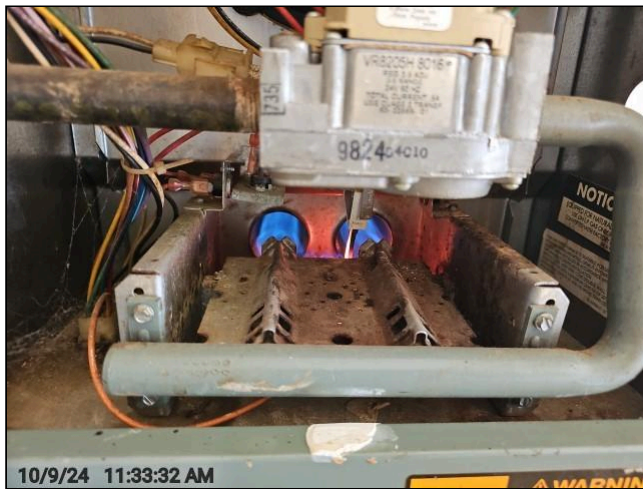
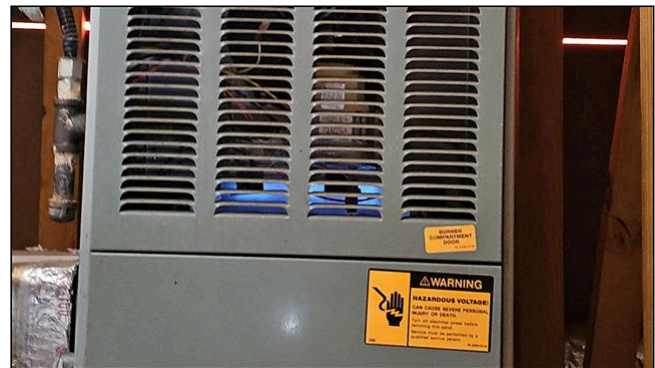
- (1) The 1999 basement and main level furnace are beyond average life expectancy. The furnaces did start at the time of the inspection. Replacement is recommended due to age. The furnace needs to be safety checked and heat exchanger check for cracks. A licensed heating and air contractor needs to inspect further.

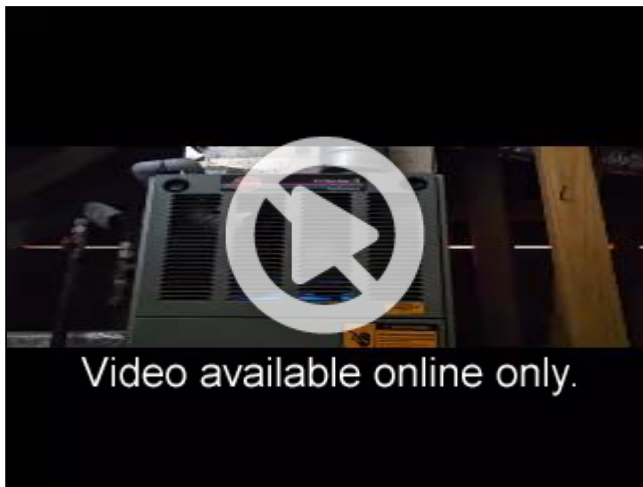
- (2) The induced draft motor on the furnace in the attic is loud. A licensed heating and air contractor needs to inspect further and repair as needed.

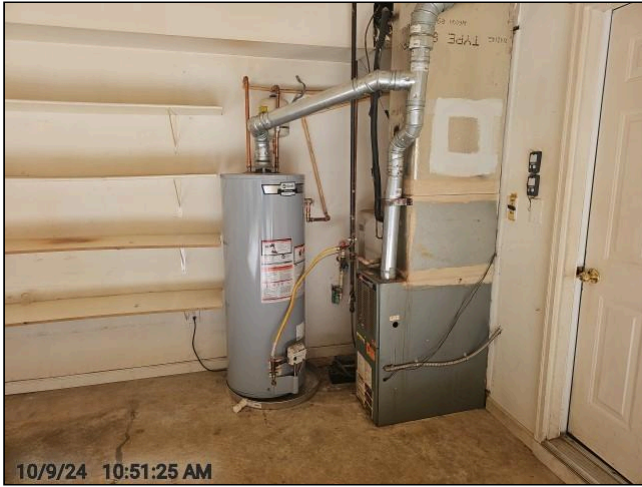
Gas appliances located in a garage or carport should be protected from impact by automobiles. A 48 inch high 4 inch steel column or a floor to ceiling 4x4 pressure treated post should be installed in front of the furnace and water heater for protection. A qualified contractor needs to provide protection from impact.

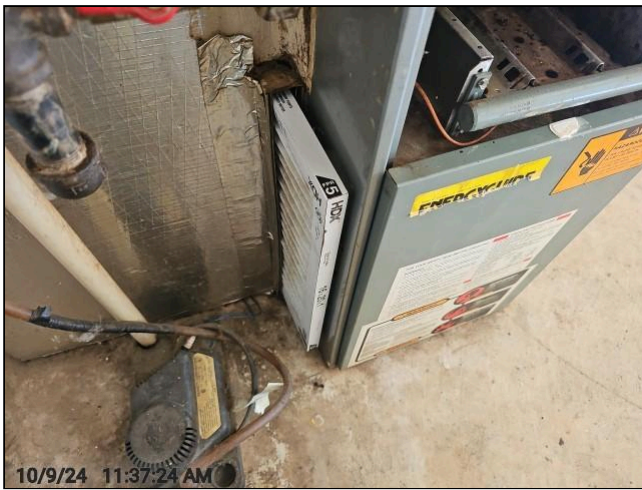
Location of return air filters (see photo). Filters should be changed every 60 to 90 days. Recommend that the filters be changed once you take possession of the house.

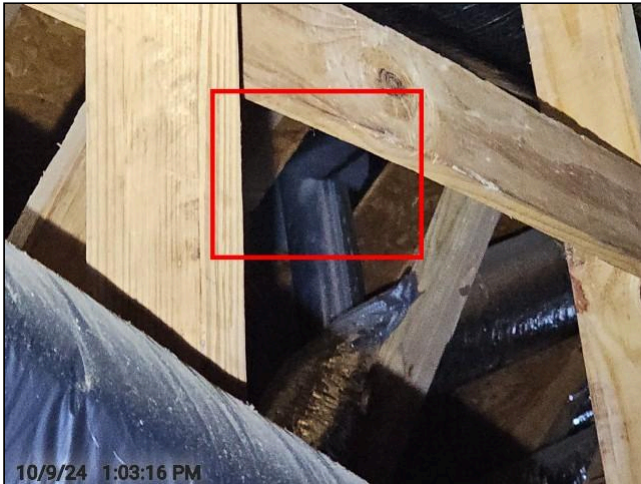
- 🏠 Furnace vent pipe in the attic should have a one inch clearance from combustibles materials. This is a safety issue. A qualified contractor needs to provide a one inch clearance from the felt paper.

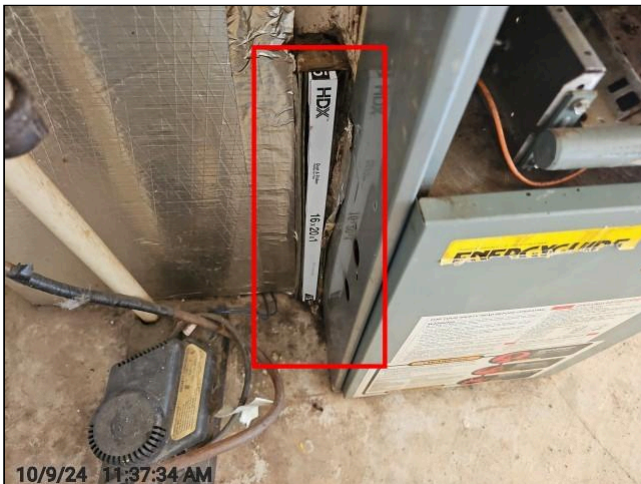
- 🏠 (1) The filter cover is missing on the furnace in the basement. A licensed heating and air contractor needs to replace the filter cover.

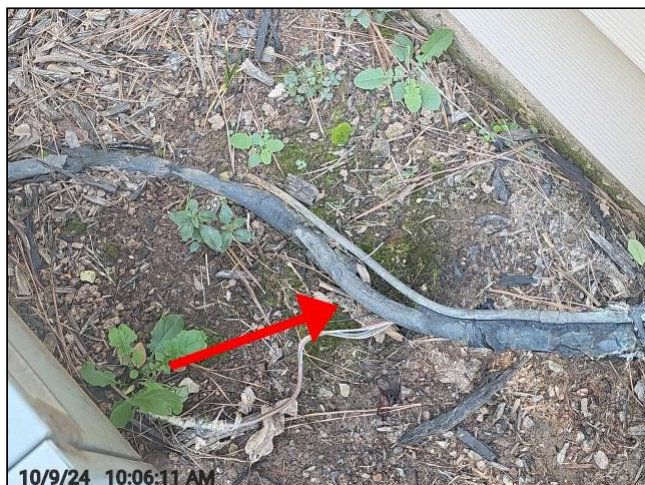
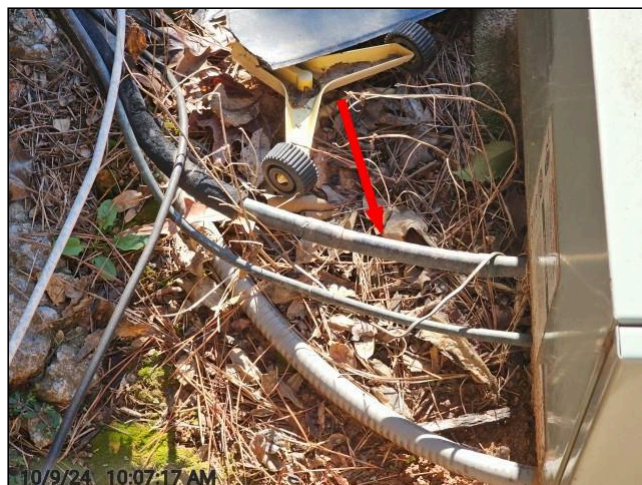
- 🏠 (1) The refrigerant line needs to be insulated at the condensing unit. The refrigerant line should be completely insulated. A licensed heating and air contractor needs to insulate the refrigerant line.

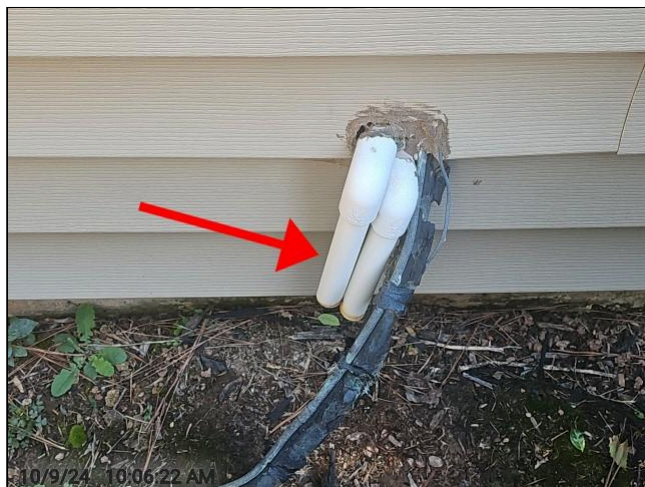
- 🏠 The condensate drain lines discharge at or near the foundation. The condensate drain lines should be extended 5 feet from the house. A licensed heating and air contractor needs to repair.

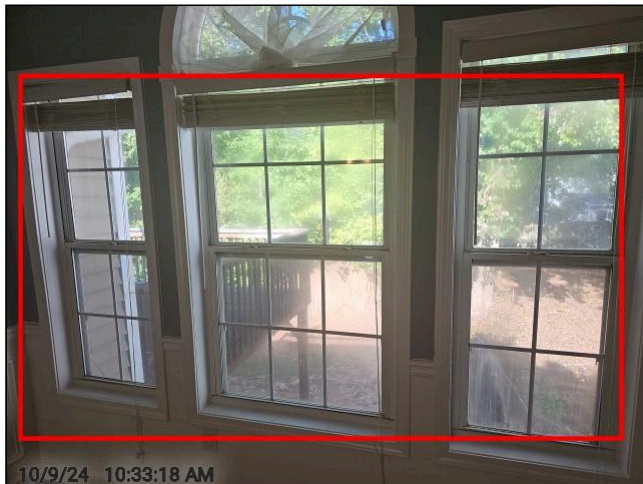
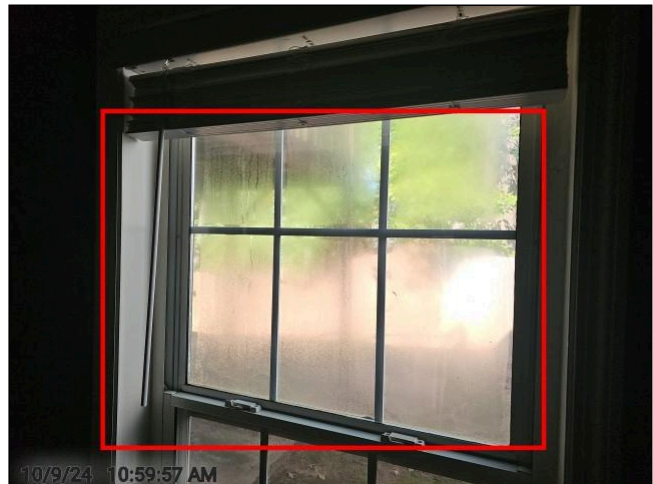
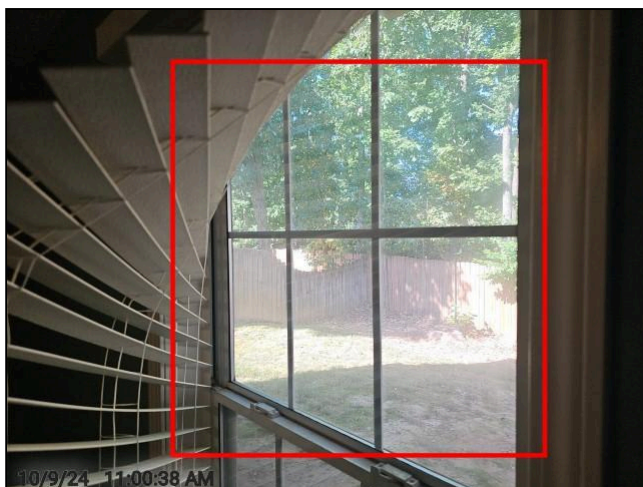
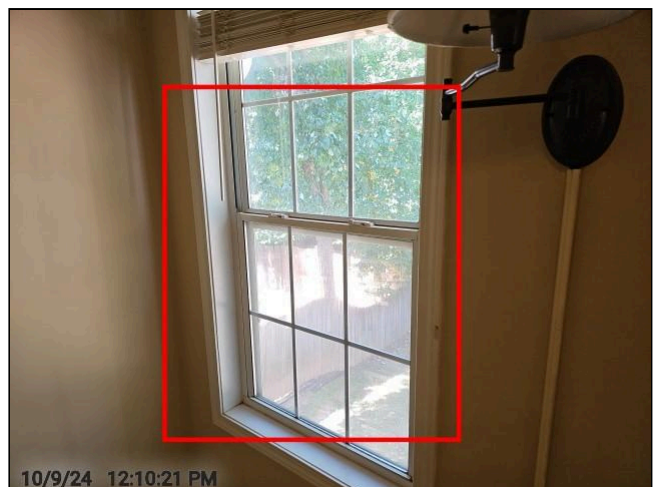
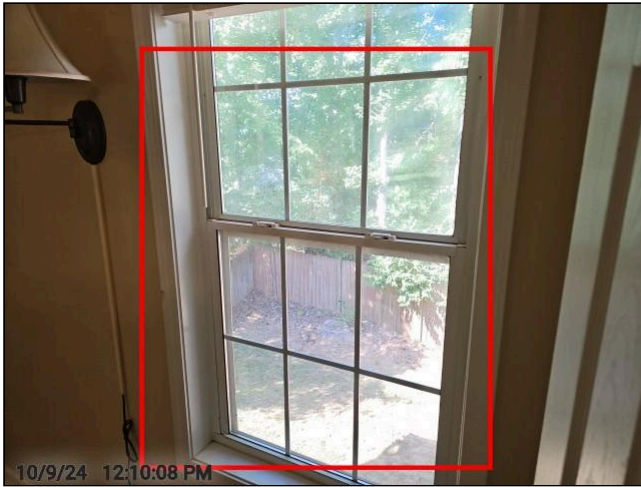
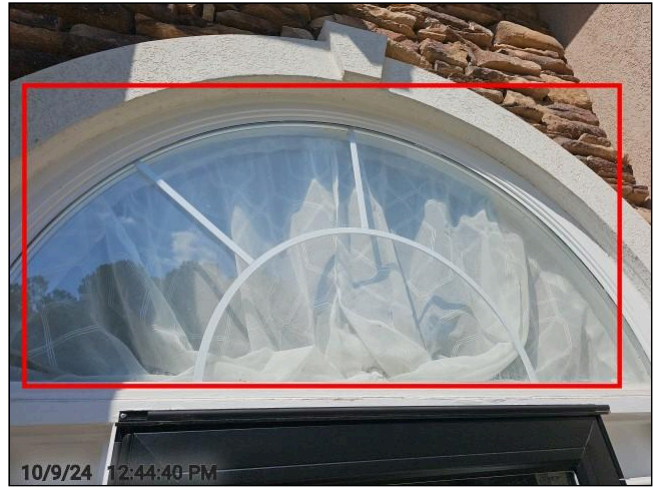
Insulation seals have failed on windows. A qualified contractor needs to replace failed glass. Location(s): dining room, basement, primary bedroom, window over front door

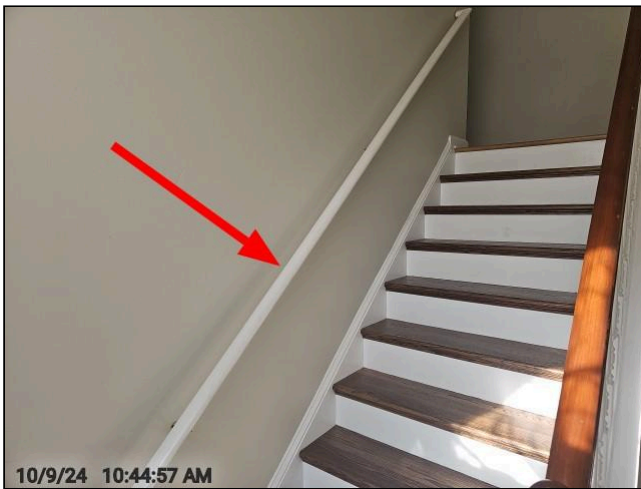
The handrail on the step is loose. A qualified contractor needs to tighten the hand rail.

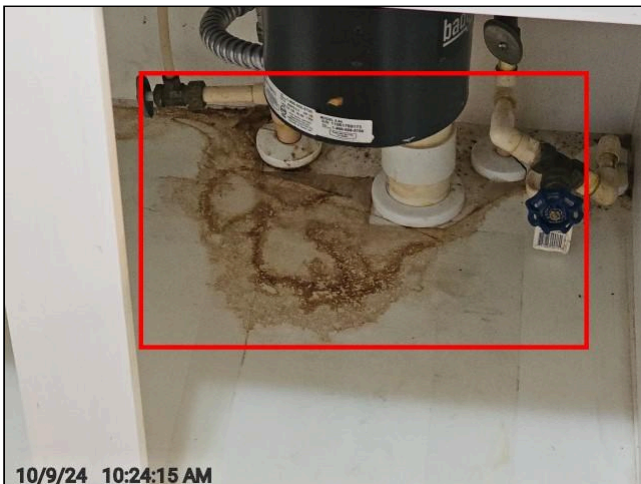
The cabinet base is rotten/water damaged. A qualified contractor needs to replace cabinet base. Location(s): kitchen

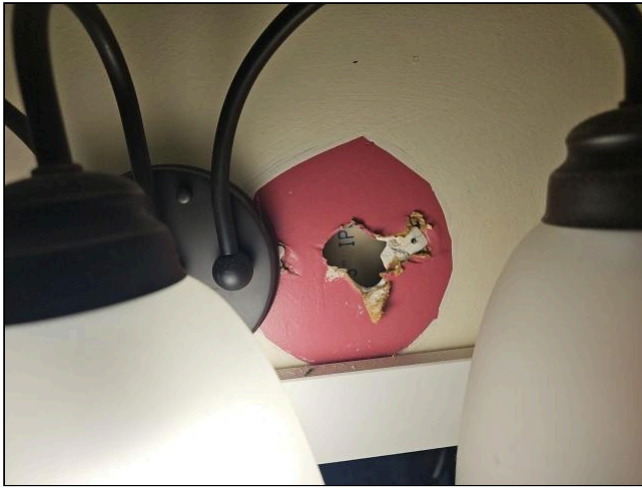
Hole in the sheetrock needs to be repaired. A qualified contractor needs to repair sheetrock and paint to match existing. Location(s): basement bath

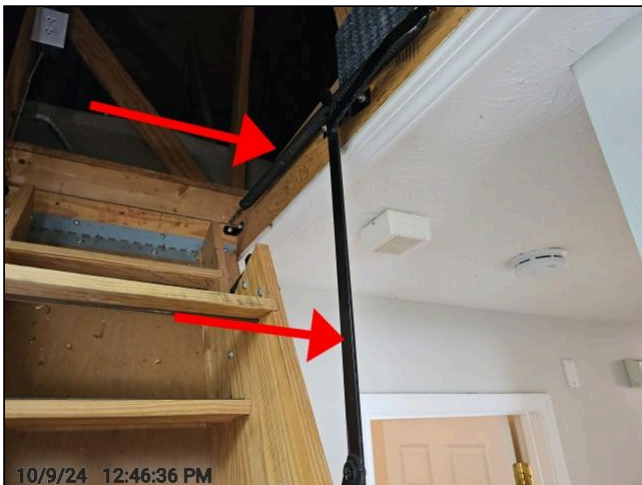
The attic stair unit needs to be replaced. The hinges and springs are close to breaking. A qualified contractor needs to install a new attic stair unit.

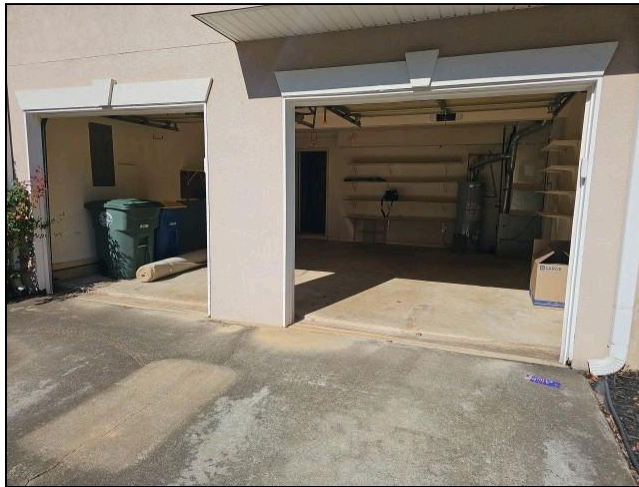
Garage Door and Operator Operational

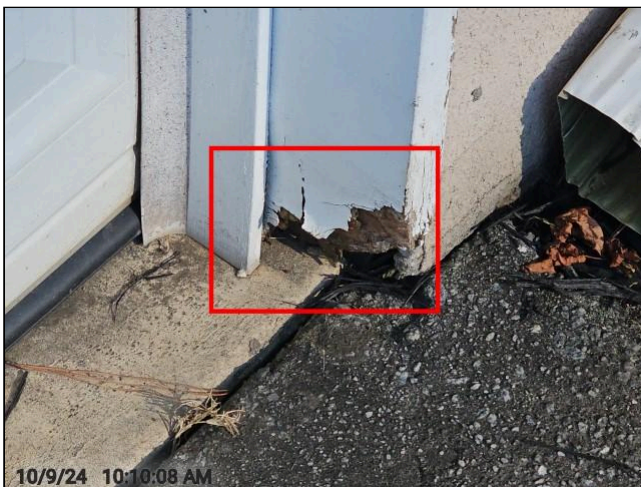
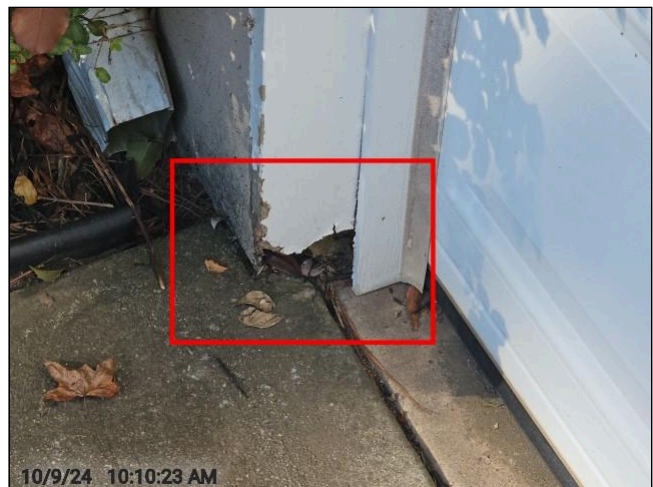
Casing is rotten. A qualified contractor needs to replace rotten casing. Location(s): garage doors

- 🏠 (1) The downspouts beside the garage doors need to be turned to drain away from the house. The drainage has caused the rot at the garage doors. A qualified contractor needs to repair.

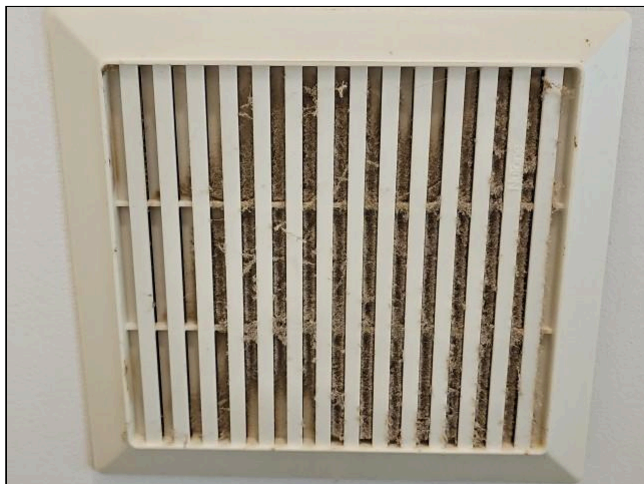
The exhaust fan motor and vent cover louvers need to be cleaned. A qualified contractor needs to clean exhaust fan motor and vent cover louvers. Location(s): basement bath

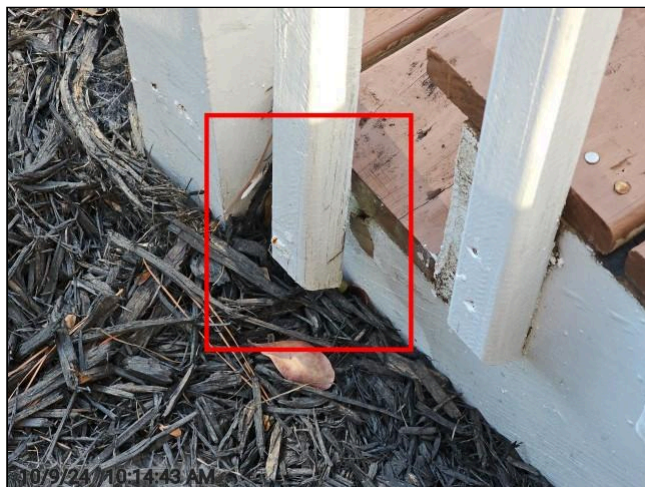
- 🏠 (1) There are pickets on the front porch that are not nailed down. A qualified contractor needs to nail pickets.

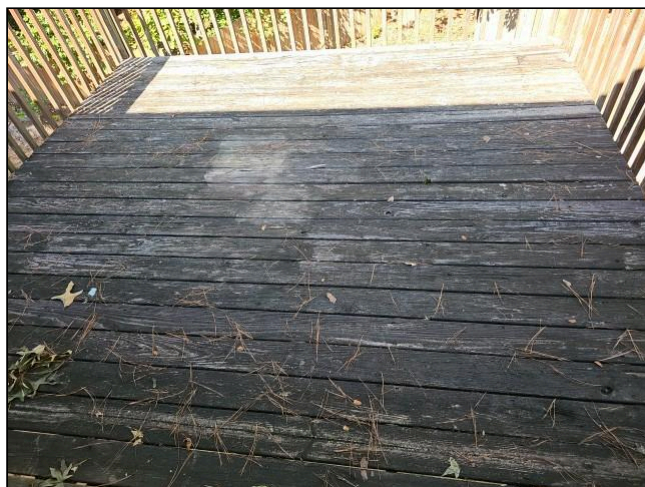
- 🏠 (2) Decking on the deck needs to be replaced. The decking is close failure. A qualified contractor needs to replace all decking.

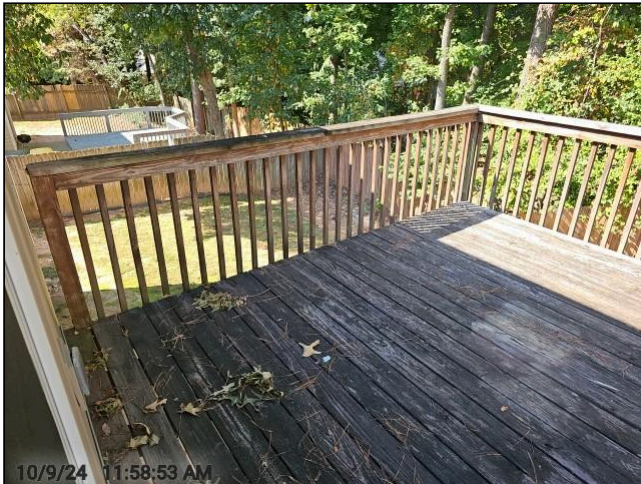
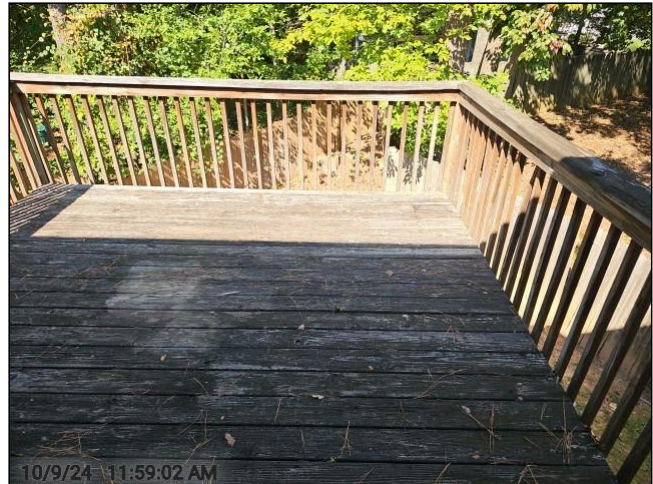
- 🏠 (3) The guardrail on the deck is not stable. A qualified contractor needs to repair or replace the guardrail as needed.

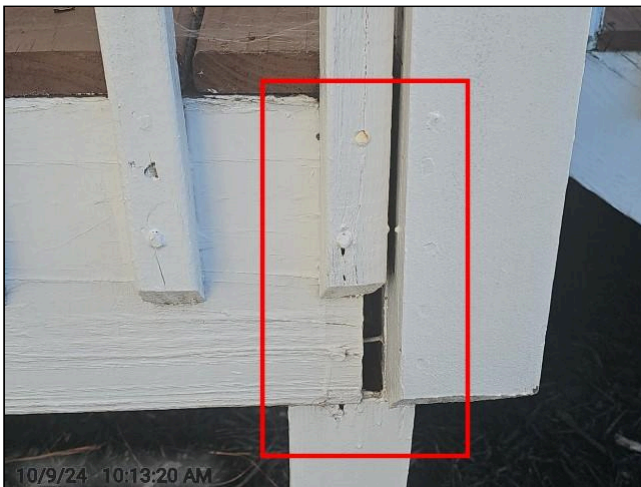
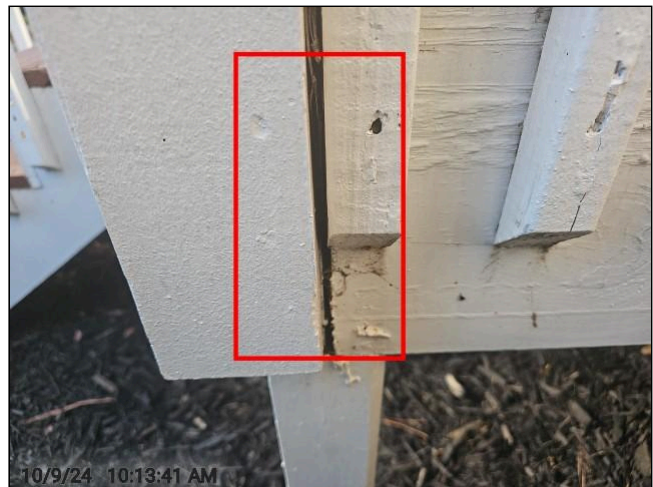
- 🏠 The outside ledger board has separated from the joist on the front porch. This is a safety issue. A qualified contractor needs to tighten all joist connections to both the inside ledger board and outside ledger board. Add additional support if needed.

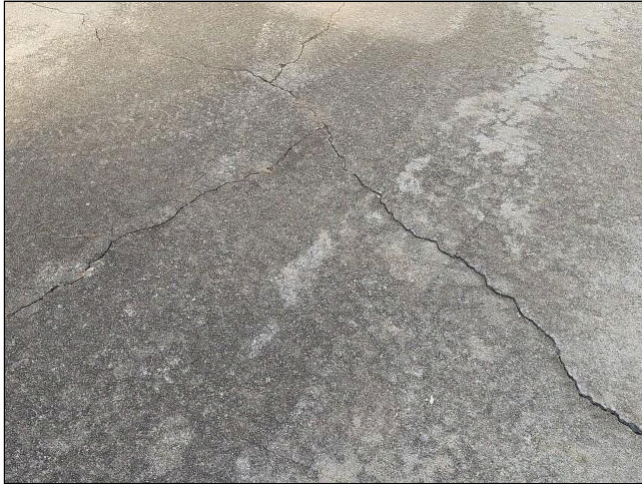
All cracks in the driveway need to be sealed with a concrete sealant.

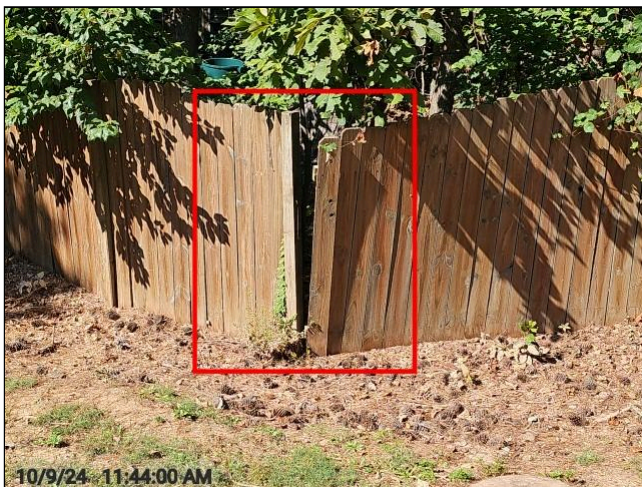
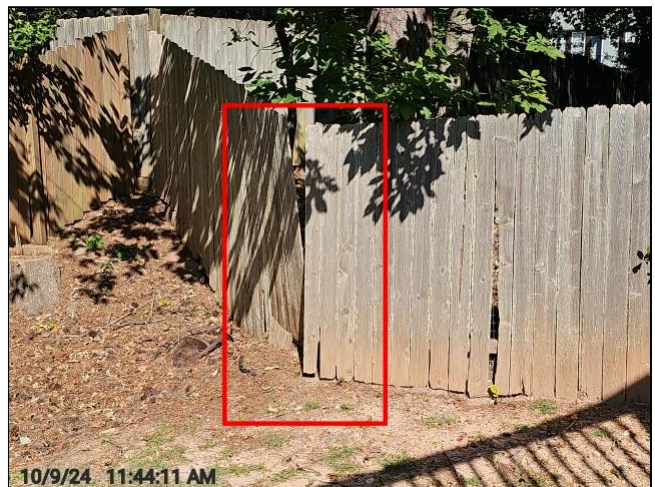
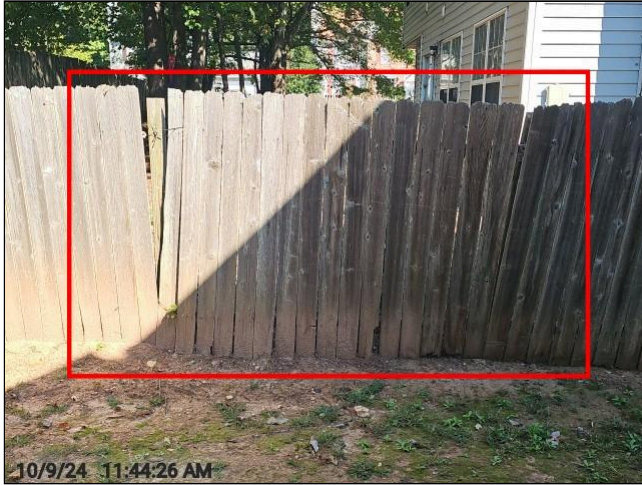
The fence needs to be repaired or replaced where damaged. A qualified contractor needs to repair or replace.

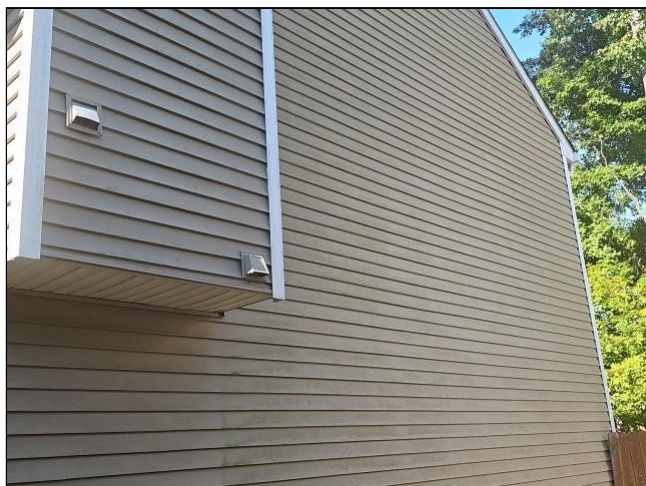
The siding and trim needs to be pressure washed. Pictures are examples. A qualified contractor needs to pressure wash the siding.

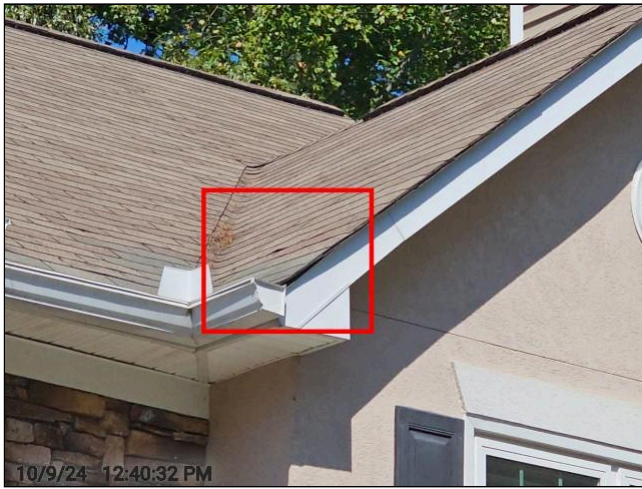
🏠 (1) There are uplifted shingles on the roof. Picture(s) are examples. A qualified roofer needs to repair.

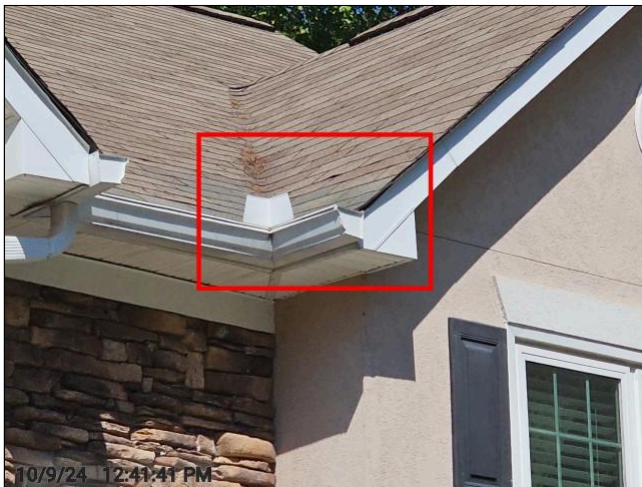
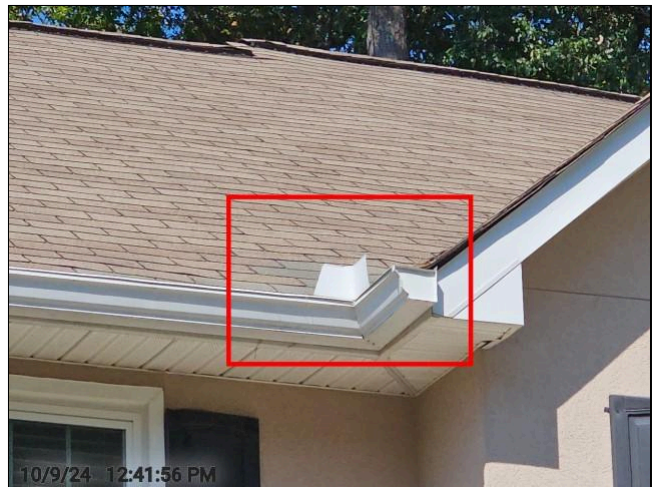
(2) A couple of roof repairs were noted on the front roof.

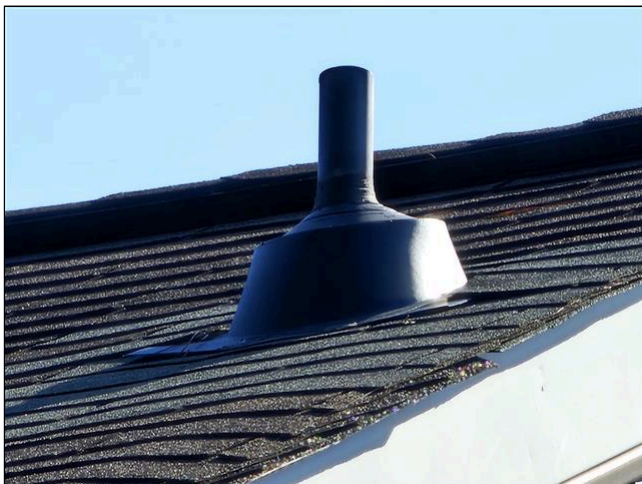
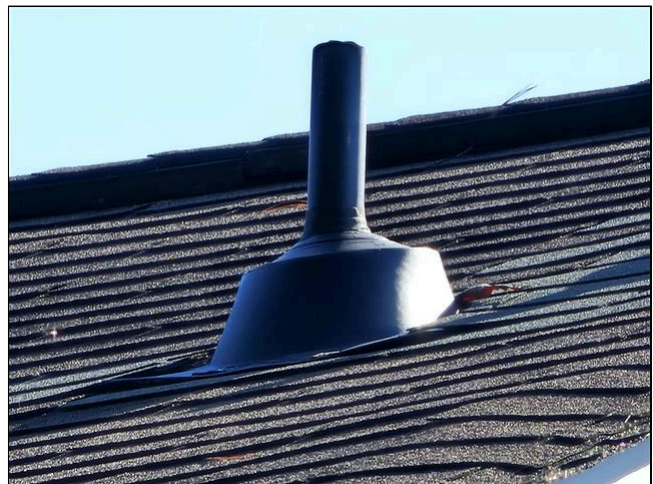
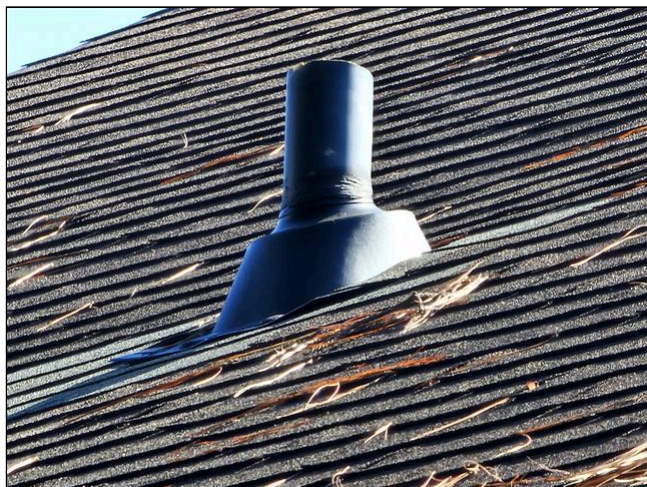
The plumbing boots on the roof have been replaced.

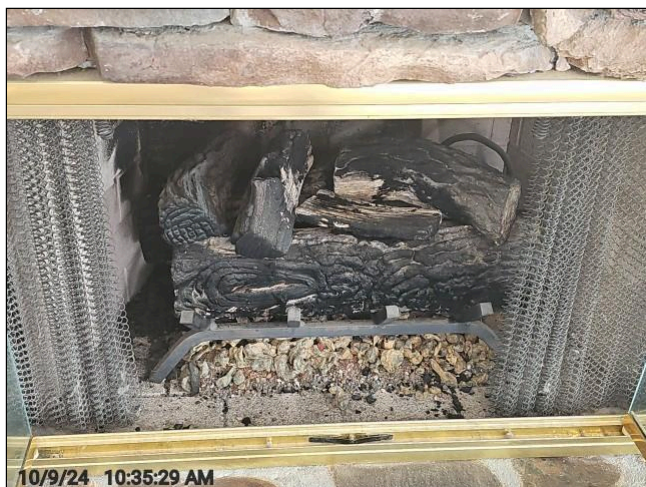
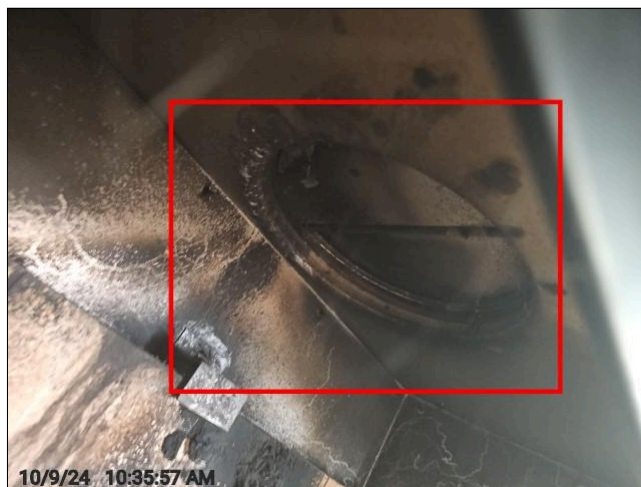
The fuel source for the fireplace is gas logs. The damper on the fireplace needs to be locked in the full open position for ventilation when burning gas logs. This is a safety issue. A qualified contractor needs to lock vent in full open position.

Soot was observed on the gas logs. Soot can be a sign of a ventilation issue. A qualified contractor needs to inspect further and repair.

- 🏠 (1) A qualified chimney sweep contractor needs to clean the chimney flue, leak test the gas valve, test the gas logs for operation and correct installation. The inspector does not operate gas valves that are turned off. Leak checking gas valves is part of a standard chimney cleaning. Repairs made as needed.

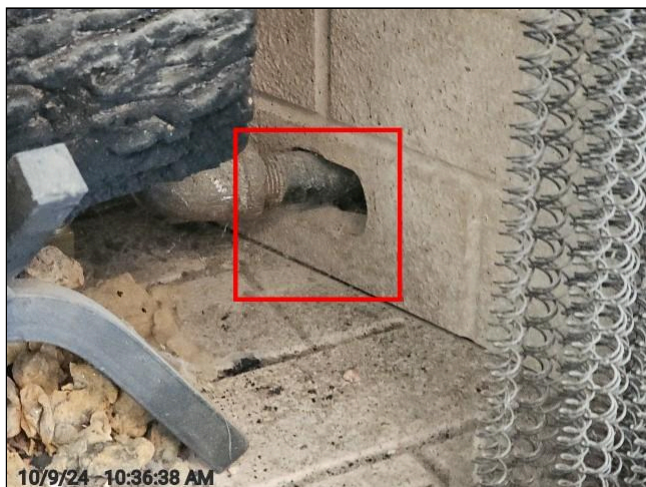
- 🏠 (2) The gas line opening into the firebox is not sealed. The opening should be sealed with refractory sealant to prevent back drafting of heat. A qualified contractor needs to seal opening around gas pipe.
