Inspection Report

2345 Main St

Marion Hodges Home Inspection Services

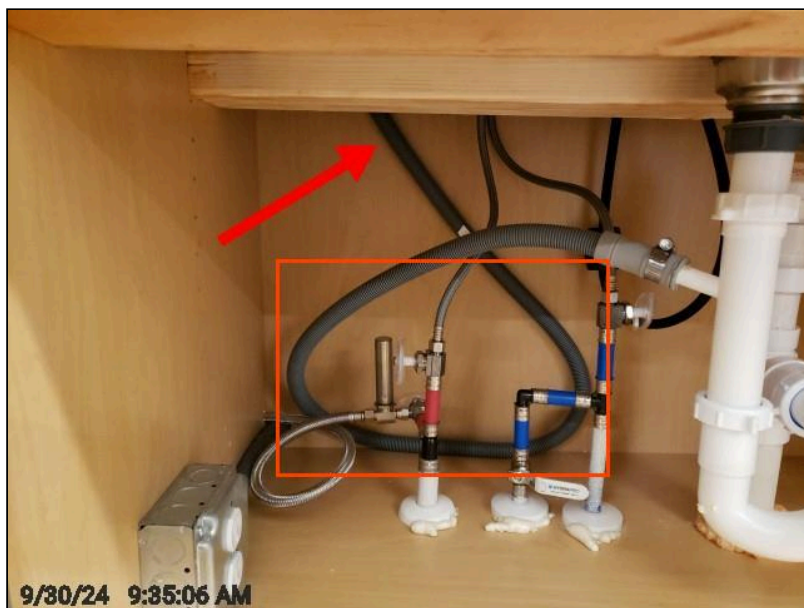
🏠 Buyer request that the dishwasher line be secured to the cabinet to prevent line from rattling/moving.

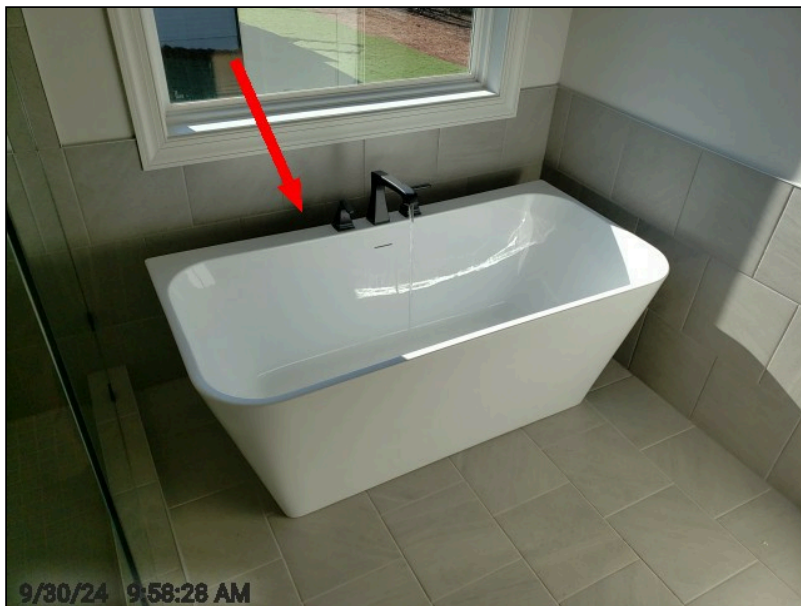
Access panel is not installed on the back of the tub. A qualified contractor needs to install access panel.
Location(s): primary bath

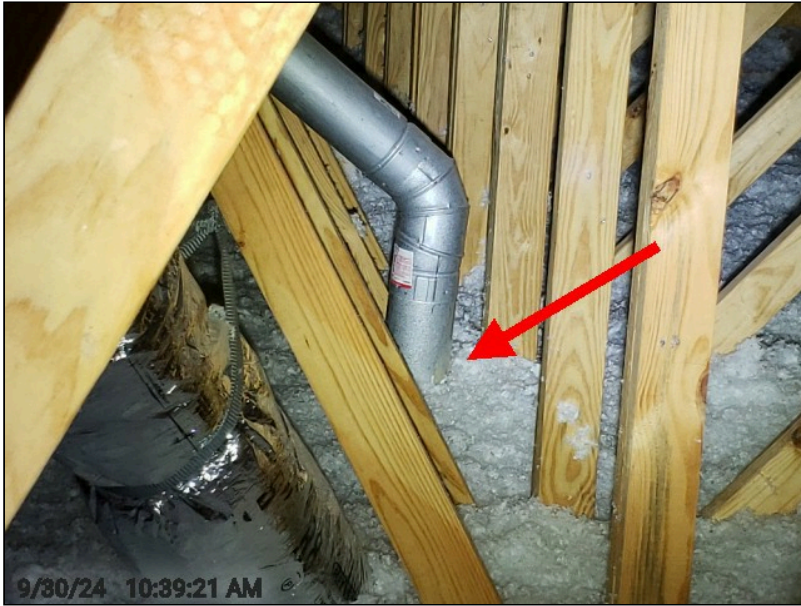
- 🏠 (1) Water heater vent pipe needs to have a one inch clearance from combustibles. This is a safety issue. A qualified contractor needs provide a one inch clearance from insulation. Location(s): attic and basement

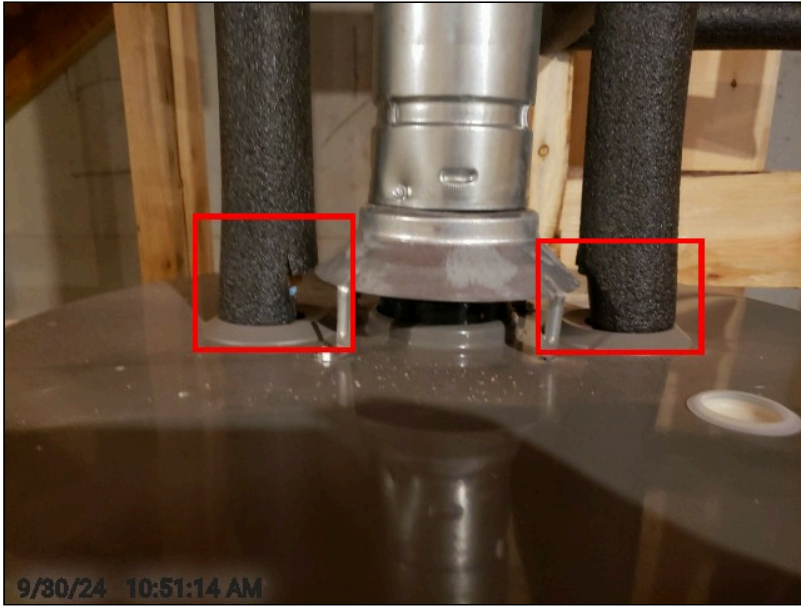
- 🏠 (2) The foam insulation is too close to the vent pipe. Water heater vent pipe needs to have 6 inches of clearance from combustible materials with single wall vent pipe. The foam insulation should be removed.

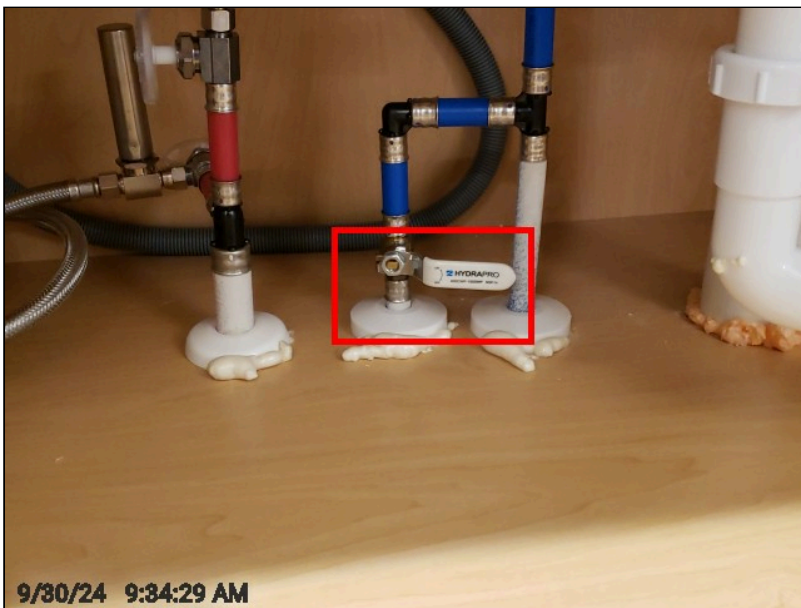
- 🏠 The right hose bibb is turned off at main cut off valve. Fixtures that are turned off are not turned on by the inspector. The builder should turn on the hose bibb prior to closing to verify there are no leaks or broken pipes. Repairs made if needed. Location(s): kitchen sink cabinet

The right hose bibb is turned off at main cut off valve. Fixtures that are turned off are not turned on by the inspector. The builder should turn on the hose bibb prior to closing to verify there are no leaks or broken pipes. Repairs made if needed. Location(s): kitchen sink cabinet

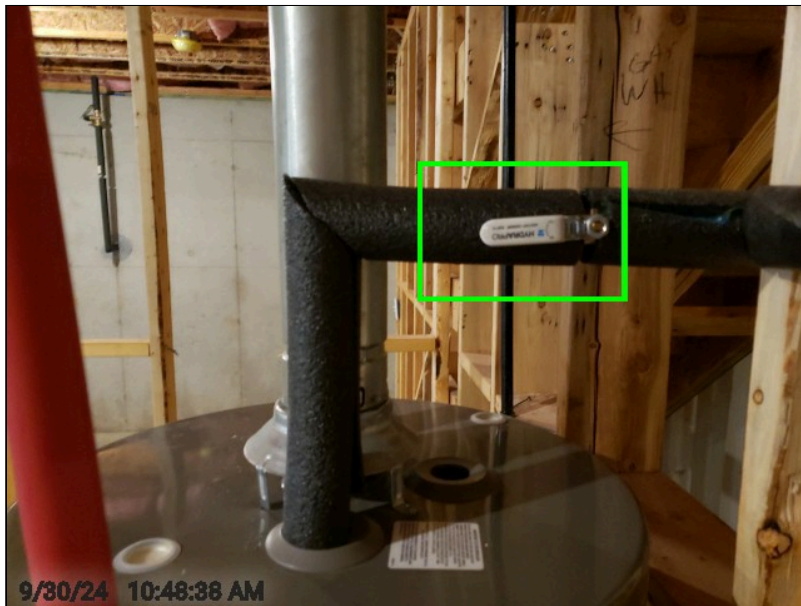
(2) Location of main water cut off to water heater (See Photo).

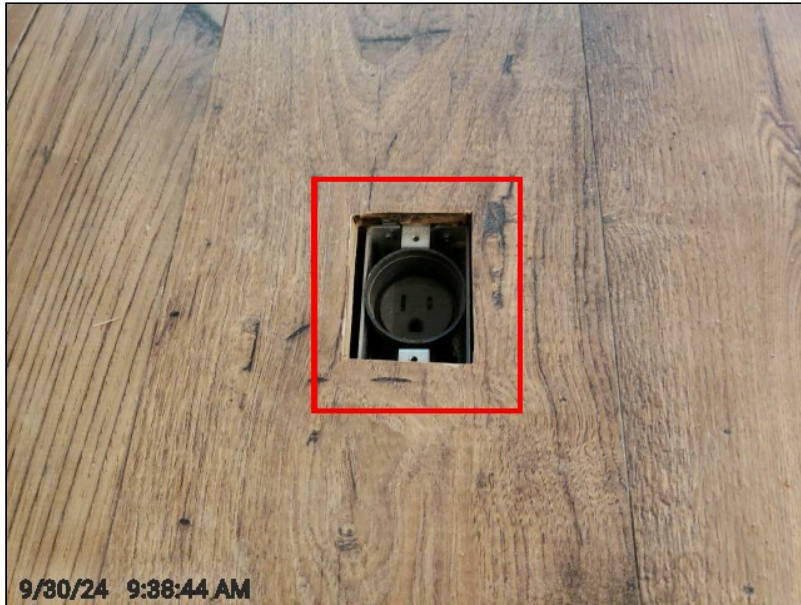
Per Buyer, The floor receptacle is supposed to be a double receptacle. A licensed electrician needs to install double receptacle and cover plate. Location(s): family room

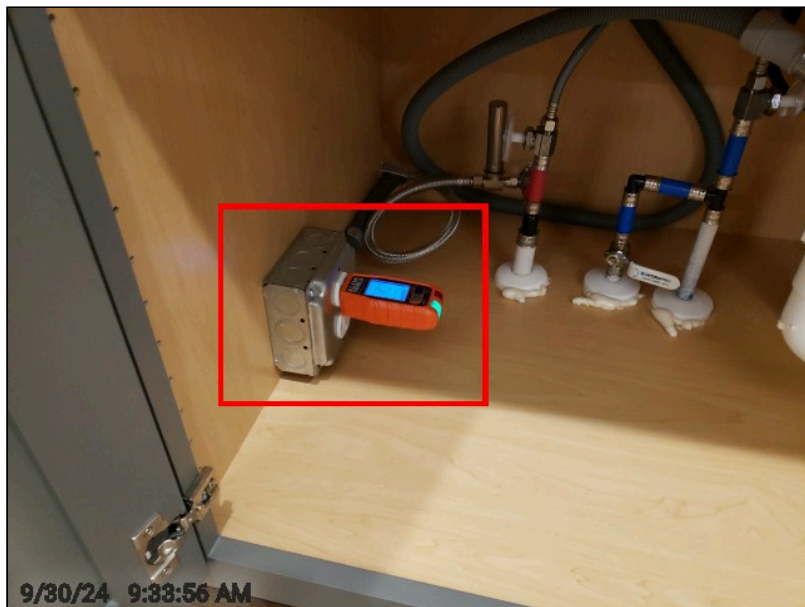
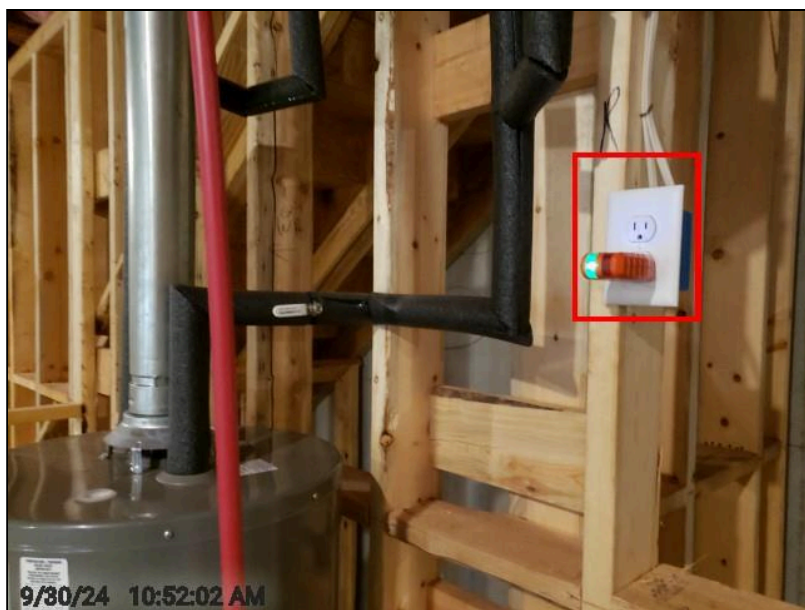
- 🏠 (1) Receptacles are within 6 feet of water. The receptacles need to be GFCI protected. A licensed electrician needs to put the receptacles on a GFCI protected circuit. Location(s): kitchen sink cabinet, basement at water heater

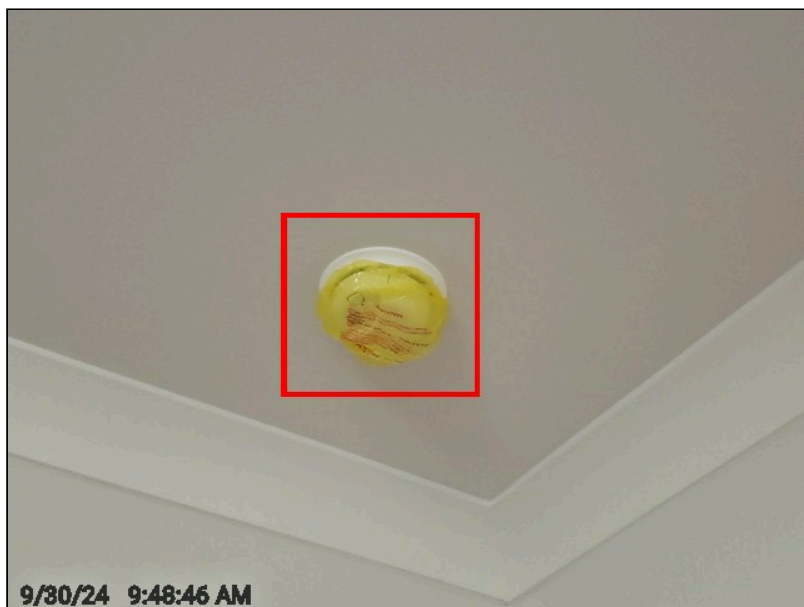
Remove dust cover on all smoke detectors prior to occupancy. Location(s): throughout the house

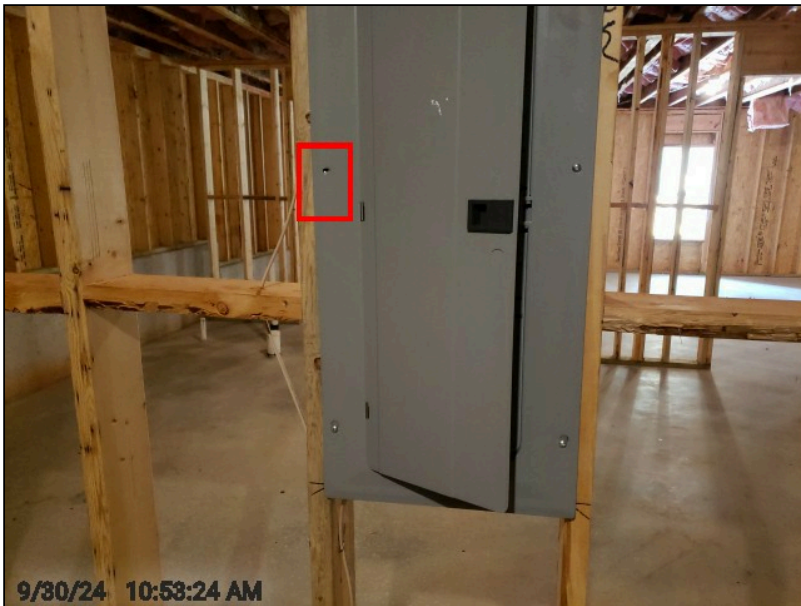
(1) Missing screws need to be installed on the electrical panel front to secure panel cover to panel box. Only blunt end screws should be used. A licensed electrician needs to repair.

(1) Missing screws need to be installed on the electrical panel front to secure panel cover to panel box. Only blunt end screws should be used. A licensed electrician needs to repair.
-

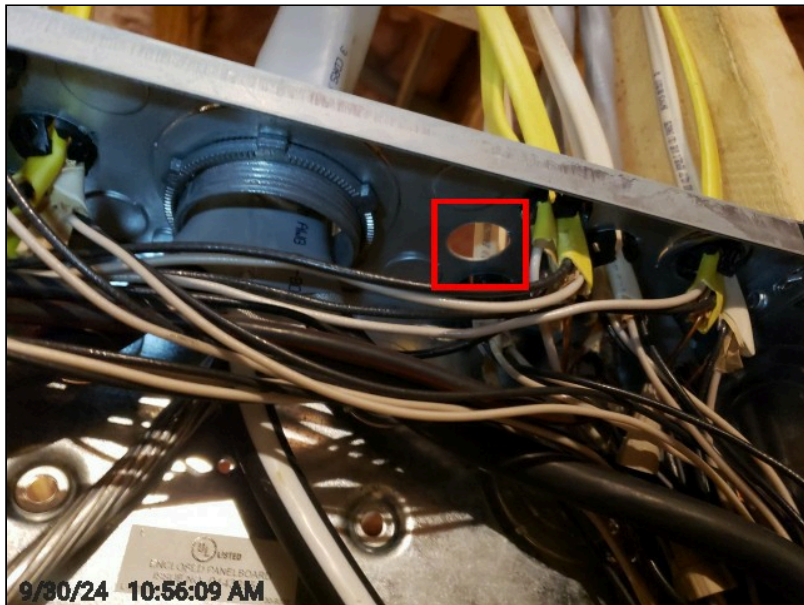
- 🏠 (2) Open knockouts in the electrical panel should be closed. Unused openings in electrical panel should be closed to afford protection substantially equivalent to the wall of the equipment. A licensed electrician needs to repair.

(2) Open knockouts in the electrical panel should be closed. Unused openings in electrical panel should be closed to afford protection substantially equivalent to the wall of the equipment. A licensed electrician needs to repair.

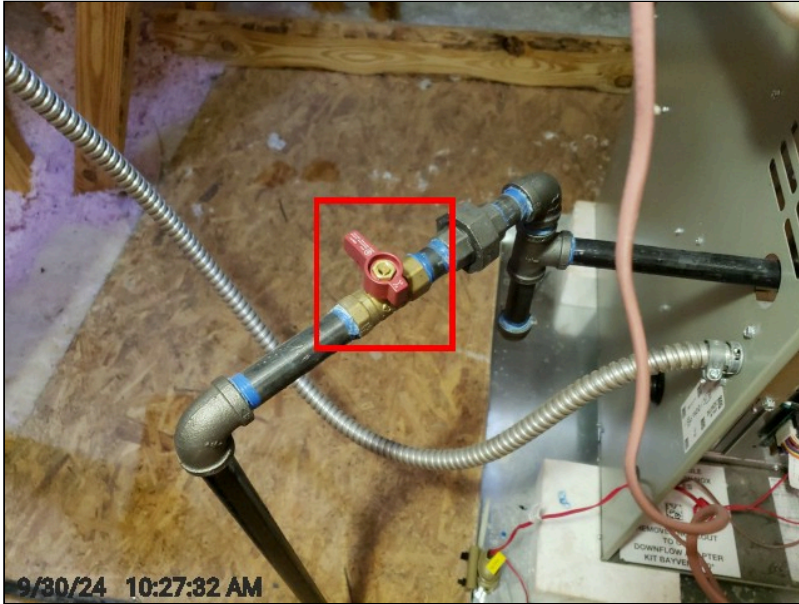
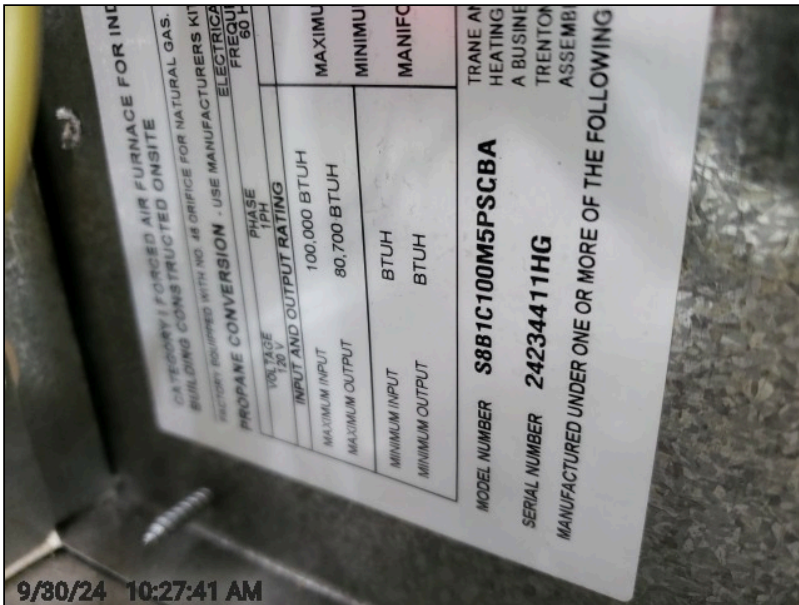
🏠 The builder had gas turned off to the furnace at the time of the inspection. The furnace was not turned on by the inspector. The inspector does not turn on gas appliances that are not in working order. A licensed heating and air contractor needs to leak check the gas pipe and perform the initial start-up of the furnace, repairs made as needed

The builder had gas turned off to the furnace at the time of the inspection. The furnace was not turned on by the inspector. The inspector does not turn on gas appliances that are not in working order. A licensed heating and air contractor needs to leak check the gas pipe and perform the initial start-up of the furnace, repairs made as needed

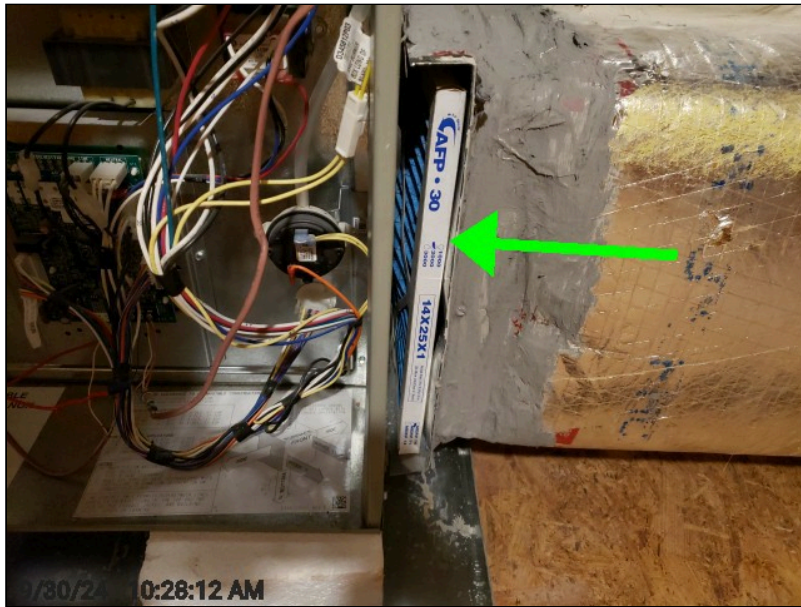
Location of return air filters (see photo). Filters should be changed every 60 to 90 days. Recommend that the filters be changed once you take possession of the house.

Arrow in the direction of air flow

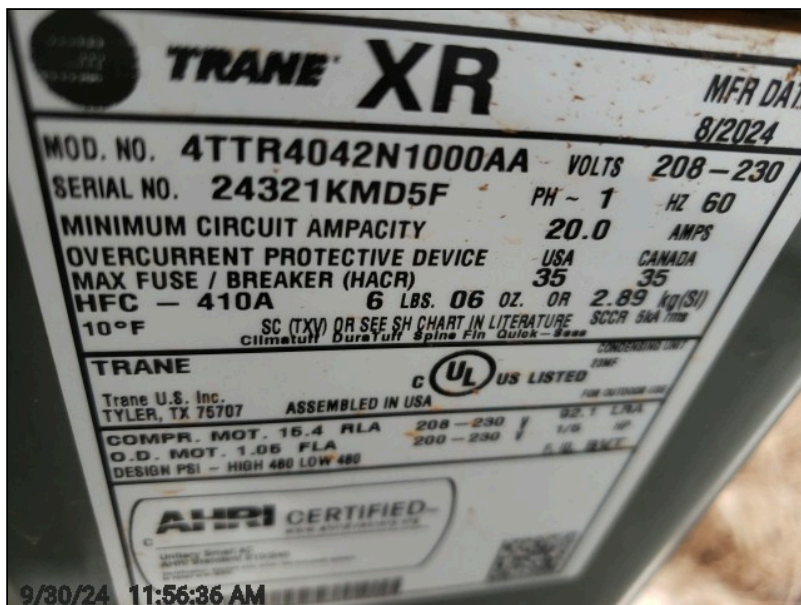
The air conditioning appeared to be in acceptable condition. The supply air temperature was 52 degrees and the return air temperature was 68 degrees. This indicates the range in temperature drop is normal. The inspector makes no warranties or guarantees as to how long the air conditioning equipment and components will last.

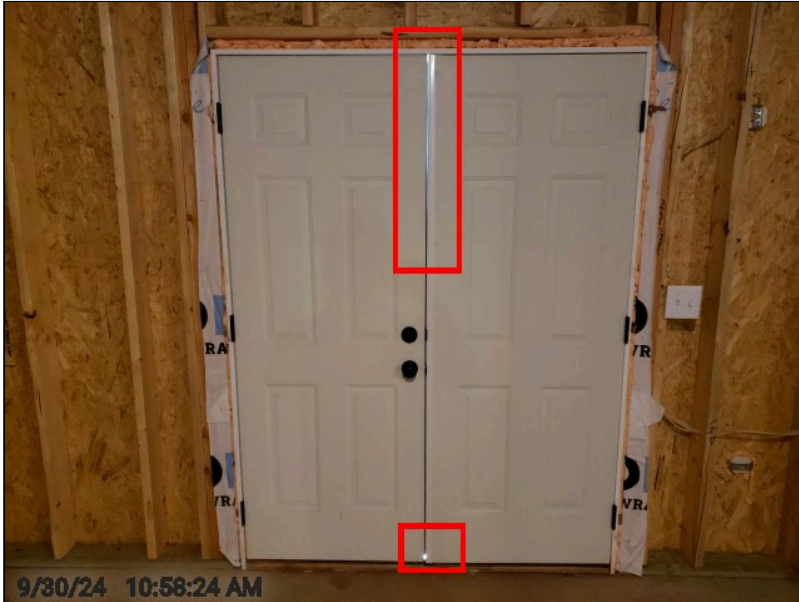
- 🏠 (1) Door reveals daylight when the door is closed. A qualified contractor needs to weatherstrip door to provide a tight seal. Location(s): basement door

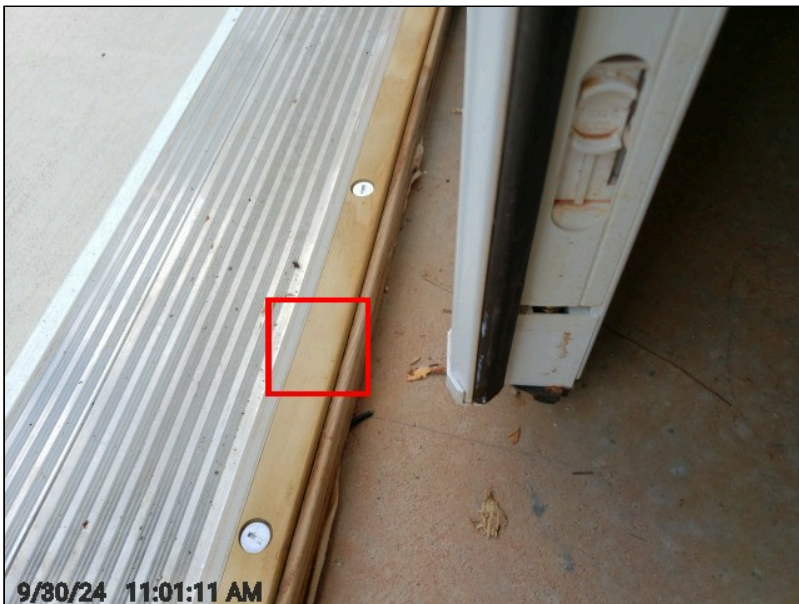
- 🏠 (2) Hole is not bored in threshold for bottom door lock. A qualified contractor needs to repair. Location(s): basement door

(2) Hole is not bored in threshold for bottom door lock. A qualified contractor needs to repair. Location(s): basement door

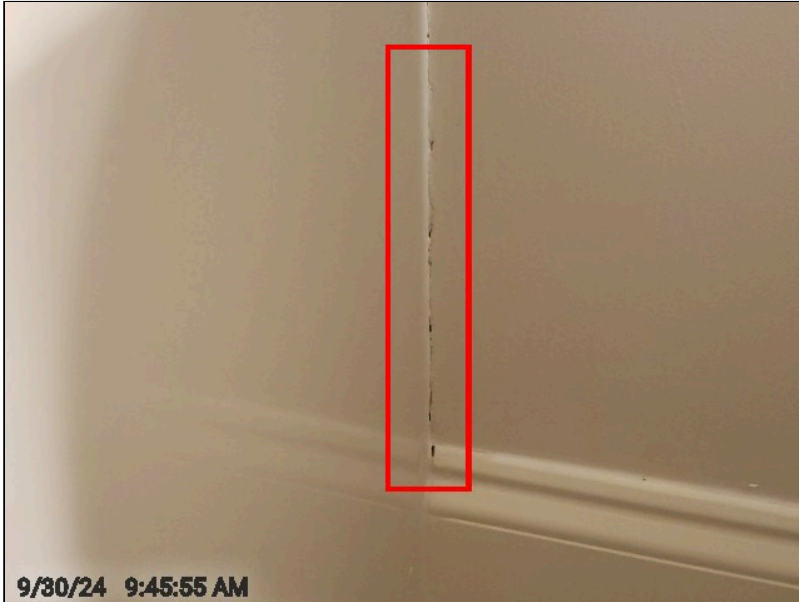
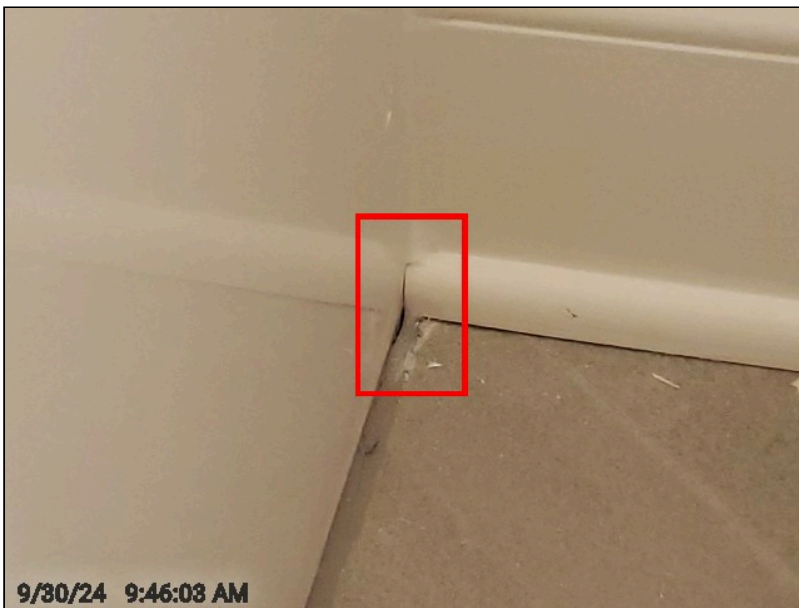
(1) Tub walls and floor need to be caulked or grouted. The pictures shown are examples. A qualified contractor needs to caulk or grout. Location(s): right hall bath and left hall bath

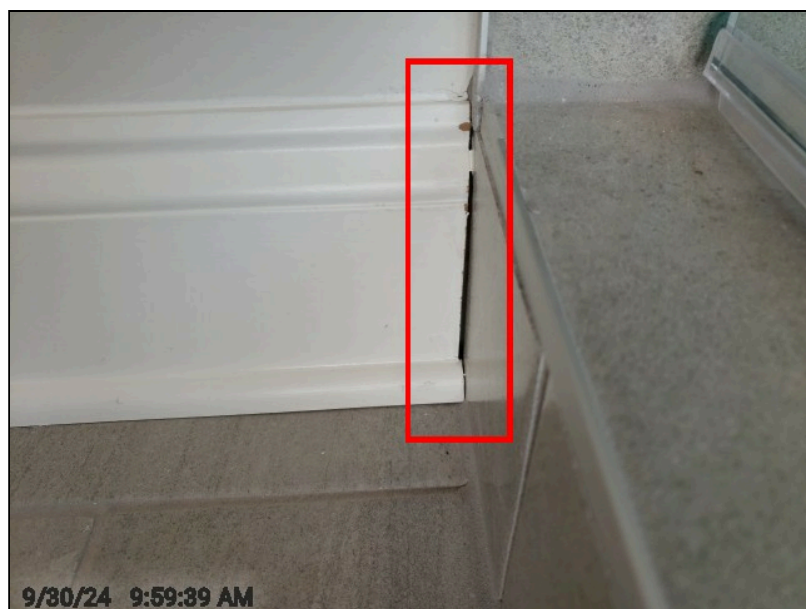
(2) Shoe mold trim at tub front and/or shower needs to be caulked to prevent water damage to the sub floor and prevent water from leaking into concealed space. A qualified contractor needs to caulk.
Location(s): primary bath

(2) Shoe mold trim at tub front and/or shower needs to be caulked to prevent water damage to the sub floor and prevent water from leaking into concealed space. A qualified contractor needs to caulk. Location(s): primary bath

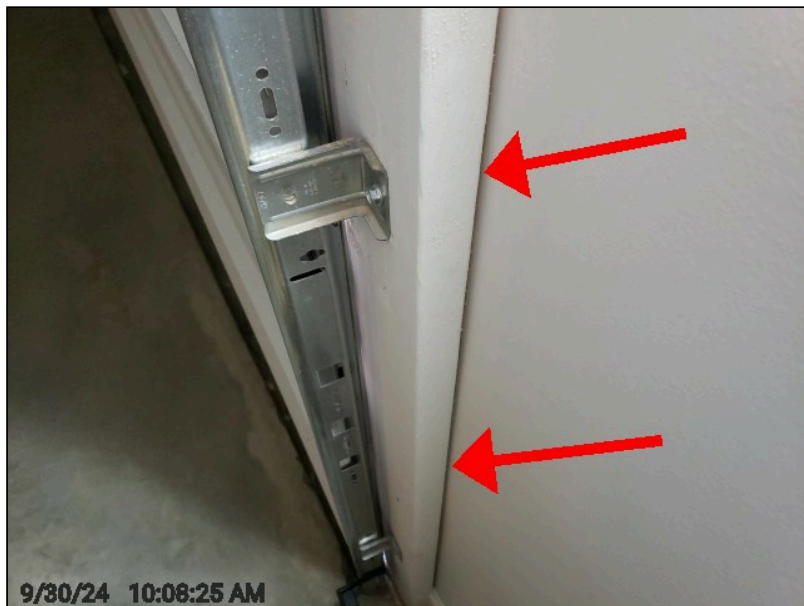
Casings supporting the garage doors have pulled away from the wall. A qualified contractor needs to re-nail casings or attach casings with lag screws as needed. Location(s): garage doors

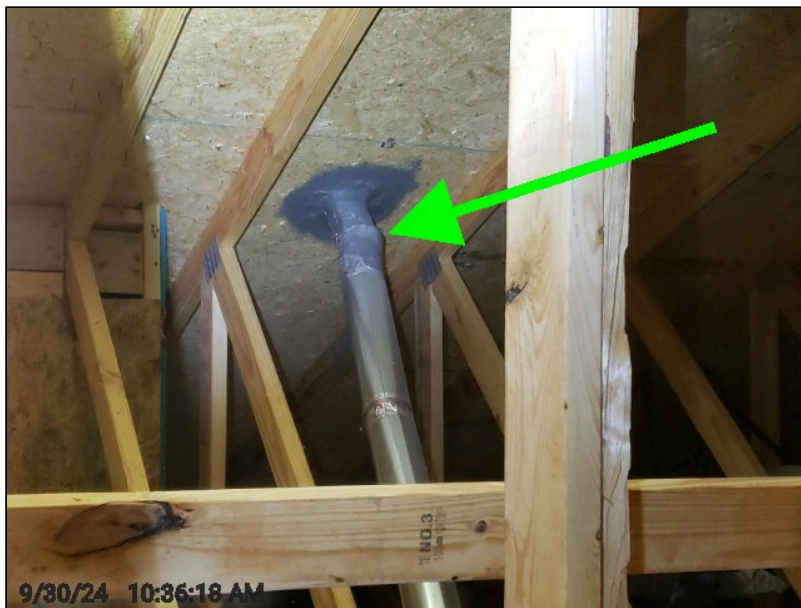
FYI, The dryer is vented through the roof. The vent pipe should be cleaned once a year.

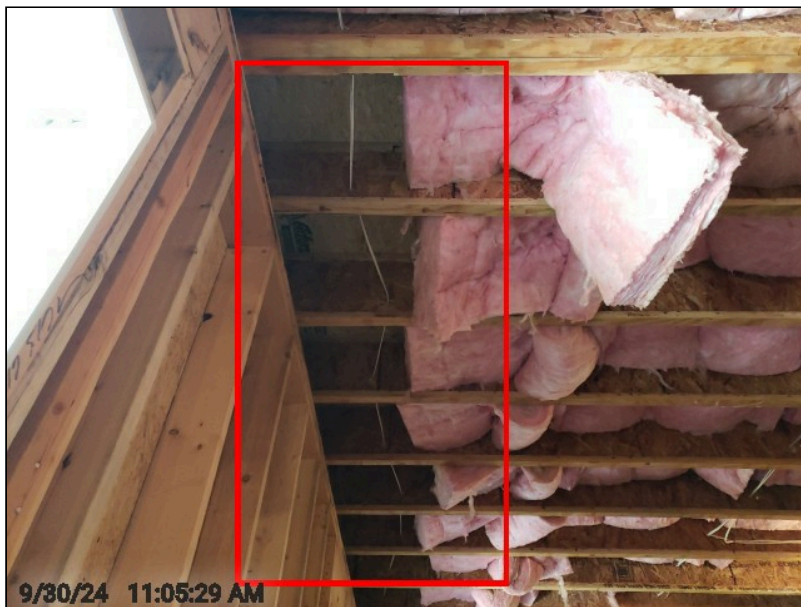
🏠 Insulation needs to be tucked in place where pulled back to tighten deck ledger bolts.

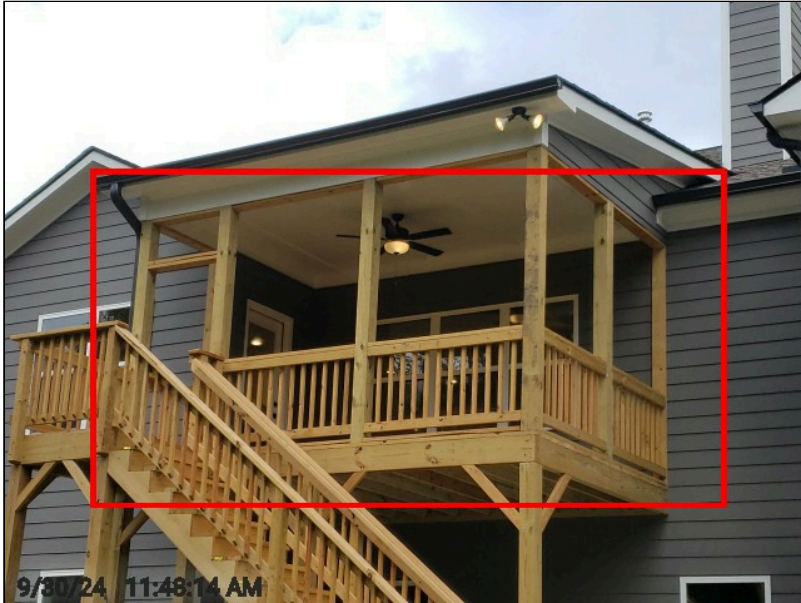
- (1) Screens are not installed on the deck. Per Buyer, screens are part of the house package. A qualified contractor needs to install screens.

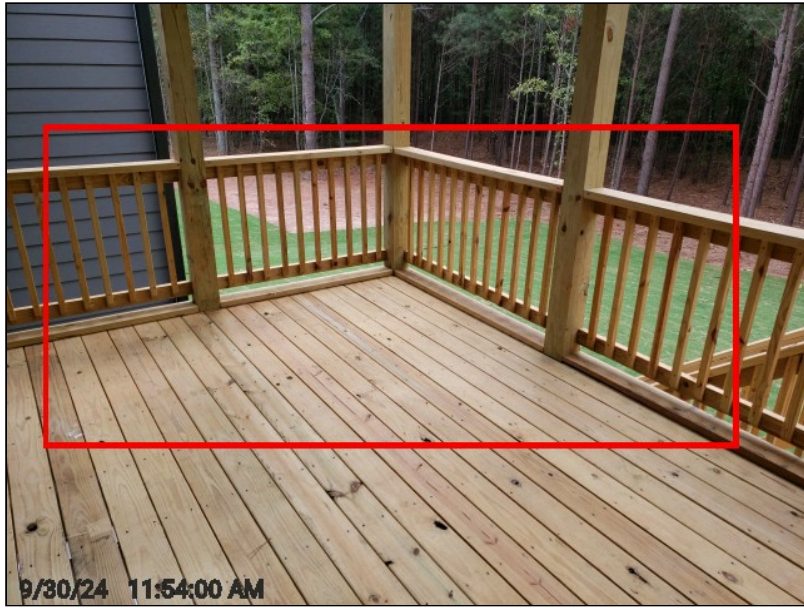
- (2) The pickets on the deck that are not nailed with 2 nails at the top of the pickets. Pickets need to be nailed with 2 nails at the top and 2 nails at the bottom. A qualified contractor needs to nail pickets.

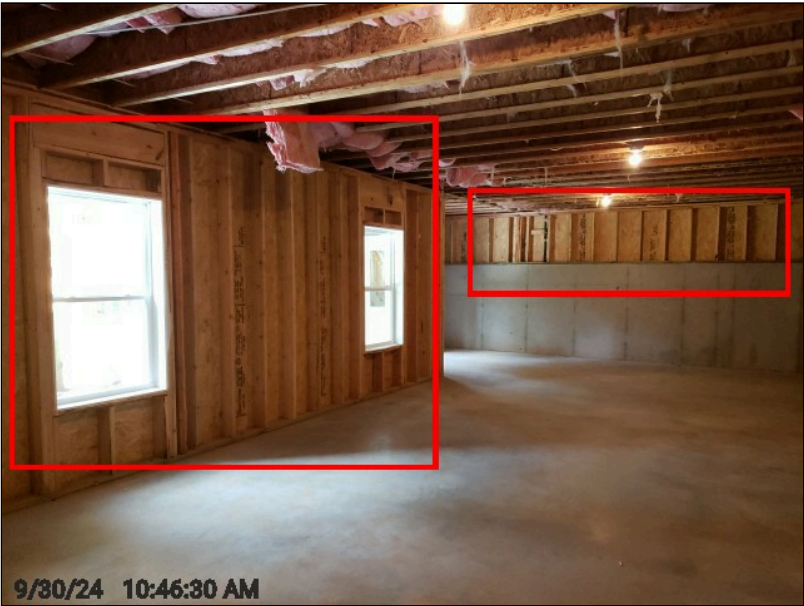
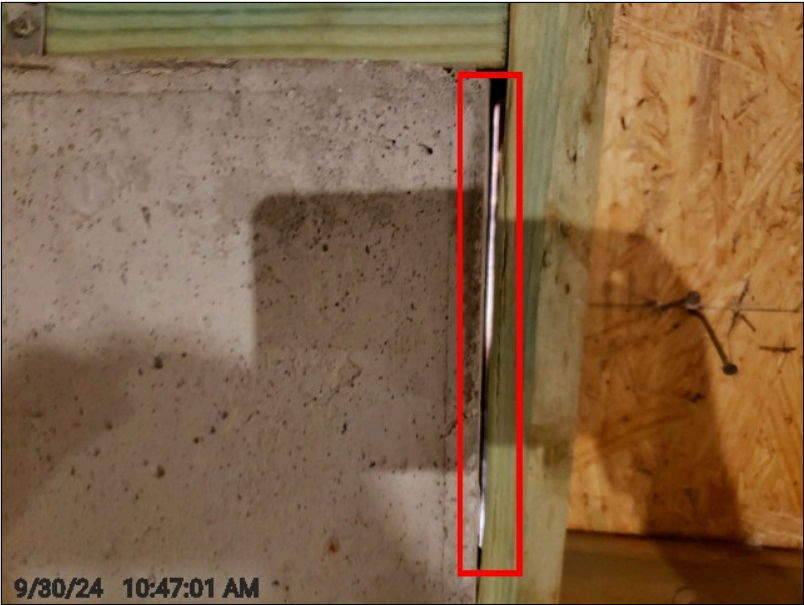
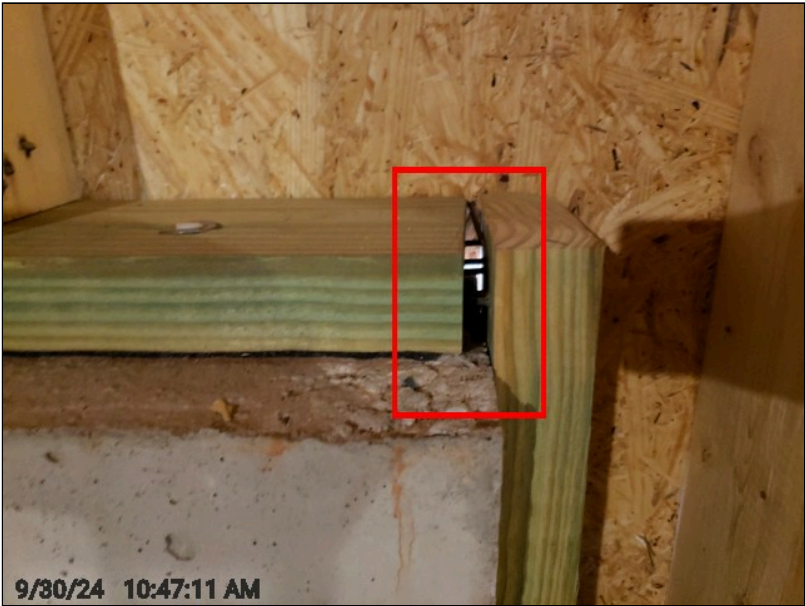
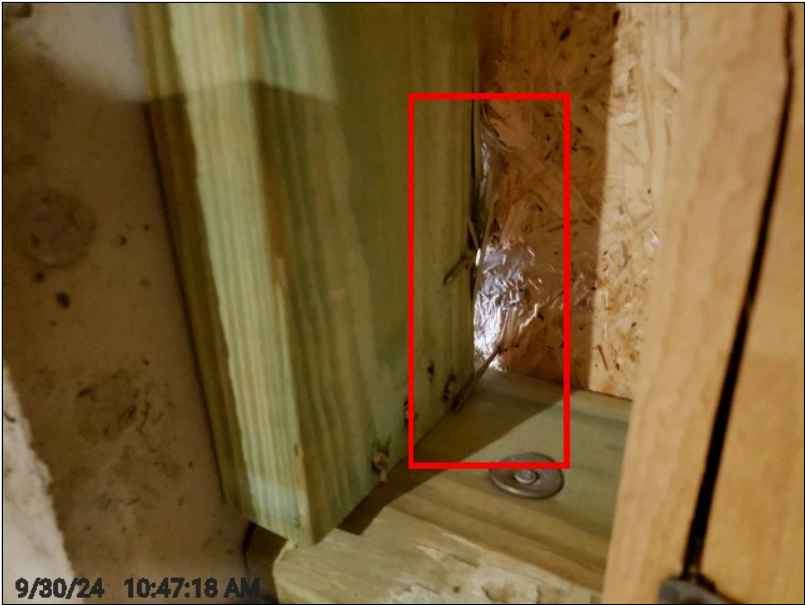
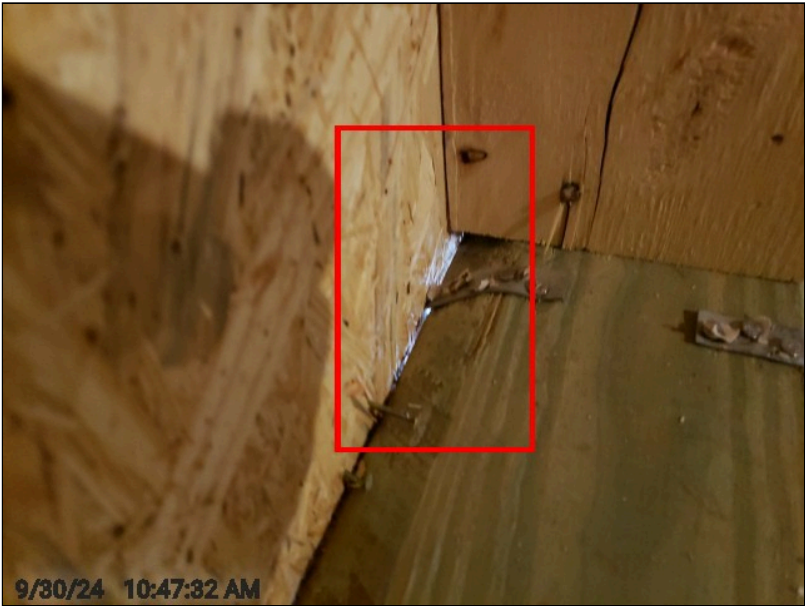
- 🏠 (1) The walls are not draft stopped in the basement. A qualified contractor needs to draft stop the walls.

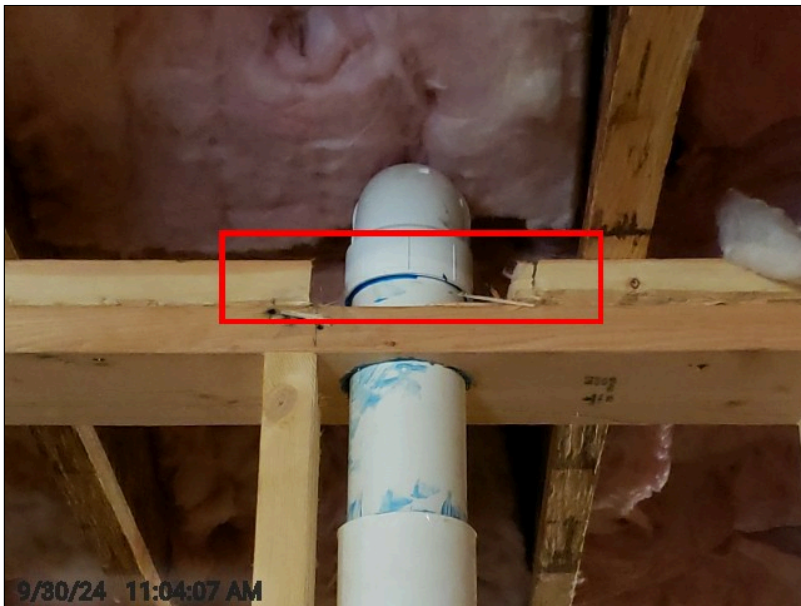
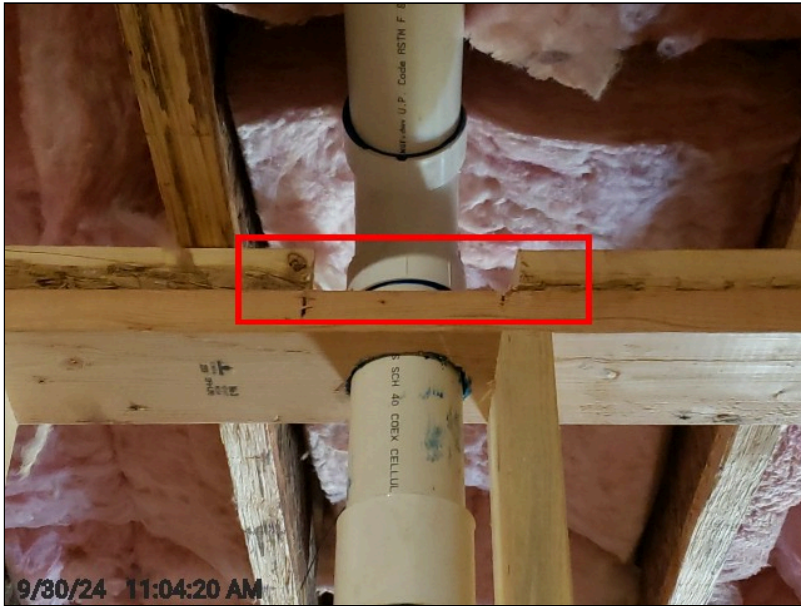
(3) Straps are needed on double top sill where the sill is cut for plumbing drain. A qualified contractor needs to install straps. Location(s): basement

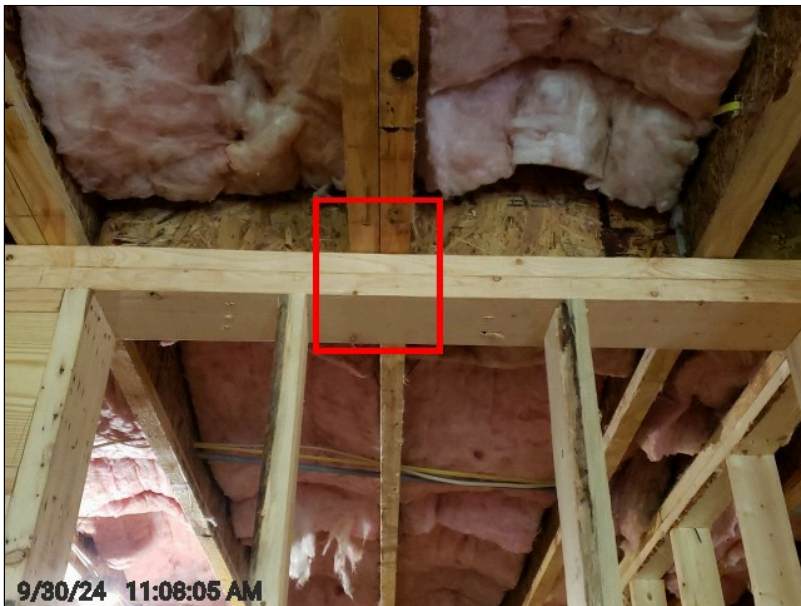
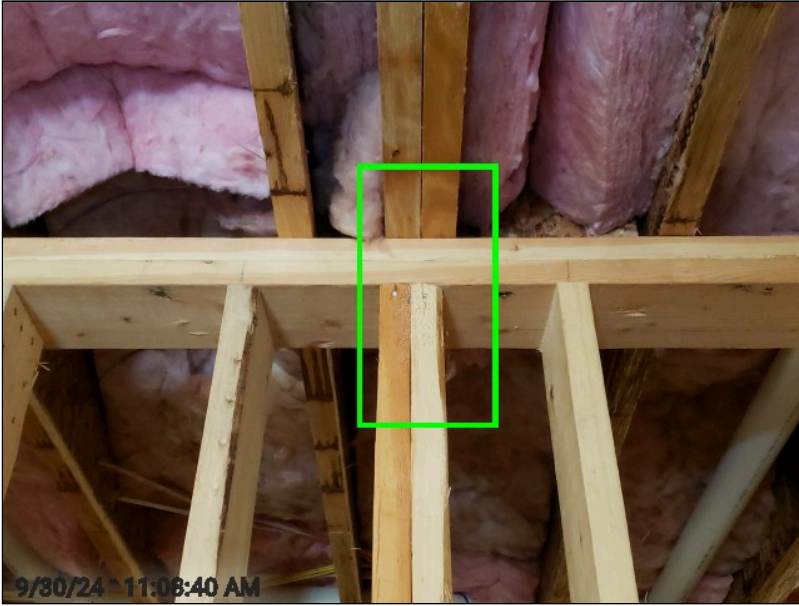
(4) All double joists need to be supported by double studs. A qualified contractor needs to repair.
Location(s): basement

(4) All double joists need to be supported by double studs. A qualified contractor needs to repair. Location(s): basement

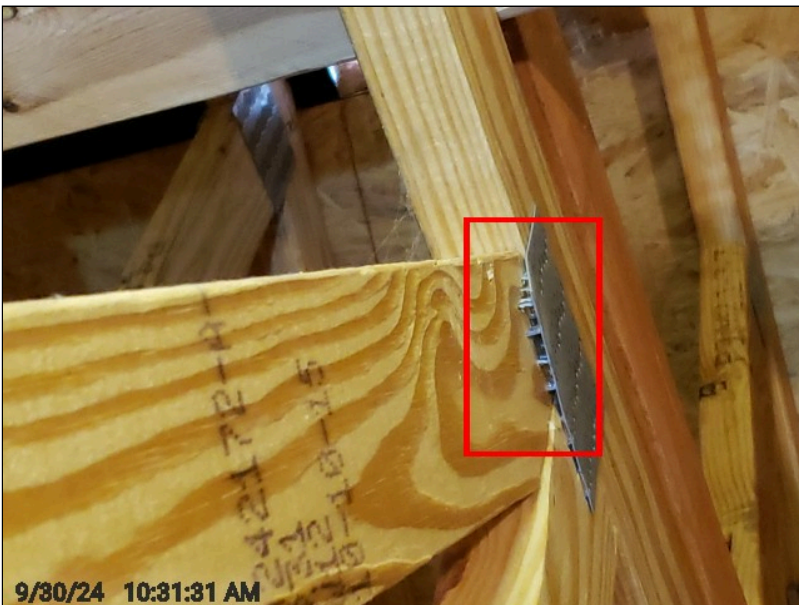
(1) Broken or loose gusset connection on truss(es) was observed in the attic. Gusset connections are part of the structural components of a truss. A licensed structural engineer needs to inspect further and design a repair plan. A qualified contractor needs to make repairs. A letter for the completed repairs needs to be provided to the buyer for their records.

(1) Broken or loose gusset connection on truss(es) was observed in the attic. Gusset connections are part of the structural components of a truss. A licensed structural engineer needs to inspect further and design a repair plan. A qualified contractor needs to make repairs. A letter for the completed repairs needs to be provided to the buyer for their records.
-

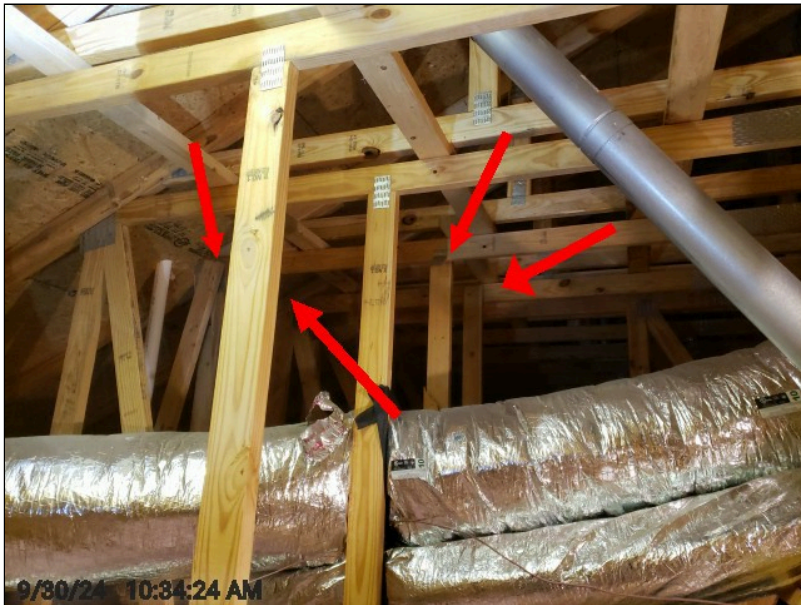
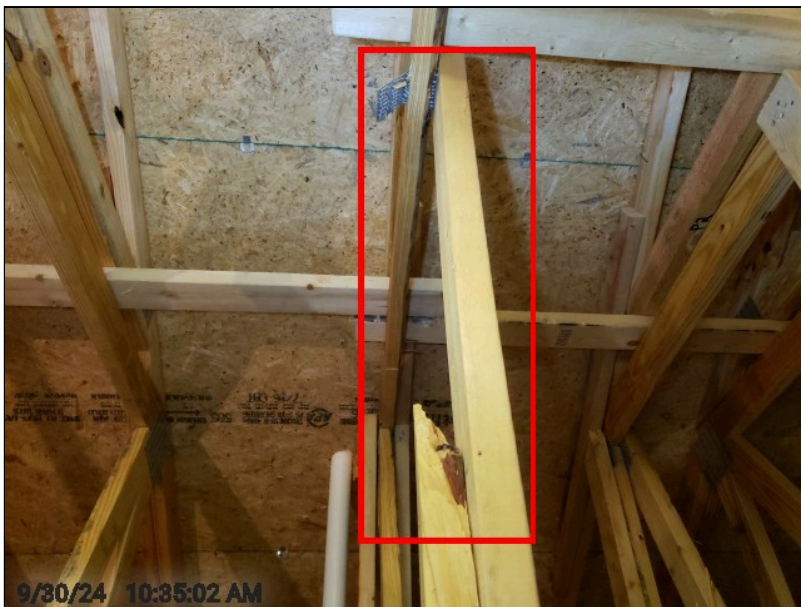
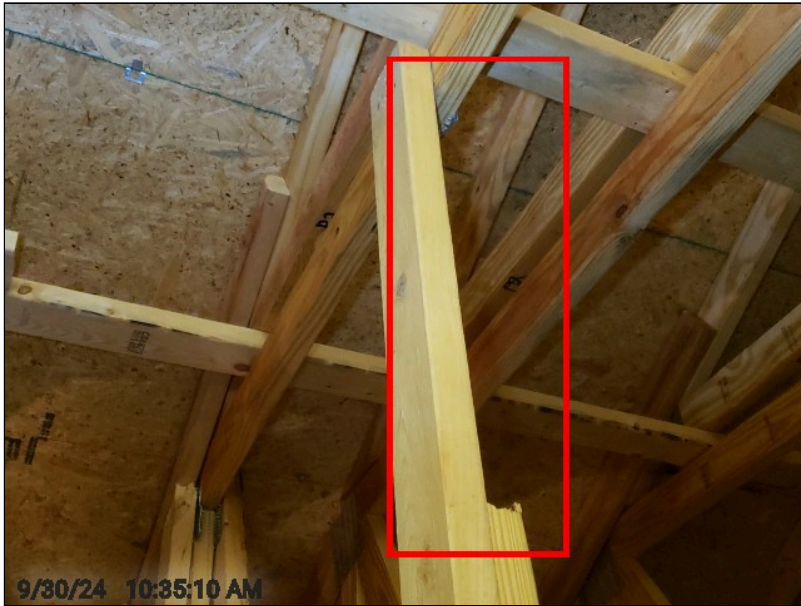
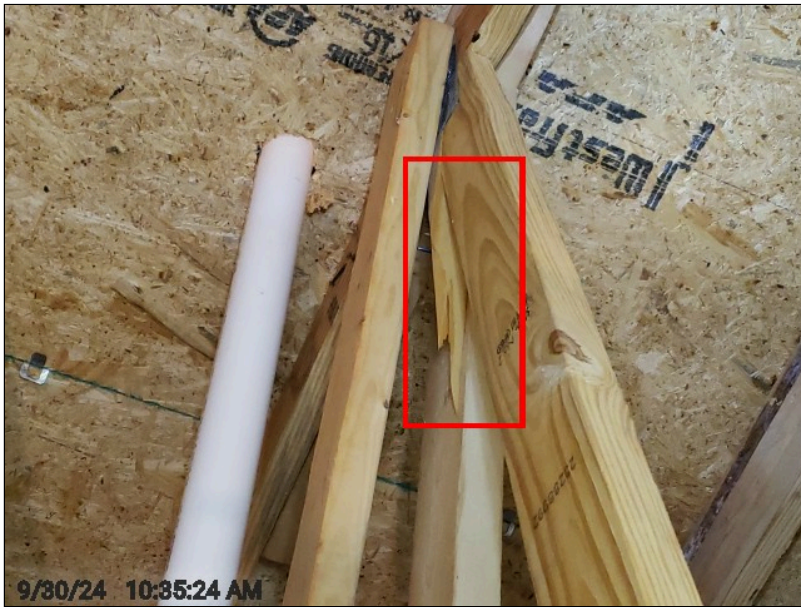
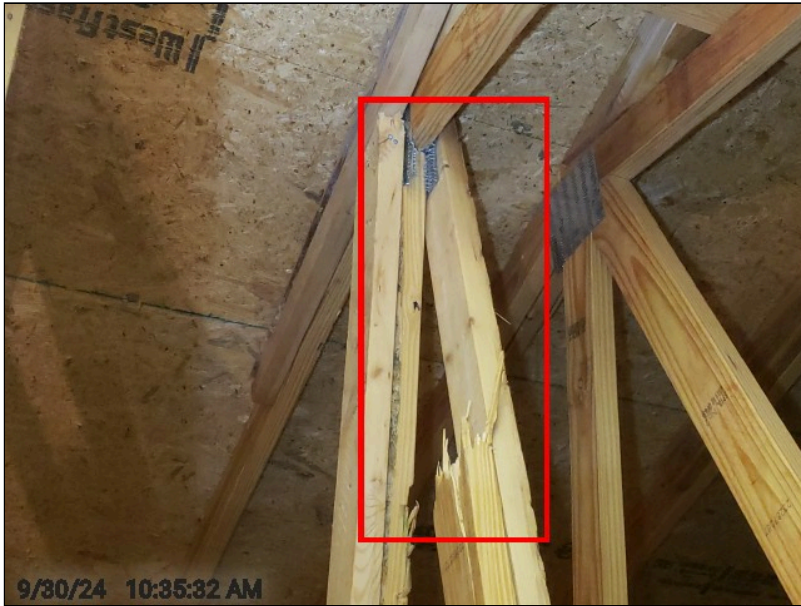
- 🏠 (2) Broken truss was observed in the attic. When a truss is broken the structural integrity of the truss is compromised. A licensed structural engineer needs to inspect further and design a repair plan. A qualified contractor needs to make repairs. A letter for the completed repairs needs to be provided to the buyer for their records.

(2) Broken truss was observed in the attic. When a truss is broken the structural integrity of the truss is compromised. A licensed structural engineer needs to inspect further and design a repair plan. A qualified contractor needs to make repairs. A letter for the completed repairs needs to be provided to the buyer for their records.

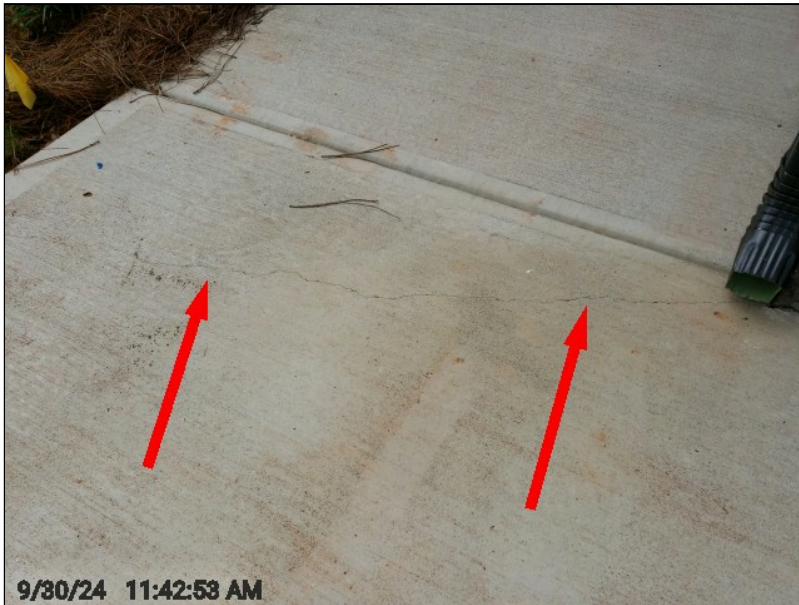
All cracks in the sidewalk need to be sealed with a concrete sealant.

All cracks in the sidewalk need to be sealed with a concrete sealant.
