Inspection Report

2345 Main St

Marion Hodges Home Inspection Services

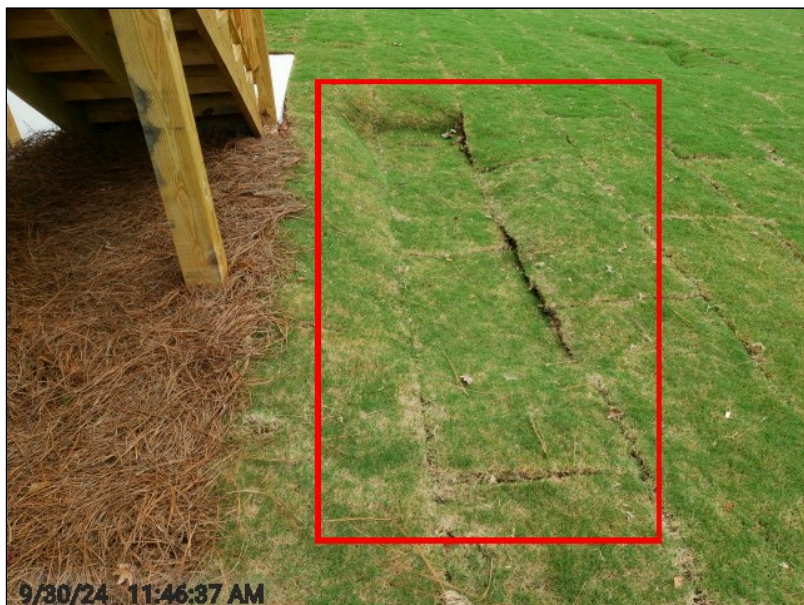
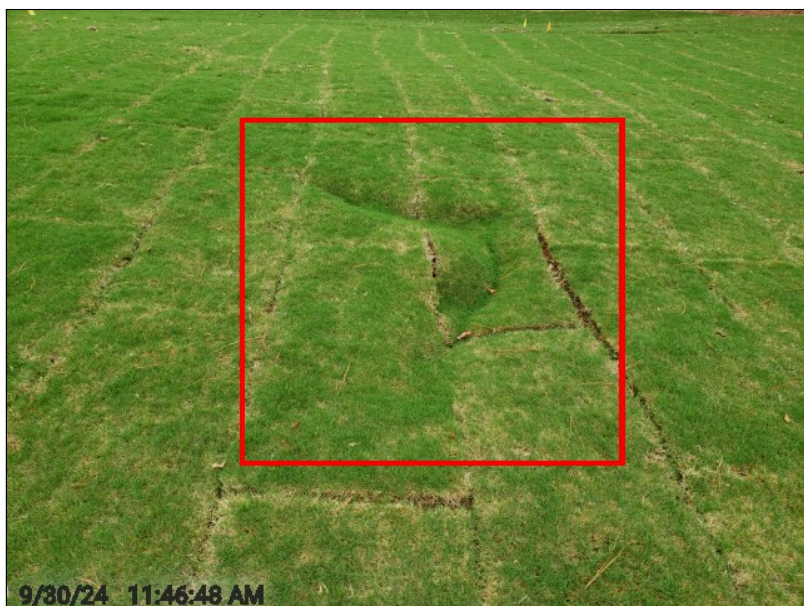
- Water runoff is washing out soil. A qualified contractor needs to evaluate further and make repairs to control water runoff. Location(s): back of the house

Water runoff is washing out soil. A qualified contractor needs to evaluate further and make repairs to control water runoff. Location(s): back of the house

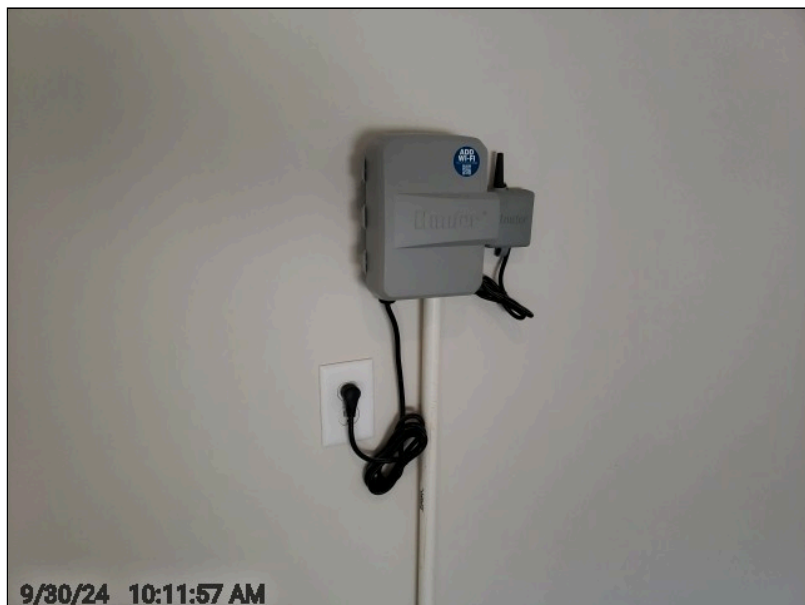
- 🏠 The lawn sprinkler system was not tested. Testing the system is outside the ASHI standards of inspections. The builder needs to demonstrate normal operation of the system.

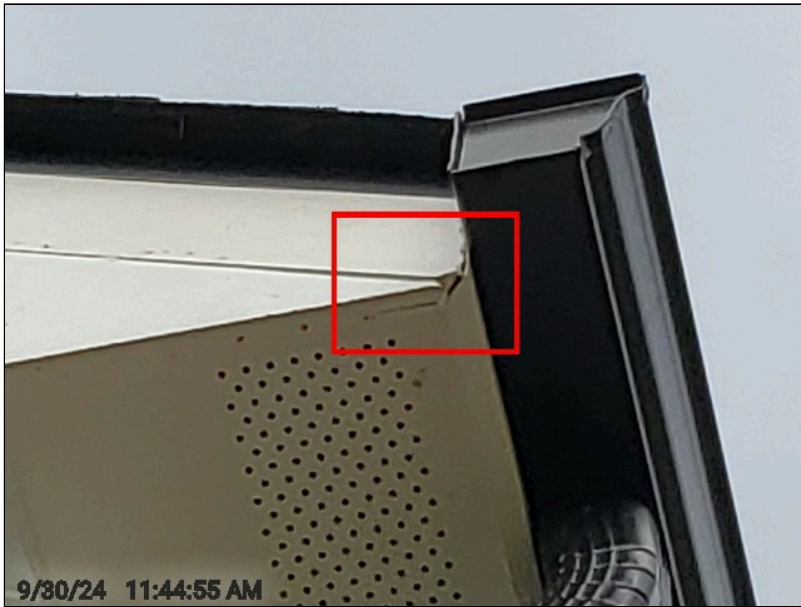
The trim needs to be caulked. A qualified contractor needs to caulk and paint trim. Location(s): front

left corner

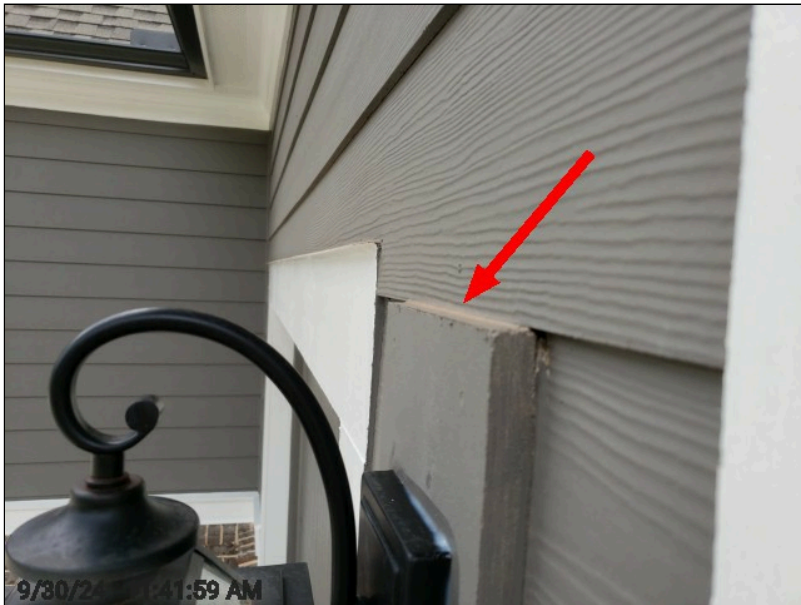
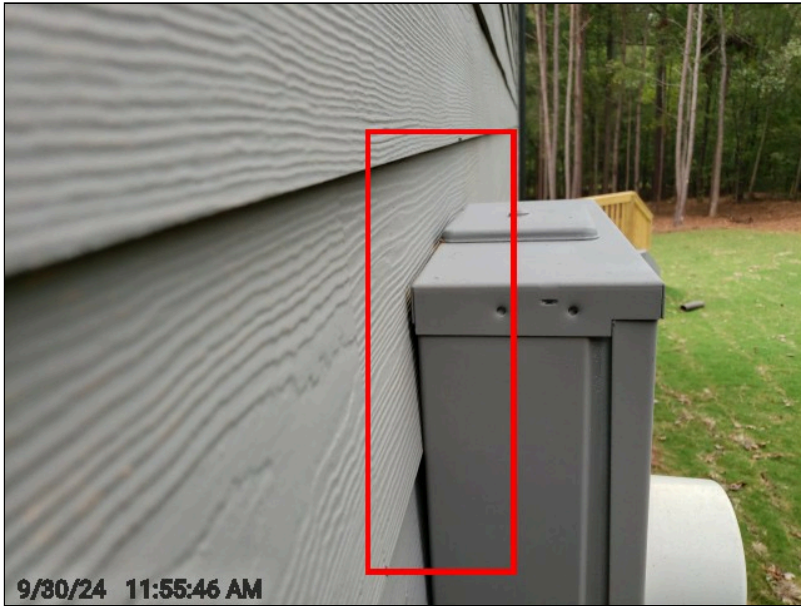
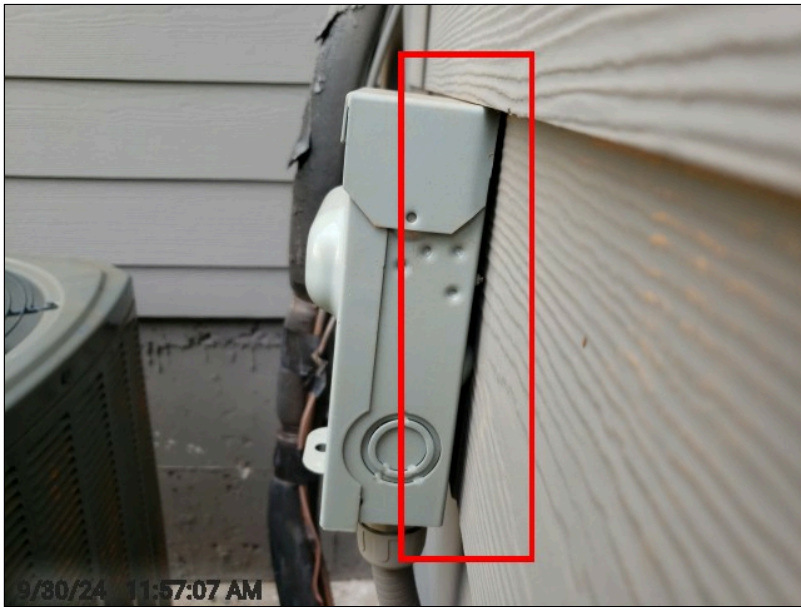
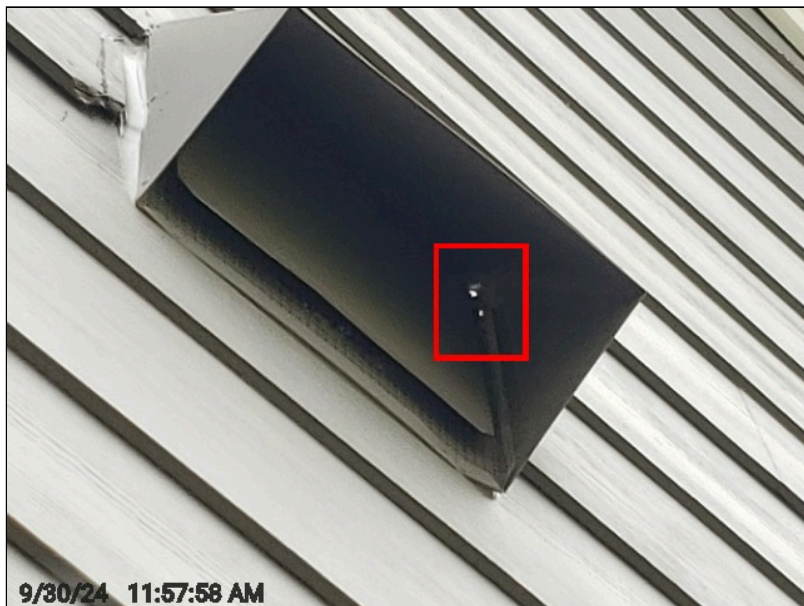
All utility penetrations through the exterior wall should be caulked or filled with foam. The following utility penetrations should be caulked or filled with foam to limit air infiltration: block at front light fixture, meter base, ac disconnect box, exhaust vent

All utility penetrations through the exterior wall should be caulked or filled with foam. The following utility penetrations should be caulked or filled with foam to limit air infiltration: block at front light fixture, meter base, ac disconnect box, exhaust vent

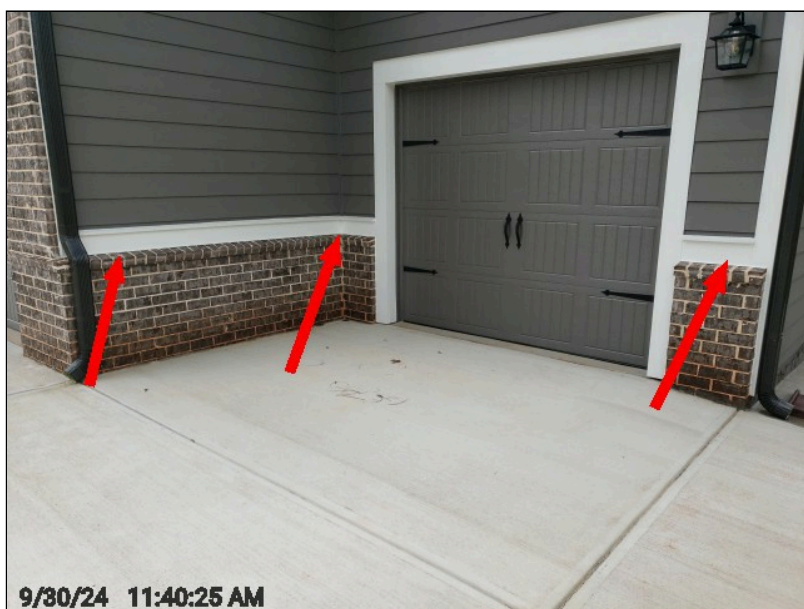
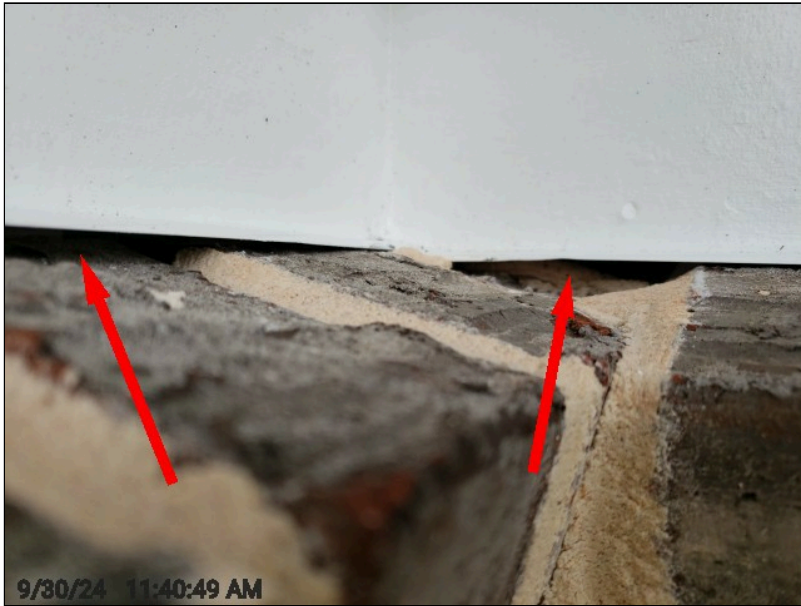
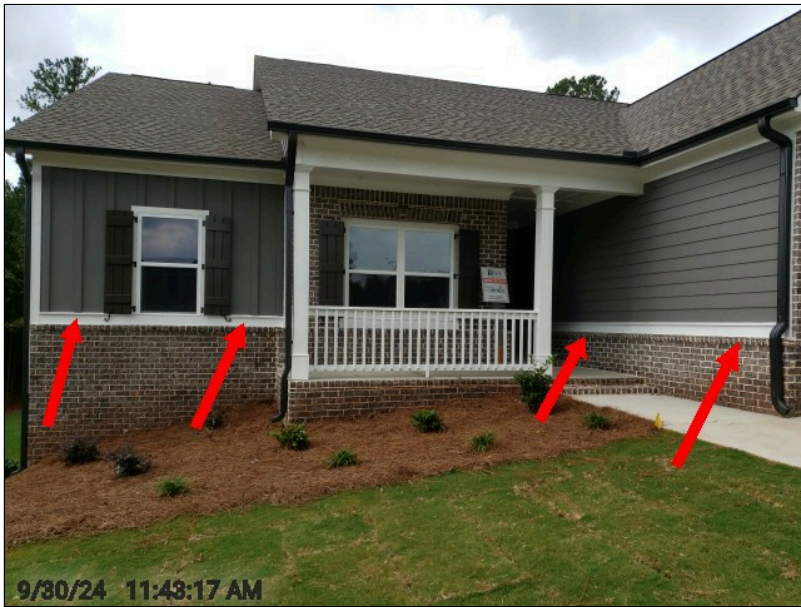
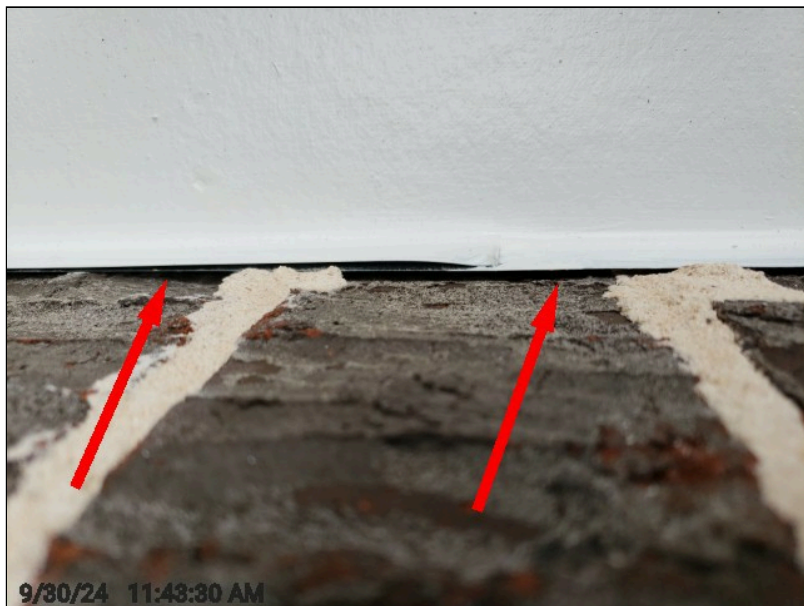
The drip edge flashing needs to be caulked to the brick to prevent water from leaking into concealed wall space. A qualified contractor needs to repair. The pictures shown are a representative.

The drip edge flashing needs to be caulked to the brick to prevent water from leaking into concealed wall space. A qualified contractor needs to repair. The pictures shown are a representative.

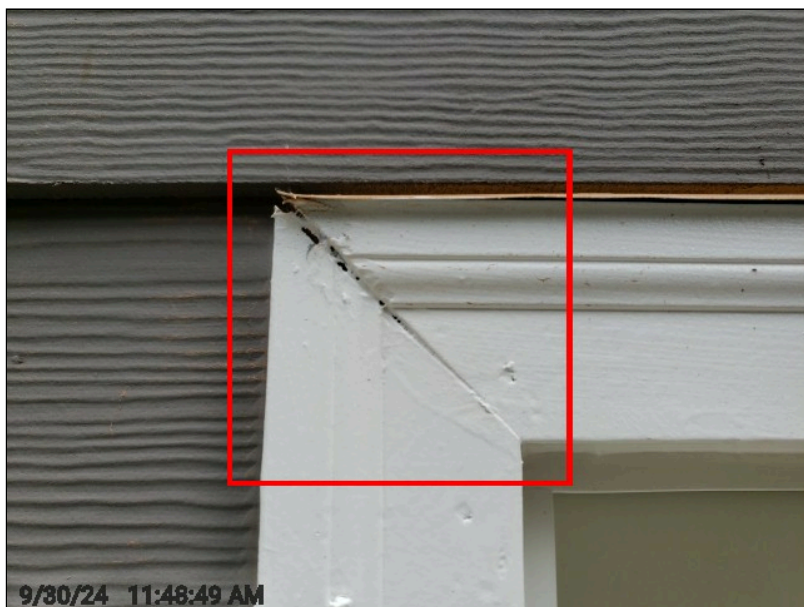
- 🏠 (1) Door trim needs to be caulked. A qualified contractor needs to caulk trim to prevent air intrusion or moisture penetration. Location(s): basement door

(1) Door trim needs to be caulked. A qualified contractor needs to caulk trim to prevent air intrusion or moisture penetration. Location(s): basement door
-

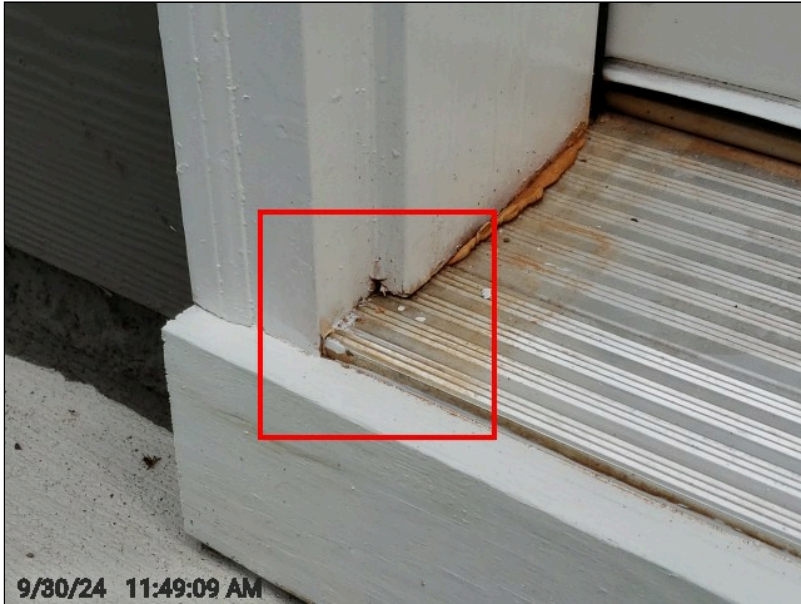
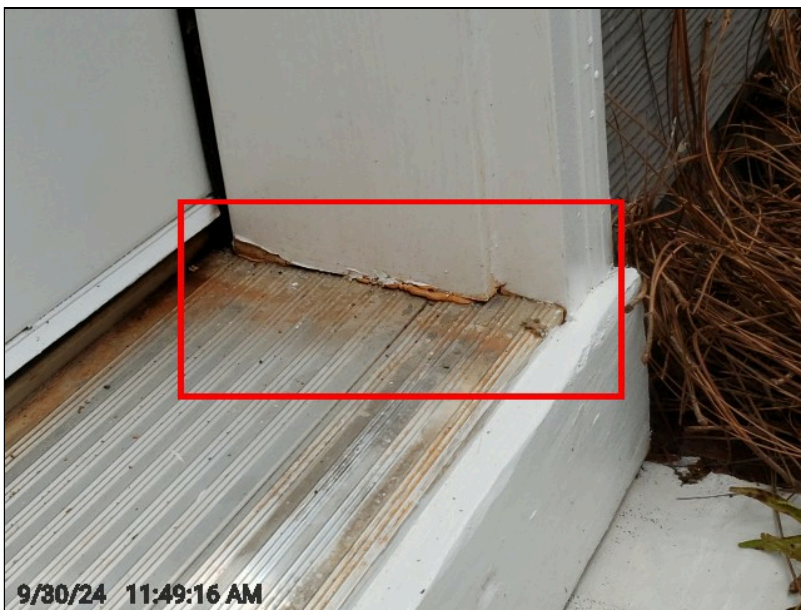
(2) Joint between the door jambs and threshold needs to be caulked. A qualified contractor needs to caulk door jambs and threshold to prevent air intrusion or moisture penetration. Location(s): basement door

(2) Joint between the door jambs and threshold needs to be caulked. A qualified contractor needs to caulk door jambs and threshold to prevent air intrusion or moisture penetration. Location(s): basement door

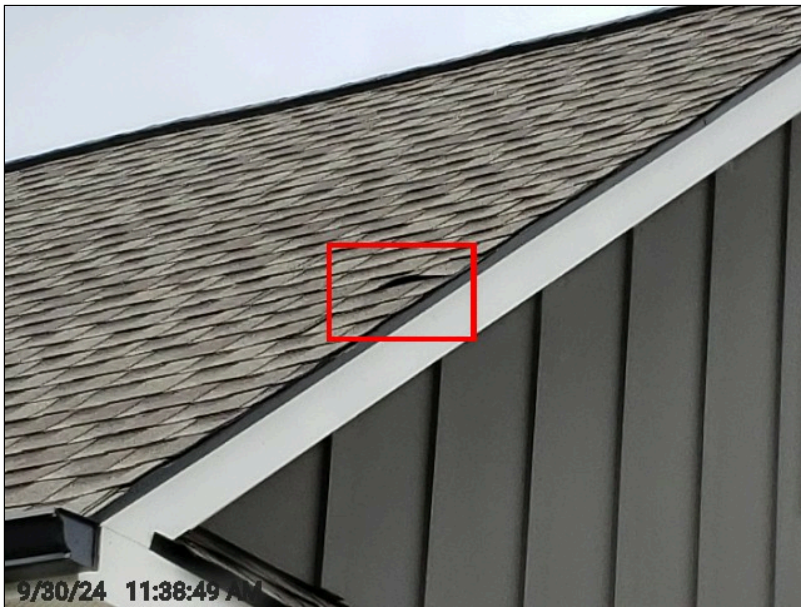
There are uplifted shingles on the roof. Picture(s) are examples. A qualified roofer needs to repair.

There are uplifted shingles on the roof. Picture(s) are examples. A qualified roofer needs to repair.

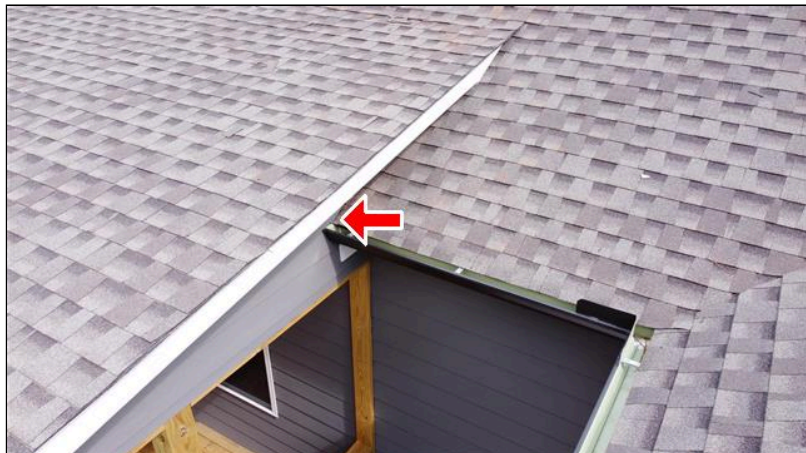
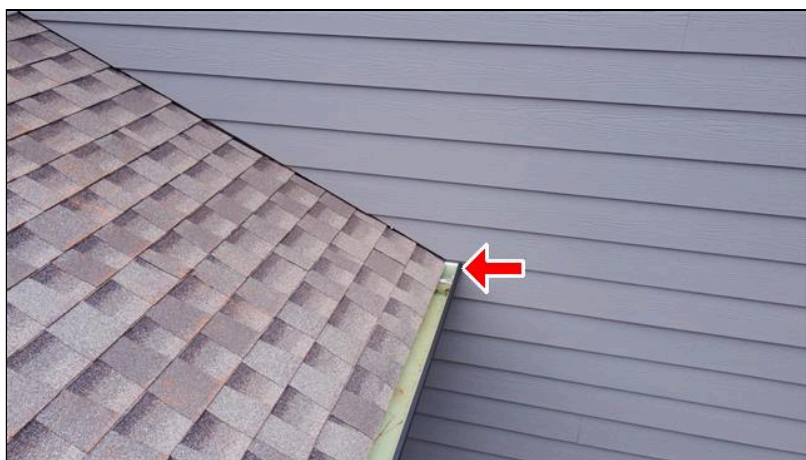
- 🏠 Kickout flashing needs to be installed to divert water into the gutters. Flashing is needed to prevent water from penetrating into the wall structure. Picture(s) are examples. A qualified roofer needs to repair.

Kickout flashing needs to be installed to divert water into the gutters. Flashing is needed to prevent water from penetrating into the wall structure. Picture(s) are examples. A qualified roofer needs to repair.

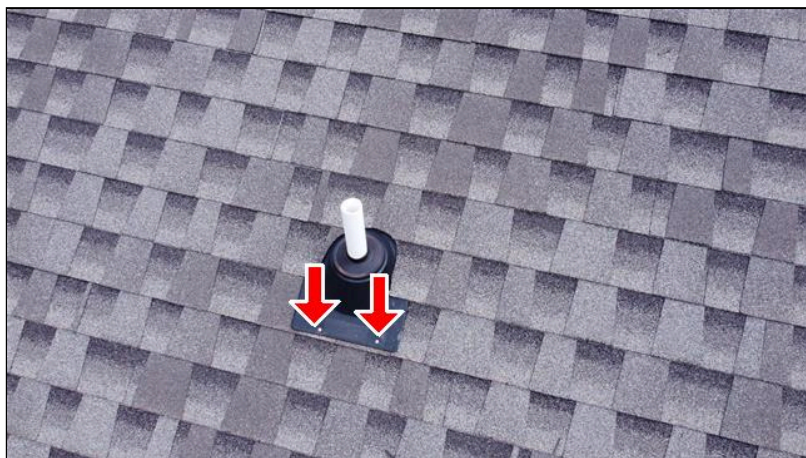
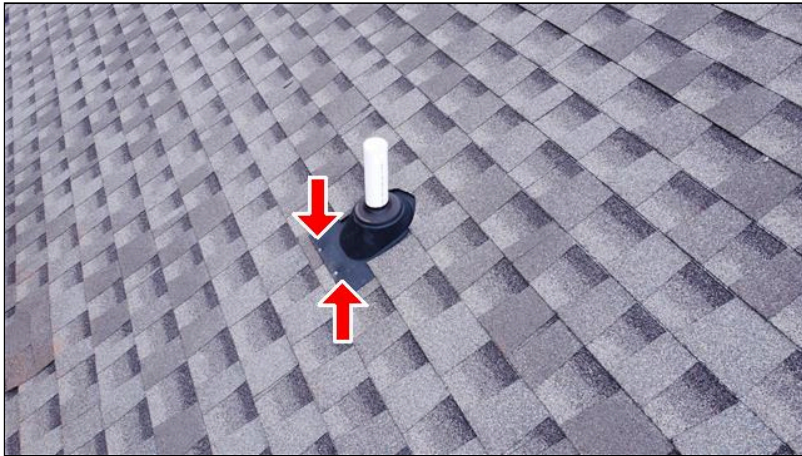
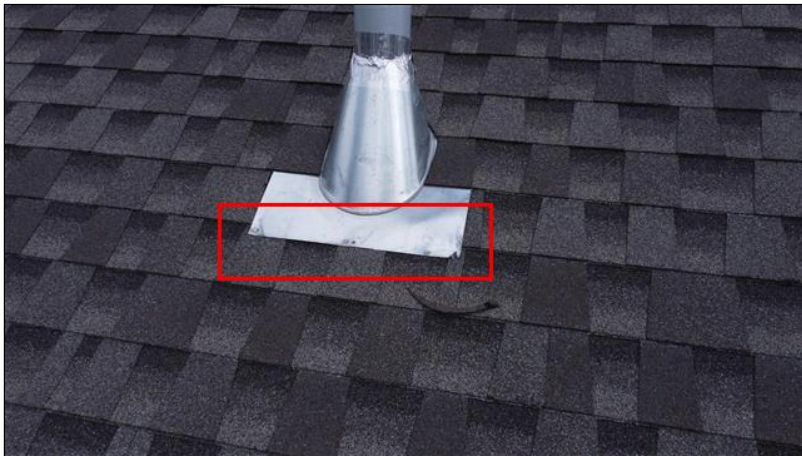
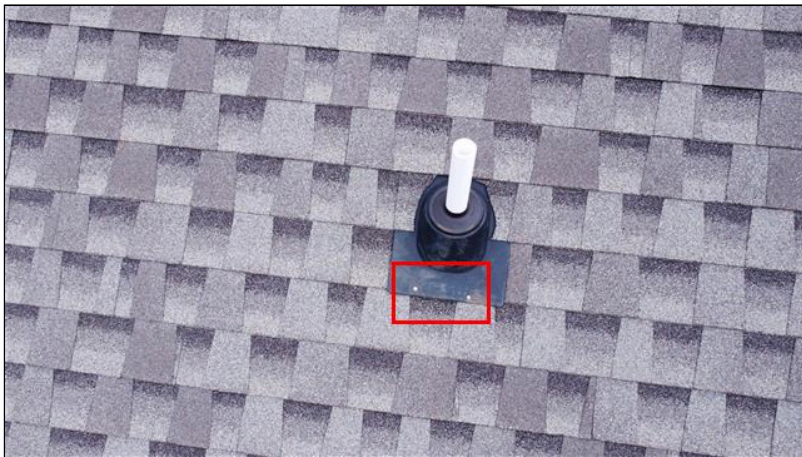
- 🏠 Nail heads on the vent flashings are not sealed. All exposed nail heads should be sealed with a roofing sealant. A qualified roofer needs to repair. Location(s): plumbing boot

Nail heads on the vent flashings are not sealed. All exposed nail heads should be sealed with a roofing sealant. A qualified roofer needs to repair. Location(s): plumbing boot

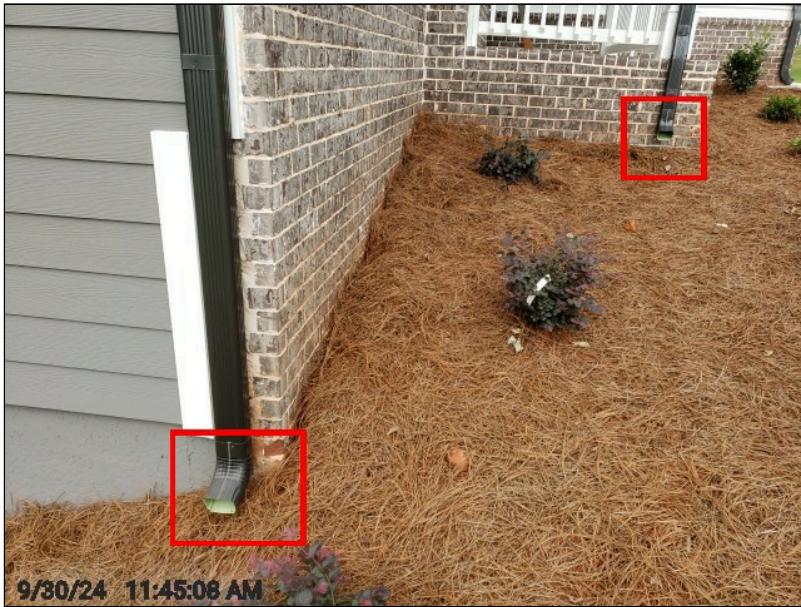
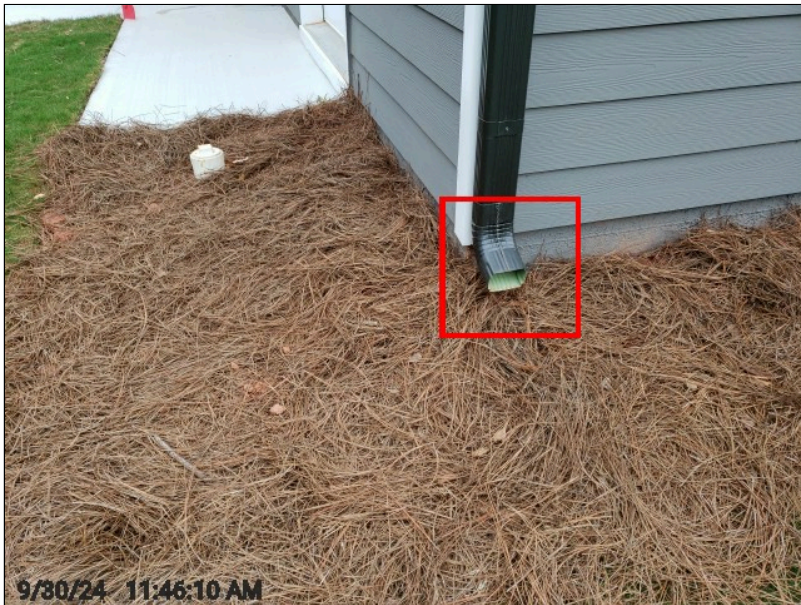
🏠 All downspouts need to be piped at least 5 to 10 feet away from the foundation.
