# Inspection Report

3456 Main St

**Marion Hodges Home Inspection Services**

10/31/2024

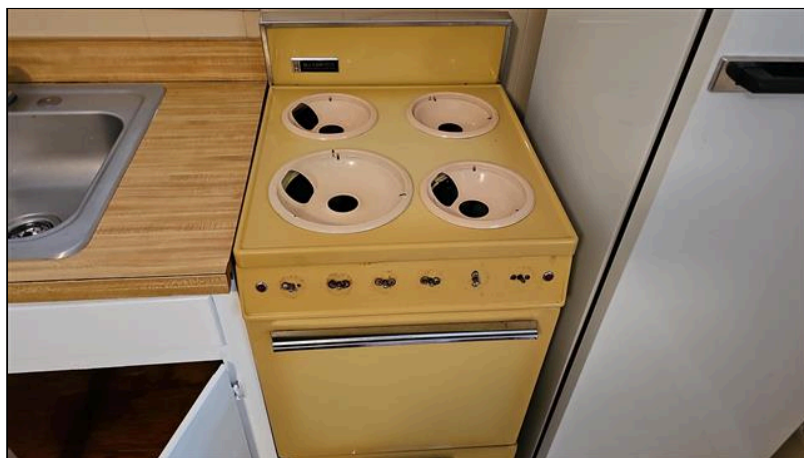
The gas range in the basement is not functional. A qualified contractor needs to replace the range.

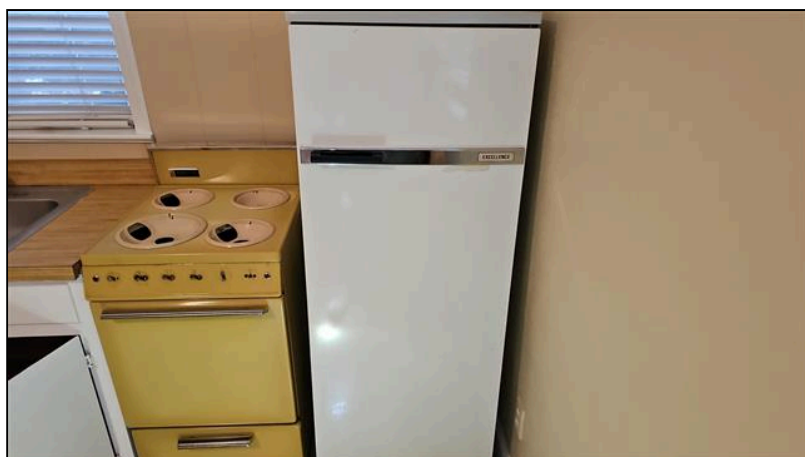
- 🏠 The refrigerator in the basement was not plugged in. The home inspector does not plug in items that are not in working order. The refrigerator appears to be beyond life expectancy. Replacement is recommended.

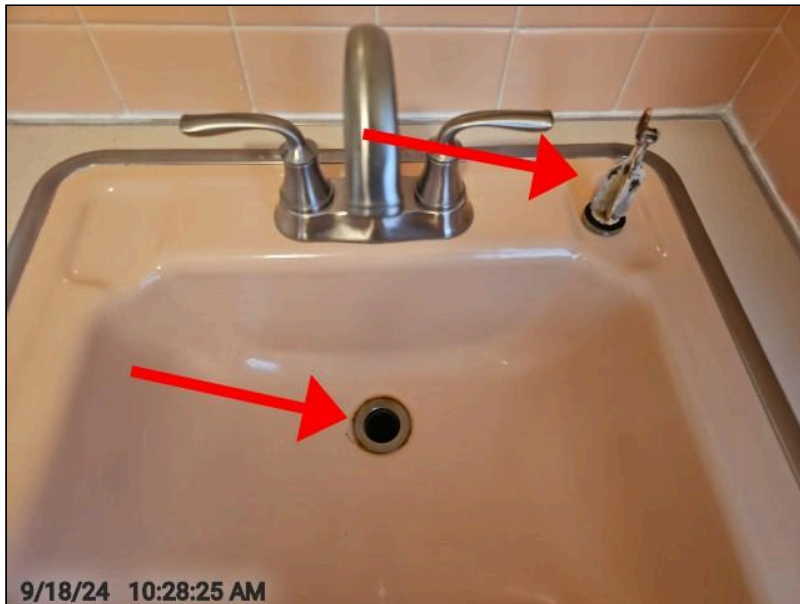
- 🏠 (1) The sink drain stopper rod is disconnected from the drain assembly. A licensed plumbing contractor needs to connect stopper rod. Location(s): shared bath

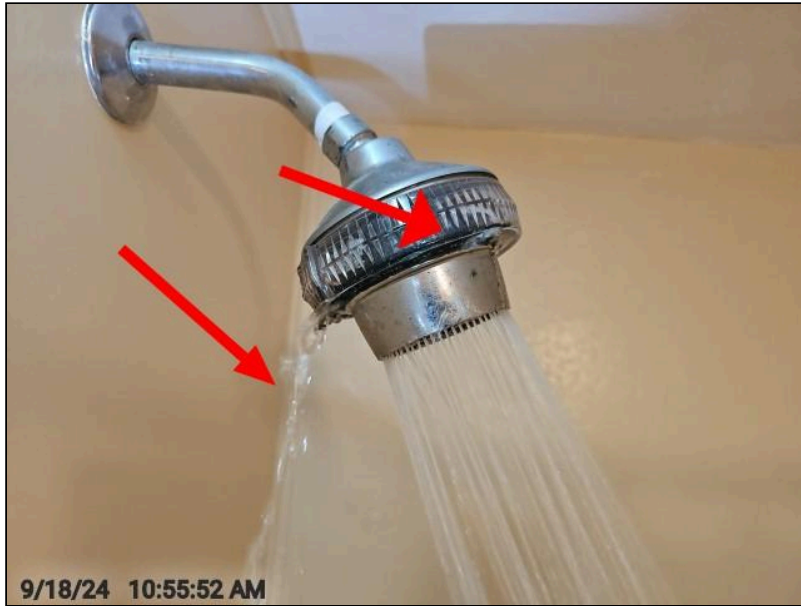
- 🏠 (1) The showerhead leaks at connections. Tighten showerhead or replace showerhead. Location(s): hall bath

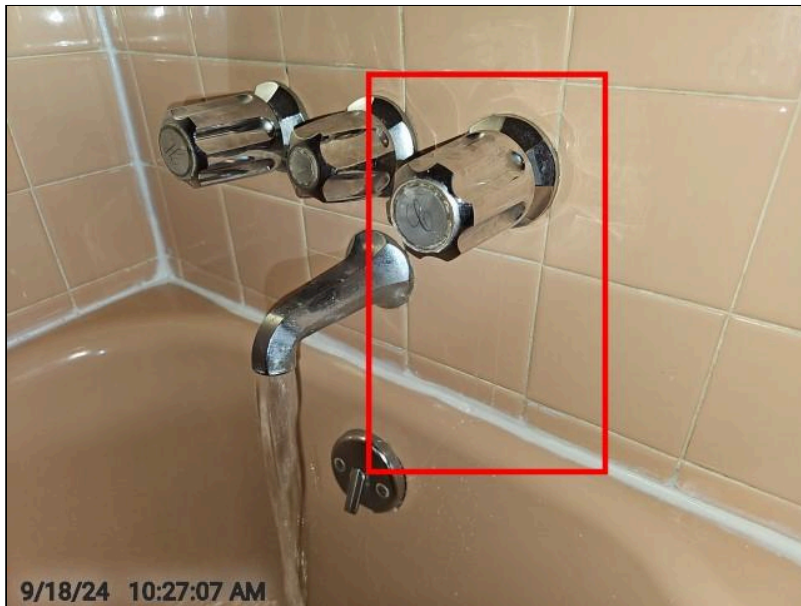
(2) The valve stem leaks on the tub fixture. A licensed plumbing contractor needs to repair or replace fixture. Location(s): shared bath

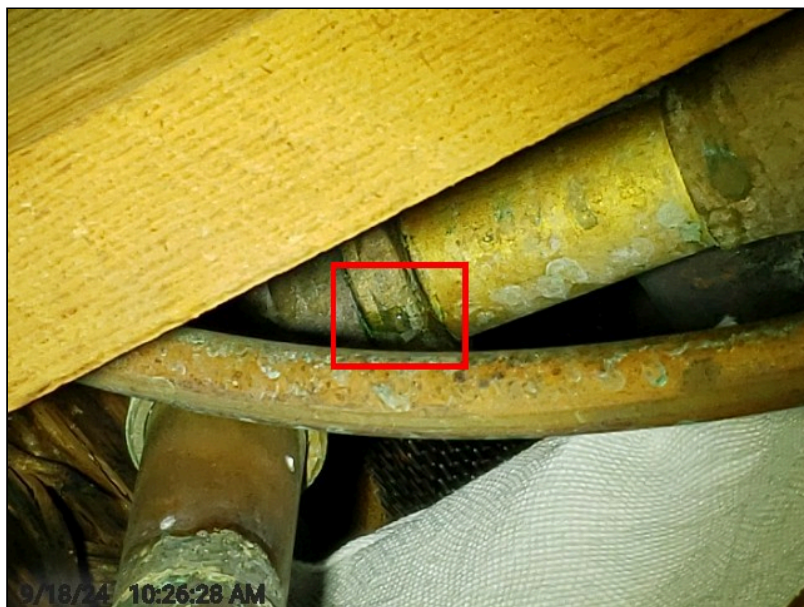
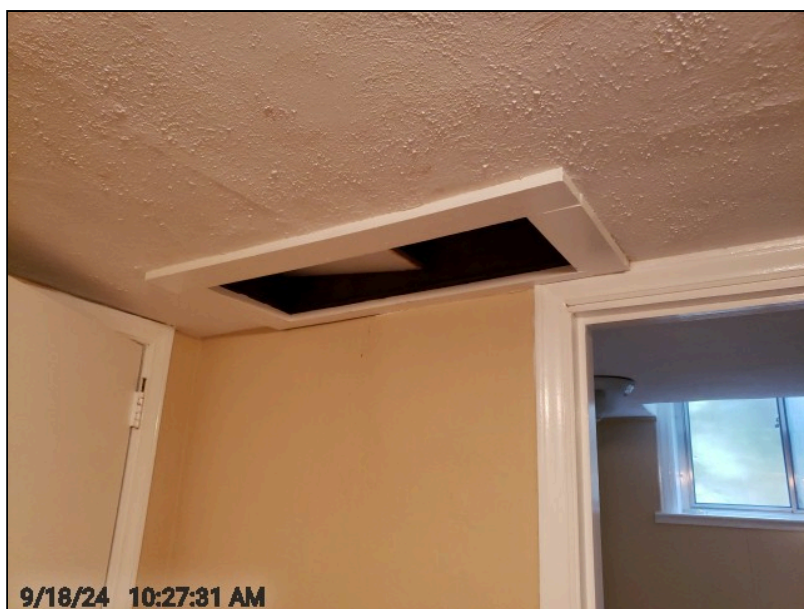
- 🏠 (3) The tub is slow draining. A licensed plumbing contractor needs to inspect further and repair. Location(s): shared bath
- 🏠 (4) The tub drain pipe is leaking. A licensed plumbing contractor needs to repair. Location(s): front bath the leak is visible from the access in the basement

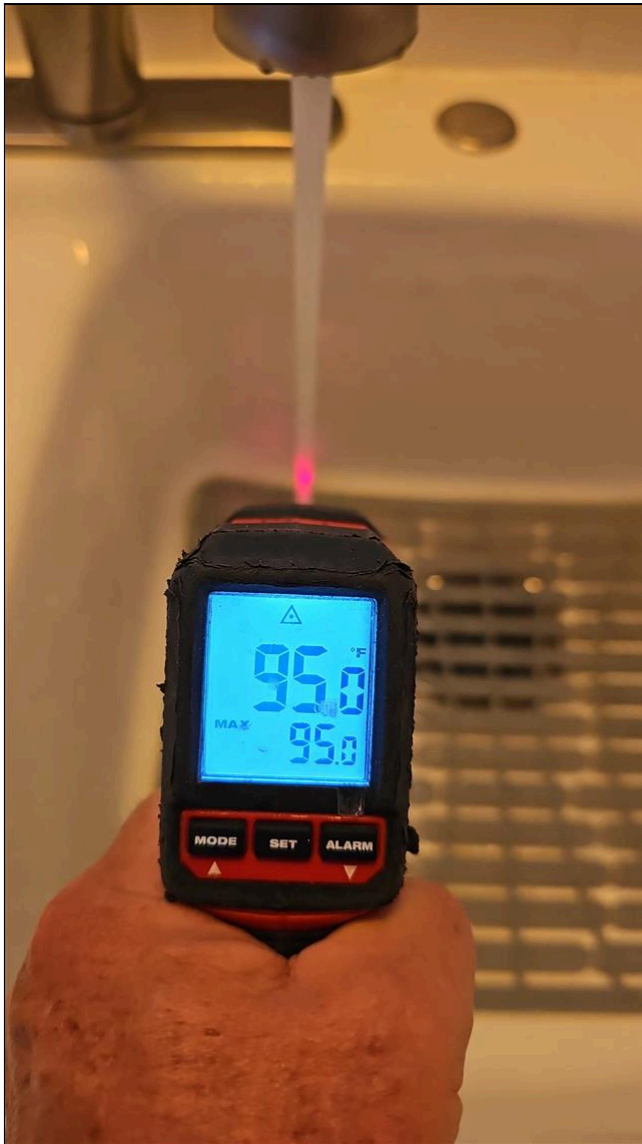
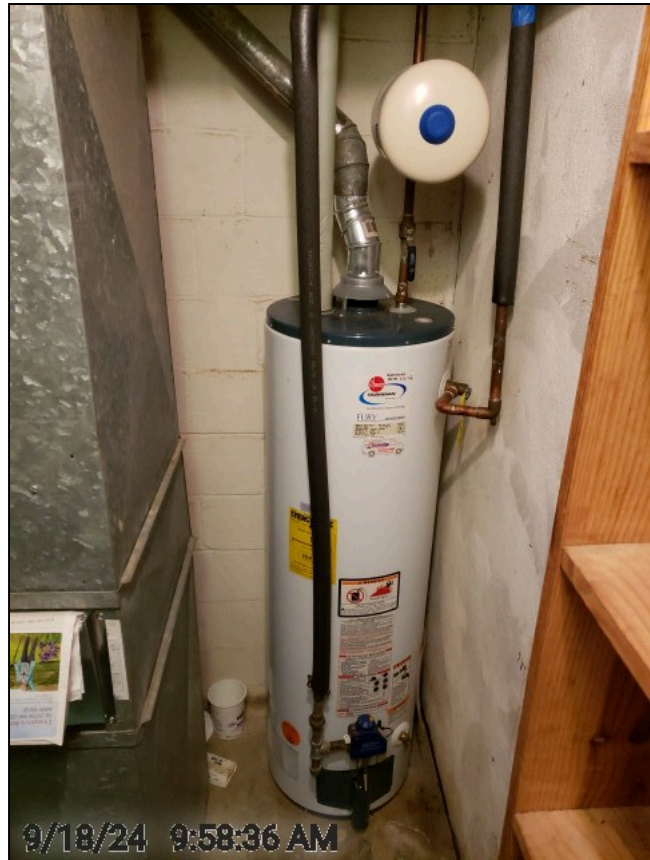
Water Heater and Thermal Expansion Tank

🏠 The water heater is at or beyond average life expectancy of 10 to 12 years. Future replacement should be anticipated. Recommend putting a water detection device near the water heater to alert you in the event there is a leak. The inspector makes no warranties or guarantees as to how long the water heater or any components of the water heater will last.

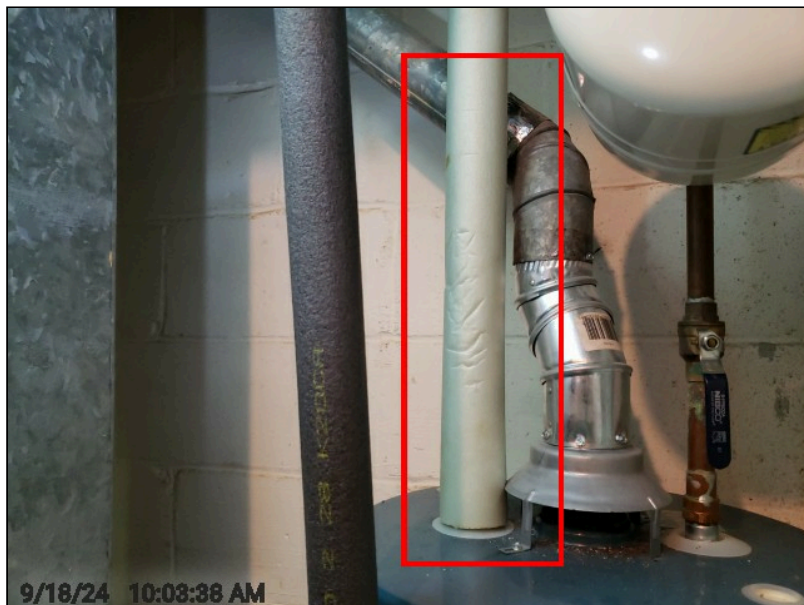
- 🏠 (1) The foam insulation is too close to the vent pipe. Water heater vent pipe needs to have 6 inches of clearance from combustible materials with single wall vent pipe. The foam insulation should be removed.

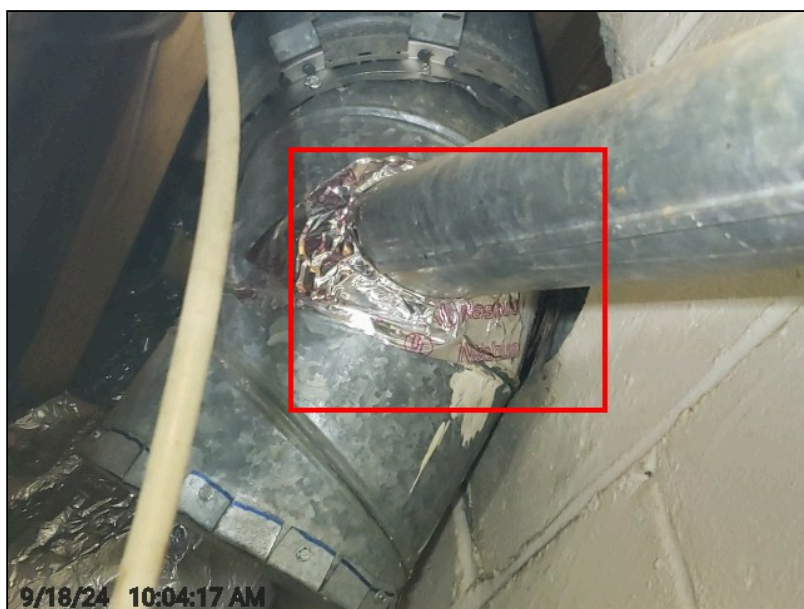
- 🏠 (2) The connections on the water heater vent pipe are held together with foil tape. Foil tape will fail due to heat from vent pipe. The vent connections should be screwed together. A licensed plumbing contractor needs to screw the connections together.

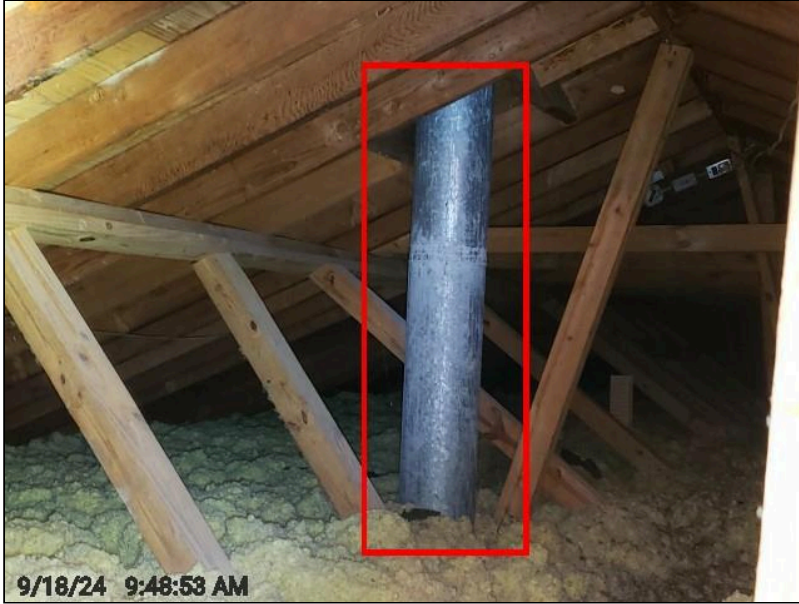
- 🏠 (3) White powder was observed on the water heater vent pipe. This is a sign of an incomplete venting of toxic combustion gases or back drafting. This is a safety issue. A licensed plumbing contractor needs to inspect further and repair. Location(s): attic

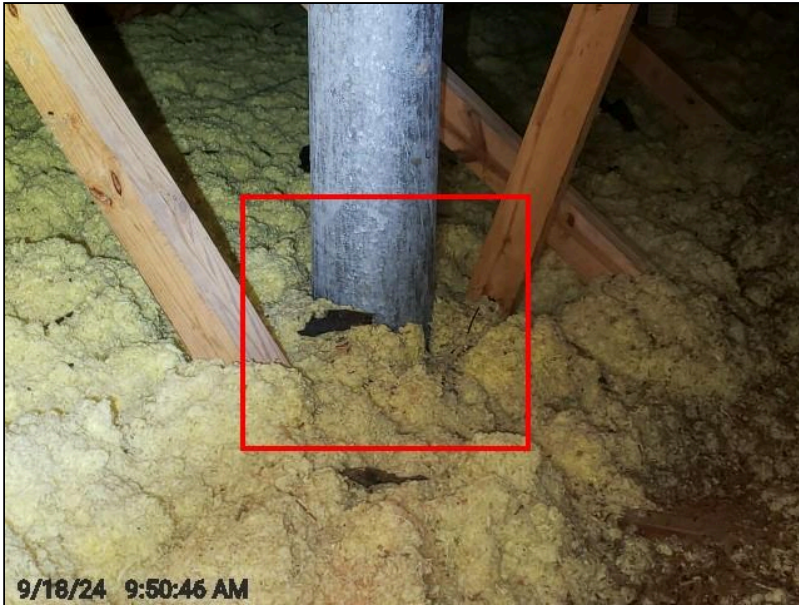
- 🏠 (4) Water heater vent pipe in the attic should have a one inch clearance from combustable materials. This is a safety issue. A qualified contractor needs to provide a one inch clearance from the insulation.

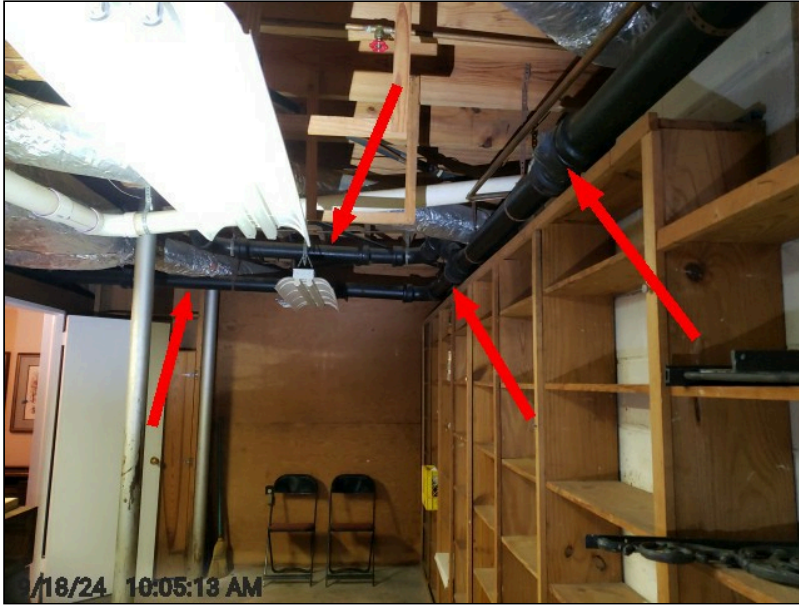
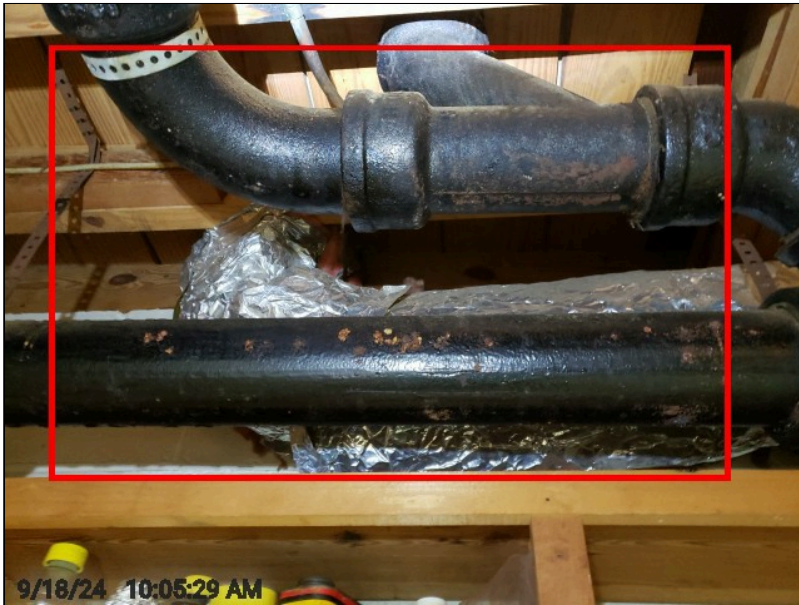
- 🏠 (1) The cast iron drain pipes are nearing life expectancy. Rust/corrosion observed on a lot of pipes. A licensed plumbing contractor needs to evaluate further.

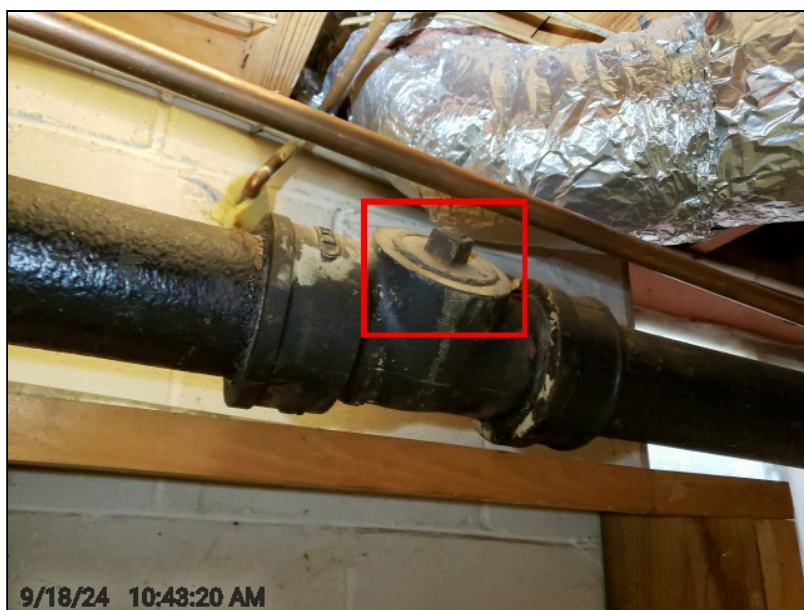
🏠 (3) Cleanout cap needed on the building drain.

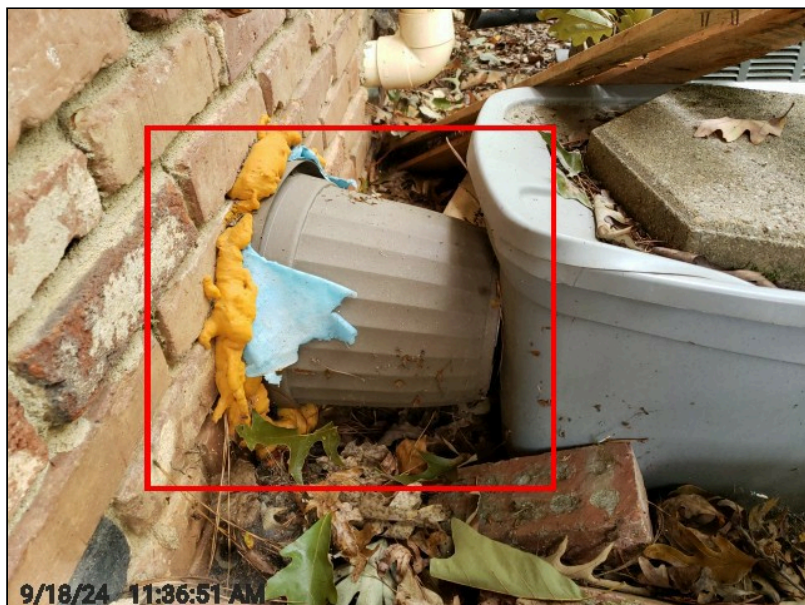
- 🏠 The back hose bibb is sealed off with a pot and spray foam. The hose bibb needs to be put in normal working order by a licensed plumbing contractor.

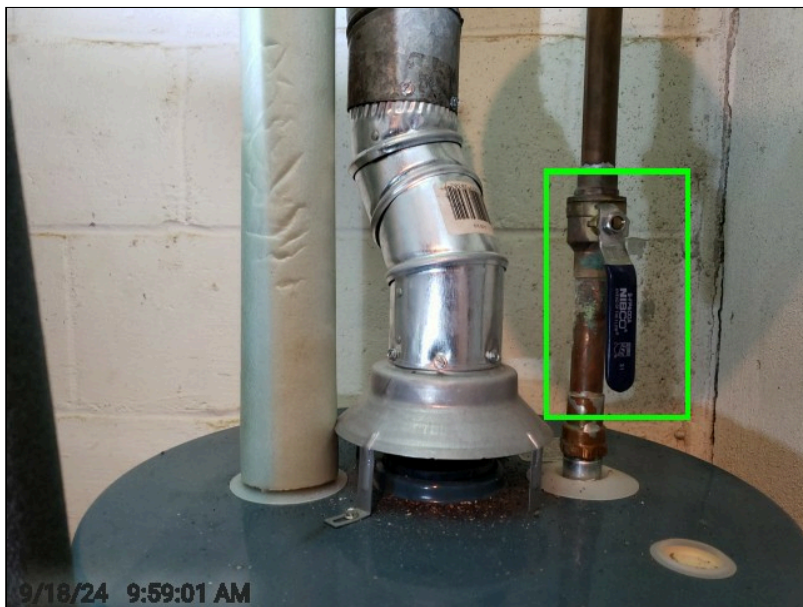
(2) Location of main water cut off to water heater (See Photo).

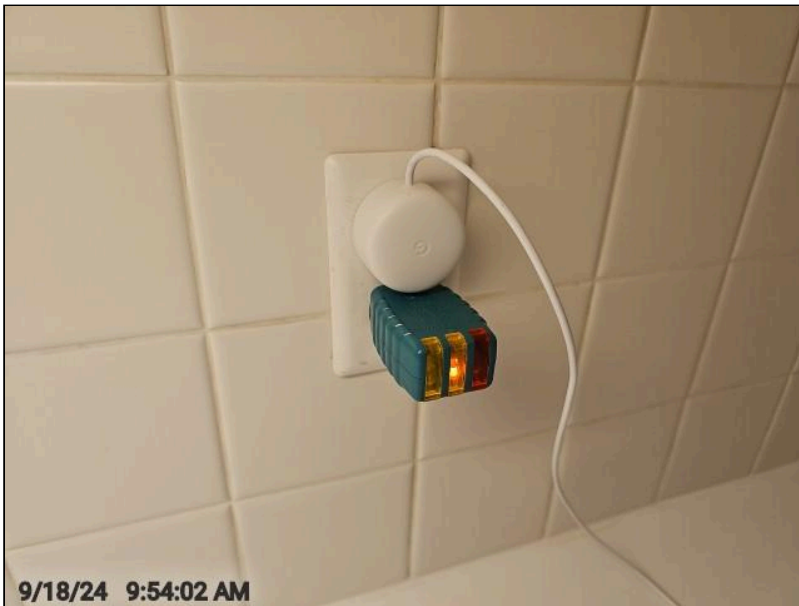
- 🏠 (1) Painted receptacles need to be replaced. A licensed electrician needs to replace the receptacles. Location(s): throughout house
- 🏠 (2) The receptacles are 2 prong receptacles connected to a 2 wire cable without ground. A licensed electrician needs to add at least one grounded receptacle in all rooms.
- 🏠 (3) Receptacle wired with open ground connection. A licensed electrician needs to repair. Location(s): kitchen

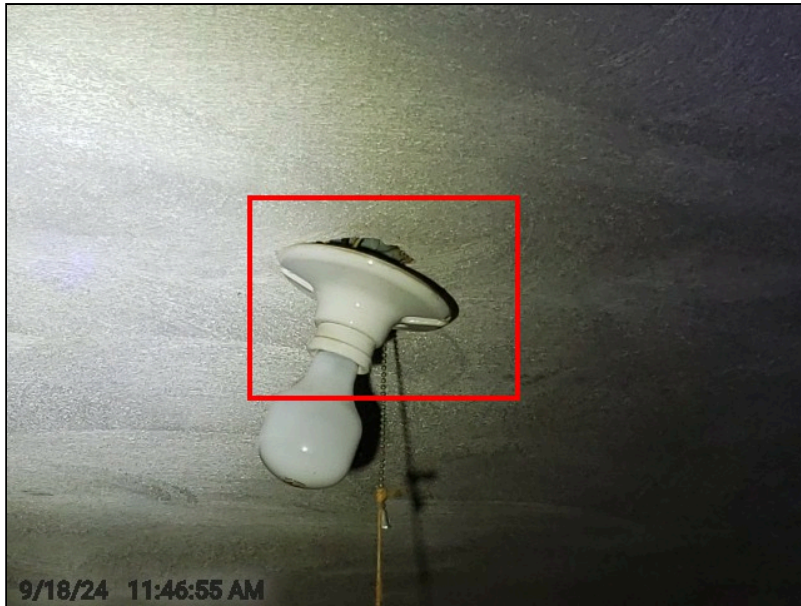
- 🏠 (1) Light fixture is missing globe. Location(s): laundry
- 🏠 (2) Exposed incandescent light fixtures are no longer approved for closets. A licensed electrician needs to replace fixture with a light with a globe or an LED light fixture.
- 🏠 (3) Light fixture is not secured to the outlet box. A licensed electrician needs to secure fixture to outlet box. Location(s): storage room

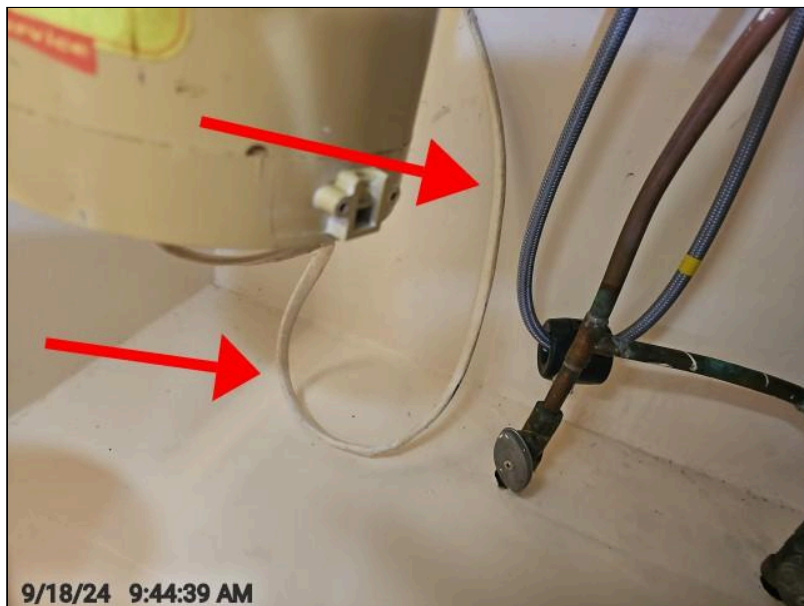
(1) The exposed cable to the disposal is subject to physical damage. Cable that is subject to physical damage should be in conduit. A licensed electrician needs to put the cable in conduit.

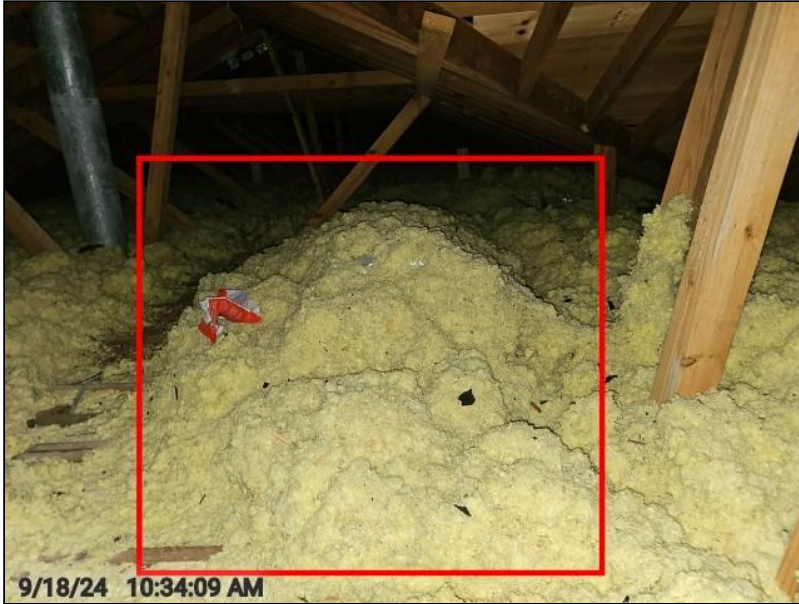
- (2) The whole house attic fans are covered over with insulation. The fans do not appear to be operational.

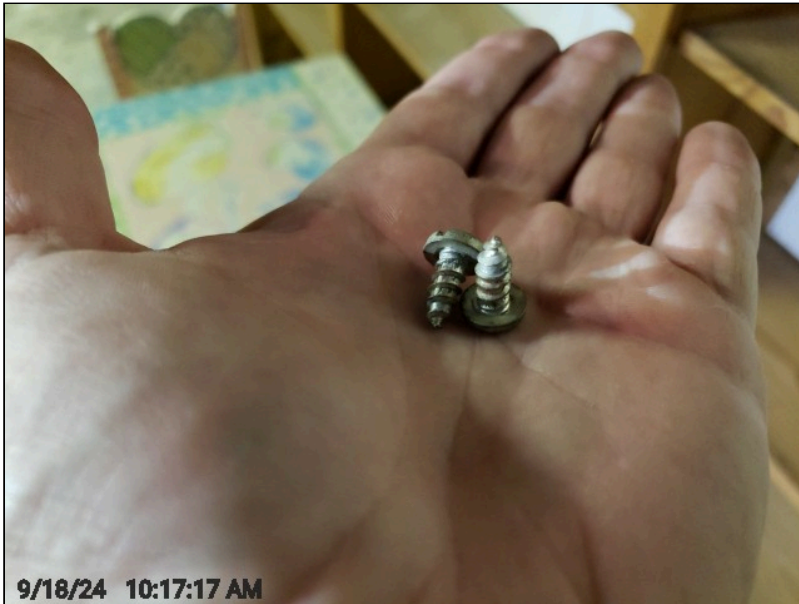
- 🏠 (1) The electrical panel is over 40 years old. A licensed electrician needs to evaluate the panel and replace if needed.
- 🏠 (2) Pointed screws are used to attach the main distribution panel front to the panel box. Blunt end screws should be used to prevent piercing of cables in the panel which can cause arcing. This is a safety hazard. A licensed electrician needs to install blunt end screws.

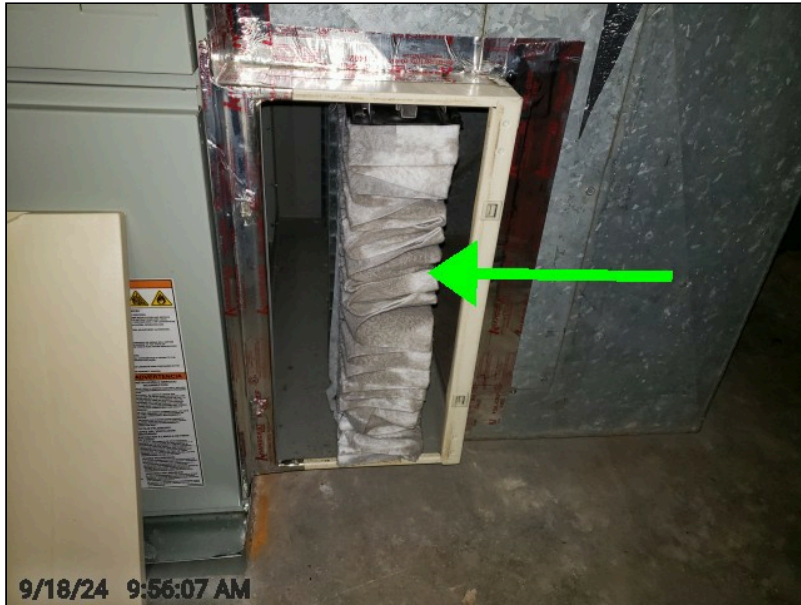
Location of return air filter(s) for heating and air equipment. The filter(s) should be changed every 9 to 12 months. Recommend that the filters be changed once you take possession of the house.

Arrow in the direction of air flow

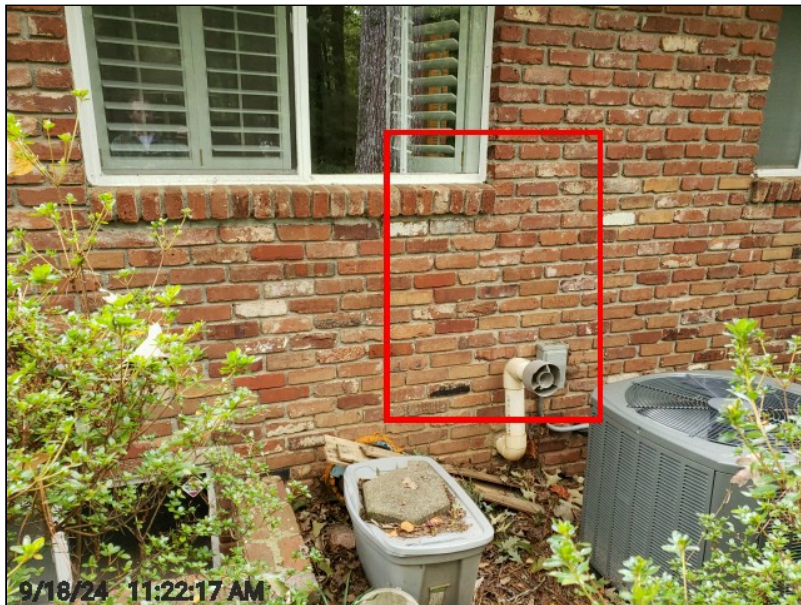
The furnace vent pipe is less than 4 feet from an operable window and the condensing unit. A licensed heating and air contractor needs to inspect further and repair. Location(s): back of the house

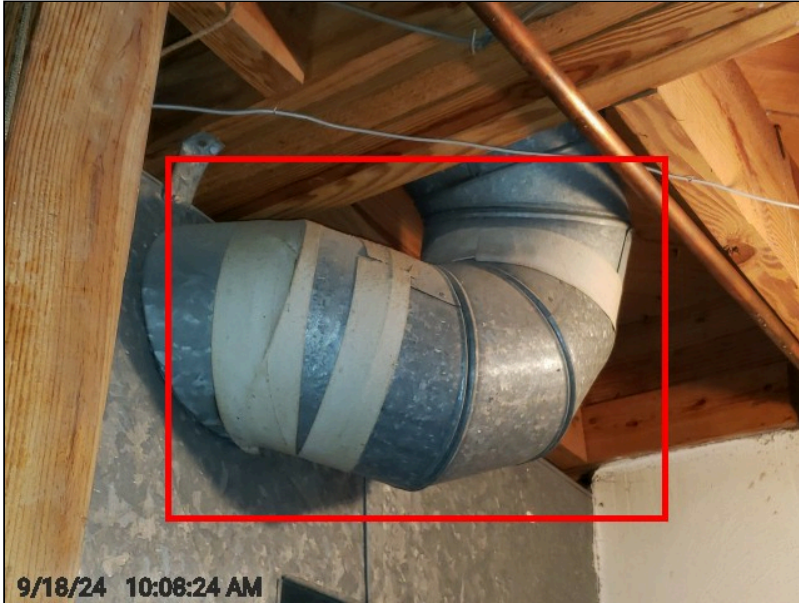
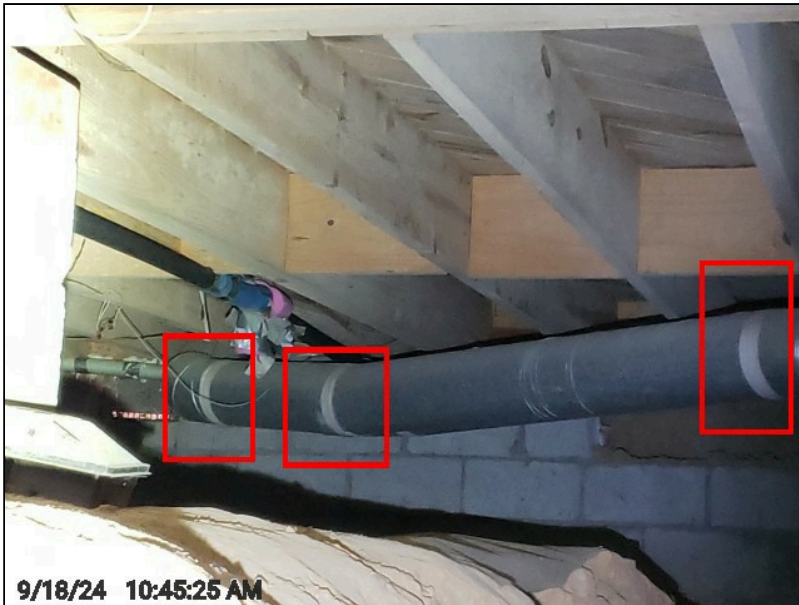
- 🏠 (1) The heating and air ducts need to be professionally cleaned.
- 🏠 (2) The filter needs replacing on the air handler.
- 🏠 (3) The duct pipe are wrapped with white tape that could be asbestos tape. Pictures shown are examples. Confirming the presence of asbestos requires testing by a qualified laboratory. A qualified asbestos contractor needs to encapsulate all exposed white tape for safety.

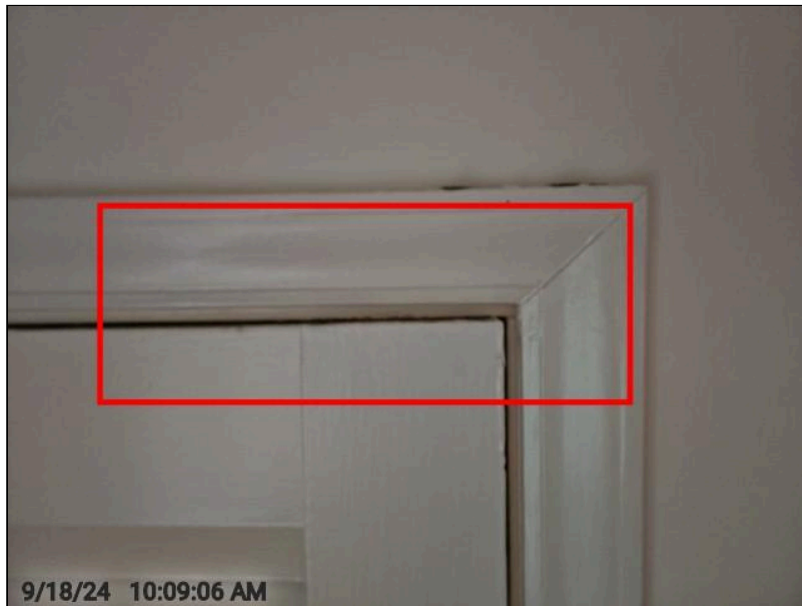
- 📍 (1) Door binds/rub on the door frame. Location(s): back right bedroom

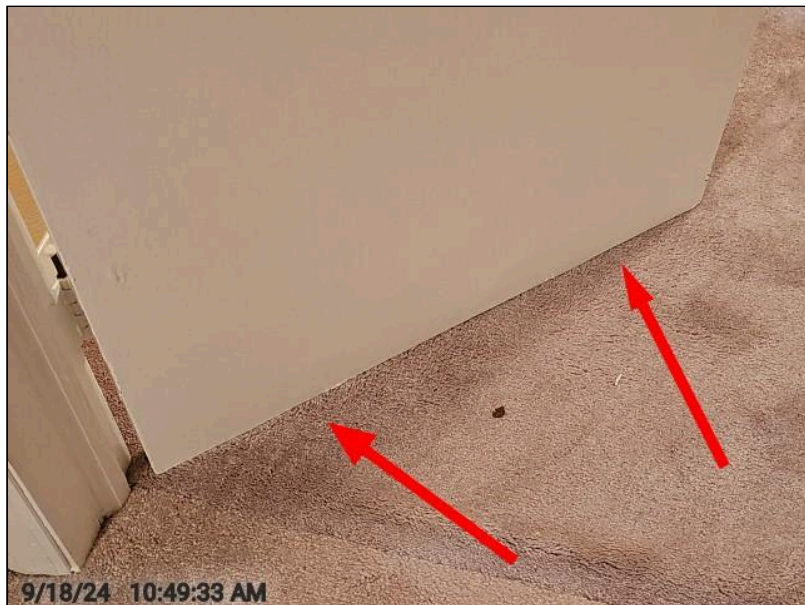
🏠 (4) Door needs to be cut about a half inch so the door can open without dragging on the flooring. A qualified contractor needs to cut door bottom. Location(s): basement bedroom

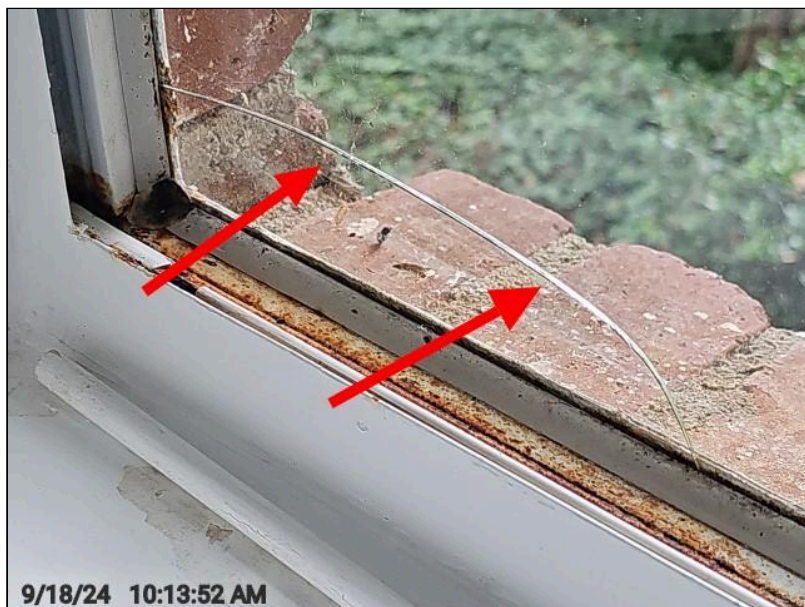
🏠 (1) Cracked/broken window observed. A qualified contractor needs to replace broken glass. Location(s): back left bedroom

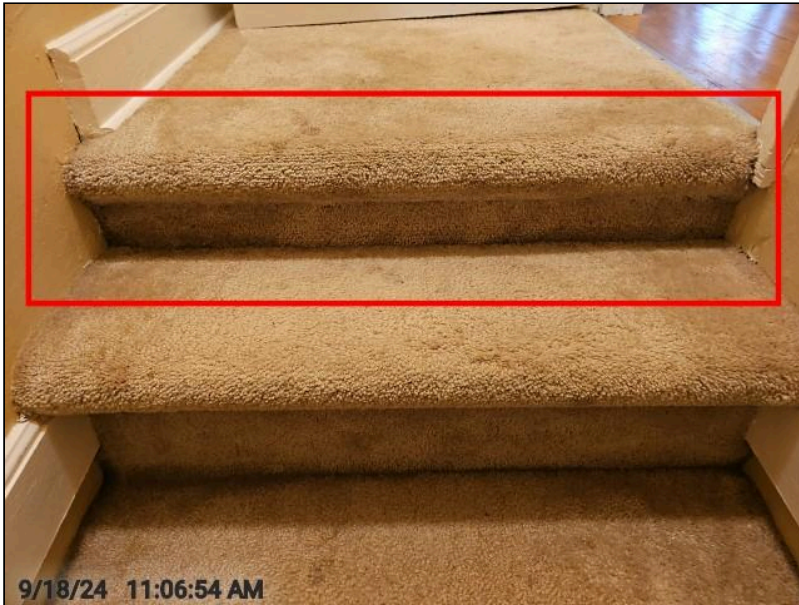
- 🏠 The basement steps were installed with the riser height on the steps less than 7 3/4 inches. This is a potential trip hazard.

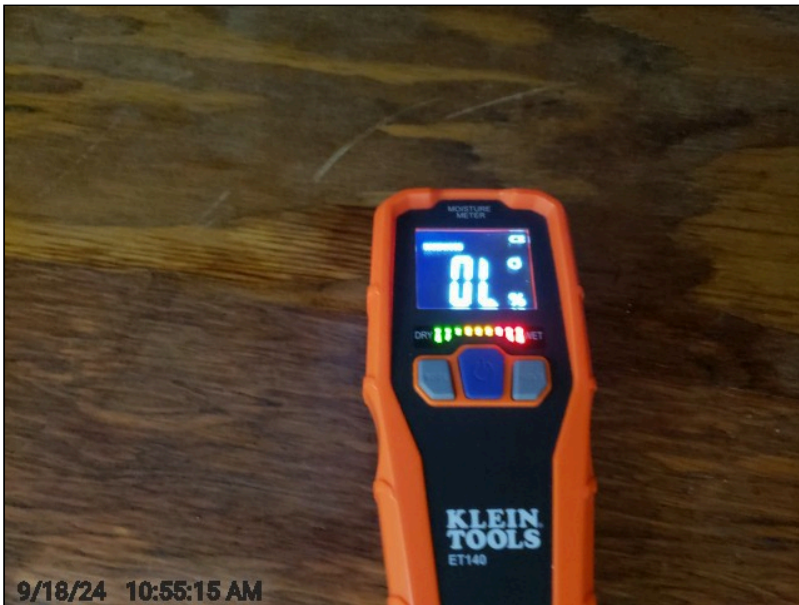
- 🏠 Moisture was detected with thermal imaging and a moisture meter inside the sink cabinet. The seller had the water to sink turned off prior to the inspection. A qualified contractor needs to evaluate further and repair. Location(s): basement kitchen sink cabinet

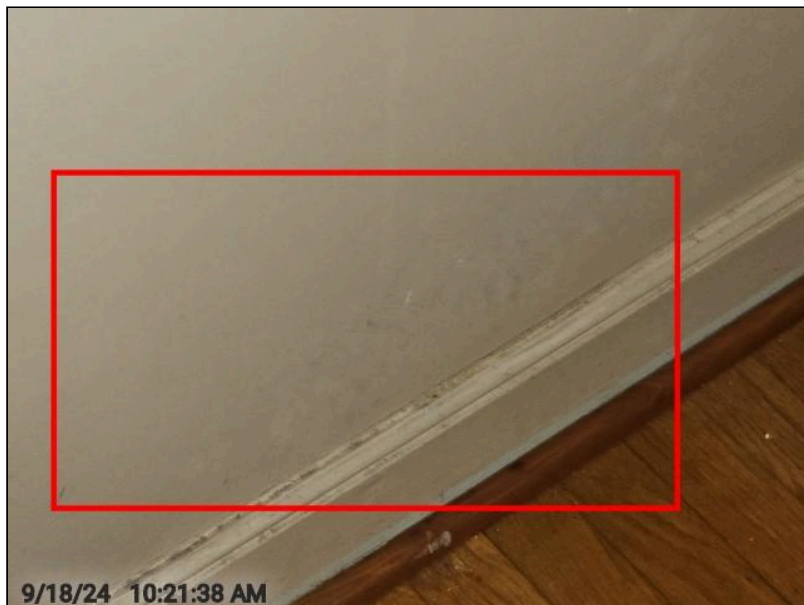
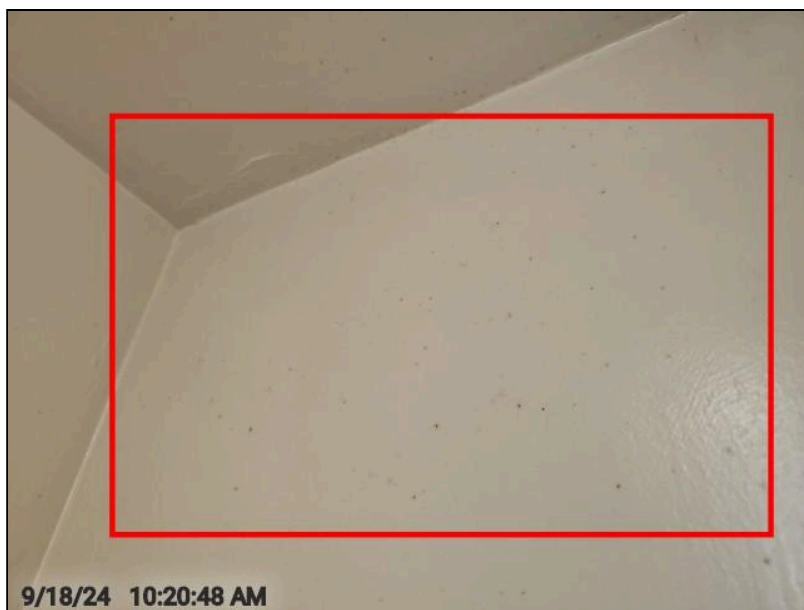
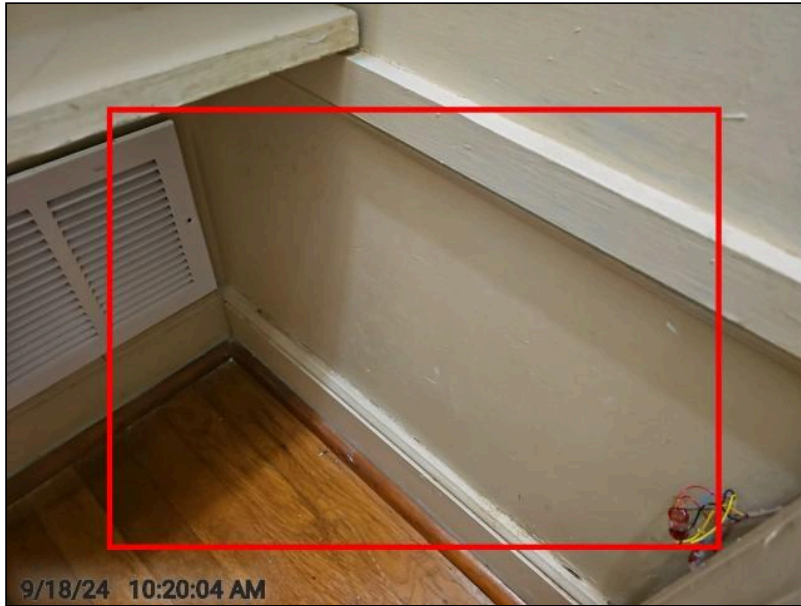
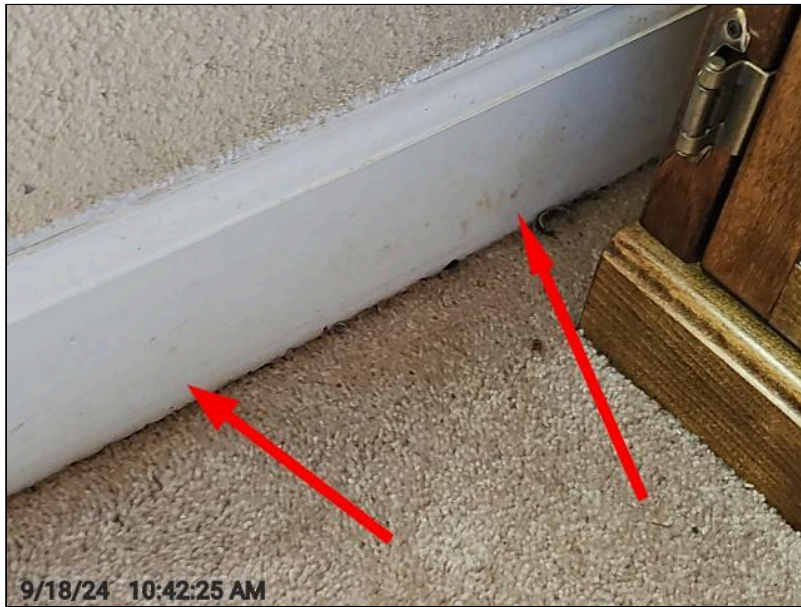
- 🏠 (1) Mold like substance was observed. A qualified contractor needs to evaluate further and provide a remediation plan if necessary. Pictures shown are examples. Location(s): front left bedroom closet, on base trim at basement door, basement kitchen cabinet

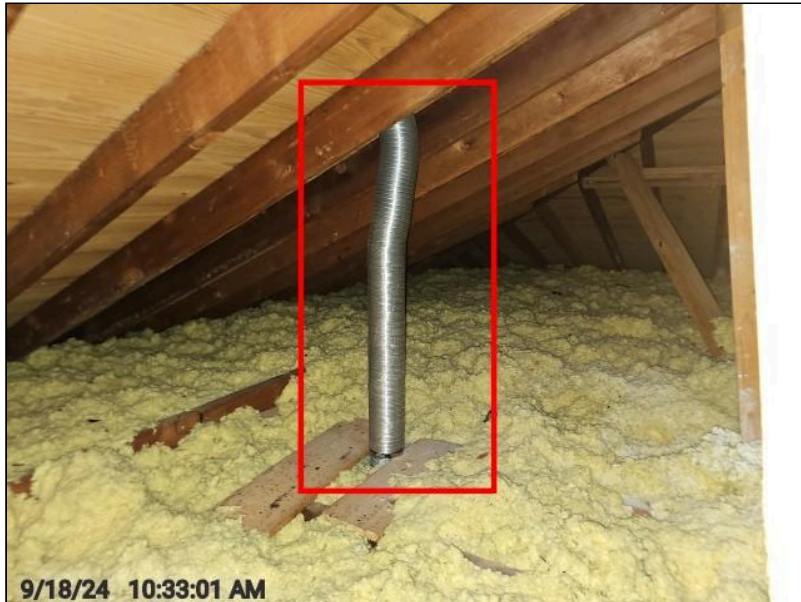
- 🏠 (1) The dryer duct pipe needs to be cleaned out from duct termination back to the dryer. Dryer duct pipe needs to be cleaned out every year. A qualified contractor needs to repair.
- 🏠 (2) The dryer exhaust duct is flex pipe in the attic. Dryer duct pipe should be constructed of minimum 4mm rigid metal pipe and be supported every 4 feet. A licensed heating and air contractor needs to repair.

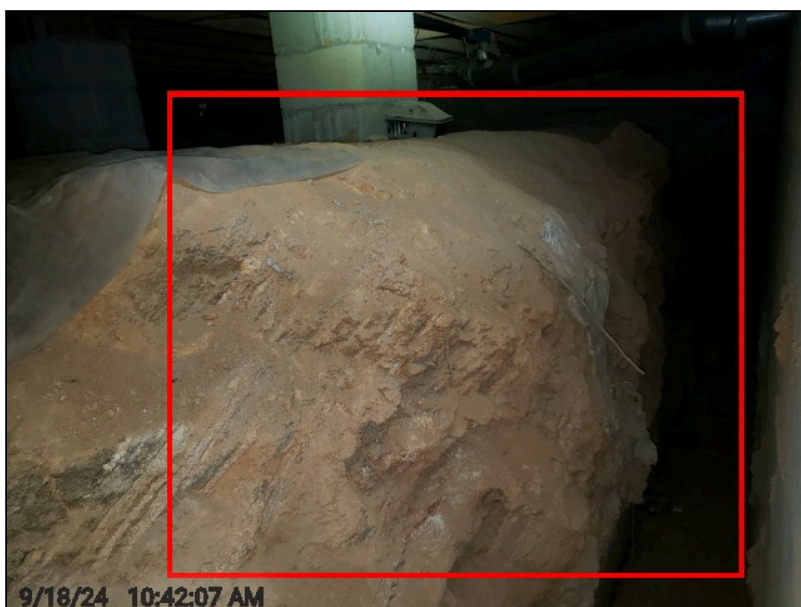
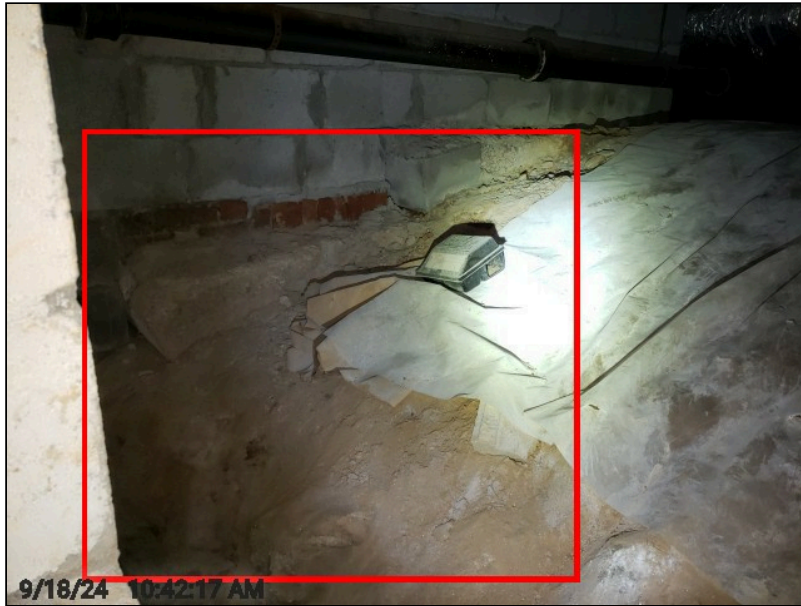
- 🏠 There is a partial vapor barrier in the crawl space. A 6 mil vapor barrier needs to cover all of the crawl space surface.

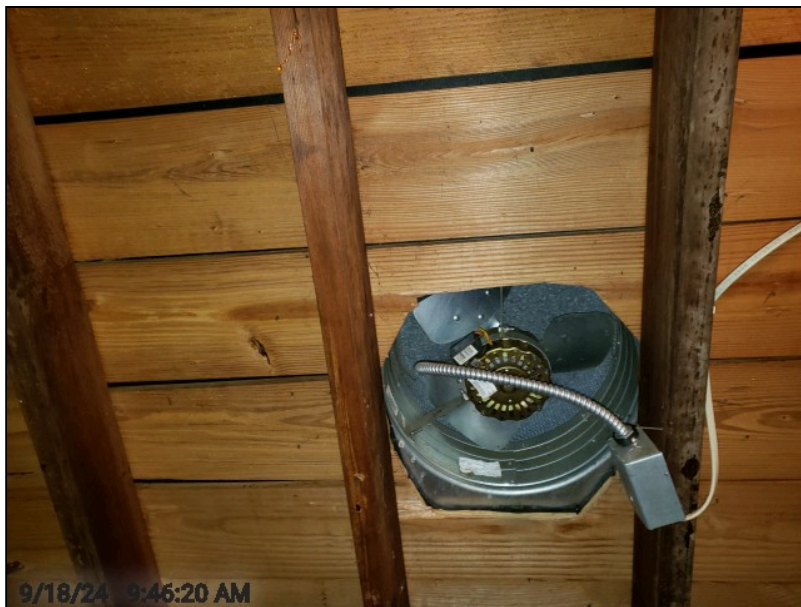
- 🏠 The power attic ventilator fan in the attic is not working. Power attic ventilator fans use a lot of electricity. Where the fan is located, there is no continuous ridge vent. Recommend replacing fan with continuous ridge vent.

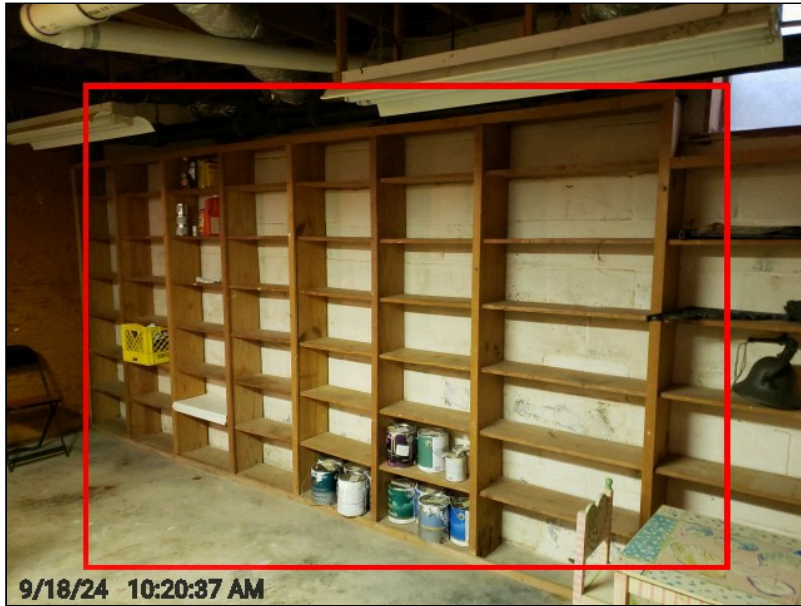
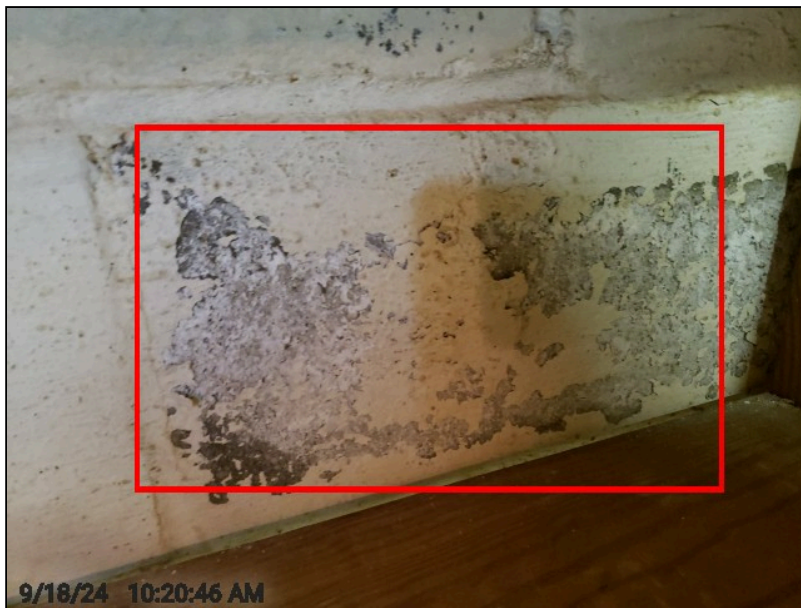
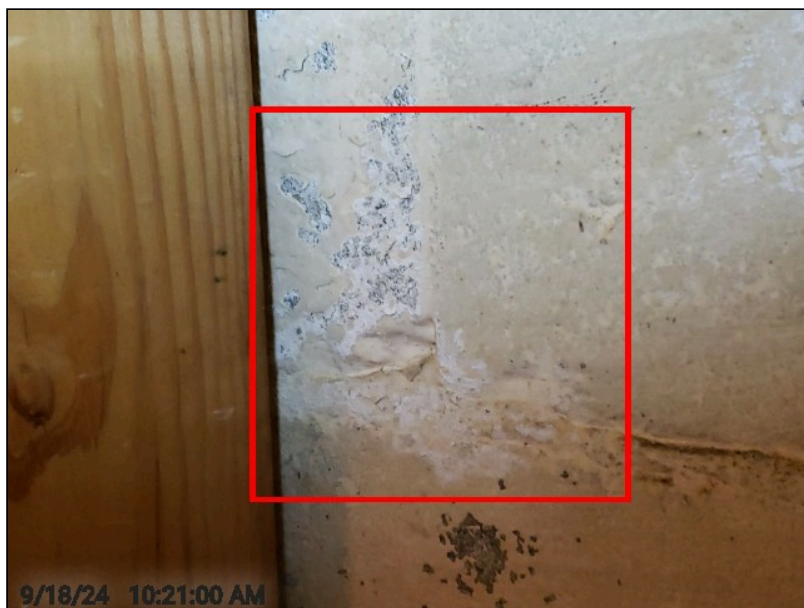
(1) Efflorescence (powder substance) on foundation wall indicates moisture has in contact with the foundation wall. This does not necessarily indicate that intrusion will occur. Recommend checking the gutters, the downspout drain lines, and grading the foundation for drainage flow away from the foundation. Efflorescence is found on many homes without water intrusion occurring inside the foundation. But, it should alert you to the possibility that future steps may be needed to control drainage around the foundation.
