# Inspection Report

3456 Main St

**Marion Hodges Home Inspection Services**

10/31/2024

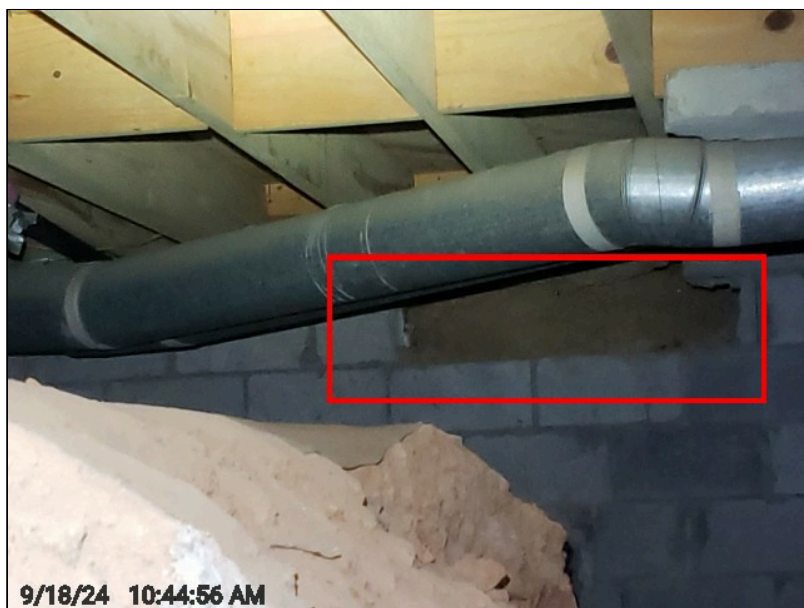
(2) Hole observed in the foundation wall under the front door in the crawlspace. The hole needs to be sealed to prevent moisture in the crawlspace. A qualified contractor needs to repair.

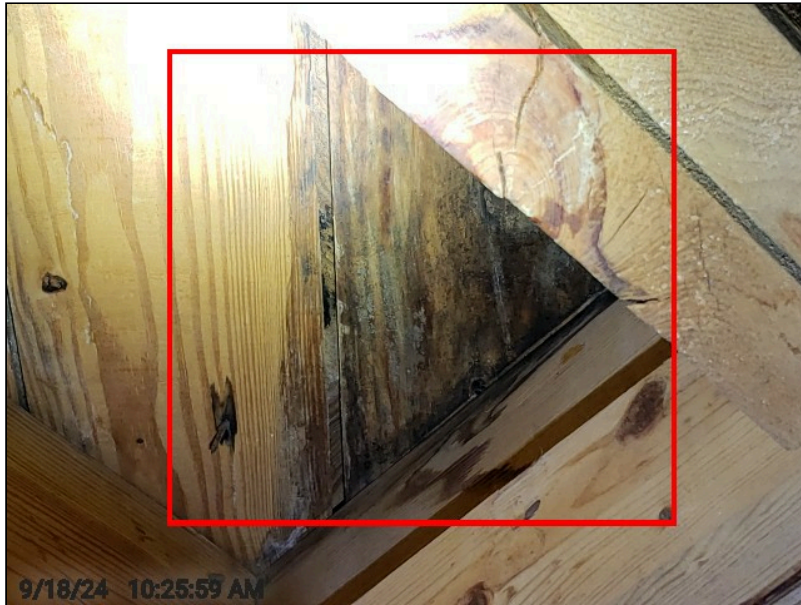
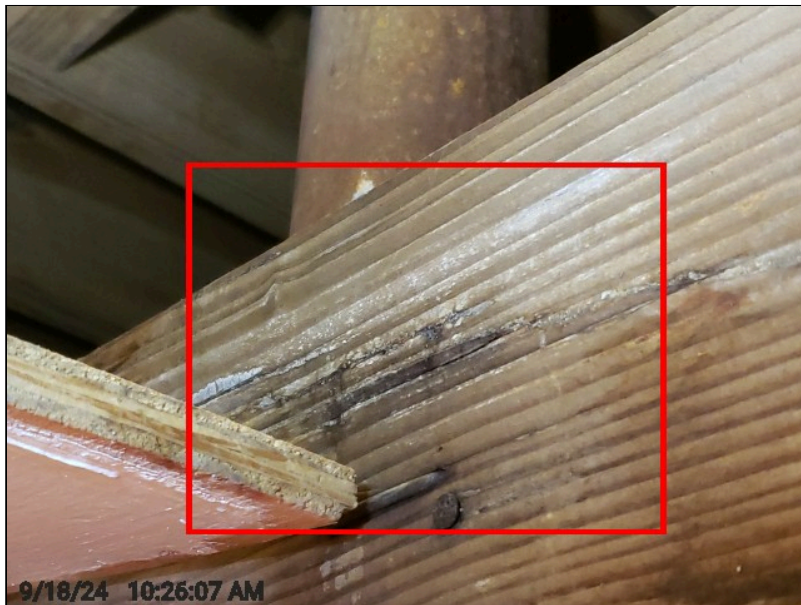
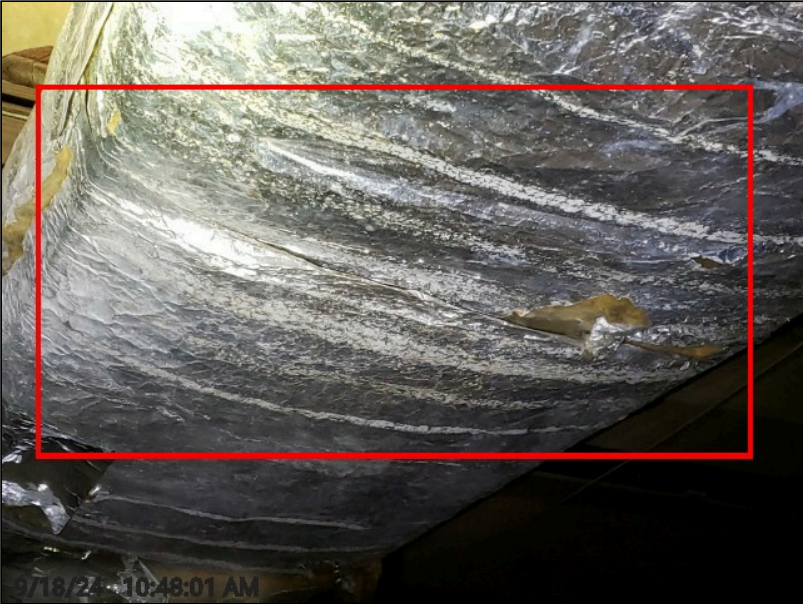
- 🏠 (1) A mold like substance was observed on the floor joist in the basement. A qualified mold contractor needs to evaluate further and provide a remediation plan if necessary. Pictures shown are examples.

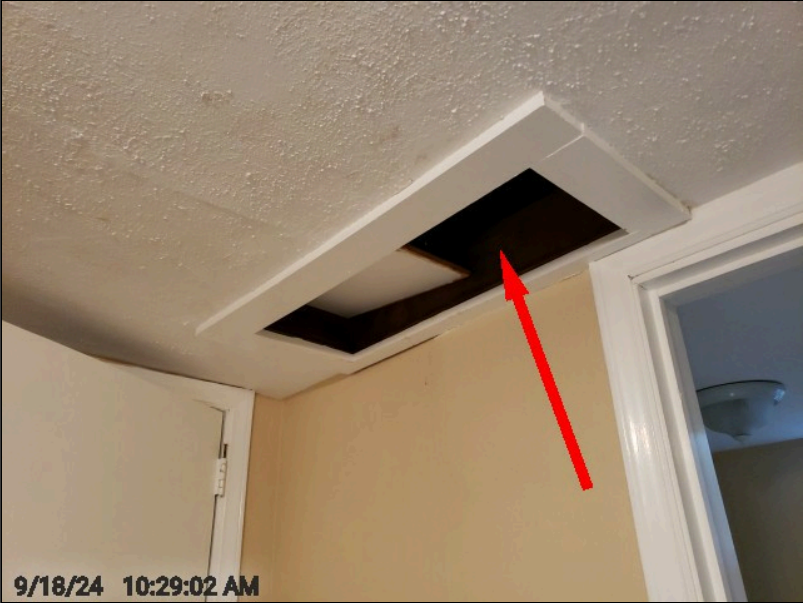
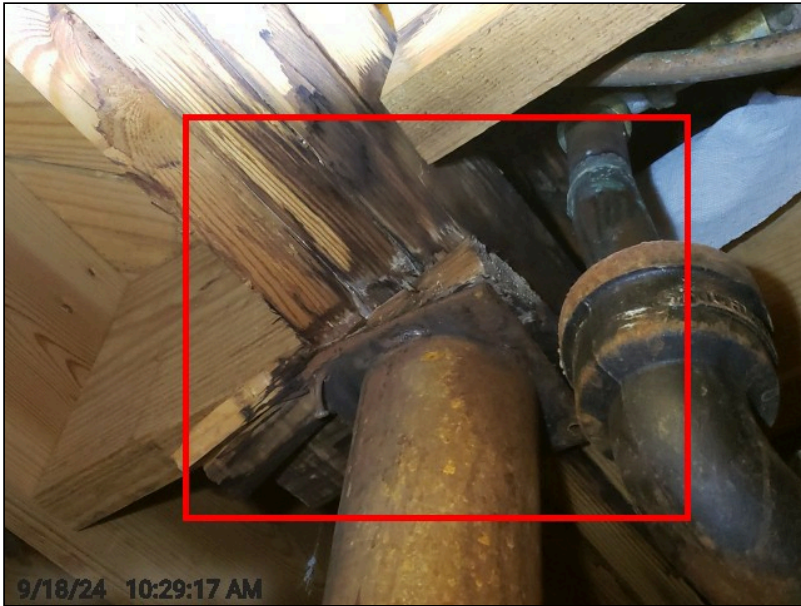
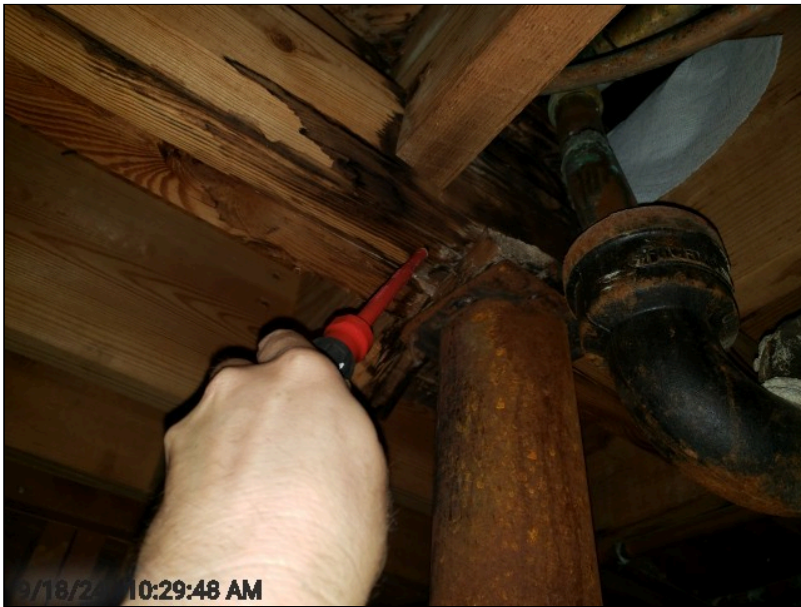
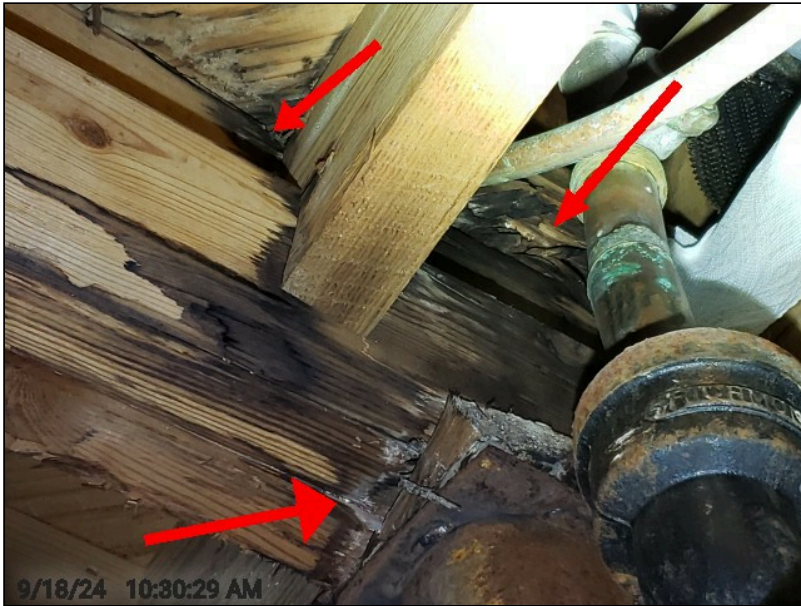
(2) The joist under the front bath are rotten. A qualified contractor needs to replace all rotten framing members and add additional support as needed.

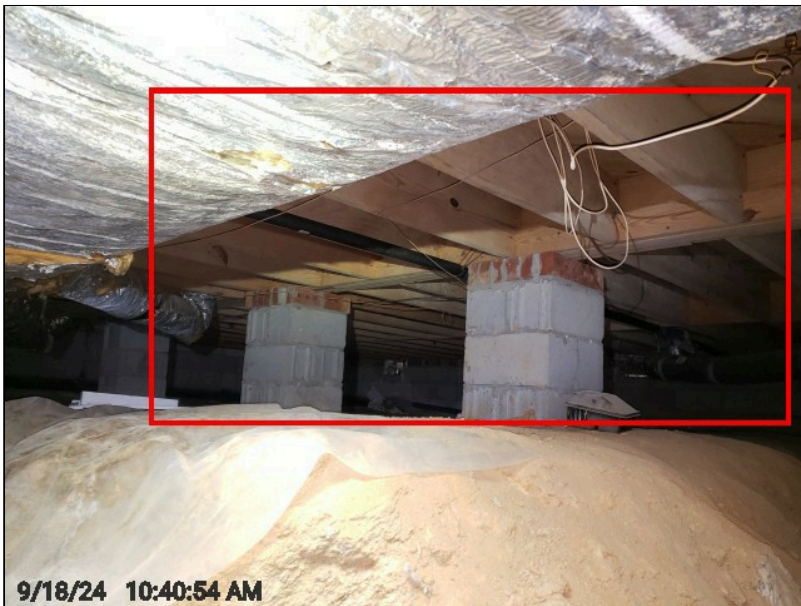
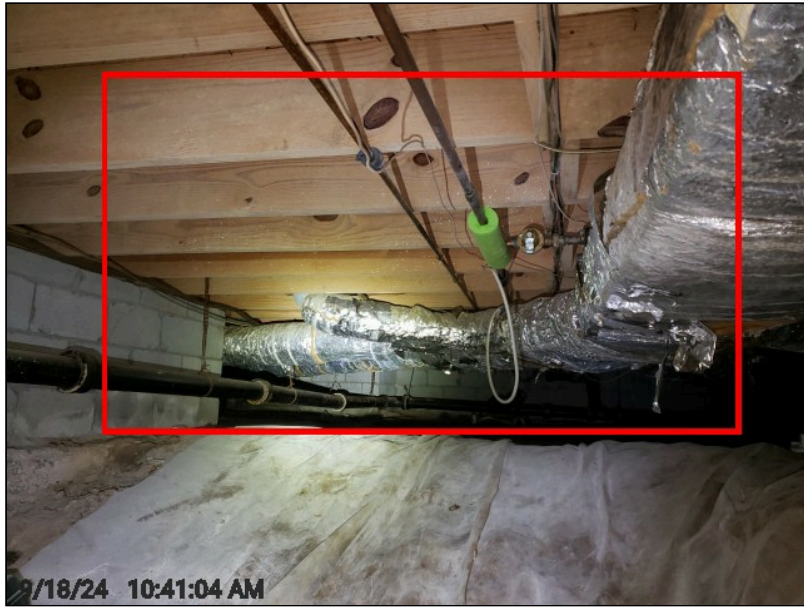
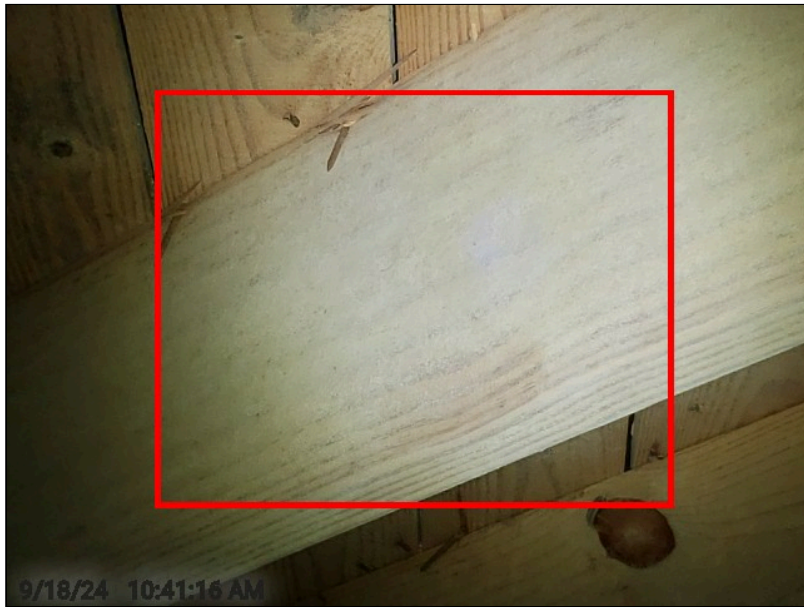
(3) A mold like substance was observed on the floor joist in the crawl space. A qualified mold contractor needs to evaluate further and provide a remediation plan if necessary. Pictures shown are examples.

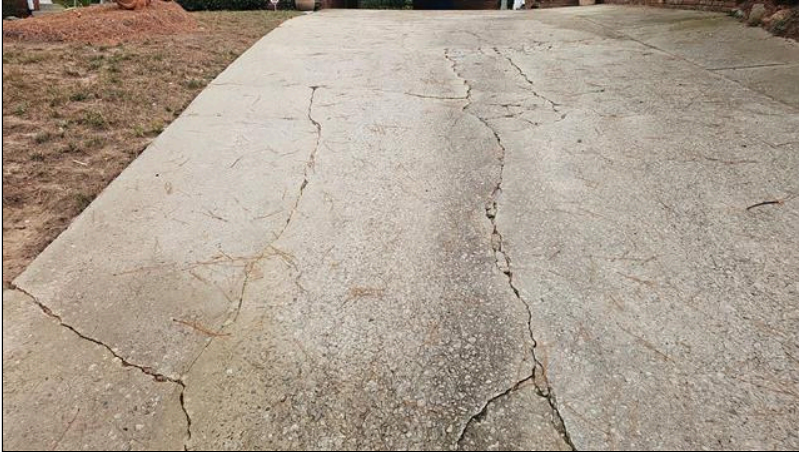
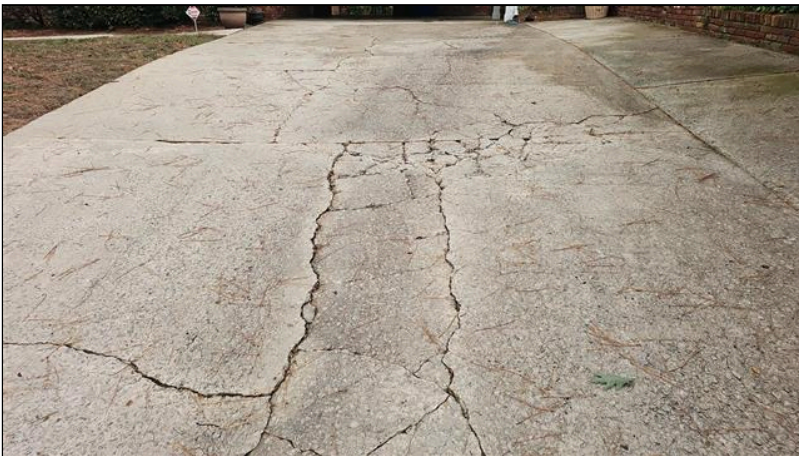
The driveway is at end of useful life expectancy. Future replacement should be anticipated.

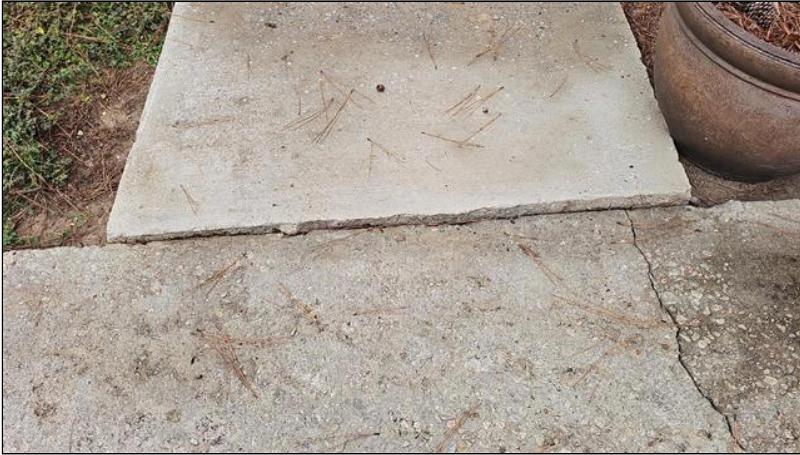
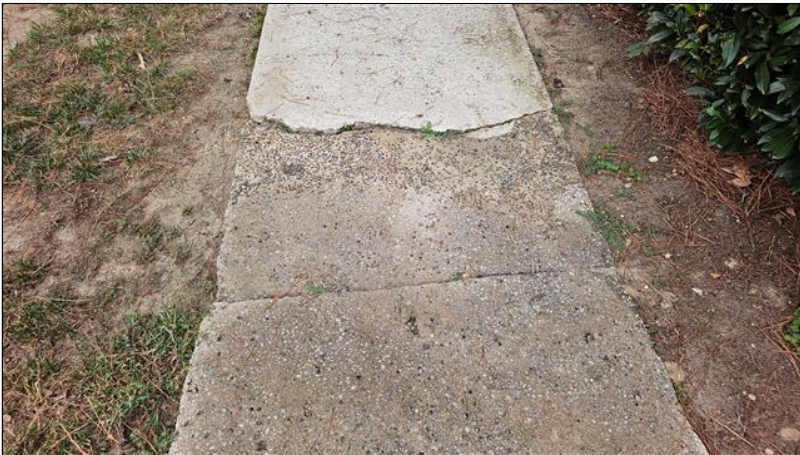
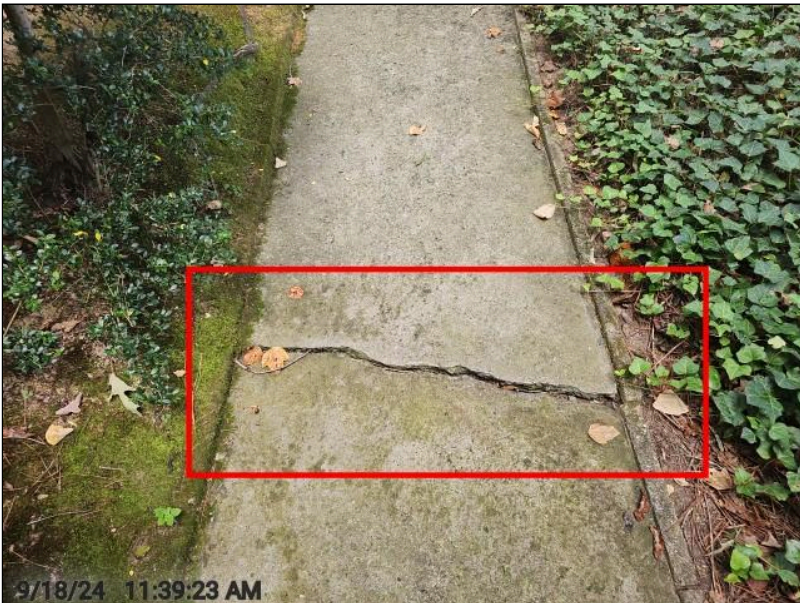
(1) The sidewalk is uplifted. The concrete uplifting can be a potential trip hazard. A qualified contractor needs to replace the concrete where uplifted.

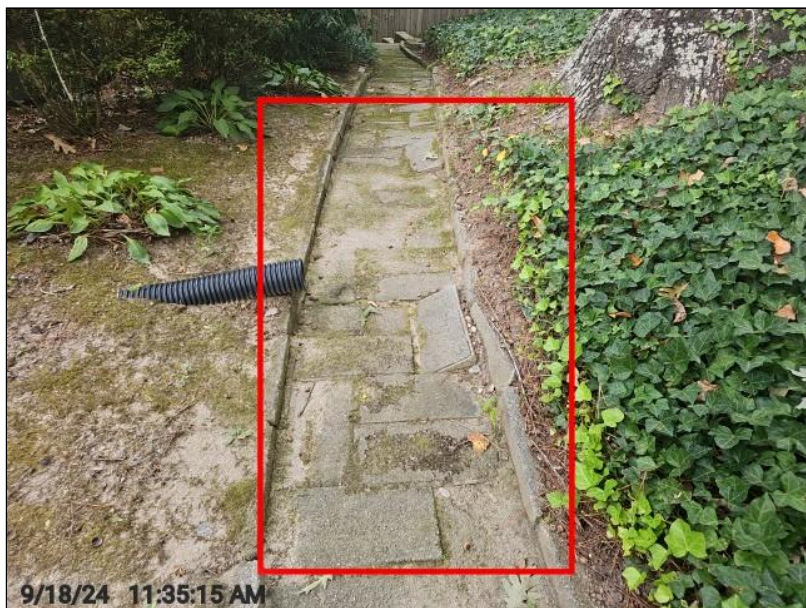
- 🏠 (2) Stones in the back walk are uplifted. The uplifted stones are trip hazard. A qualified contractor needs to repair.

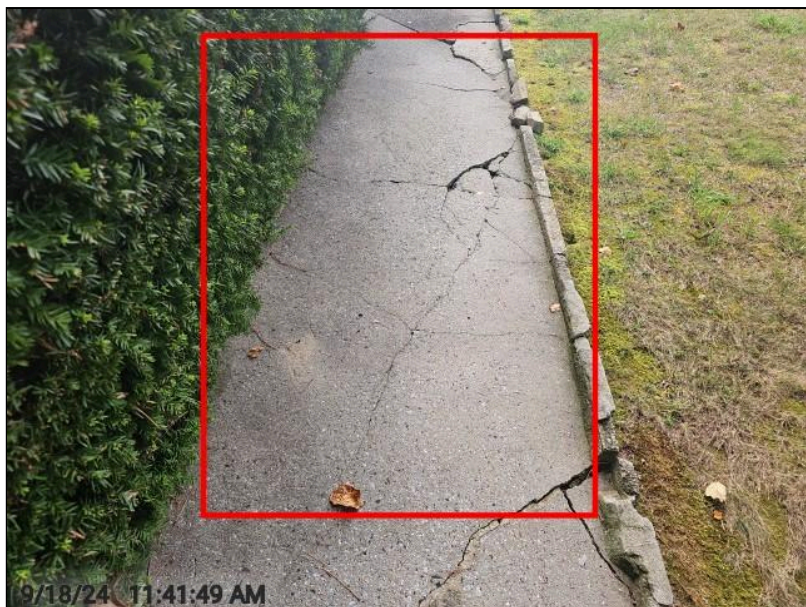
- 🏠 (3) Part of the front sidewalk is at end of useful life expectancy. Future replacement should be anticipated.

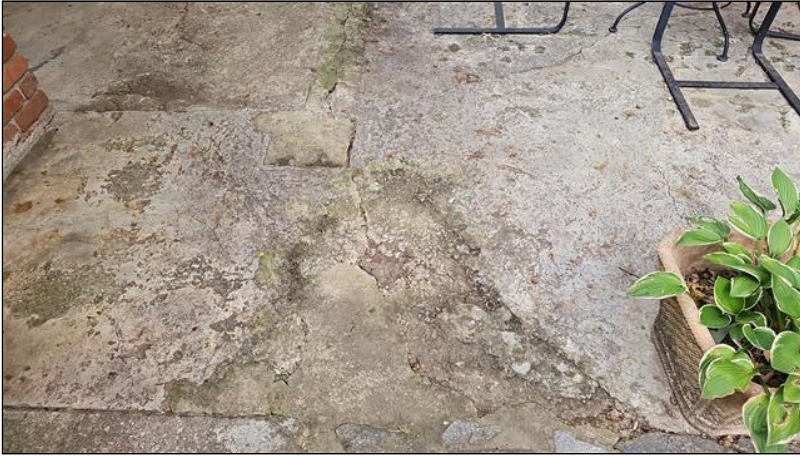
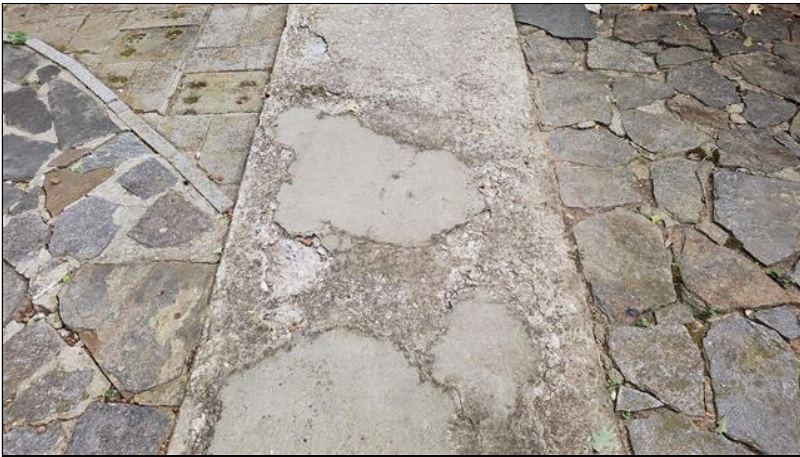
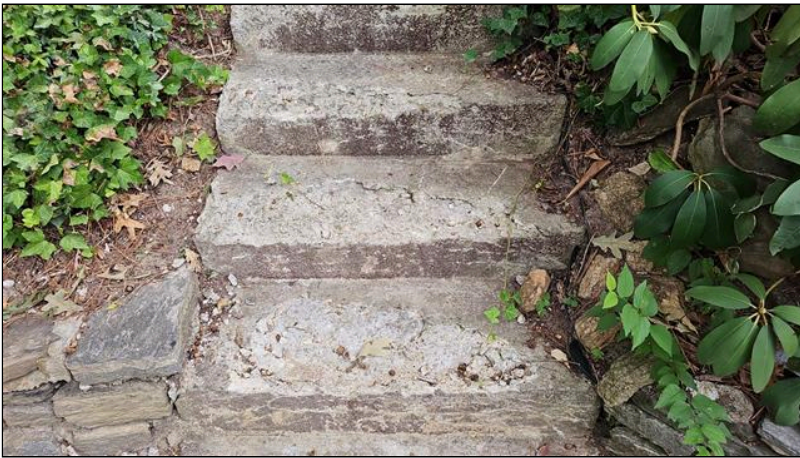
The patio and steps to backyard are at end of useful life expectancy. Future replacement should be anticipated.

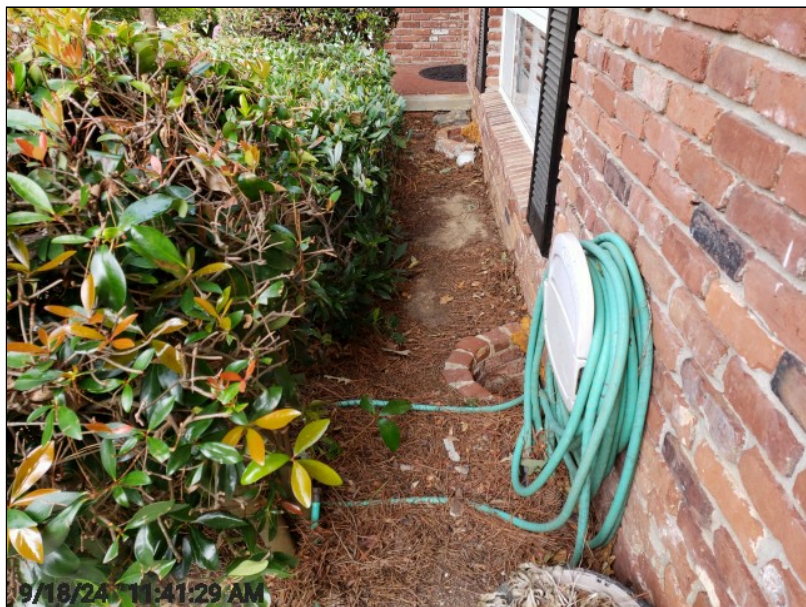
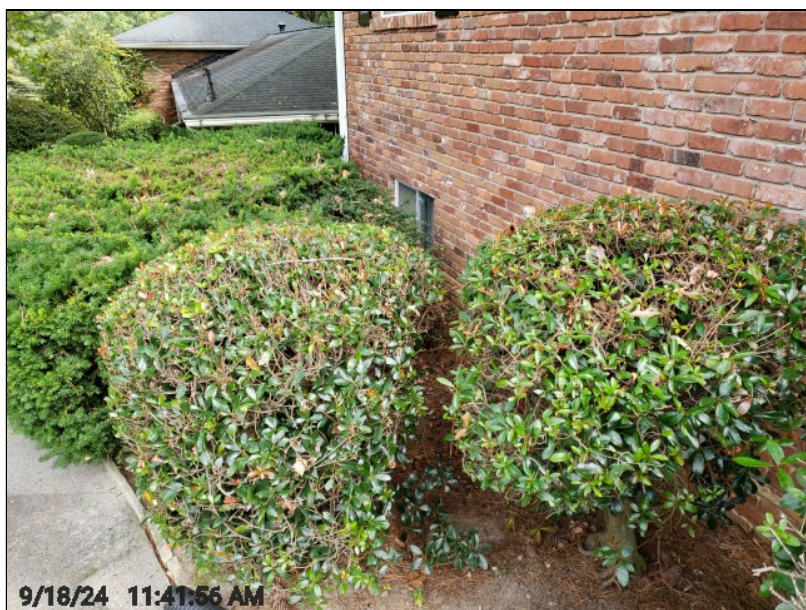
- 🏠 (1) The grading generally does not provide positive drainage away from the foundation. There should be 6" of fall in the first 10' away from the foundation. A qualified contractor needs to evaluate further and repair. Location(s): front of the house

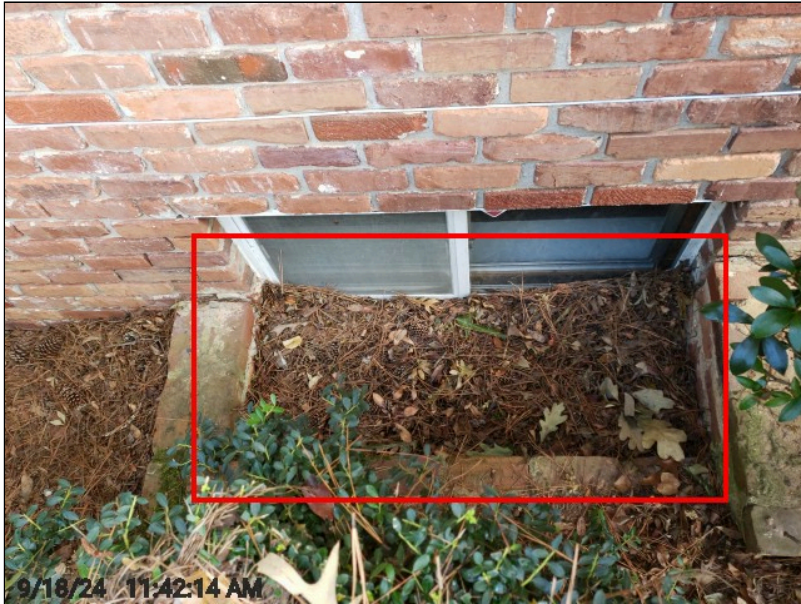
- 🏠 (2) Window wells are filled with leaves and pine straw. The window wells need to be cleaned out. If there are drains in the window wells the drains and buried drain pipes need to be cleaned from inlet to outlet. A qualified contractor needs to repair. Location(s): front and back of the house

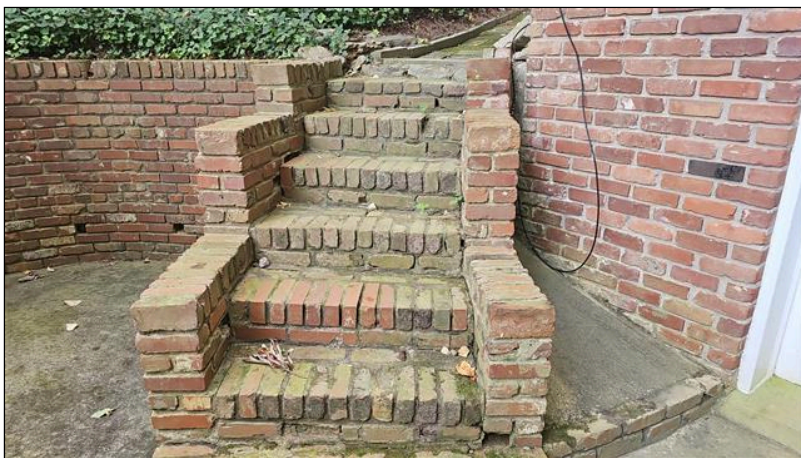
- 🏠 (1) The back brick steps have four or more risers and should have a hand rail. Hand rails shall be provided on at least one side of each continuous run of treads or flight with four or more risers. A qualified contractor needs to repair.

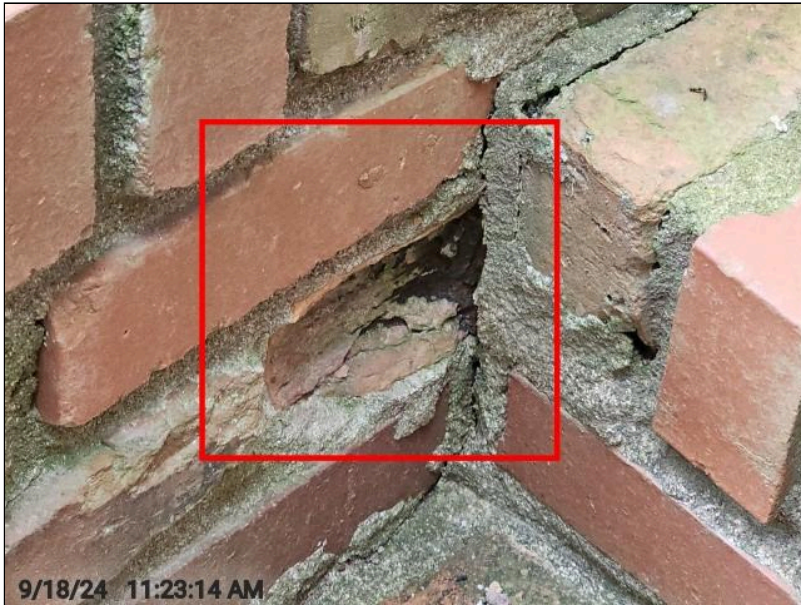
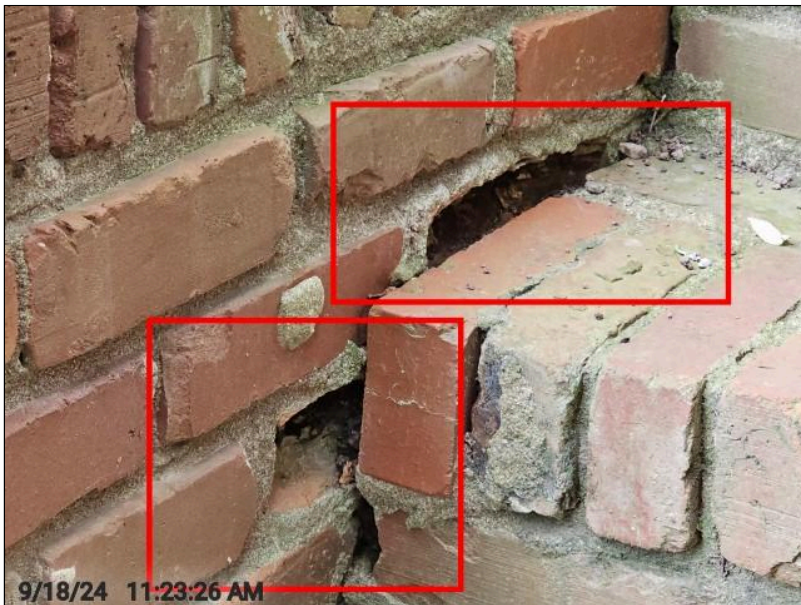
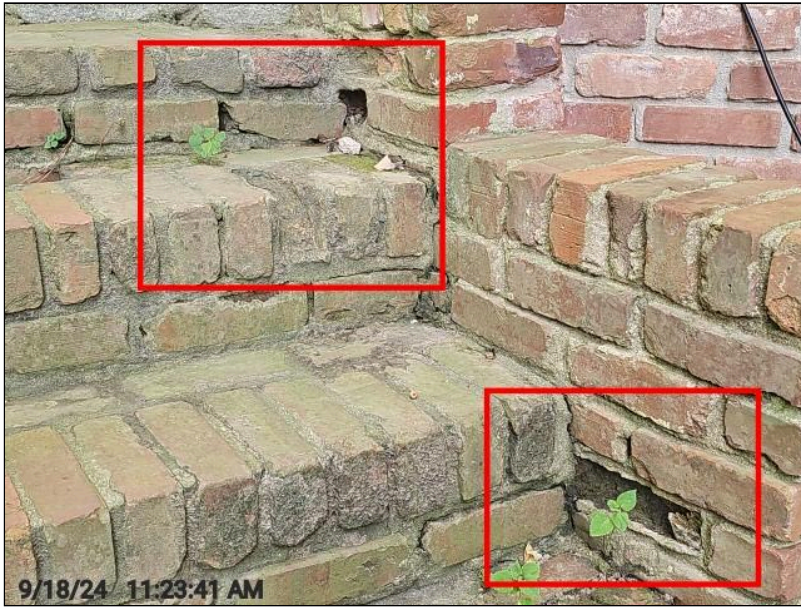
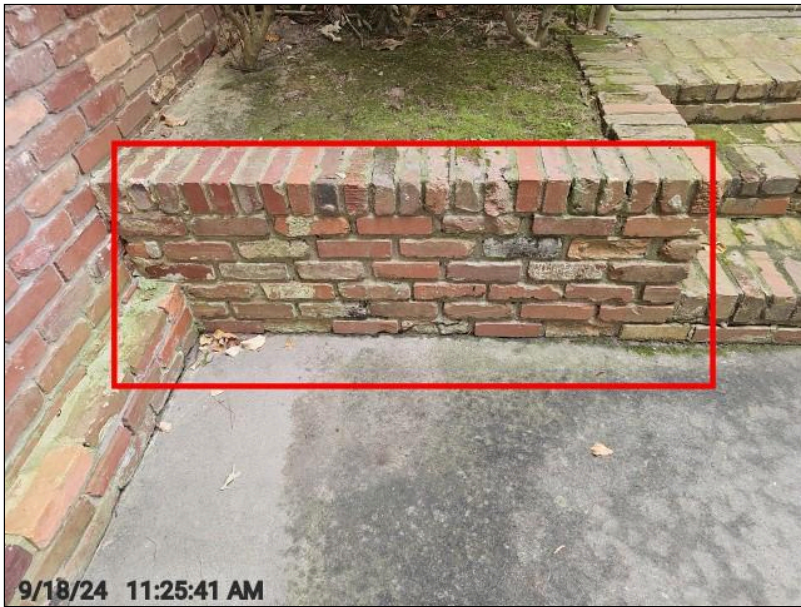
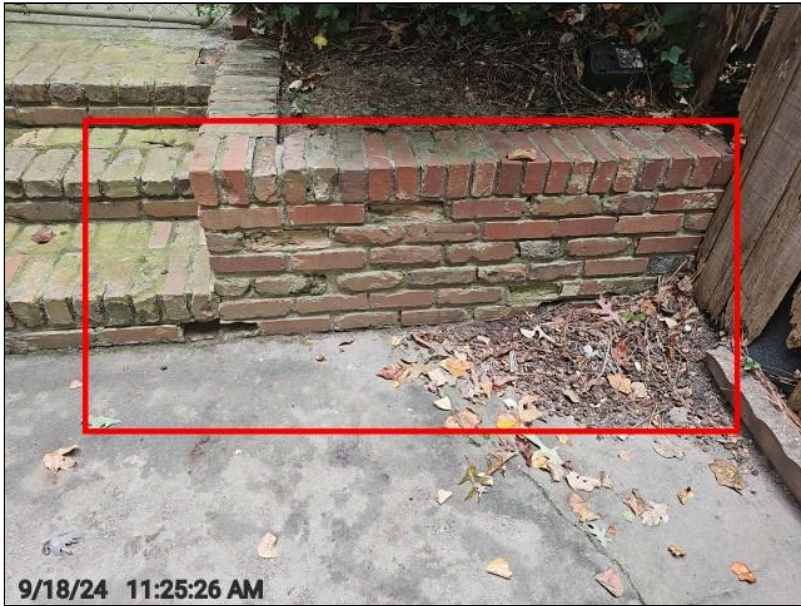
- 🏠 (2) Bricks spalling observed on the back brick steps and retaining walls. Pictures are examples. A qualified contractor needs to repair.

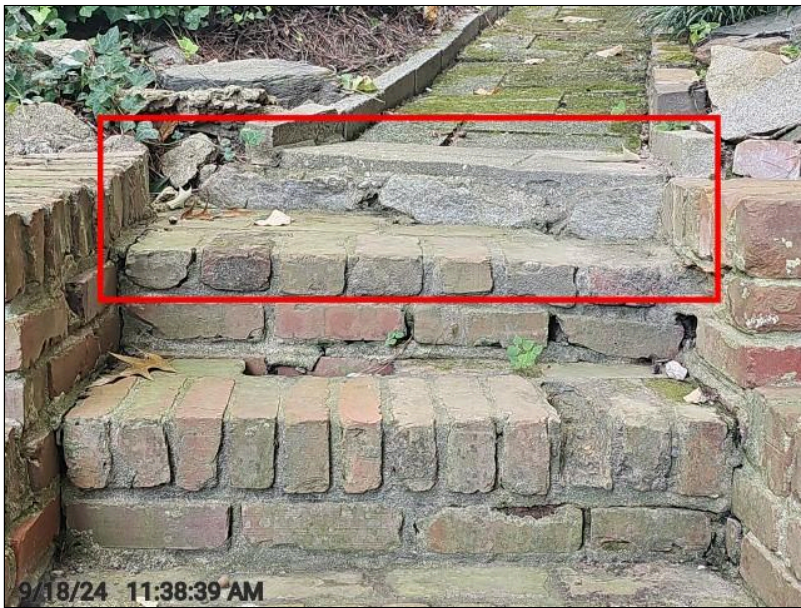
(3) The brick steps were installed with the riser height on the steps less than 7 3/4 inches. This is a potential trip hazard.

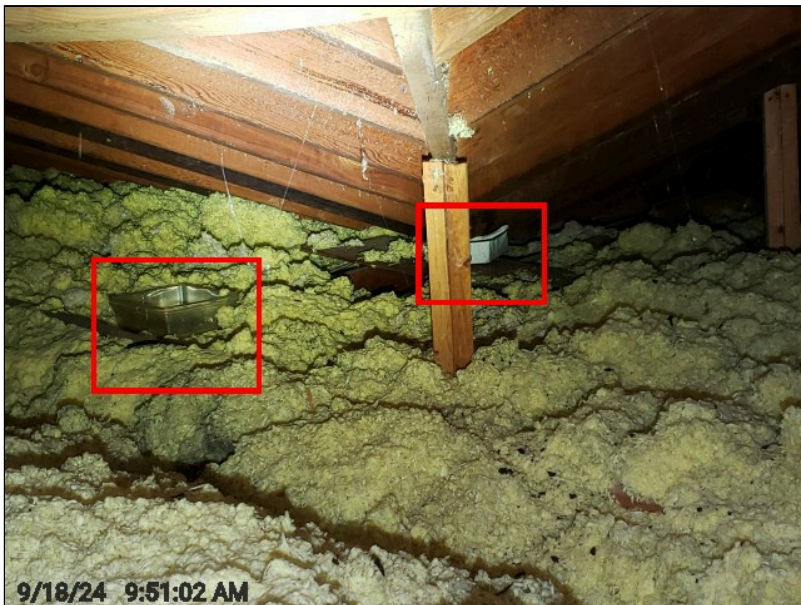
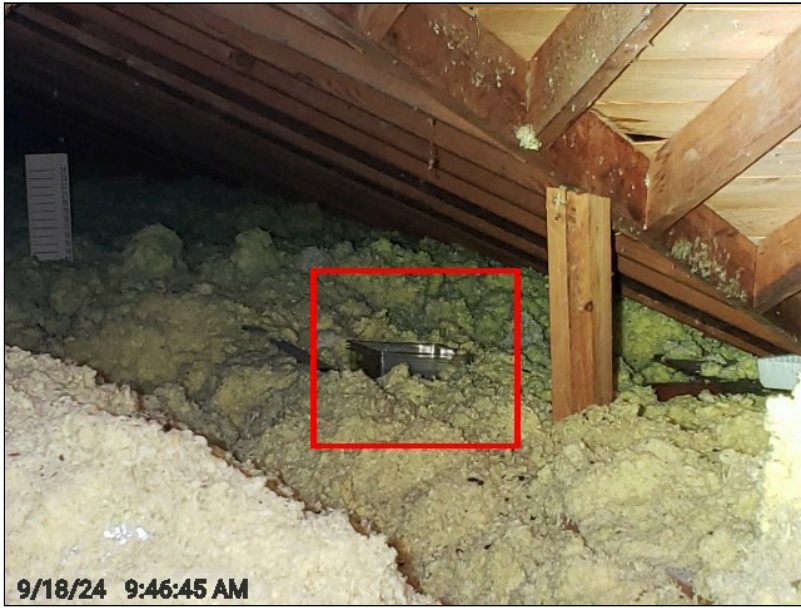
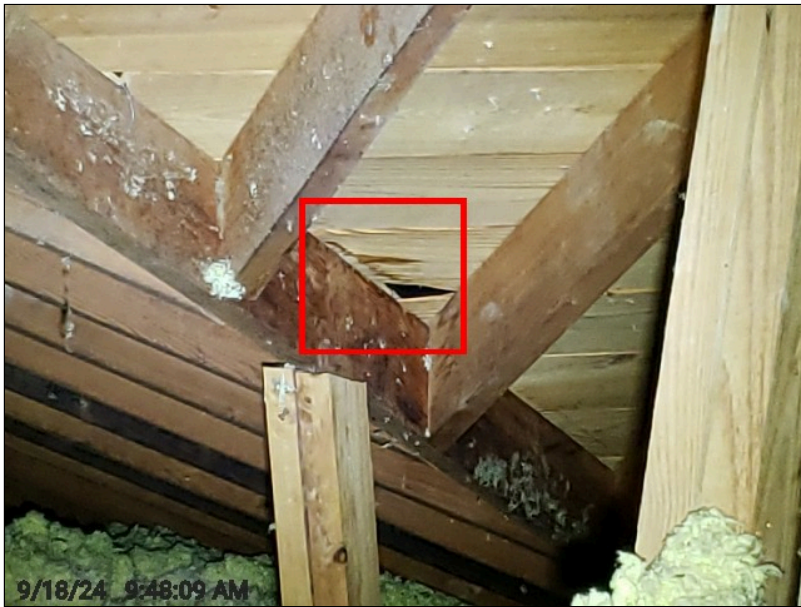
(1) Water stains from a past roof leaks and containers were observed. A qualified roofer needs to inspect roof and verify permanent repairs were made. Location(s): attic (pales under leaks)

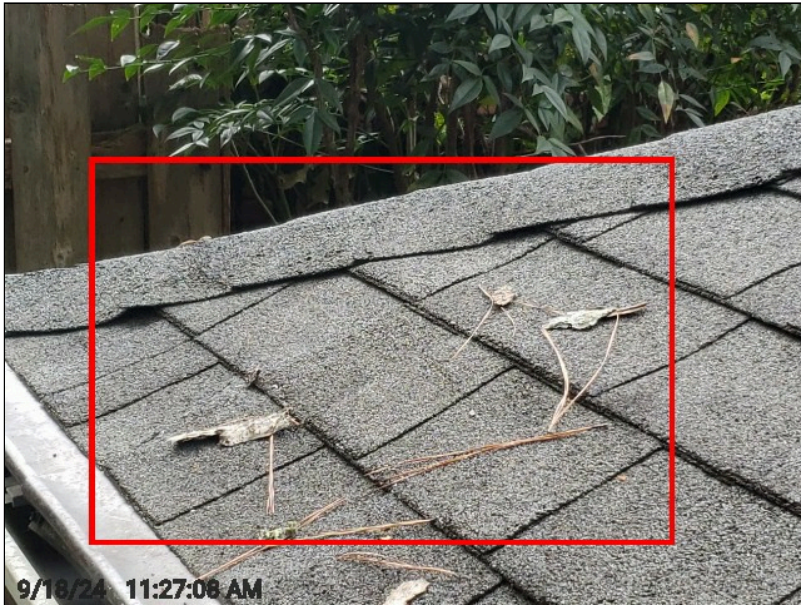
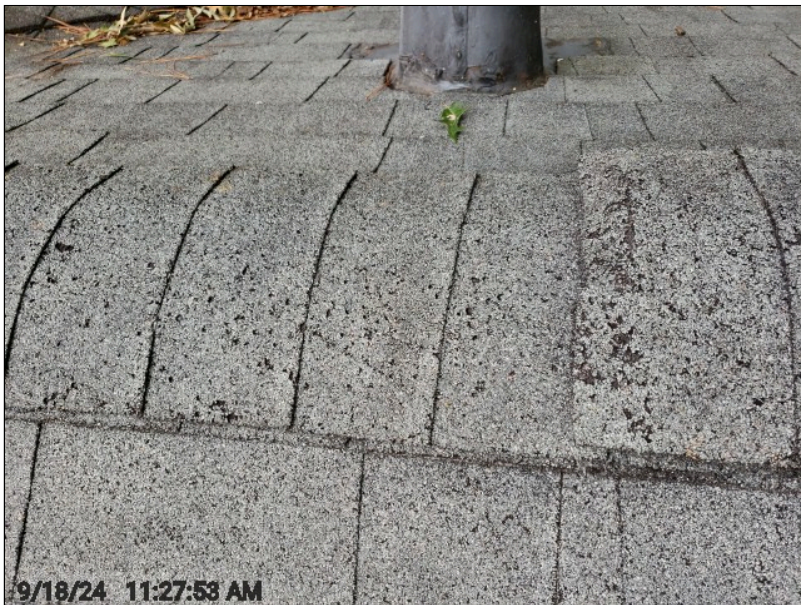
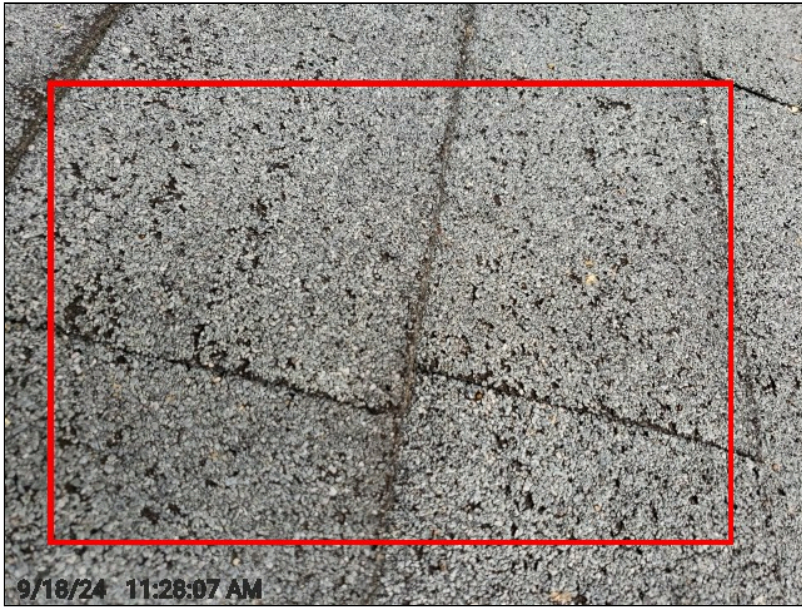
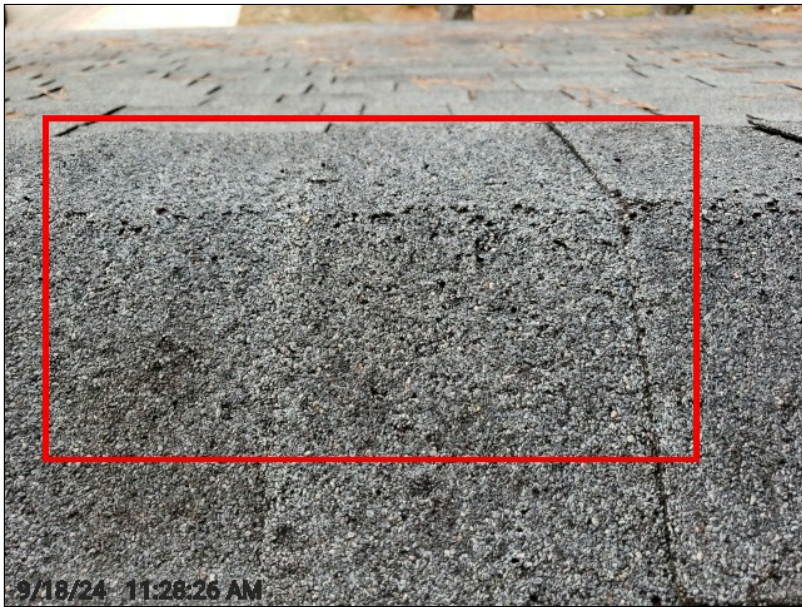
(2) The age of the roof is unknown. Based on condition, the roof appears to be around 15 years old +/- . The inspector makes no warranties or guarantees as to how long the roof will last.

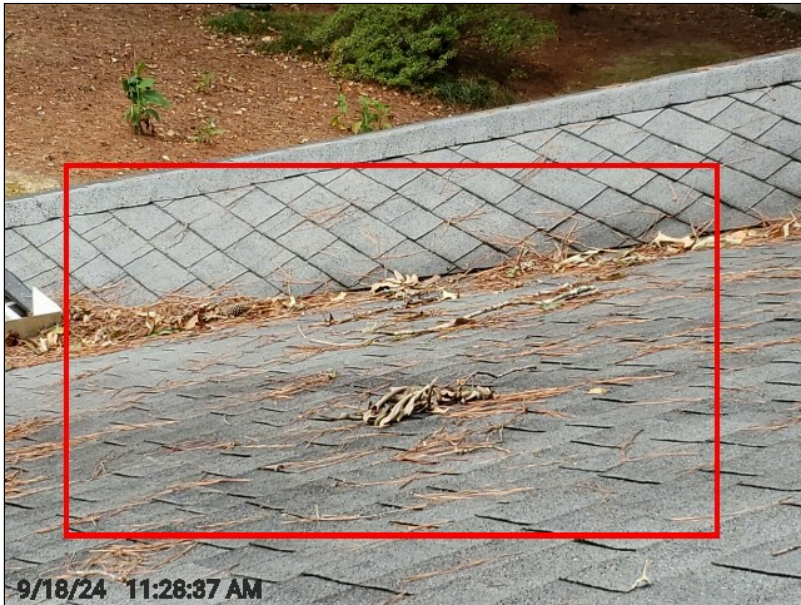
(3) The roof needs to be cleaned off.

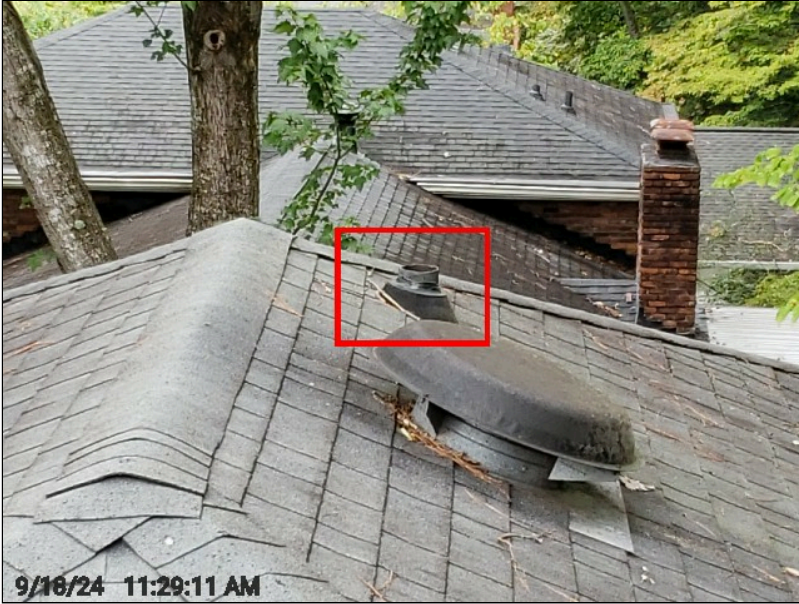
- 🏠 Plumbing vent stack is less than 6 inches above the roof surface. The plumbing vent stack should extend at least 6 inches above the roof surface. A qualified contractor needs to inspect further and extend vent stack.

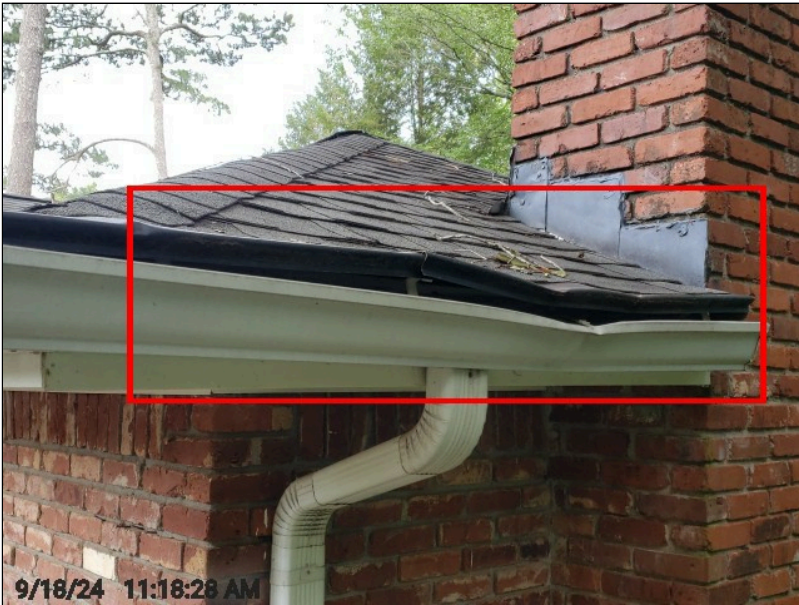
- 🏠 Damaged gutter observed. A qualified contractor needs to replace damaged gutters. Location(s): back of the house

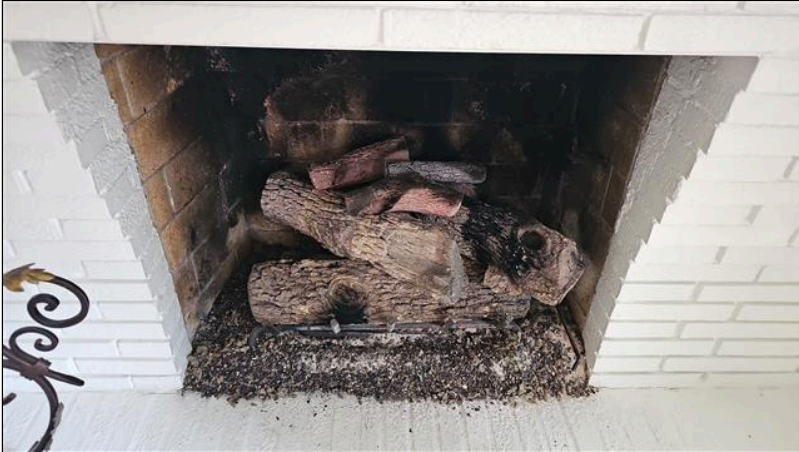
- 🏠 (1) A qualified chimney sweep contractor needs to clean the chimney flue, leak test the gas valve, test the gas logs for operation and correct installation. The inspector does not operate gas valves that are turned off. Leak checking gas valves is part of a standard chimney cleaning. Repairs made as needed.

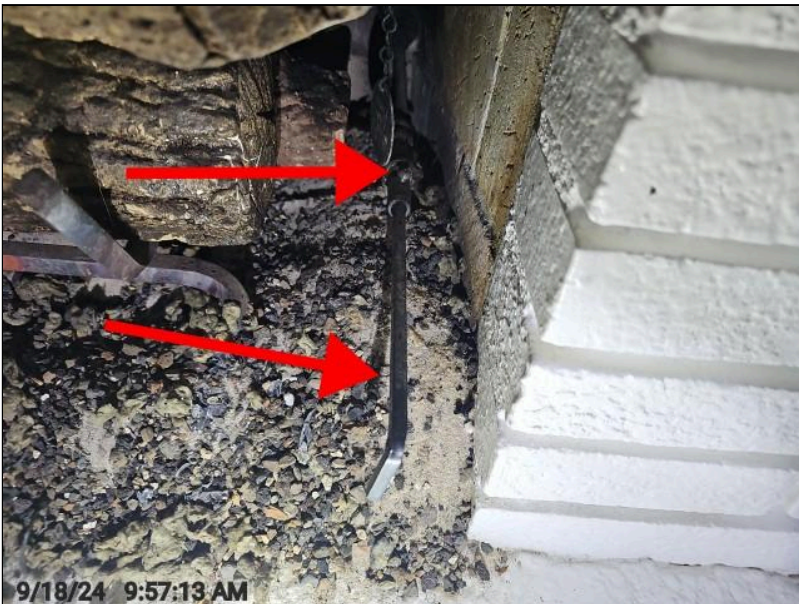
- 🏠 (2) The gas valve in the fireplace needs to be updated. The gas valve installed is no longer an approved gas valve. A qualified contractor needs to repair.

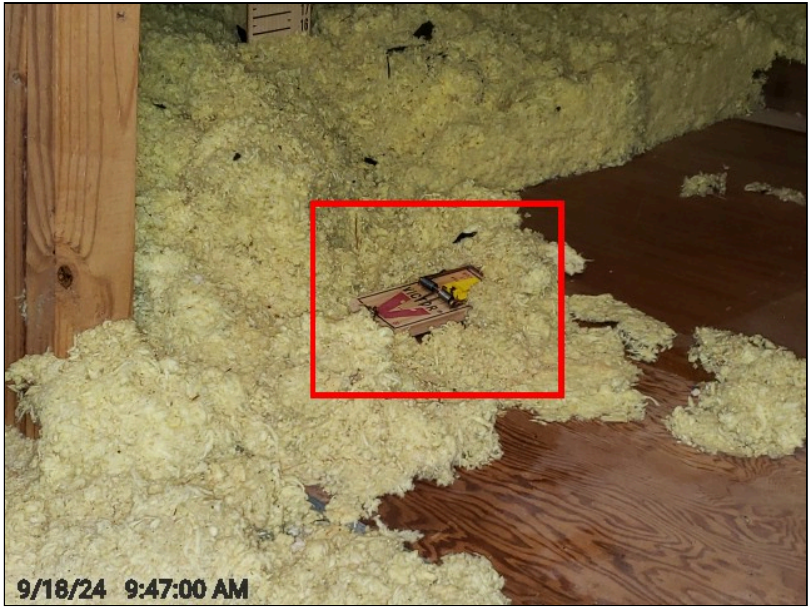
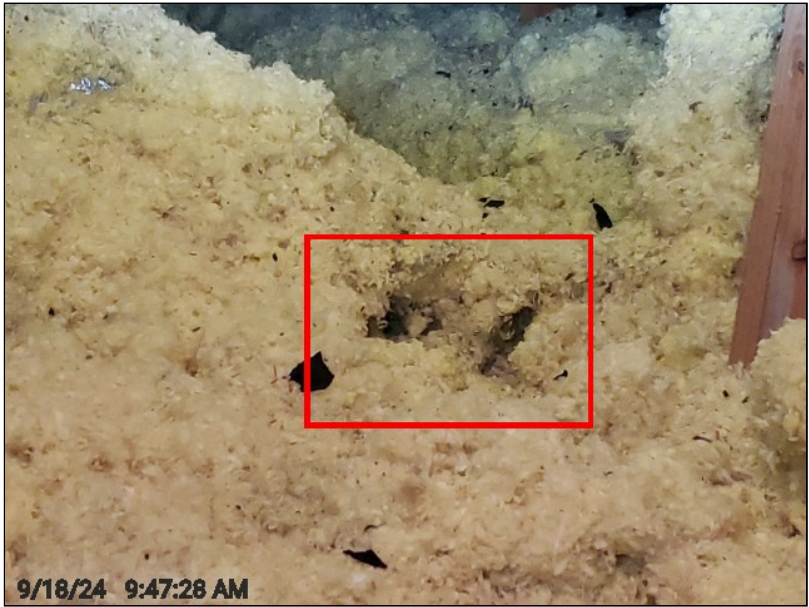
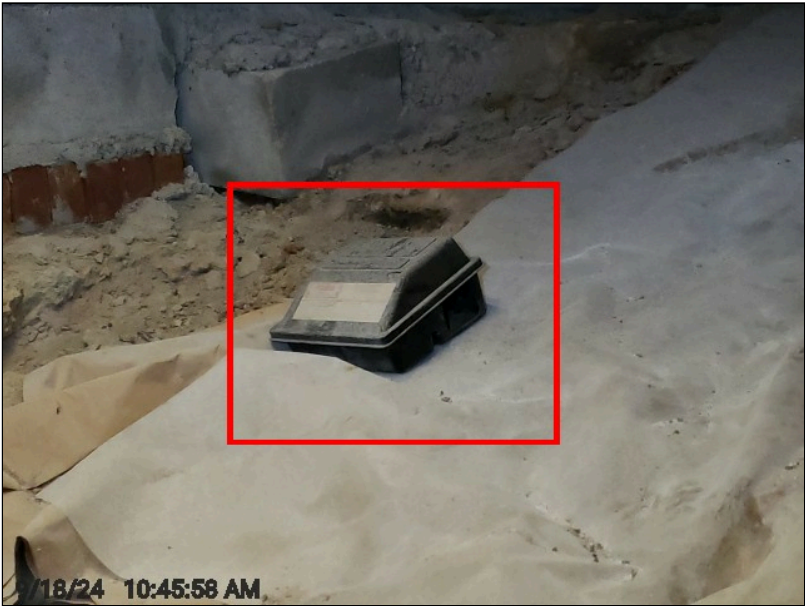
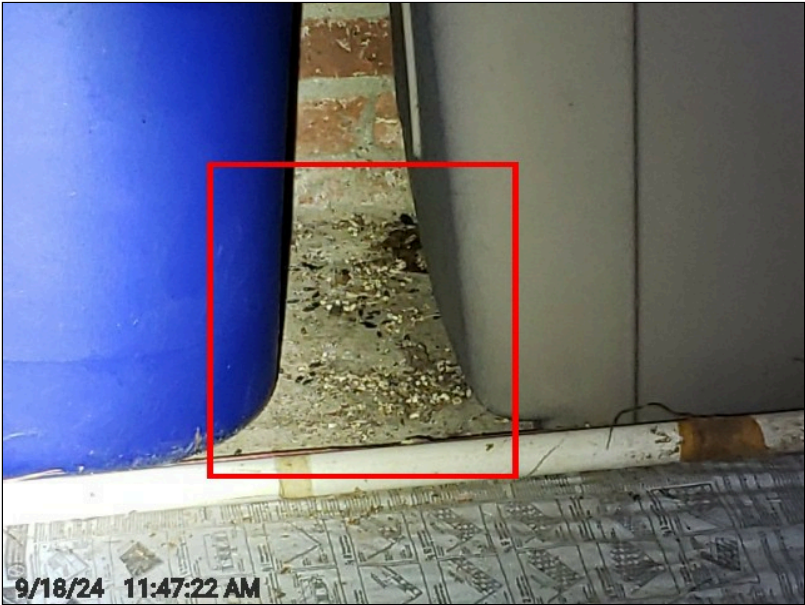
- (1) Your home inspection does not include a pest, termite, or wildlife inspection. These inspections are outside the scope of ASHI standards and practices. Any comments or lack thereof in the report are not a part of an in depth inspection. We are not licensed in Georgia or trained as pest, termite, or wildlife inspectors. We recommend with any real estate transaction that you have a pest, termite, and wildlife inspection by a State of Georgia licensed contractor.
- (2) There is evidence of wildlife inside the structure. A licensed wildlife company needs to evaluate further and treat as needed. All droppings need to be removed and area sanitized. Any insulation that is soiled needs to be removed and replaced with R-38 loose fill. Picture is example. Location(s): attic, crawlspace, and exterior storage room
