Inspection Report

4567 Main St

Marion Hodges Home Inspection Services

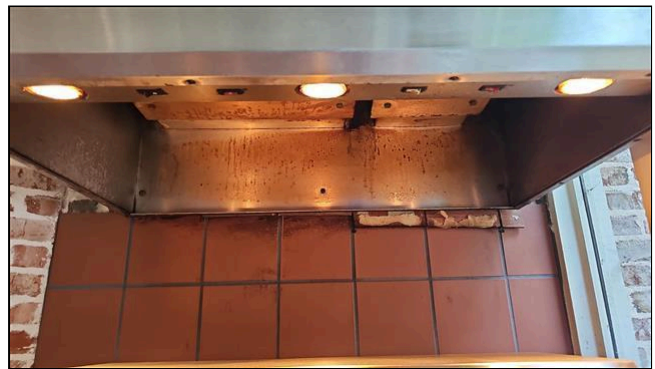
Exhaust Vent Above Grill

- 🏠 The exhaust vent did not start. A qualified contractor needs to put exhaust vent in working order or replace exhaust vent.

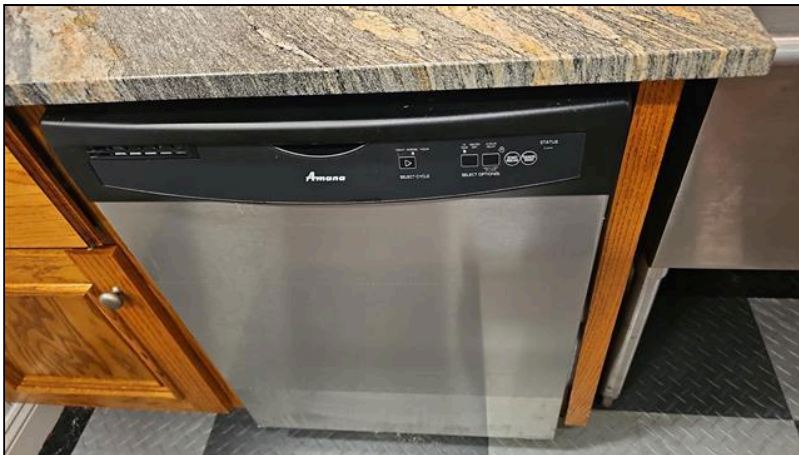
- 🏠 The dishwasher did not start at the time of the inspection. A qualified contractor needs to put the dishwasher in working order or replace dishwasher. Location(s): man cave

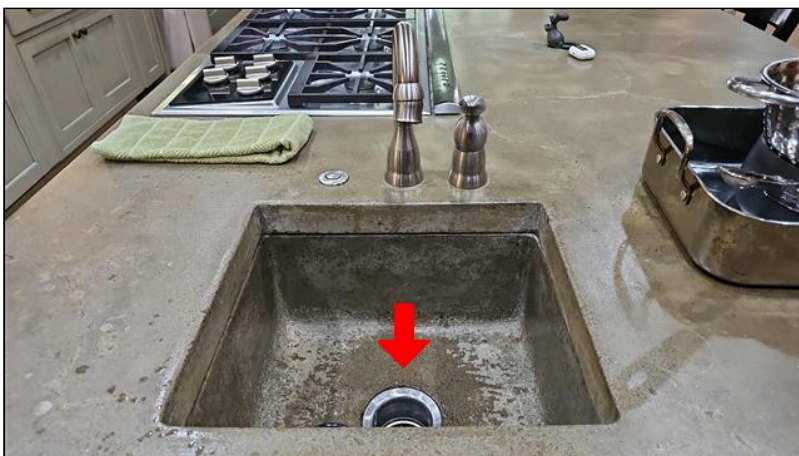
- 🏠 The disposal does not work. A licensed plumbing contractor needs to repair or replace the disposal.

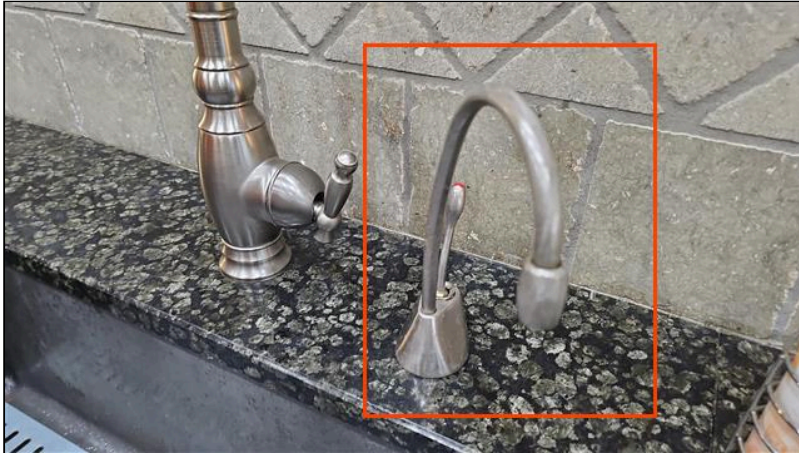
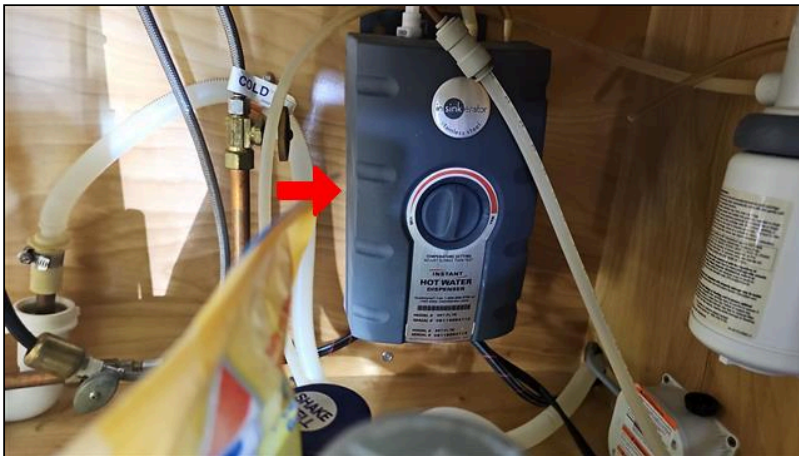
The instant hot water at the kitchen sink was not working. A qualified contractor needs to put the instant hot water and working order or replace as needed.

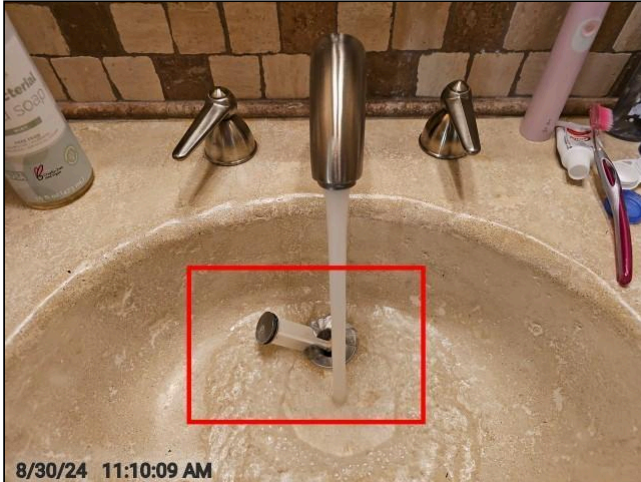
- 🏠 (1) The sink drain stopper is disconnected from the drain assembly. A licensed plumbing contractor needs to connect drain stopper. Location(s): main level bath, primary bath

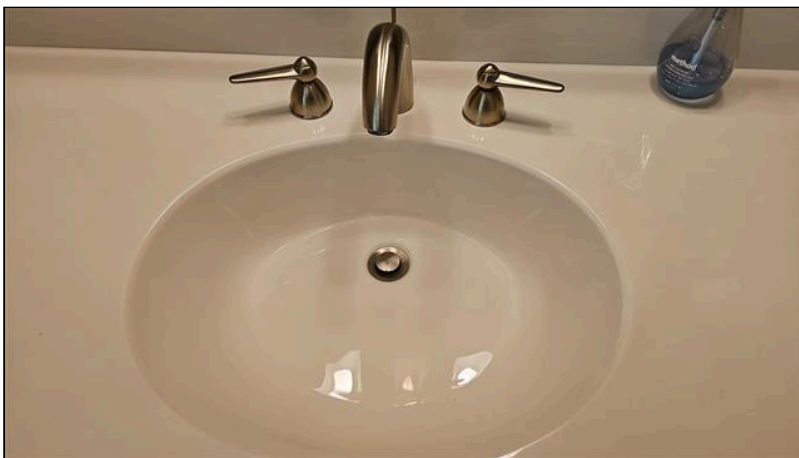
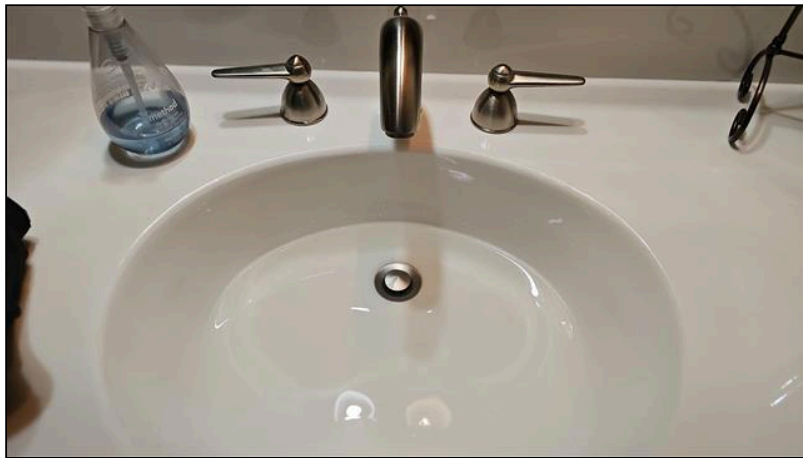
- 🏠 (2) The sink drain stopper will not close. A licensed plumbing contractor needs to repair. Location(s): primary bath (right sink)
- 🏠 (3) The sink is slow draining. A licensed plumbing contractor needs to put sink drain in working order. Location(s): right and left private bath

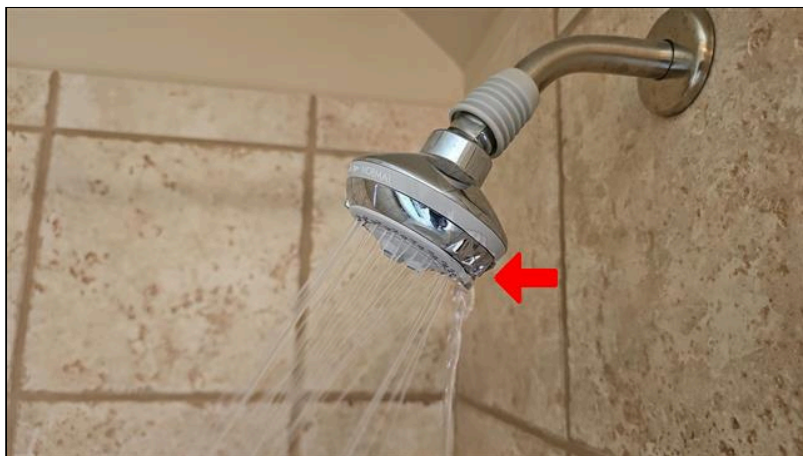
The showerhead leaks at connections. Tighten showerhead or replace showerhead. Location(s): right private bath

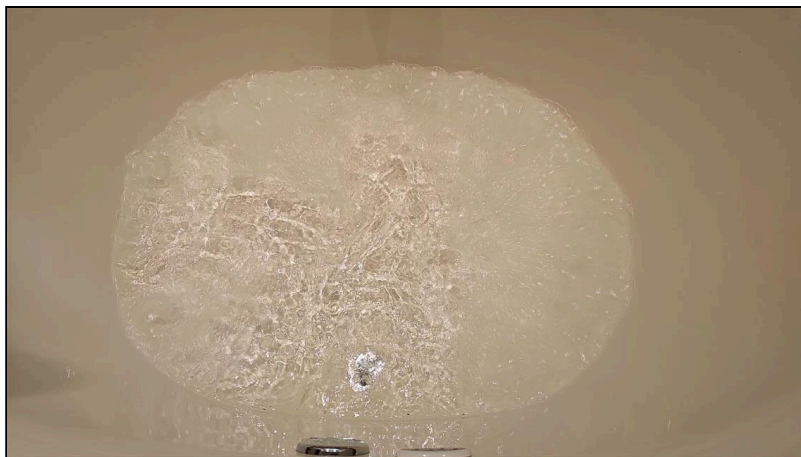
(3) There is no access to the whirlpool circulation pump. The circulation pump and its components were not inspected. An opening 12 inches by 12 inches should be installed to provide access to the circulation pump. Usually access can be made through the end of a cabinet at opposite end of the tub drain or from access made through a wall at opposite end of the tub drain. A door or panel should be provided to close the opening. A qualified contractor needs to repair.

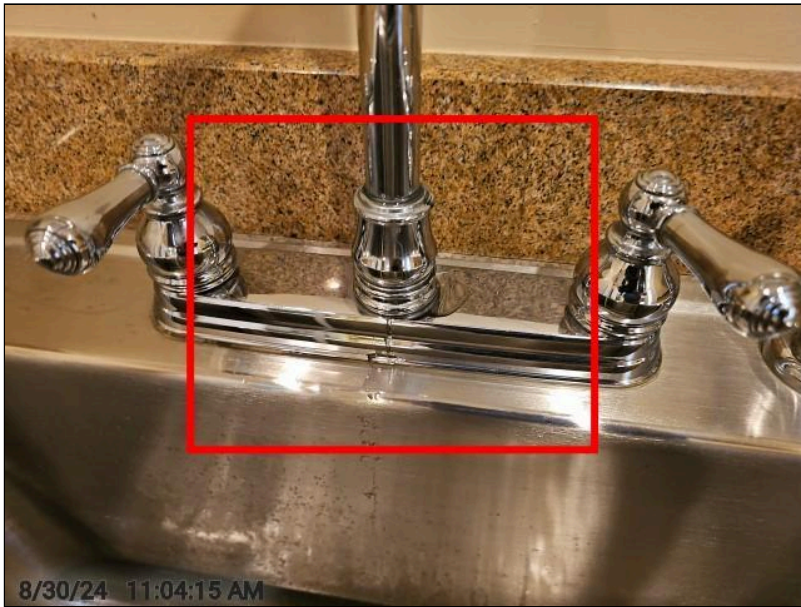
The laundry sink fixture leaks. A licensed plumbing contractor needs to repair.

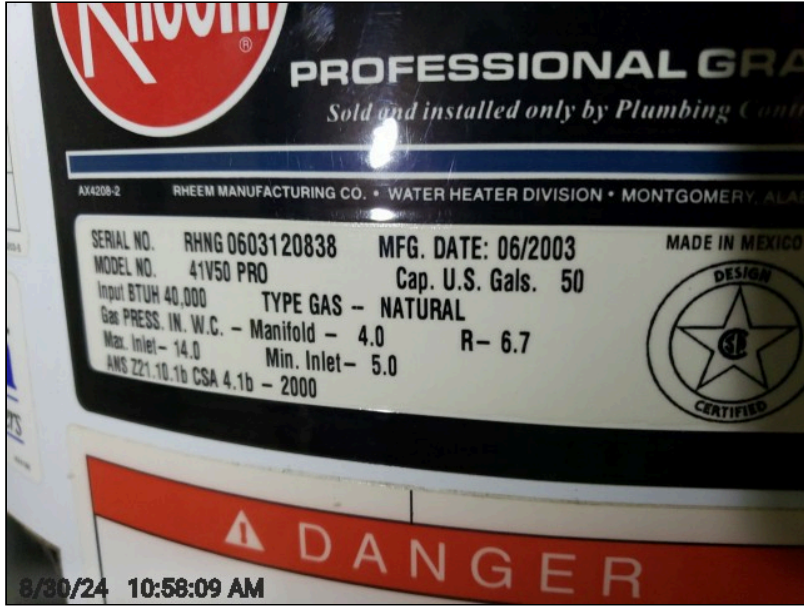
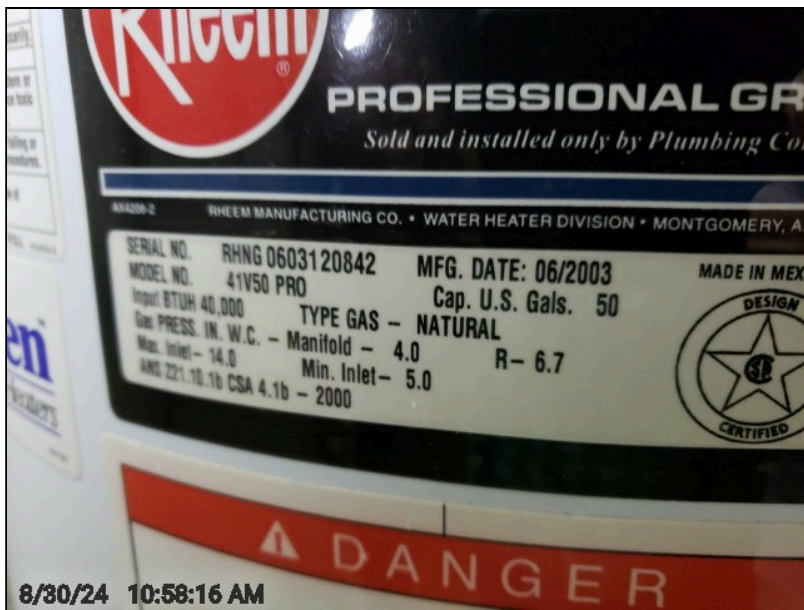
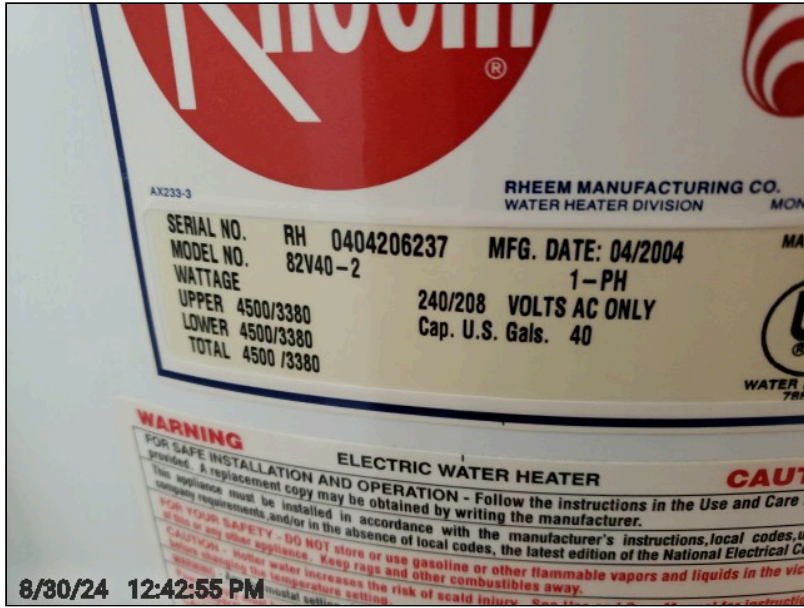
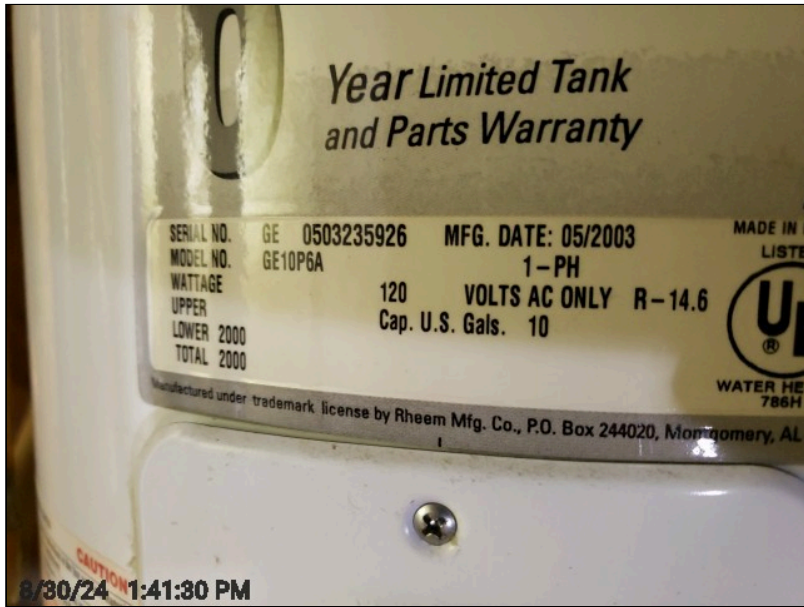
🏠 (1) The water heaters are at or beyond average life expectancy of 10 to 12 years. Future replacement

should be anticipated. Recommend putting a water detection device near the water heaters to alert you in the event there is a leak. The inspector makes no warranties or guarantees as to how long the water heaters or any components of the water heaters will last. Location(s): all water heaters

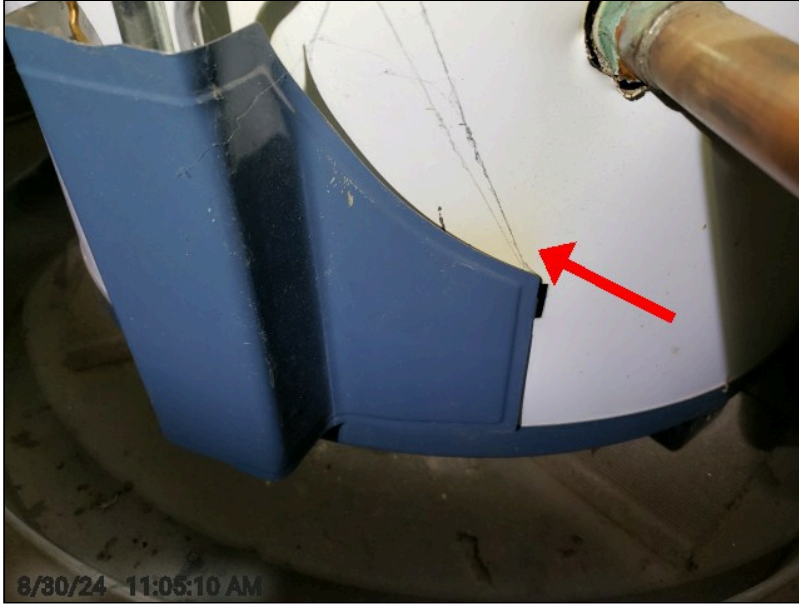
- 🏠 (2) Flame roll out was observed. Flame roll-out is an indicator of water heater failure. Roll-out can also be caused by a damaged or improper vent, insufficient combustion air, or a defective burner. A licensed plumbing contractor needs to repair or replace water heater. Location(s): basement

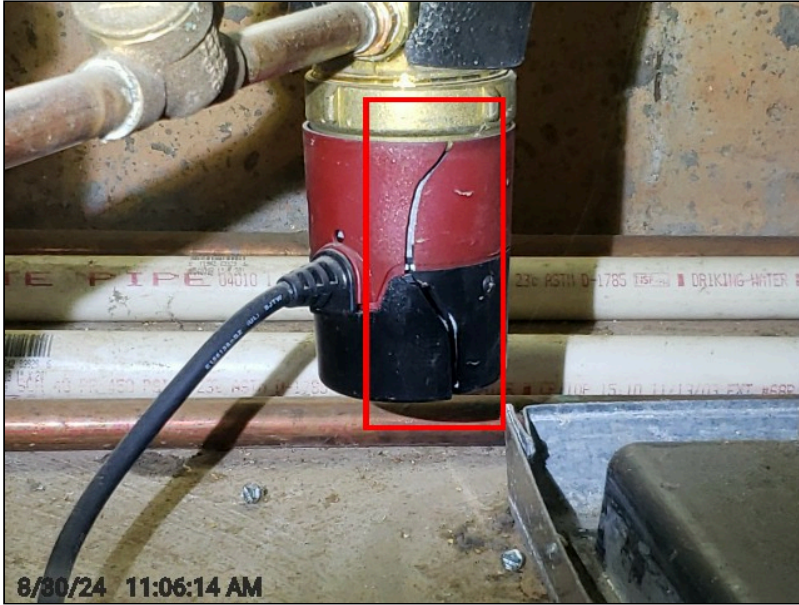
- 🏠 (4) The hot water recirculating pump housing is cracked. A licensed plumbing contractor needs to replace the recirculating pump. Location(s): basement

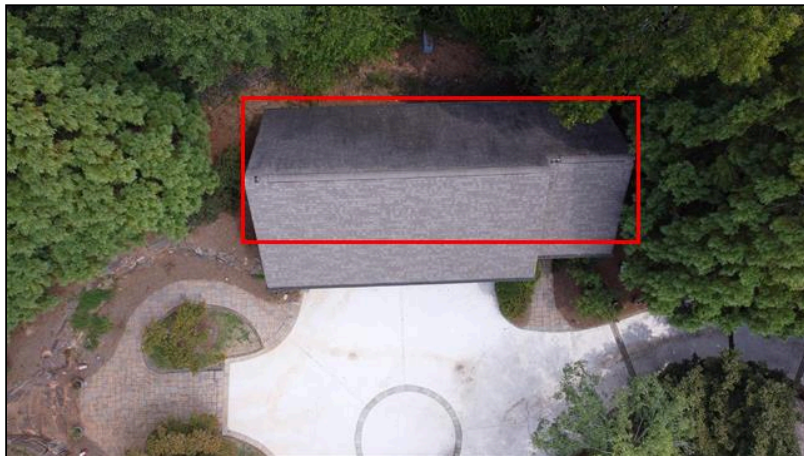
- 🏠 The plumbing in the man cave is not vented through the roof to the exterior. The plumbing system vents into the attic through an air admittance valve. There should be at least one plumbing fixture vented through the roof. A licensed plumbing contractor needs to repair.

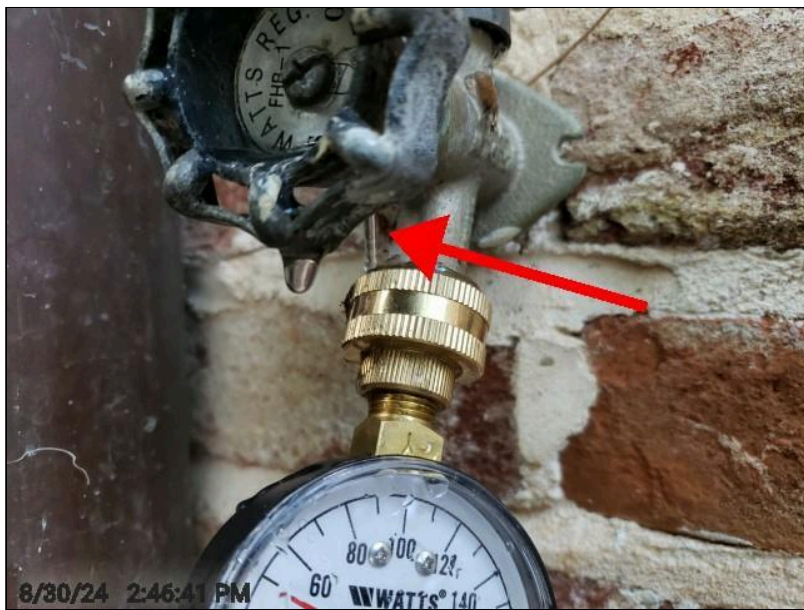
- 🏠 (1) The hose bibb leaks when water is activated. A licensed plumbing contractor needs to repair. Location(s): by attached garage

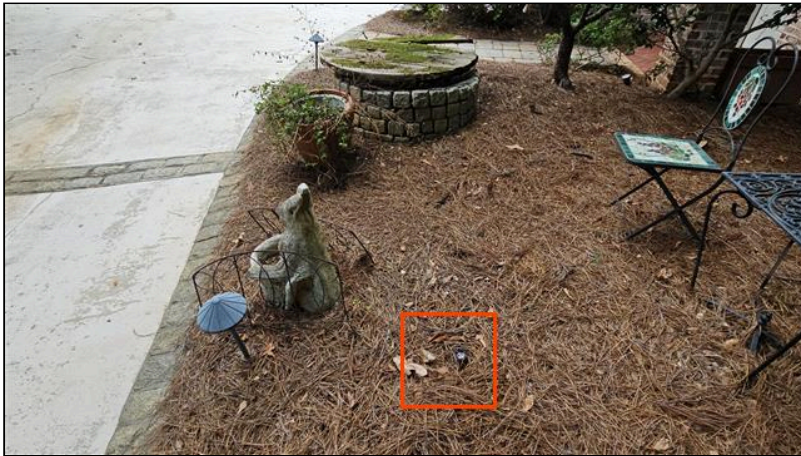
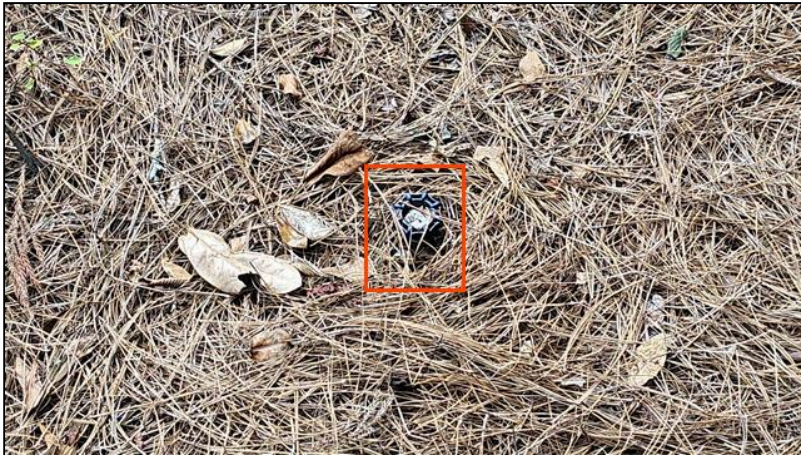
- 🏠 (2) The hose bibb is turned off at main cut off valve. Fixtures that are turned off are not turned on by the inspector. The seller should turn on the hose bibb prior to closing to verify there are no leaks or broken pipes. Repairs made if needed. Location(s): by back porch
- 🏠 (3) The hose bibb near the well is turned off at main cut off valve. Fixtures that are turned off are not turned on by the inspector. The seller should turn on the hose bibb prior to closing to verify there are no leaks or broken pipes. Repairs made if needed.

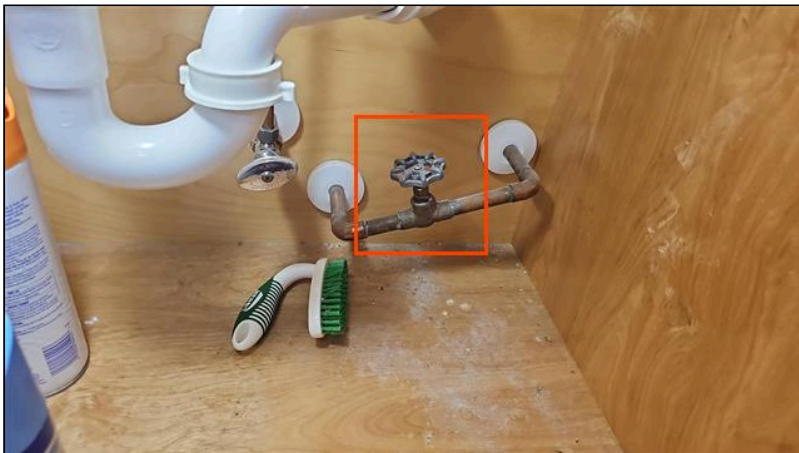
🏠 (3) Check with the seller to see if the cutoff valve in the bath cabinet in the man cave is the main cut off for the man cave.

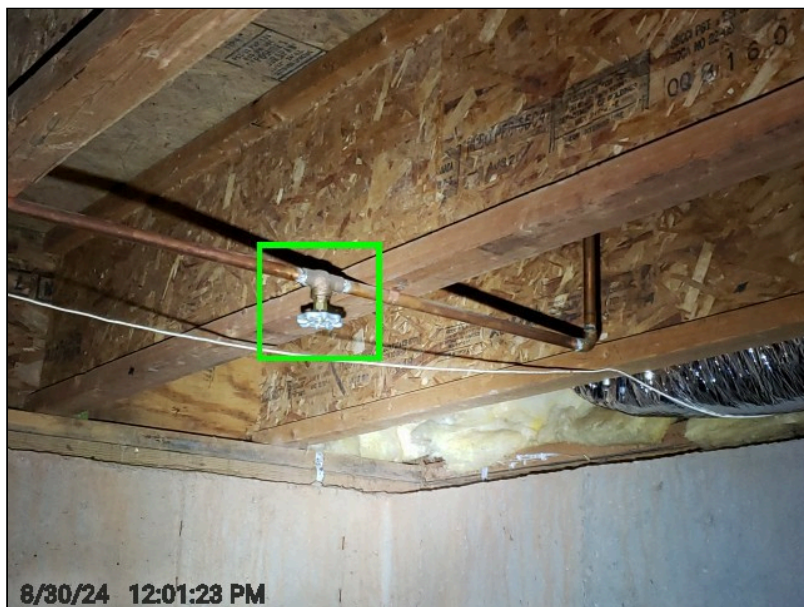
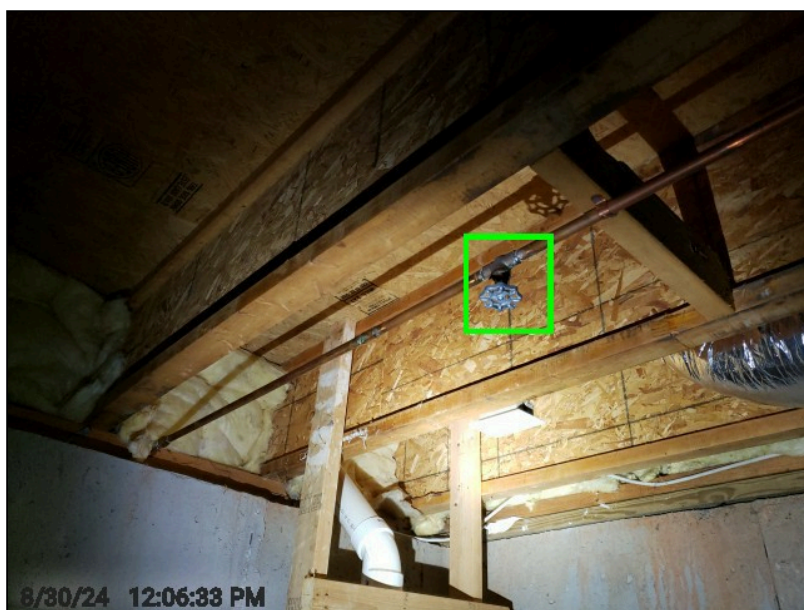
FYI, Location of exterior water faucet shutoff. (See Photo). In the winter time, a good practice is to turn off the water to the exterior faucets and drain exterior faucet to prevent pipe from freezing. This is for your information.

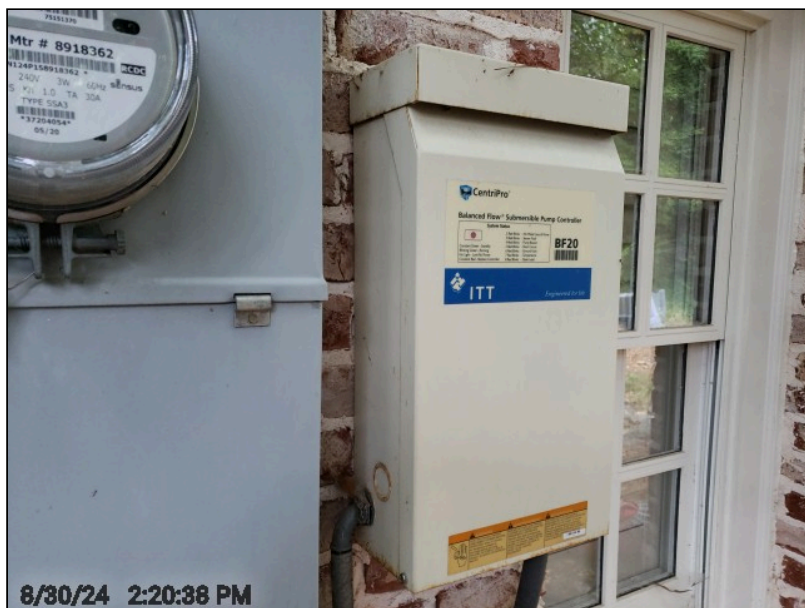
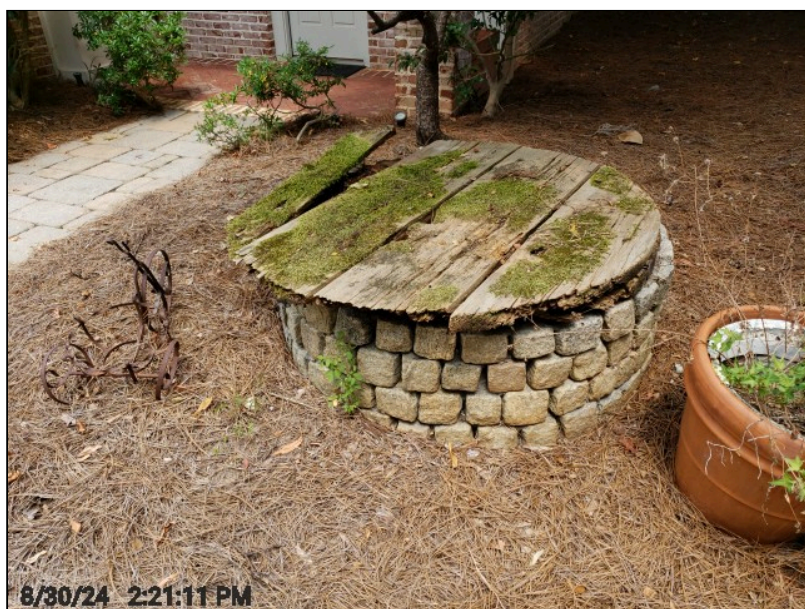
- 🏠 (1) The well equipment needs to be inspected and tested by a qualified contractor.

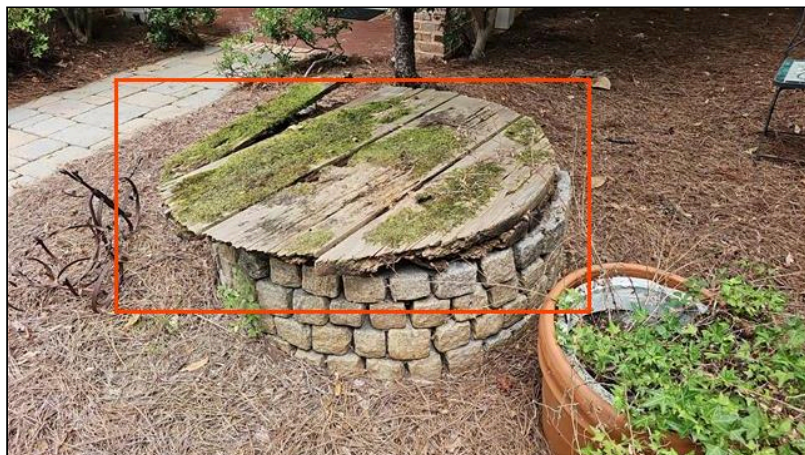
- 🏠 (2) The lid on the well needs to be replaced with a metal lid locks for safety.

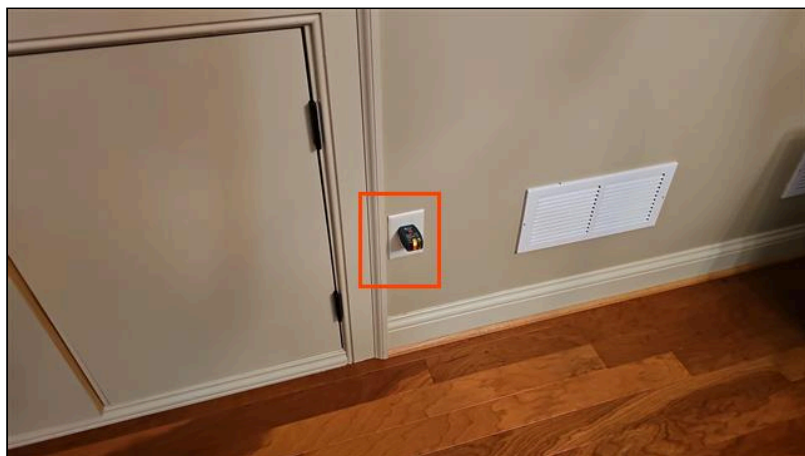
(2) Receptacle wired with open ground connection. A licensed electrician needs to repair. Location(s): bonus room

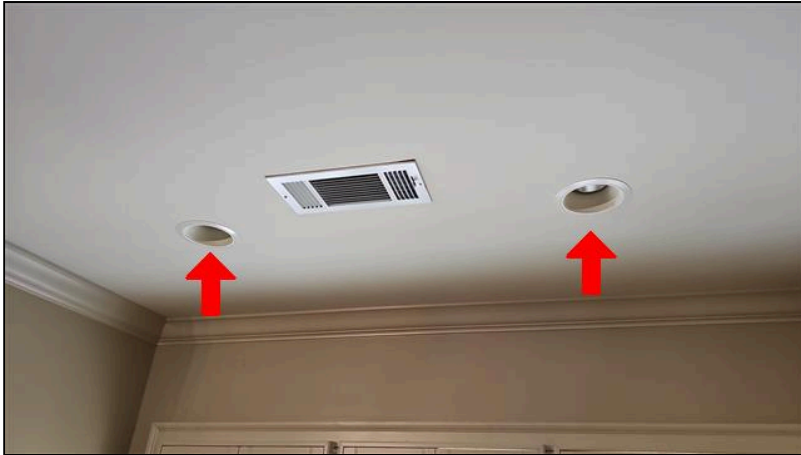
(2) Recess light(s) did not turn on. Replace bulb and verify operation of recess light fixture. In the event the recess light fixture does not work, a licensed electrician needs to repair. Location(s): bonus room

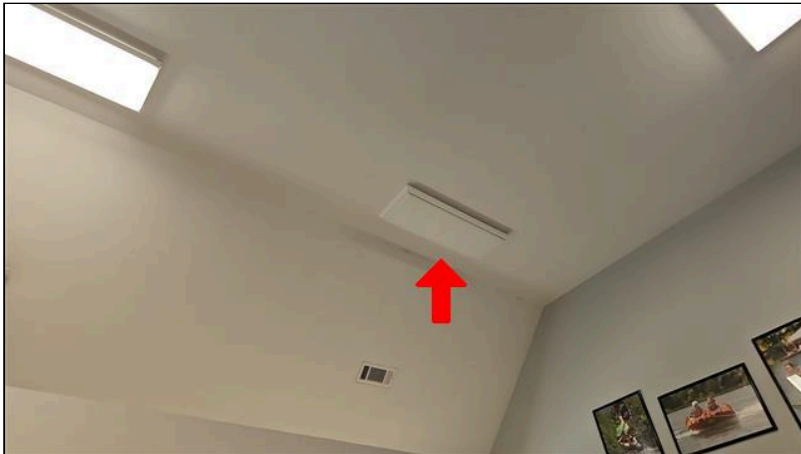
(3) Light fixture(s) did not turn on. Replace bulb and verify operation of light fixture. In the event the light fixture does not work, a licensed electrician needs to repair. Location(s): man cave

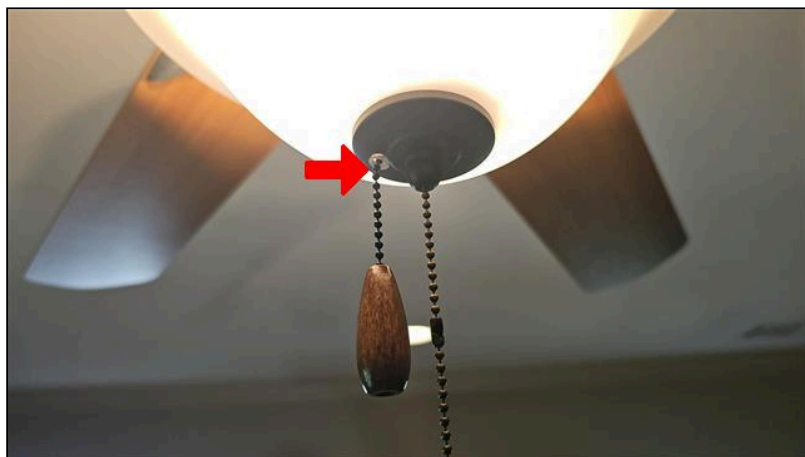
- 🏠 Ceiling fan did not turn on. The pull cord mechanism appears to be broken. A licensed electrician needs to put fan in working order. Location(s): back left bedroom

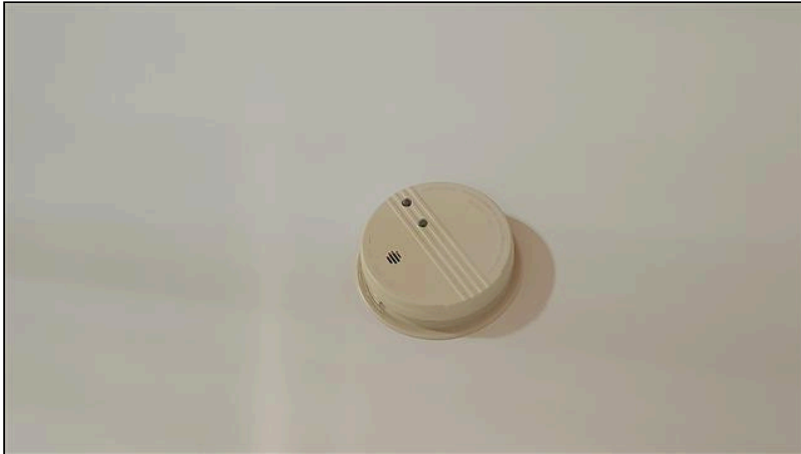
Smoke detector upstairs hall

- 🏠 The installed smoke detectors and/or combination smoke/carbon monoxide detectors are older and need to be replaced. There should be one smoke detector in each bedroom, one combination smoke and carbon monoxide detector in the hall outside of the bedrooms, and one on each floor of the house including basements and habitable attics. A licensed electrician needs to install smoke detectors and carbon monoxide detectors.

The purchaser needs to test all smoke and carbon monoxide detectors for operation prior to someone sleeping in the house. Batteries need to be replaced every 6 months. Smoke and carbon monoxide detectors tested every month. Smoke detectors last 7 to 10 years. Carbon monoxide detectors last 6 years.

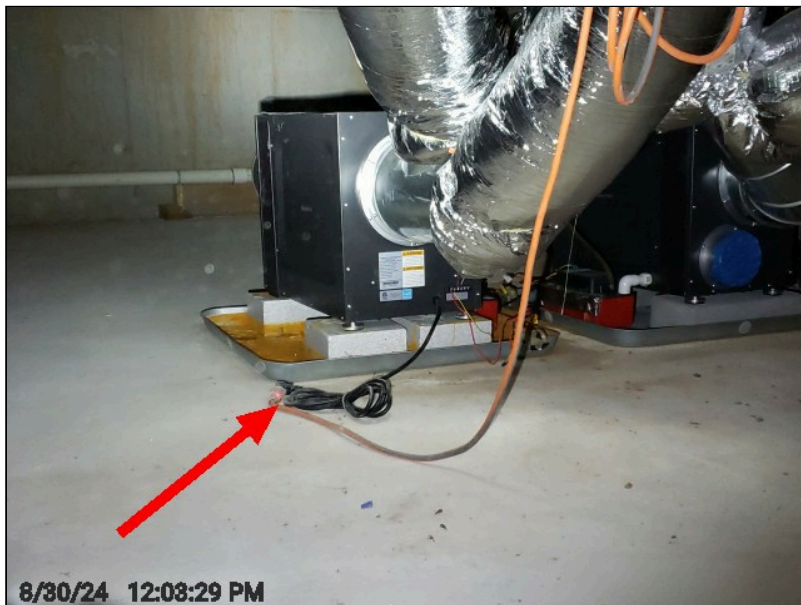
- 🏠 (1) The dehumidifier is powered by an extension cord. This is a safety issue. A licensed electrician needs to add a receptacle at the dehumidifier.

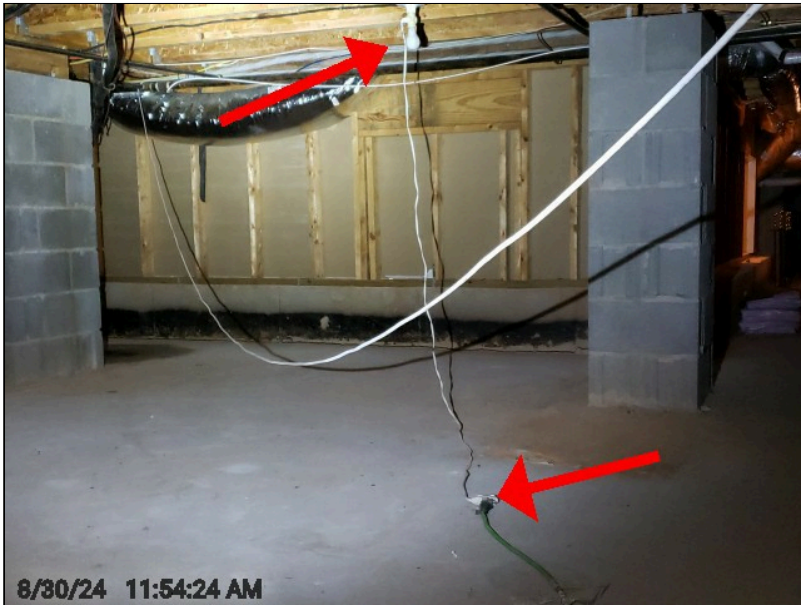
- 🏠 (2) Several light fixtures are wired with extension cords. This is a safety issue. A licensed electrician needs to hard wire the light fixtures. Location(s): crawlspace

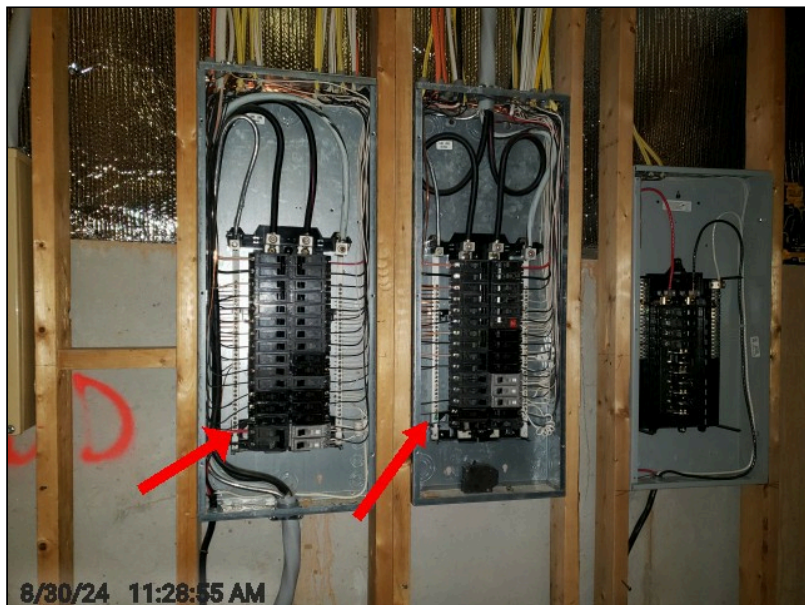
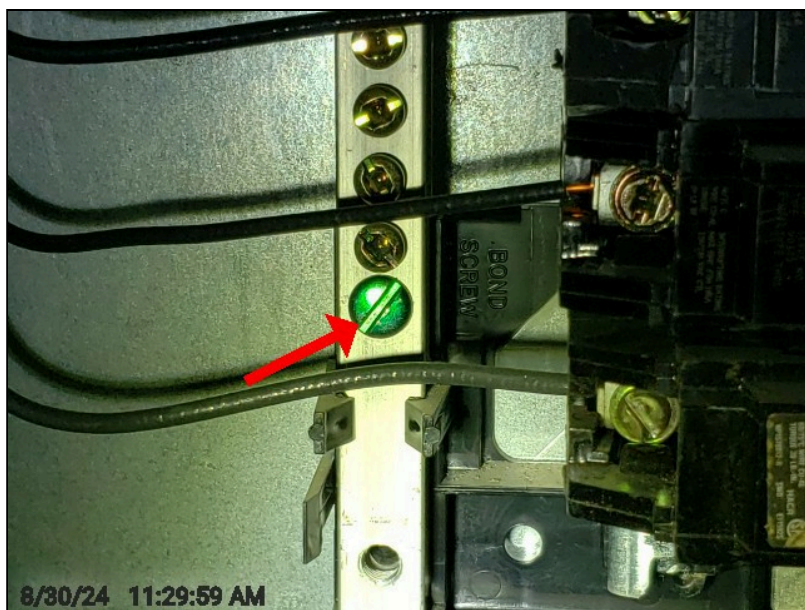
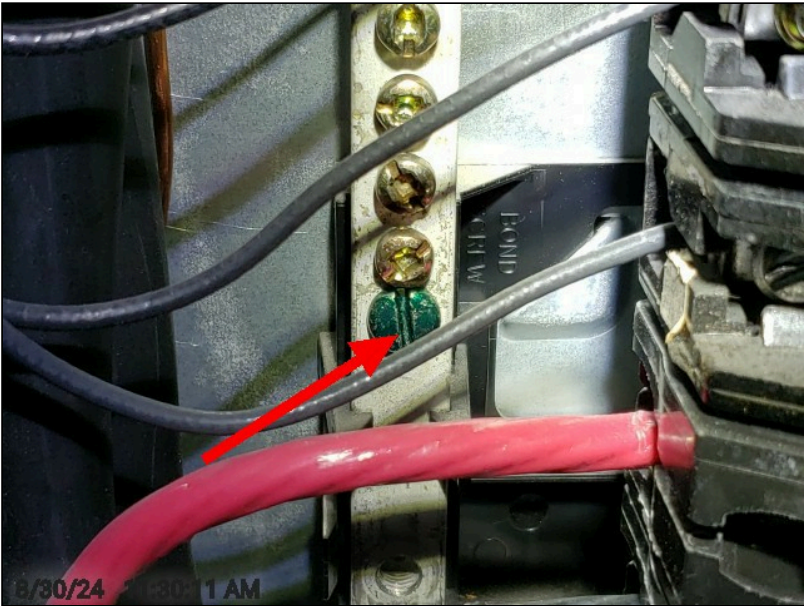
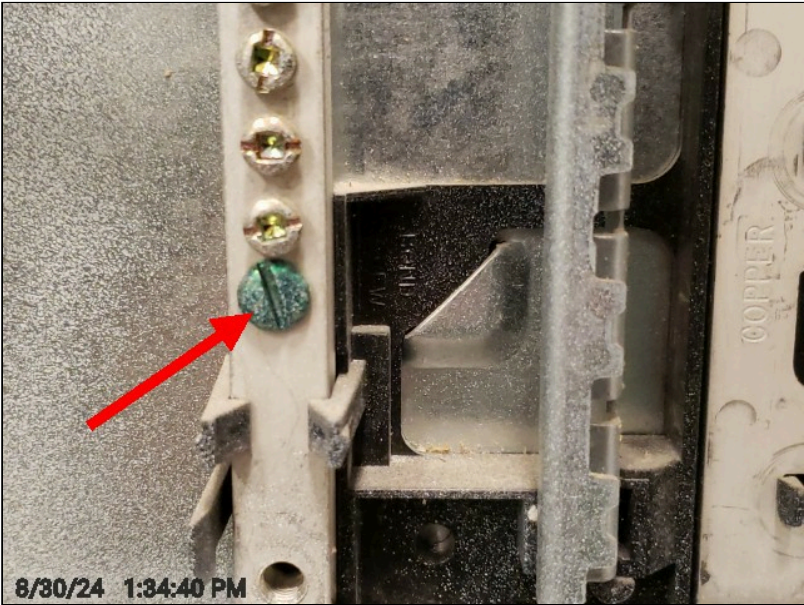
- 🏠 (2) Three of the distribution panels are bonded. Electrical panels should be bonded at the closest point to the main disconnect breaker. The main disconnect breaker is on the exterior. A licensed electrician needs to repair. Location(s): basement and detached garage

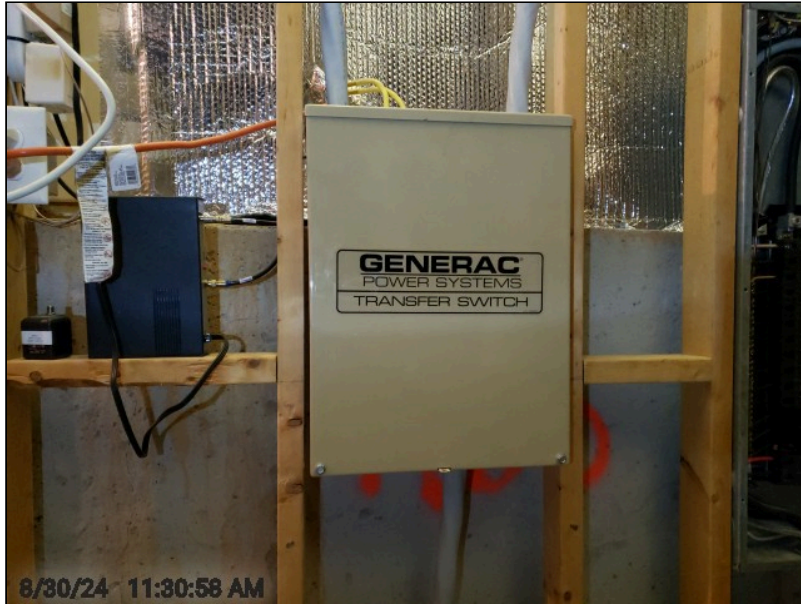
- 🏠 (3) Testing generators and generator electrical equipment is outside the scope of a home inspection. The generator and electrical equipment were not tested by the home inspector. A licensed electrician needs to test the generator and inspect equipment. Repairs made if needed.

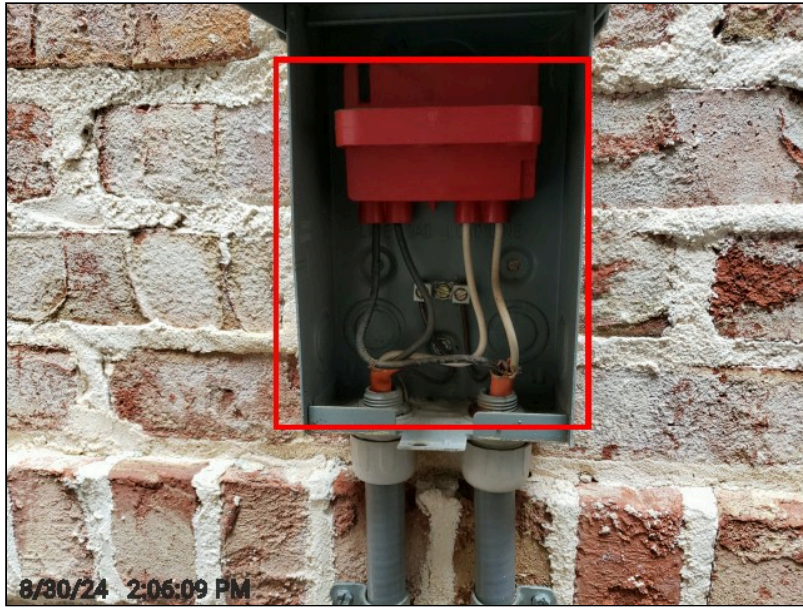
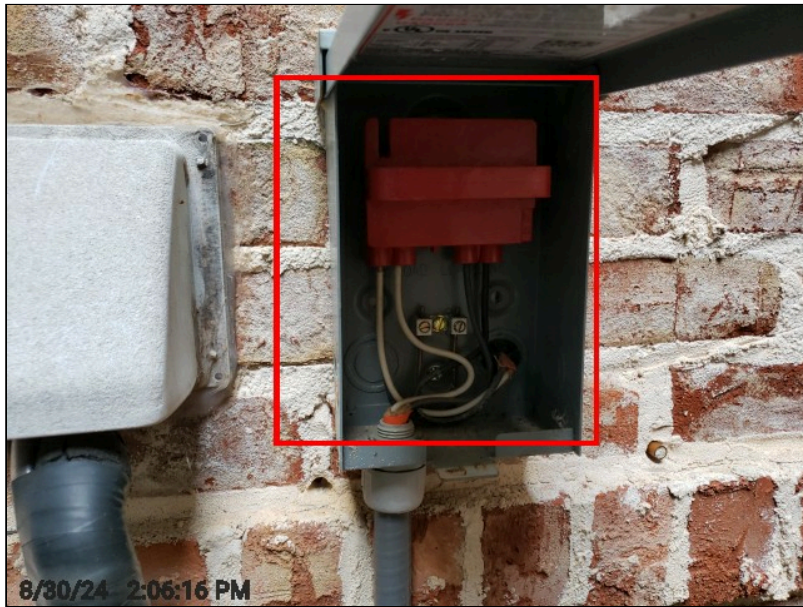
- 🏠 (4) Panel fronts are missing on the disconnect boxes at the water heater and condensing units. This is a safety issue. A licensed electrician needs to add panel front.

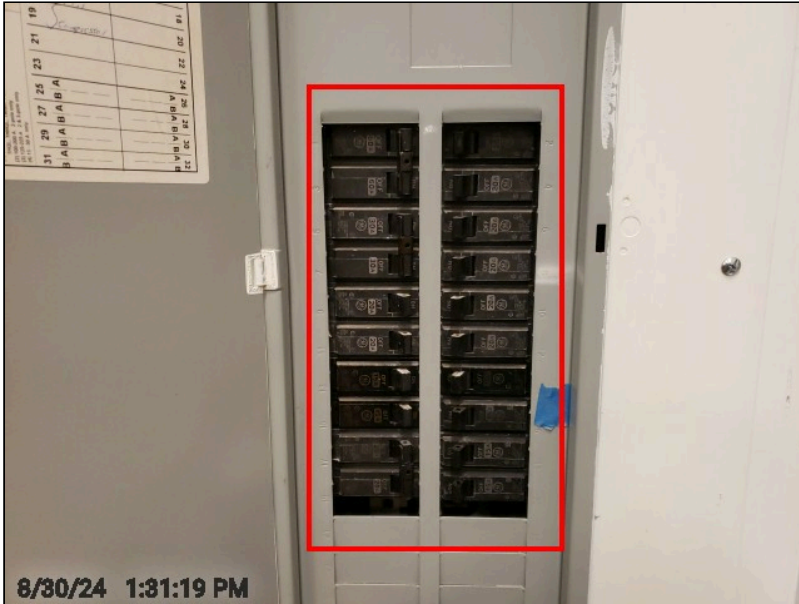
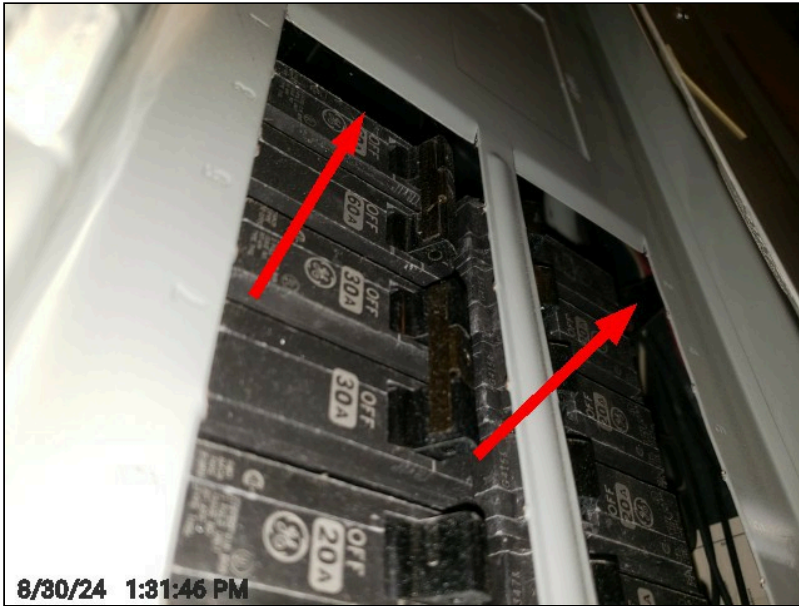
- 🏠 (5) There is a gap between the panel cover and the breakers. There should be no gaps between the panel cover and breakers that could allow foreign objects to be put into the panel. This is a safety issue. A licensed electrician needs to repair. Location(s): panel in detached garage

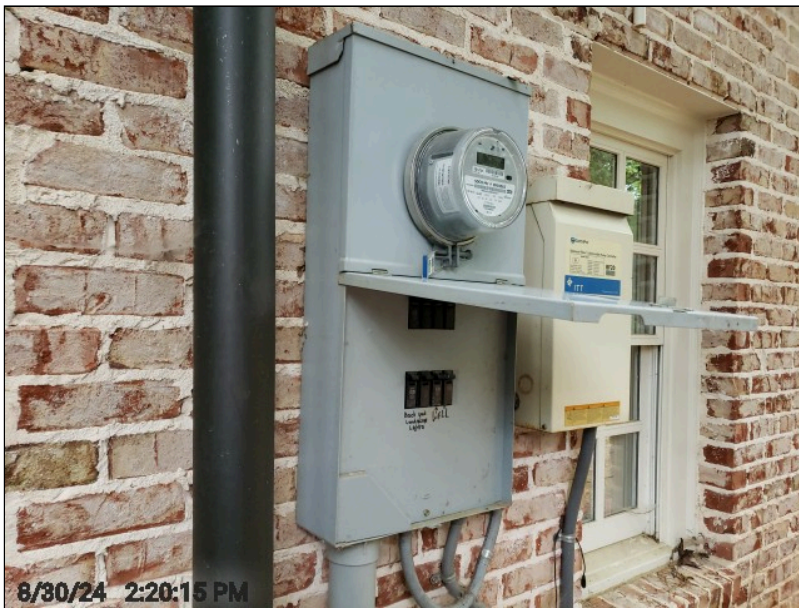
FYI, the detached garage has a separate electrical meter base.

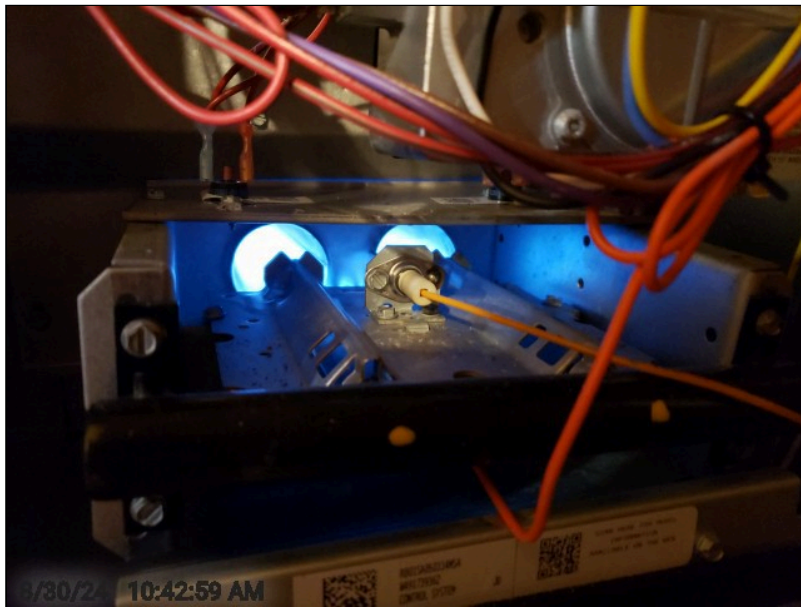
- 🏠 (1) The upstairs furnace was operational. Underlying issues can still exist with an operating system. A licensed heating and air contractor should do annual service based on manufacturers specs and repair as needed. The inspector makes no warranties or guarantees as to how long the heating equipment will last.

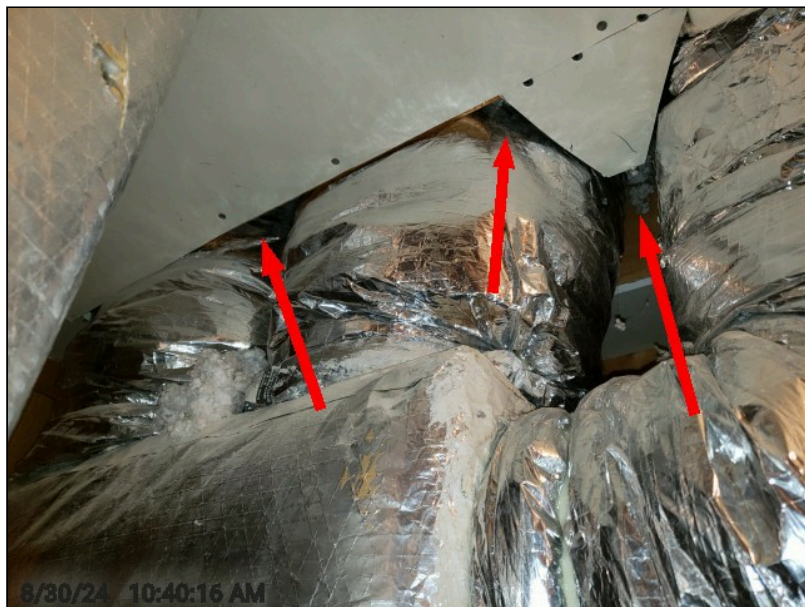
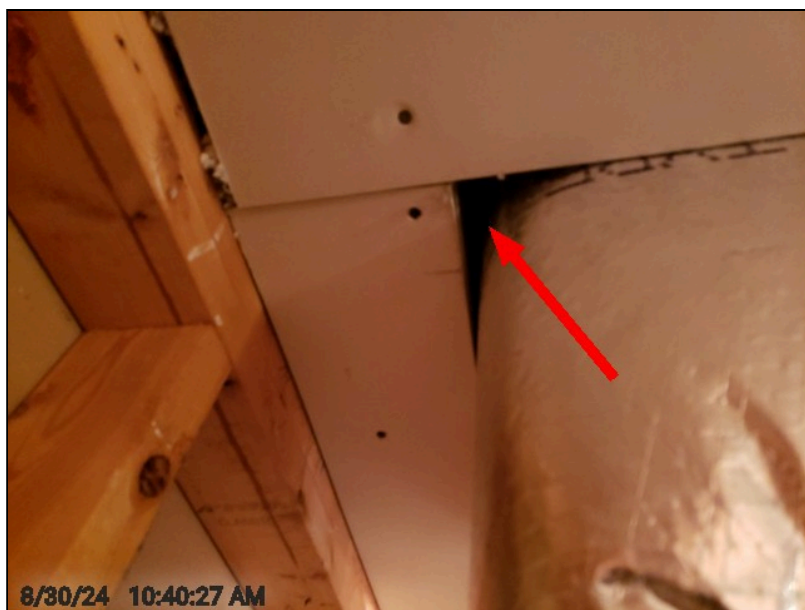
- 🏠 (2) The open ceiling above the furnace needs to be draft stopped to prevent a fire from spreading into the attic. A qualified contractor needs to draft stop the ceiling with fire rated foam. Location(s): upstairs mechanical closet

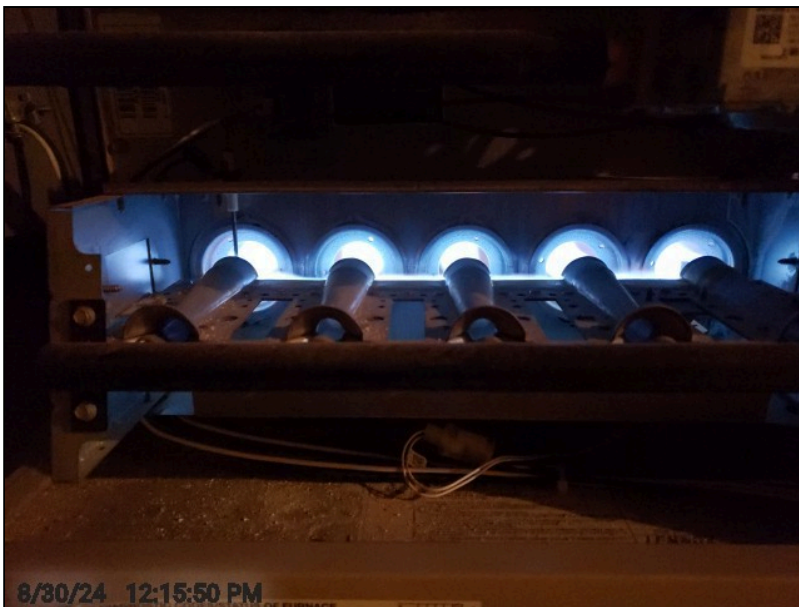
- 🏠 (3) Three of the furnaces (2003) are at or beyond average life expectancy. The furnaces did start at the time of the inspection. The furnaces must be safety checked and the heat exchangers checked for cracks. A licensed heating and air contractor needs to inspect further and repair or replace as needed. Location(s): primary bedroom furnace, main level furnace, garage furnace
