Inspection Report

4567 Main St

Marion Hodges Home Inspection Services

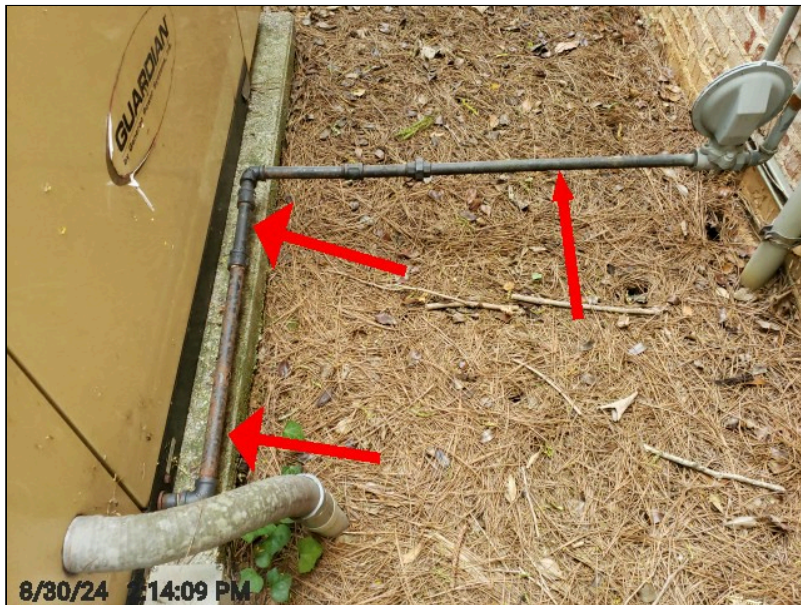
- 🏠 The gas pipe is not protected from corrosion. Exterior gas piping should be protected from corrosion with corrosion resistant paint. A qualified contractor needs to paint the gas pipe with corrosion resistant paint. Location(s): generator

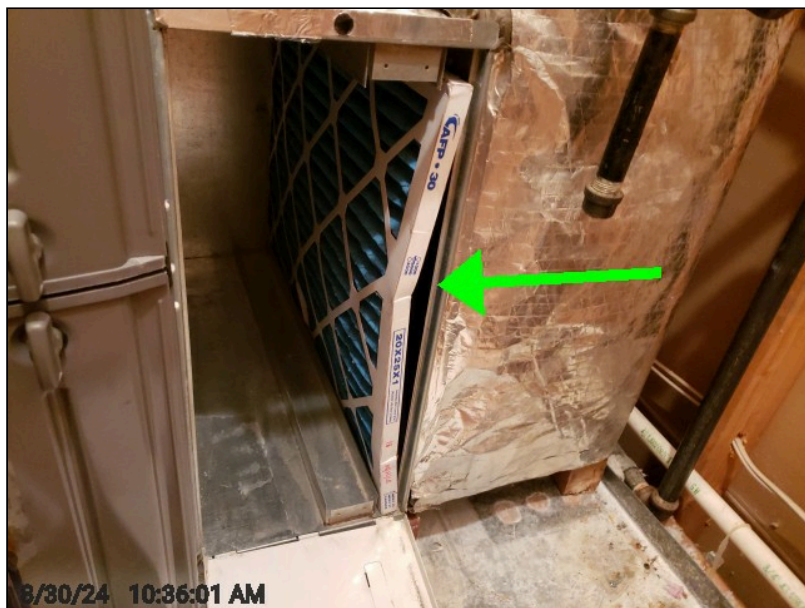
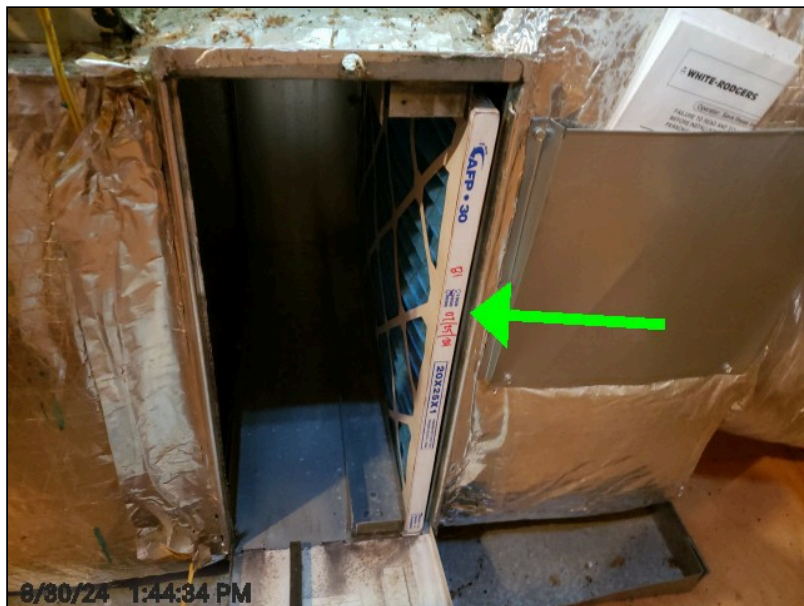
(1) Location of return air filters (see photo). Filters should be changed every 60 to 90 days. Recommend that the filters be changed once you take possession of the house.

Arrow in the direction of air flow

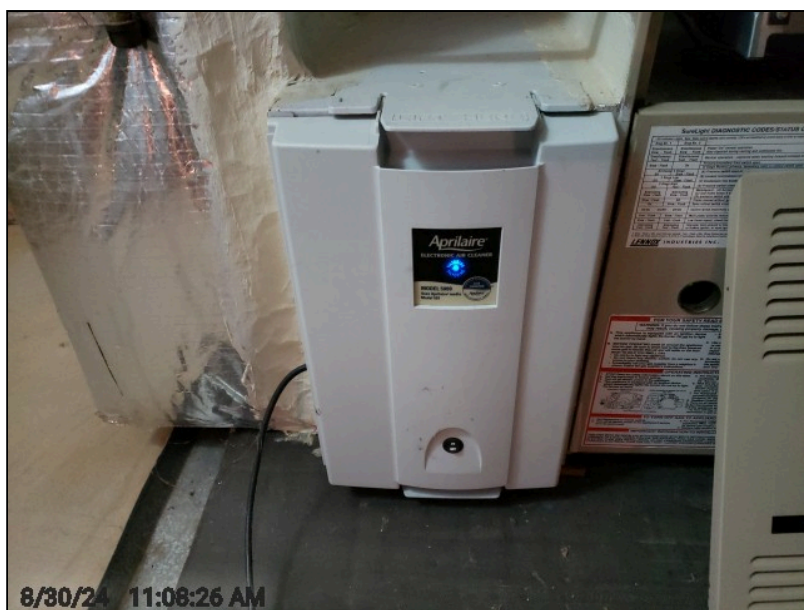
- 🏠 (2) Electronic air filters are installed on the 2 air handlers in the basement. If the electronic air filters have not been serviced and/or cleaned/replaced in the past year, a licensed heating and air contractor needs to service and/or clean/replace the filters.

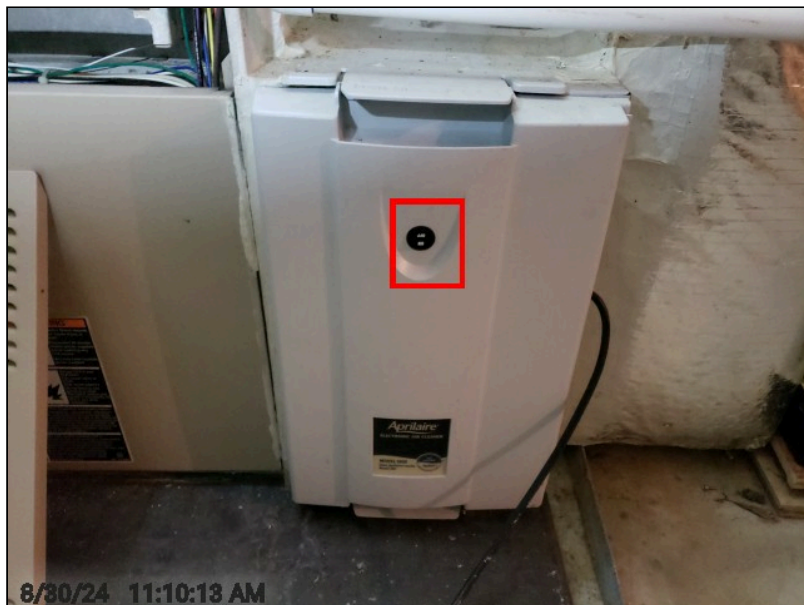
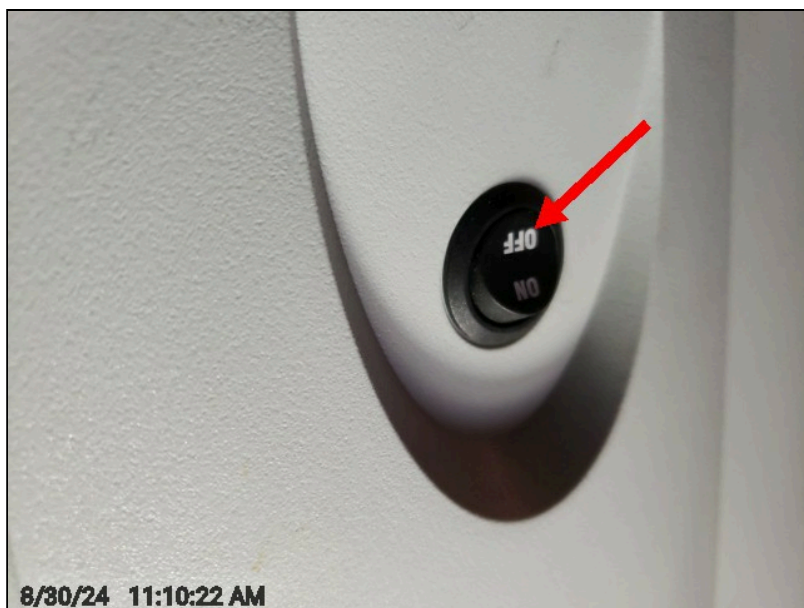
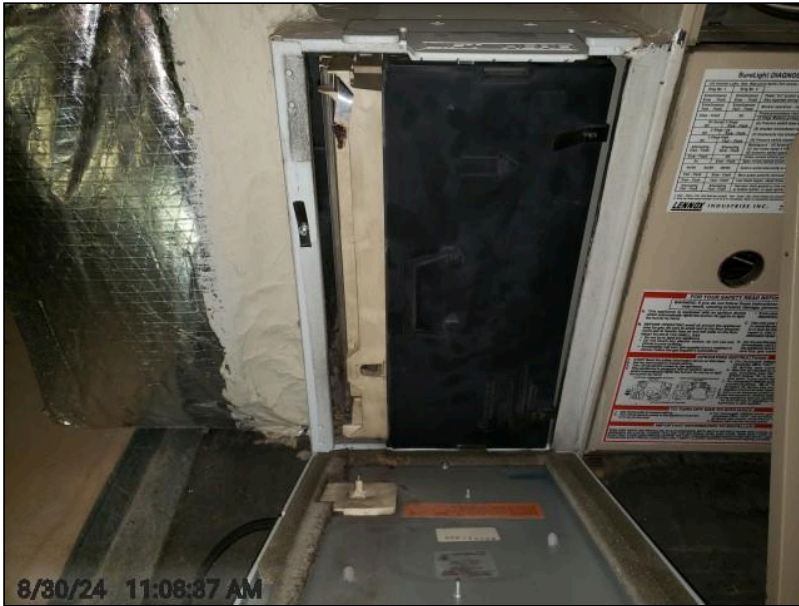
- 🏠 (3) The seller had the power turned off to the electronic air cleaner at the time of the inspection. A licensed heating and air contractor needs to put the electronic air cleaner in normal working order. Location(s): basement

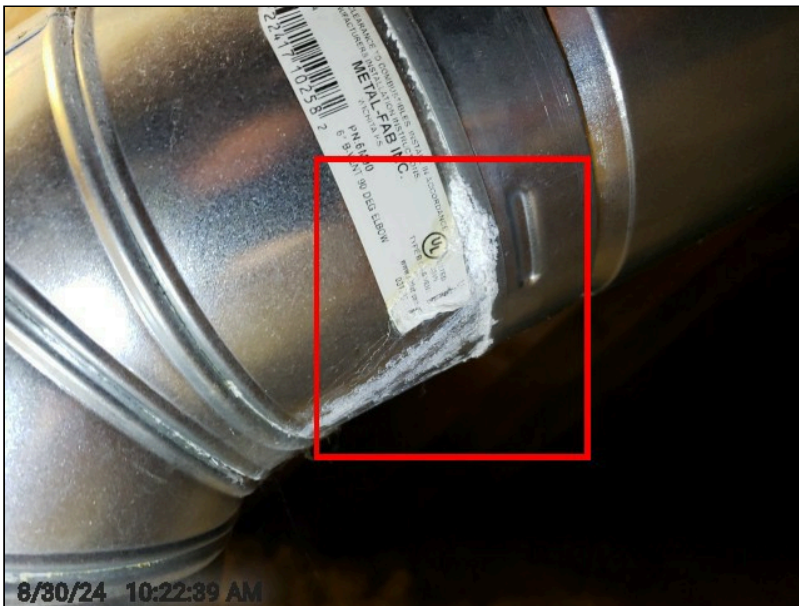
- 📍 (1) White powder was observed on the furnace vent pipe. This is a sign of an incomplete venting of toxic combustion gases or back drafting. This is a safety issue. A licensed heating and air contractor needs to inspect further and repair. Location(s): attic and basement

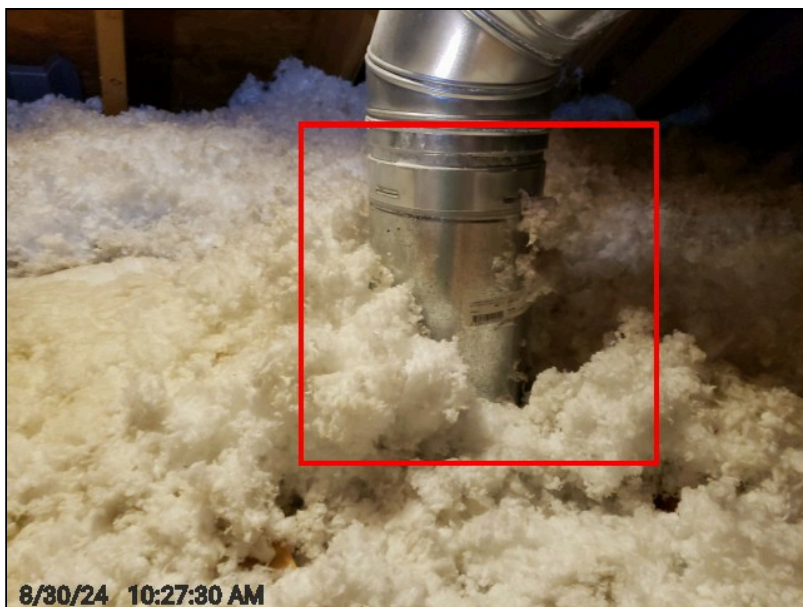
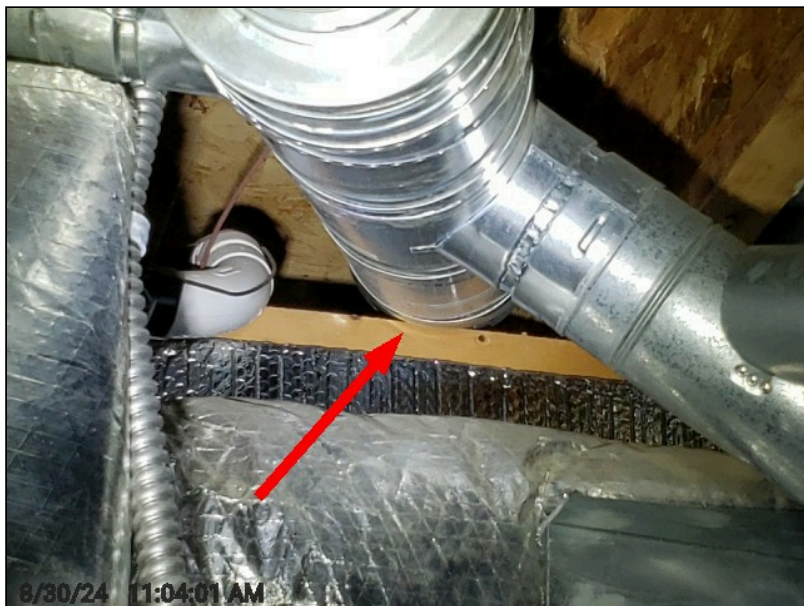
- 🏠 (2) Furnace vent pipe should have a one inch clearance from combustible materials. This is a safety issue. A licensed heating and air contractor needs to provide a one inch clearance from insulation and wood. Location(s): attic and basement

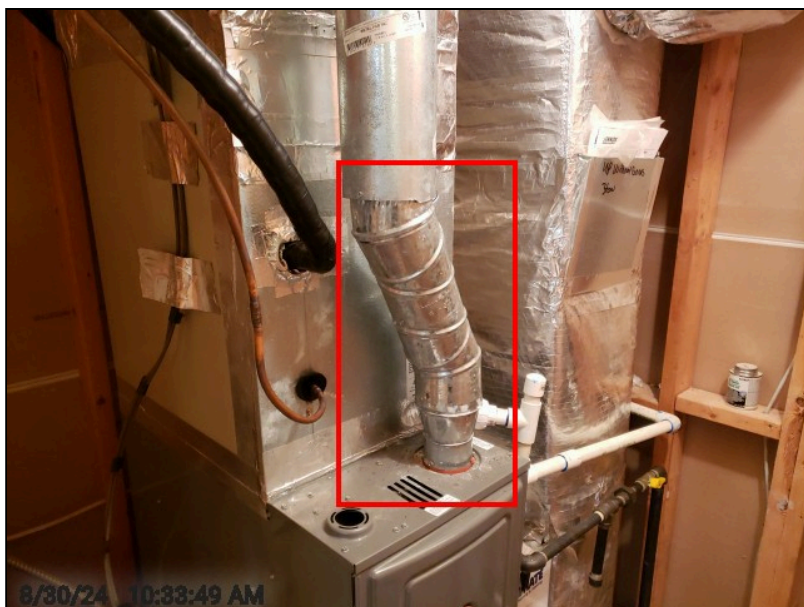
- 🏠 (3) Single wall vent pipe is venting the furnace. Most manufacturers recommend the vent to be double wall vent pipe. All single wall pipe should be replaced on the furnace with double wall vent pipe. A licensed heating and air contractor needs to repair. Location(s): upstairs furnace

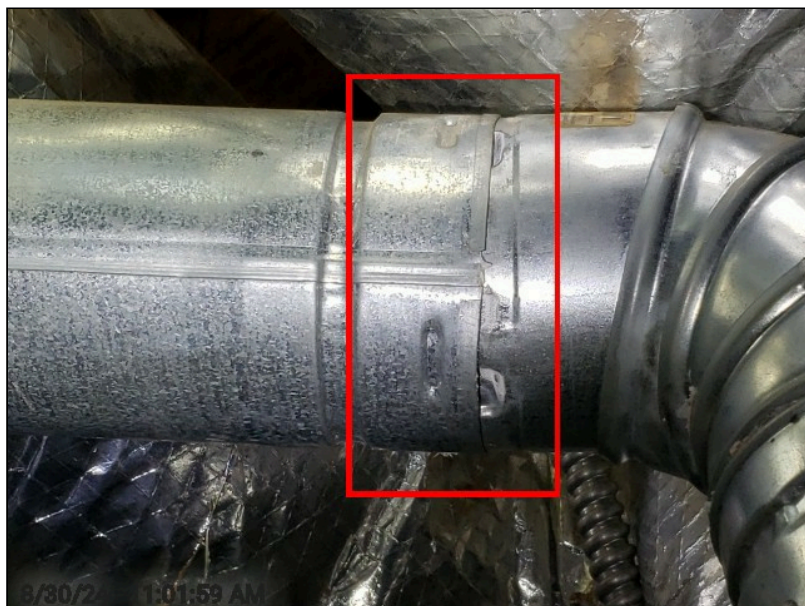
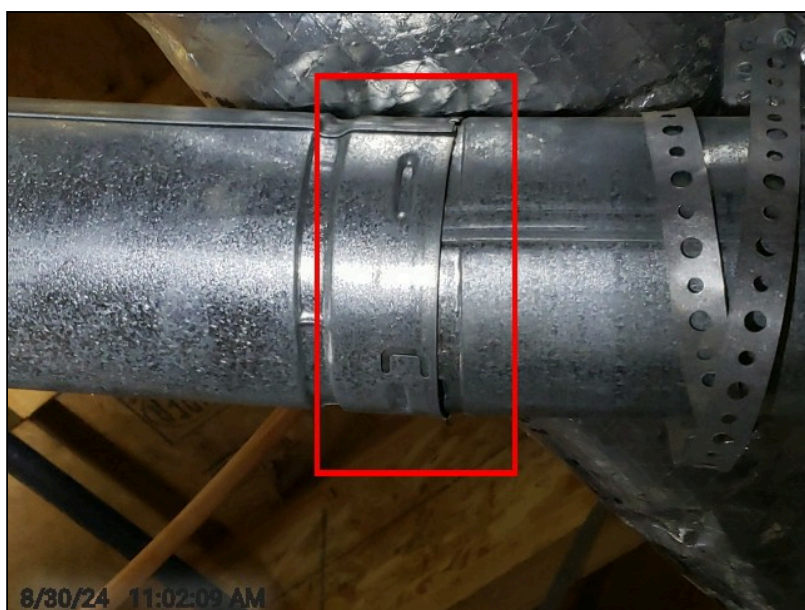
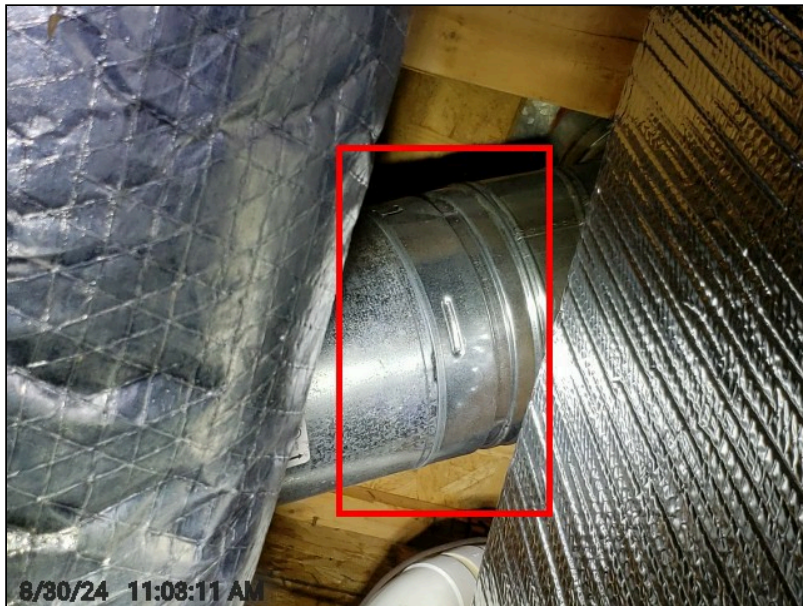
- 🏠 (4) The furnace vent pipe twist lock connections are loose/coming apart. This is a carbon monoxide safety issue. All of the twist lock connections on the furnace vent pipe from the basement to the roof need to be checked and secured as needed. A licensed heating and air contractor needs to repair. Location(s): basement

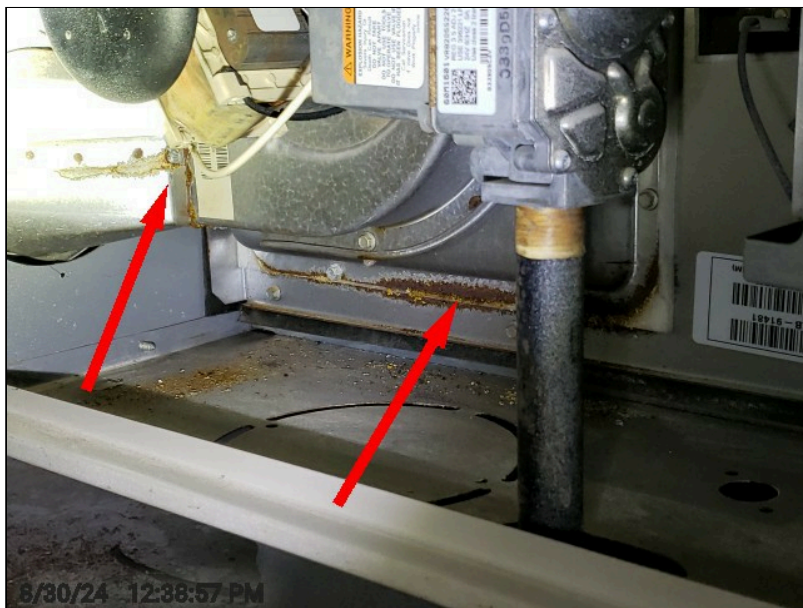
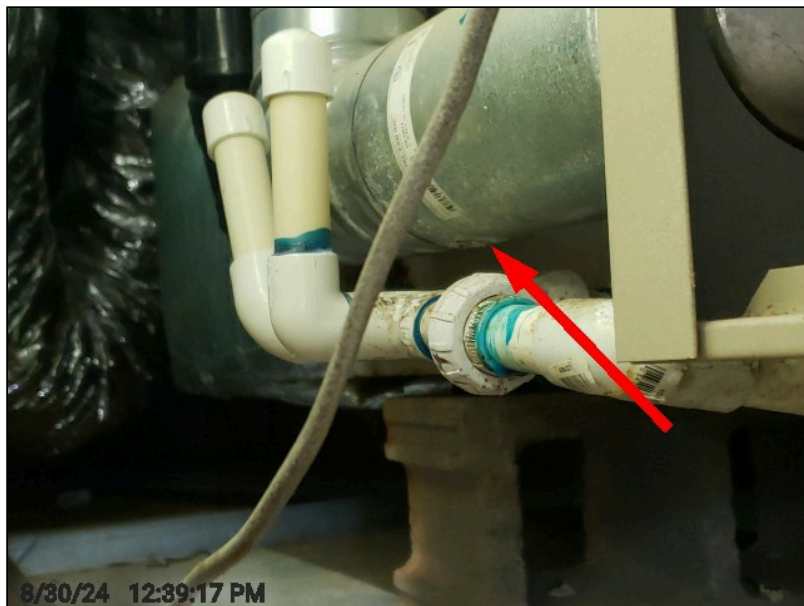
- (5) Rusted/deteriorated furnace vent pipe was observed. This is a safety issue. A licensed heating and air contractor needs to inspect further and replace all compromised vent pipe. Location(s): garage attic

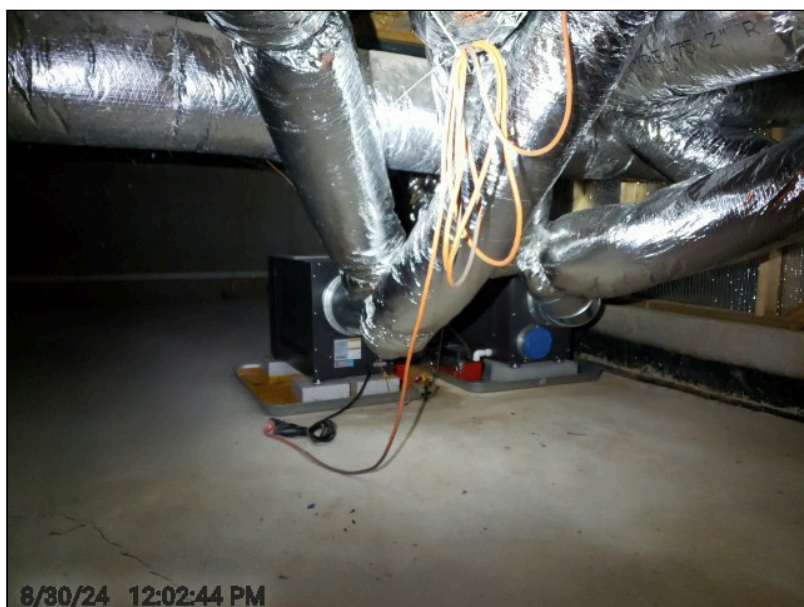
- 🏠 (1) There are dehumidifiers installed in the crawlspace. The Inspector does not evaluate dehumidifiers. The dehumidifiers need to be serviced by a licensed heating and air contractor.

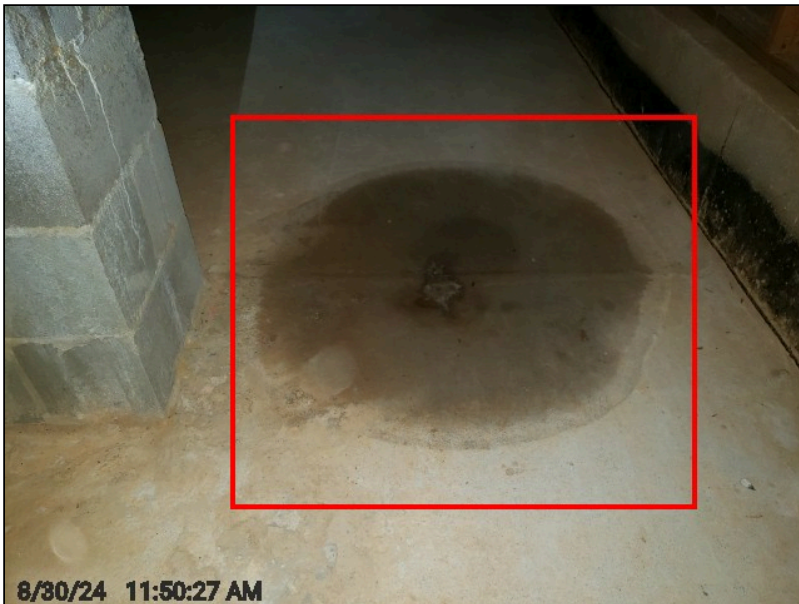
- 🏠 (1) The condensation drain line in the crawl space leaks. A licensed heating and air contractor needs to repair the leak.

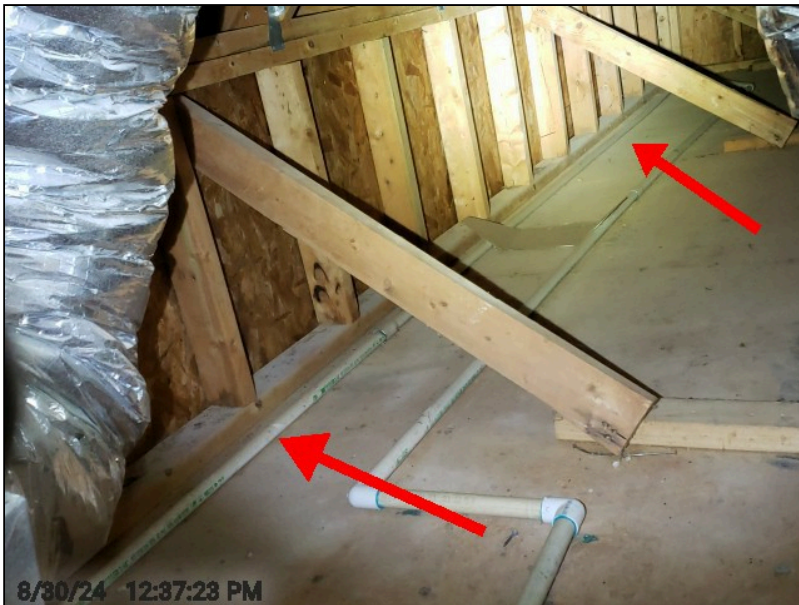
- 🏠 (3) The condensation drain line does not have a gravitational flow to the exterior in the attic. The drain line lays flat without slope in pipe. The pipe should have a 1% slope to prevent backup. A licensed heating and air contractor needs to repair. Location(s): attached garage attic

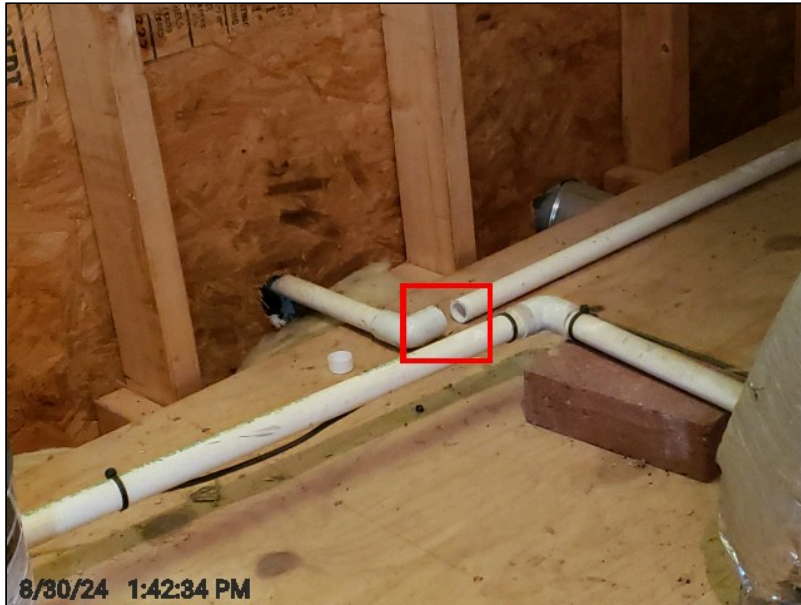
- 🏠 (4) The auxiliary condensation drain line is disconnected in the attic. A licensed heating and air contractor needs to re-connect auxiliary condensation drain line. Location(s): detached garage attic

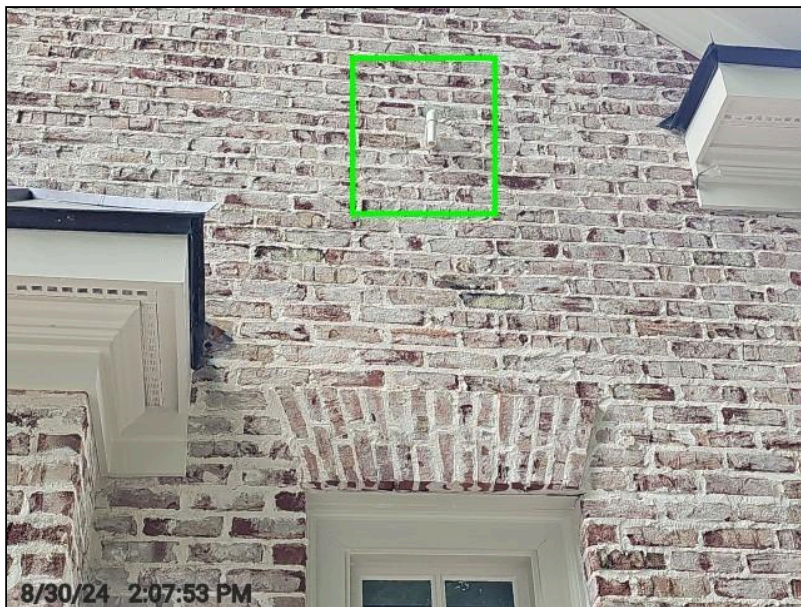
right side of house

- (5) FYI, The picture shown is the location of the auxiliary condensation drain line from the air conditioning system. The drain line is installed in a conspicuous place so that you can be alerted if water is dripping from the pipe. If there is water draining from the pipe, the A/C should be serviced ASAP by a licensed HVAC contractor. The primary drain could be blocked which can cause an overflow.

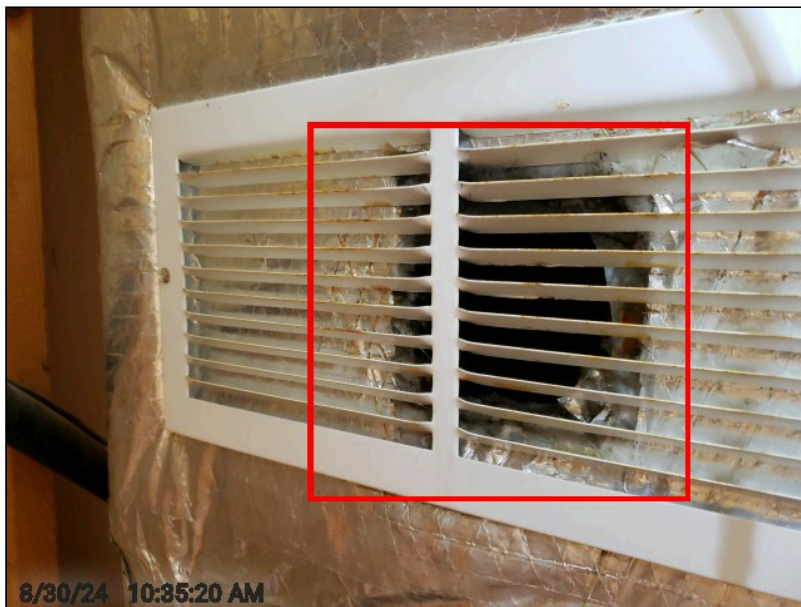
- 📍 There is a hole in the supply air plenum. Heating and cooling loss can be expected where there is a hole in the supply plenum. Location(s): Location(s): upstairs mechanical closet

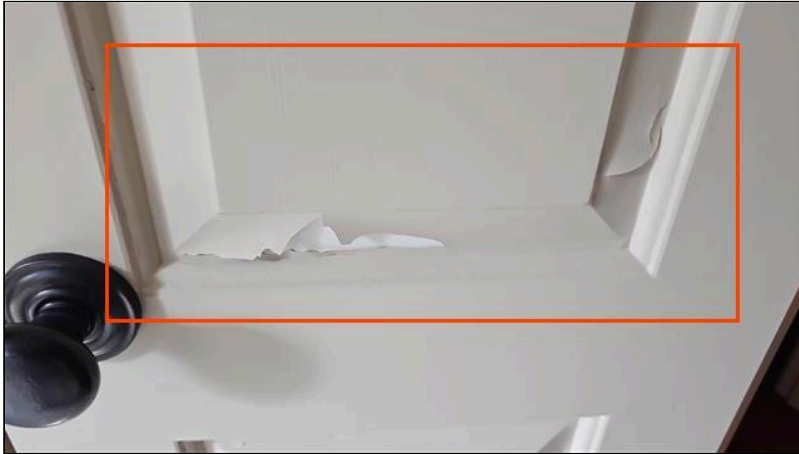
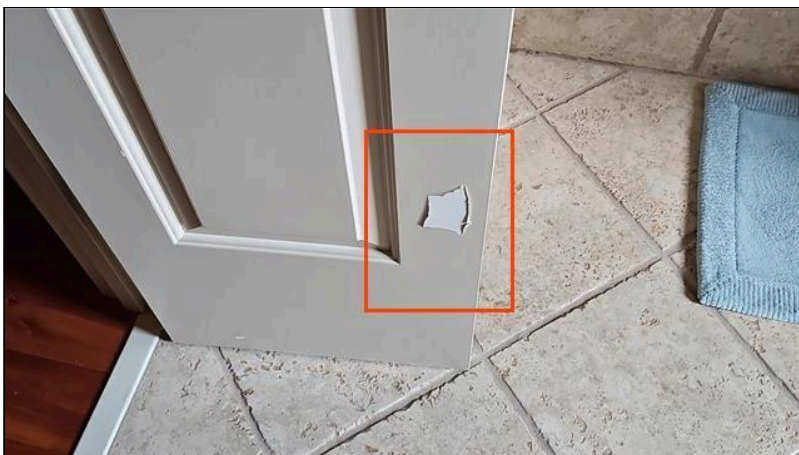
The paint is peeling on the door into the right private bath.

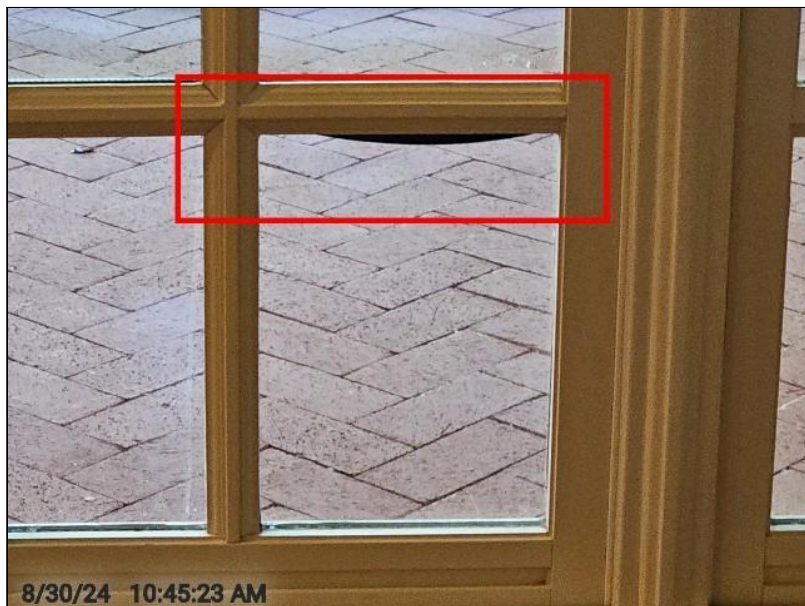
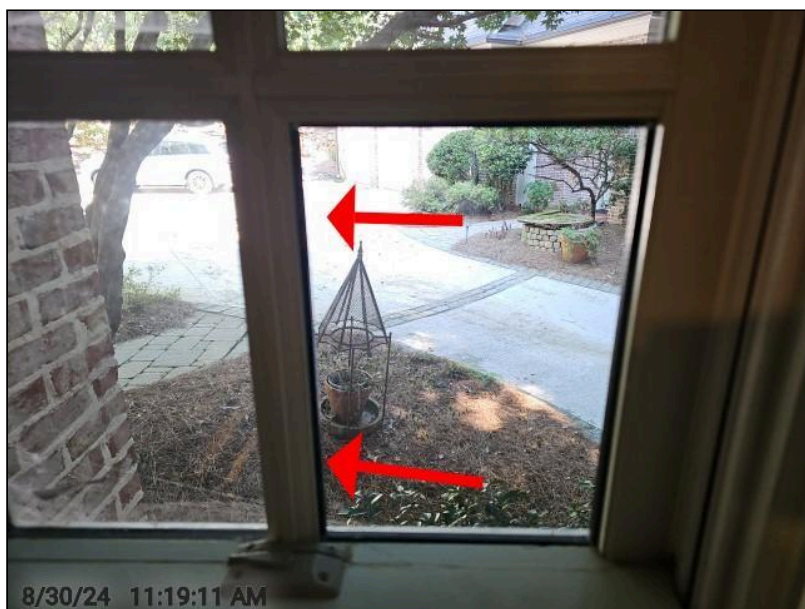
- 🏠 Insulation seal has failed on window. A qualified contractor needs to replace failed glass. Location(s): family room, primary bedroom, right private bath, man cave

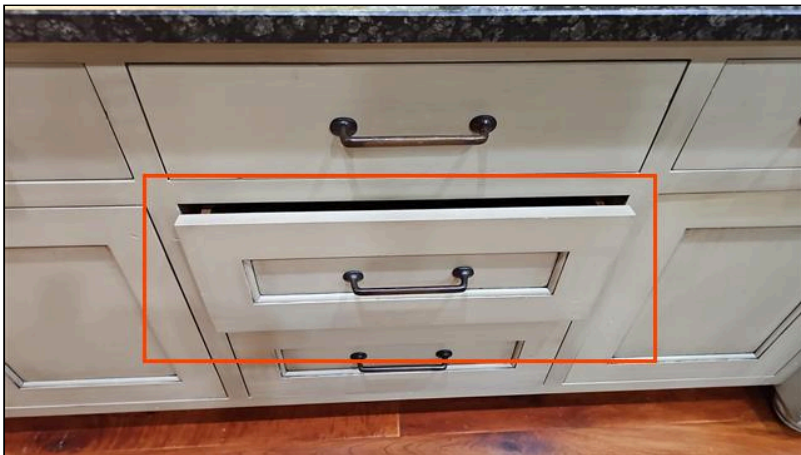
- 🏠 Middle drawer to the left of the kitchen sink does not stay closed. It qualified contractor needs to adjust the drawer.

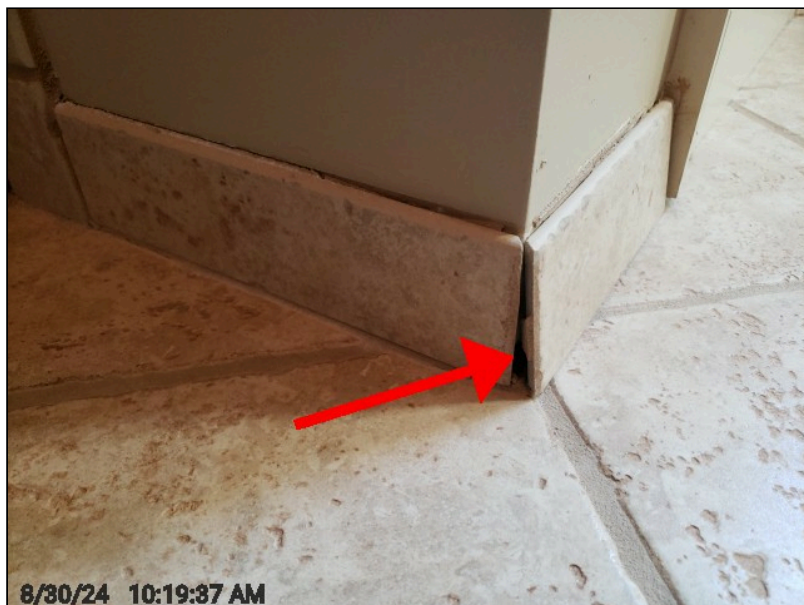
- 🏠 Loose tile needs to be reset. A qualified contractor needs to repair. Location(s): private bath (front right bedroom)

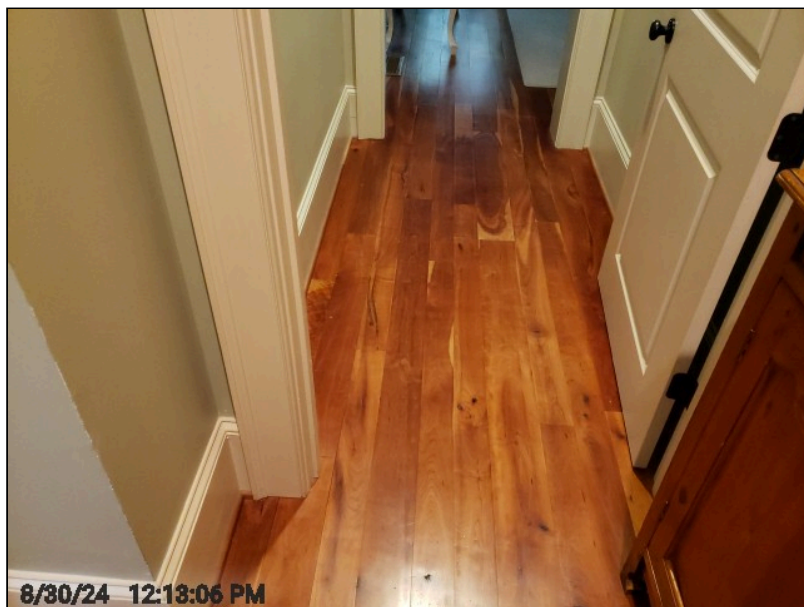
- 🏠 Squeaking floors were noted. A qualified contractor needs to evaluate further and make needed repairs to stop floor from squeaking (refer to comment 9.3.1 and 9.3.2). Location(s): primary bedroom

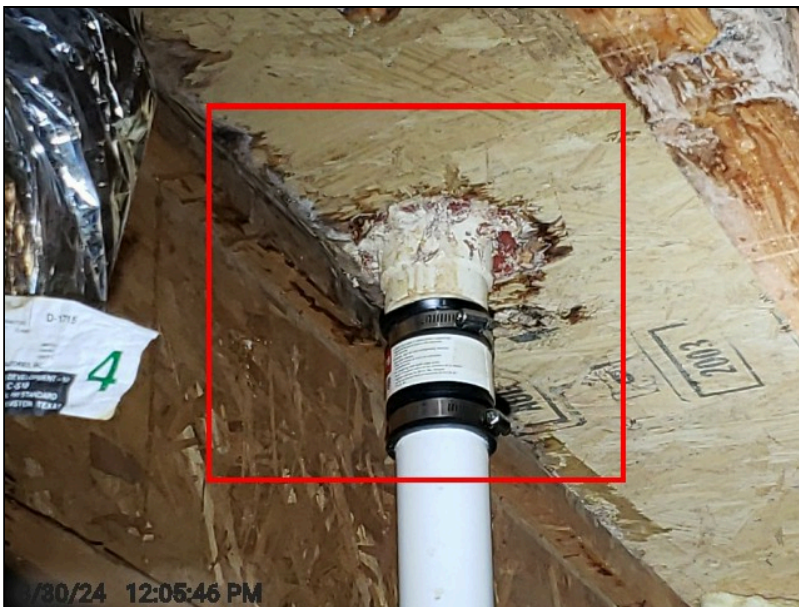
6.7 Potential Plumbing Leaks

- 🏠 Water stains observed. Check with seller about knowledge of past leak and any repairs. A licensed plumbing contractor should inspect further and verify permanent repairs were made. Location(s): right side of crawlspace under master bath

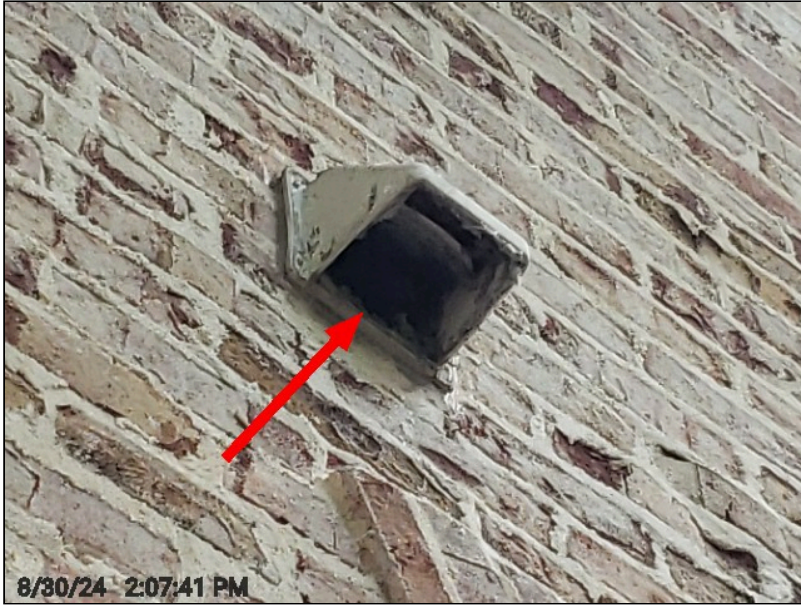
- 🏠 The dryer duct pipe needs to be cleaned out from duct termination back to the dryer. Dryer duct pipe needs to be cleaned out every year. A qualified contractor needs to repair.

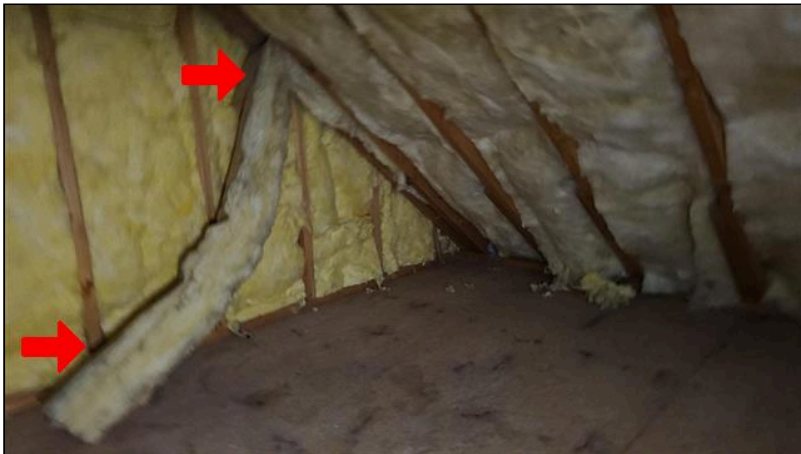
- 🏠 Replace insulation that is falling out of the rafter in the left attic access

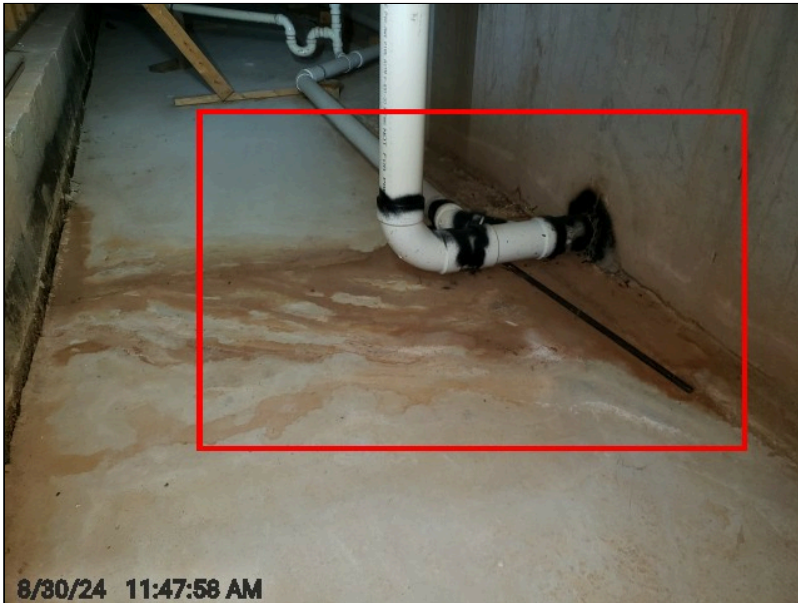
Past water leak was observed where drain/waste line penetrates foundation wall. Check with seller about knowledge of past repairs.

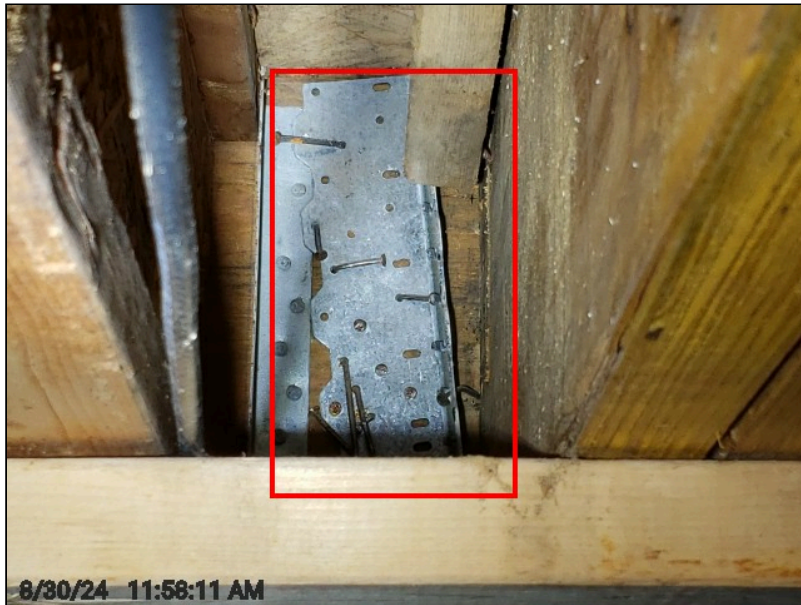
- 🏠 (1) The joist hangers supporting the floor joist in the crawlspace under primary bedroom are not nailed at all eyelets. This could be why the floor squeaks in the primary bedroom. A qualified contractor needs to add additional nails on all joist hangers as needed and remove all bent nails that are not approved joist hanger nails. Pictures shown are examples.

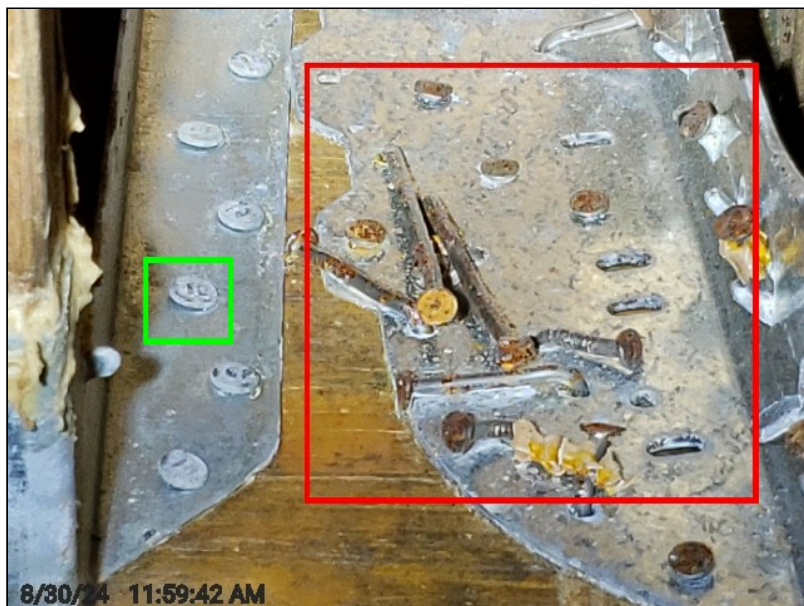
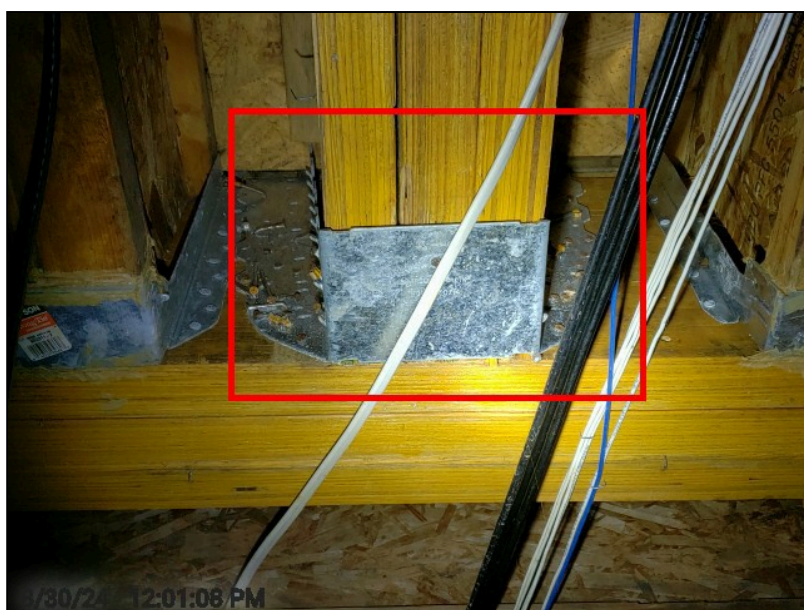
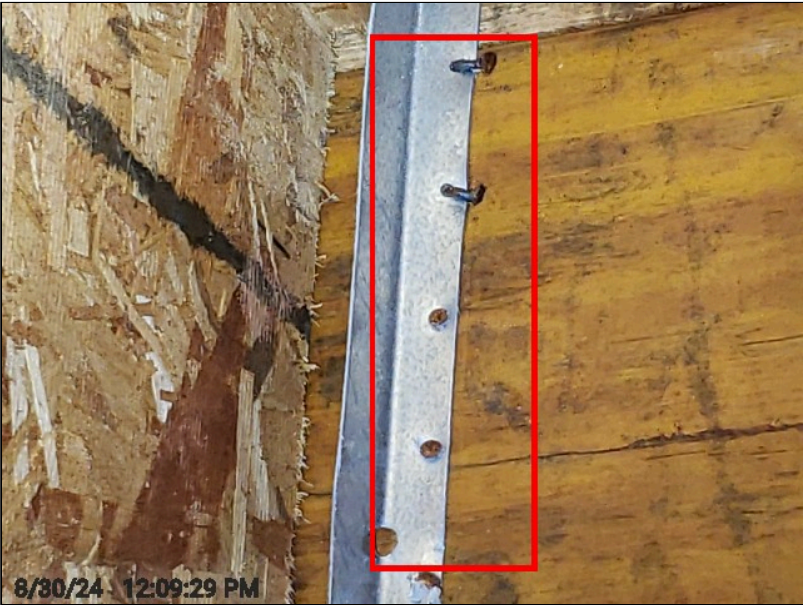
- 🏠 (2) A lot of the nails attaching the joist hangers to the ledger are not galvanized nails. The nails are rusting. The bent nails are the wrong size nail. All rusted nails need to be replaced to prevent joist failure. All nails need to be galvanized Simpson joist hanger nails. A qualified contractor needs to repair. Location(s): crawlspace under primary bedroom

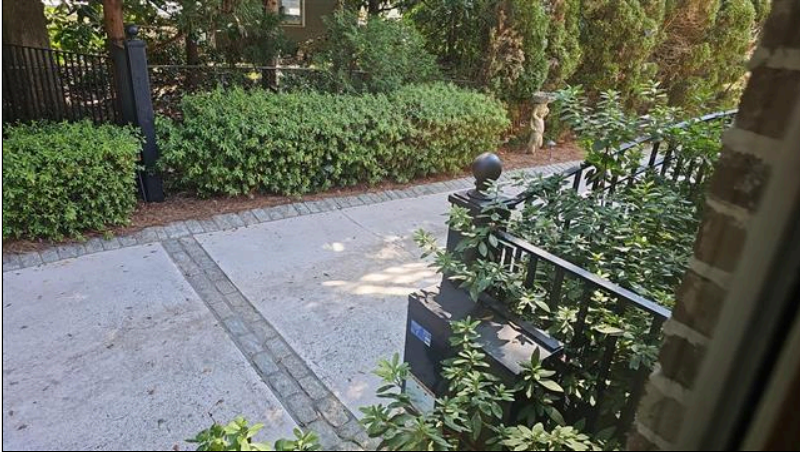
(1) The seller needs to demonstrate normal operation of the gate on the driveway.

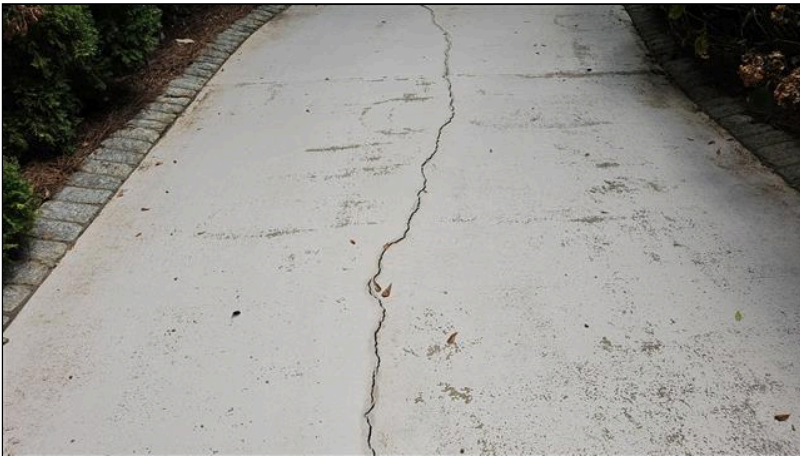
(2) All cracks in the driveway need to be sealed with a concrete sealant.

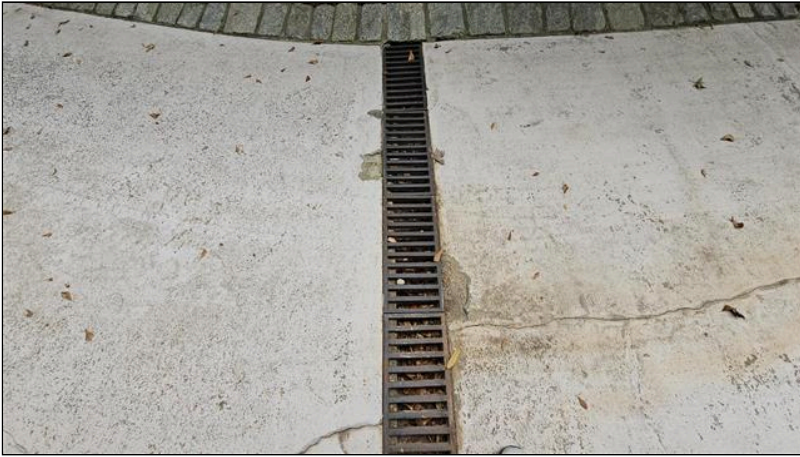
- 🏠 (3) The drain in the driveway needs to be cleaned out.

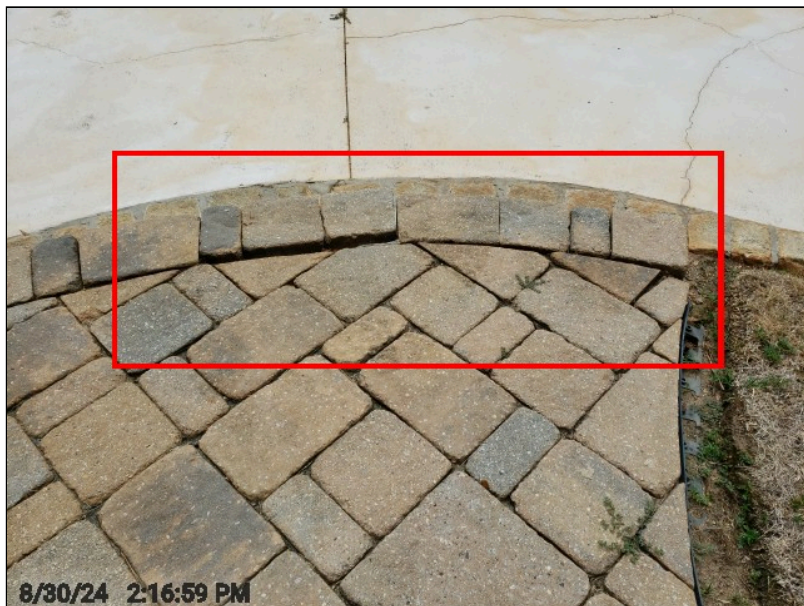
- 🏠 Loose stone on the sidewalk need to be reset. A qualified contractor needs to repair.

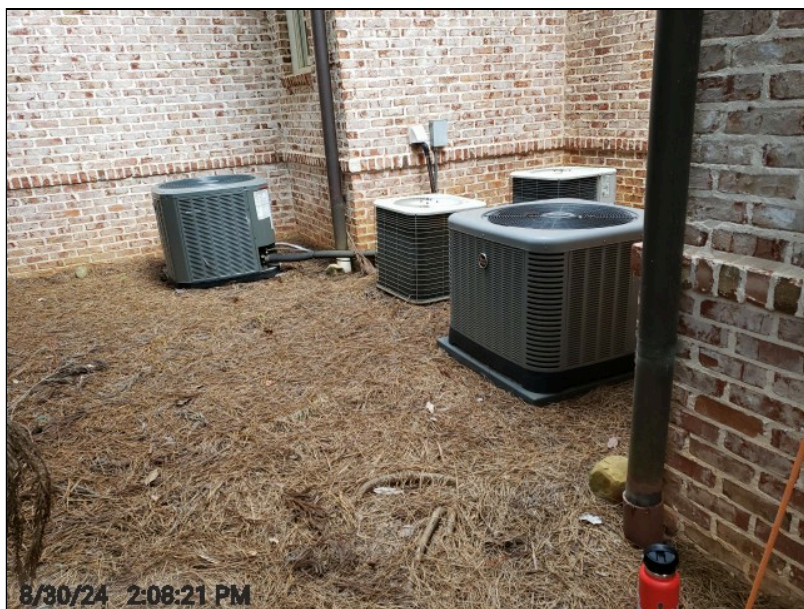
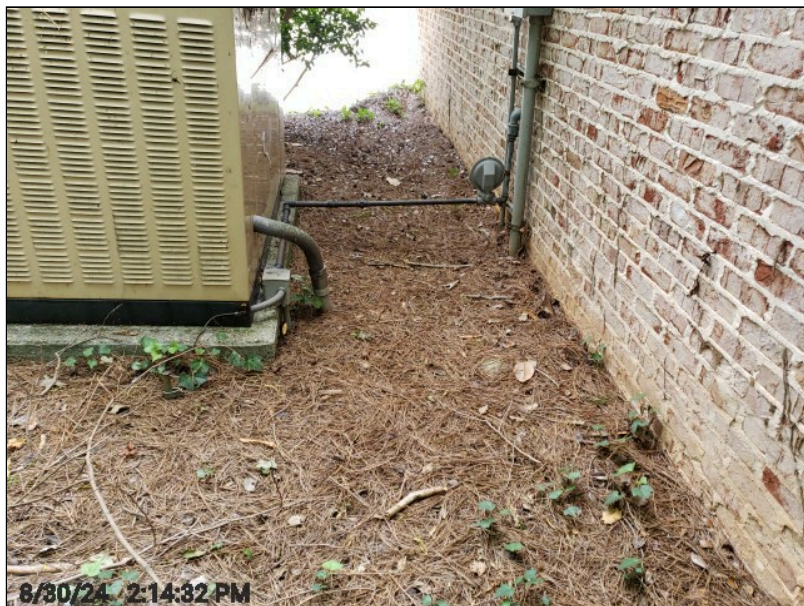
- 🏠 (1) The grading generally does not provide positive drainage away from the foundation. There should be 6" of fall in the first 10' away from the foundation. A qualified contractor needs to evaluate further and repair. Location(s): left side and back of the house

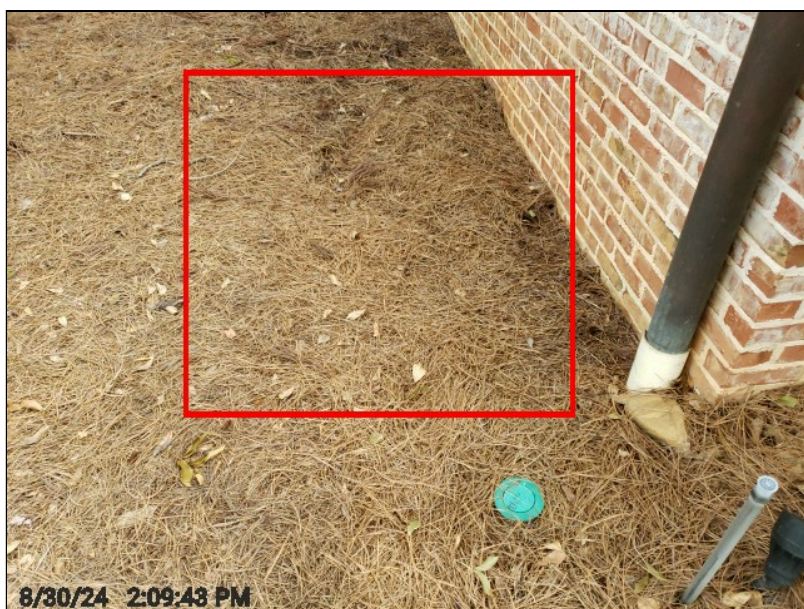
(2) Water appears to pool after rain. Some additional dirt, light grading, and yard drain boxes may be needed to drain the water off of the lot if water stands for more than 48 hours. Location(s): left side of the house

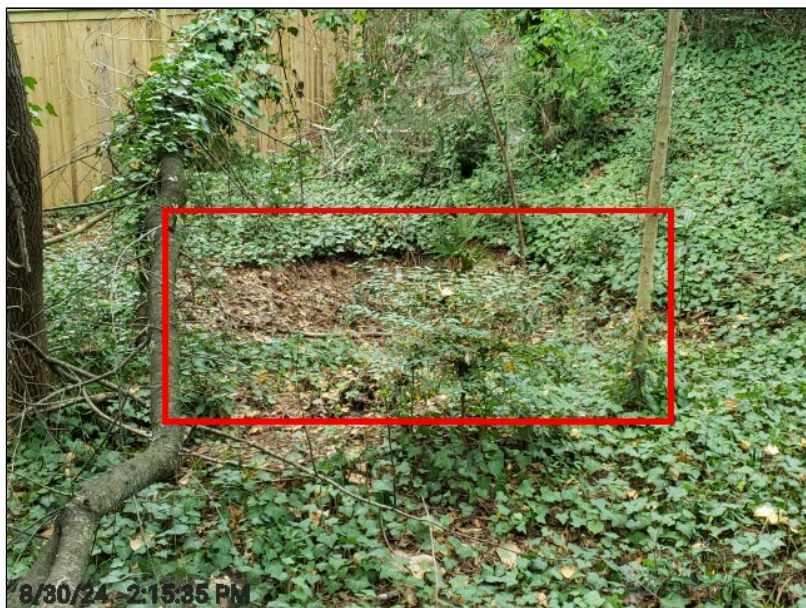
(3) The depression in the backyard needs to be filled with dirt. The depression could be from decaying construction trash. A qualified contractor needs to fill depression with dirt.
