Inspection Report

4567 Main St

Marion Hodges Home Inspection Services

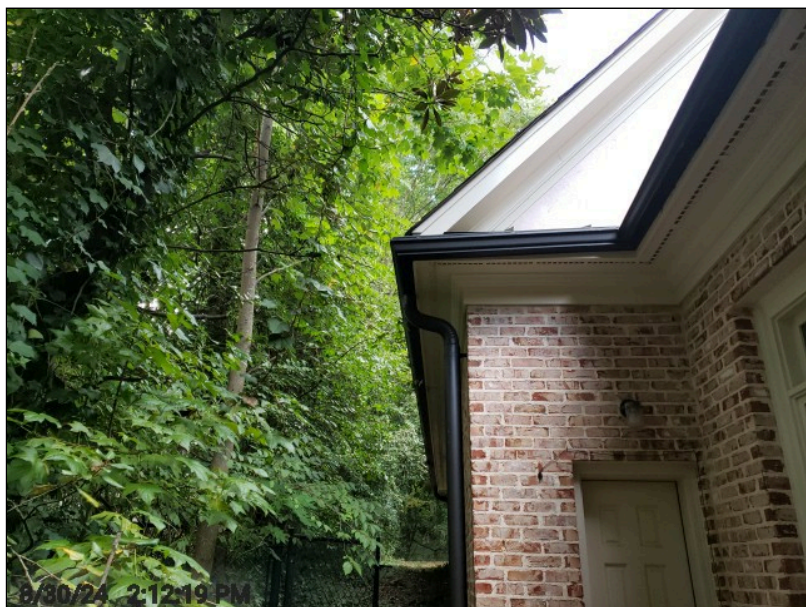
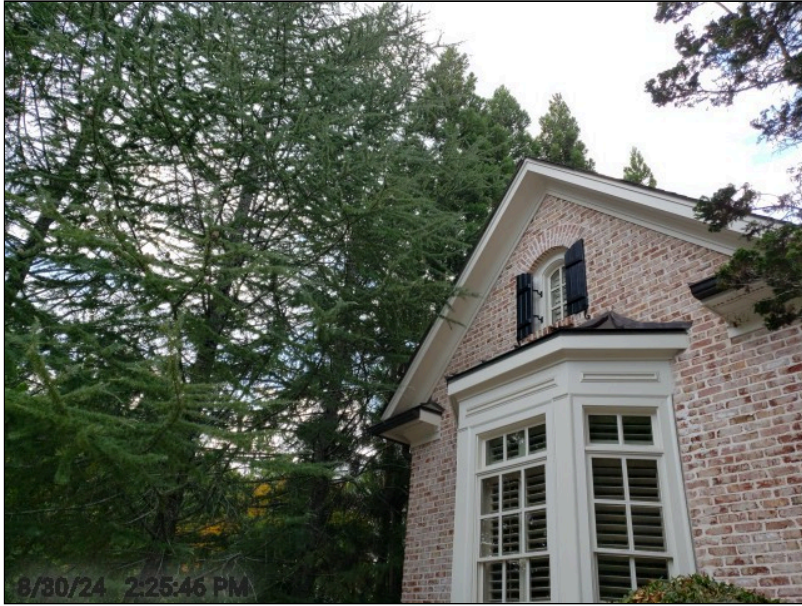
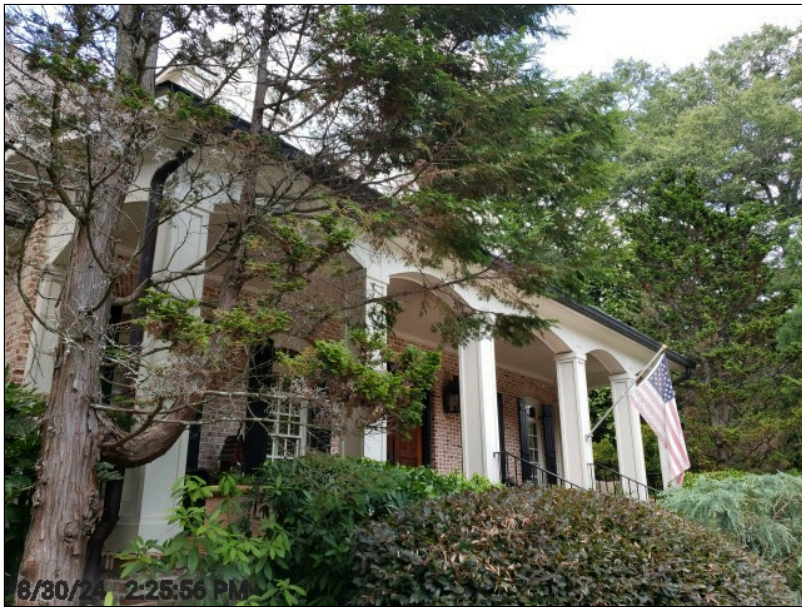
(1) Tree limbs that are in contact with the roof or hanging over the roof need to be trimmed at least 5 feet away from the house.

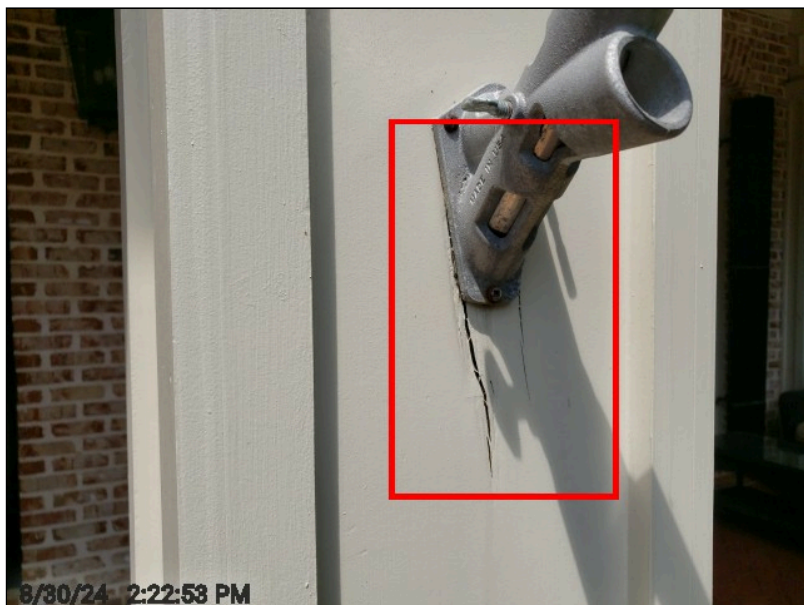
Rotten trim was observed on column with flag attached. A qualified contractor needs to replace all rotten trim and paint to match existing.

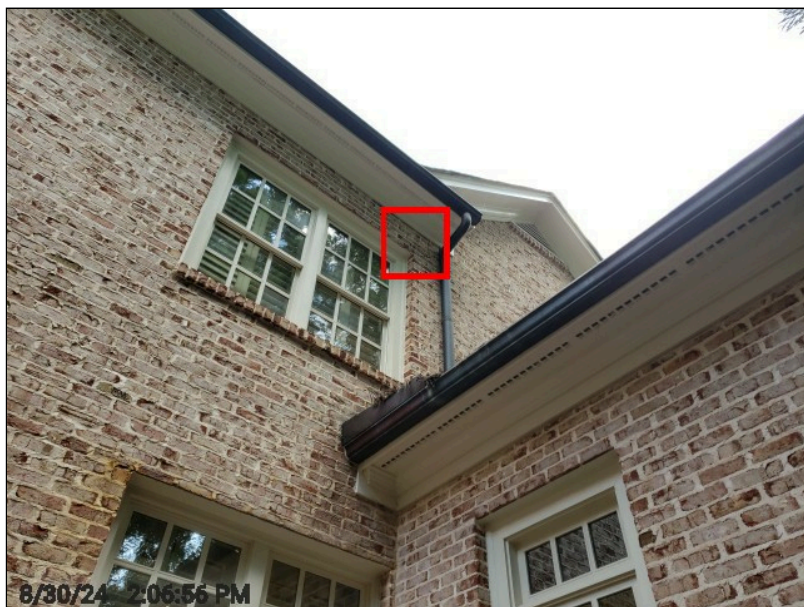
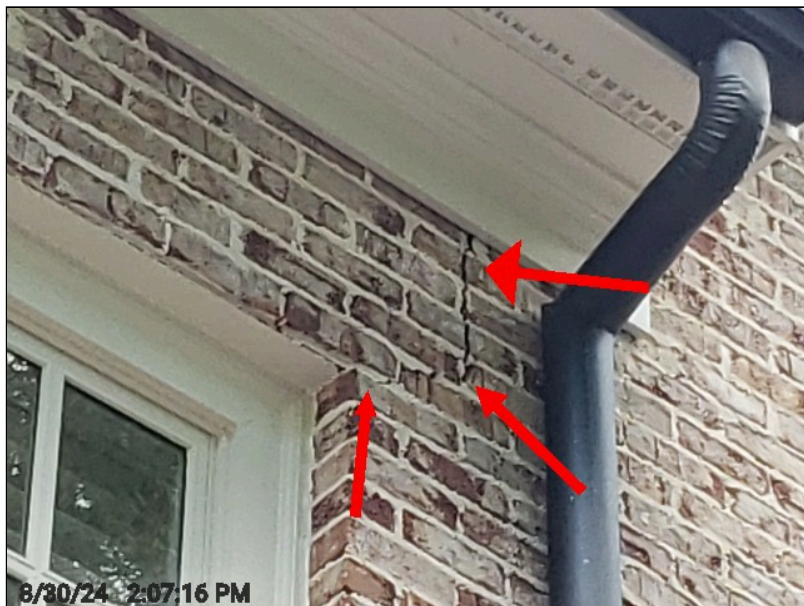
(1) Mortar and brick cracks were observed. A qualified contractor needs to point cracks. Location(s): left side of the house

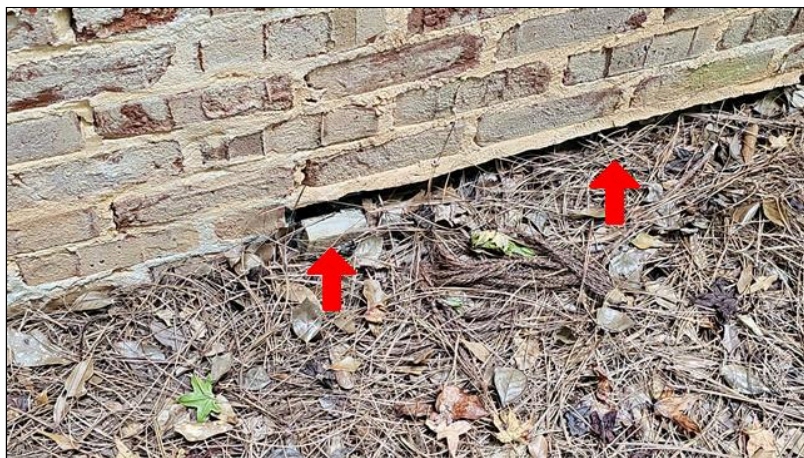
(2) The form board on the back of the man cave needs to be removed. This is potential food for termites.

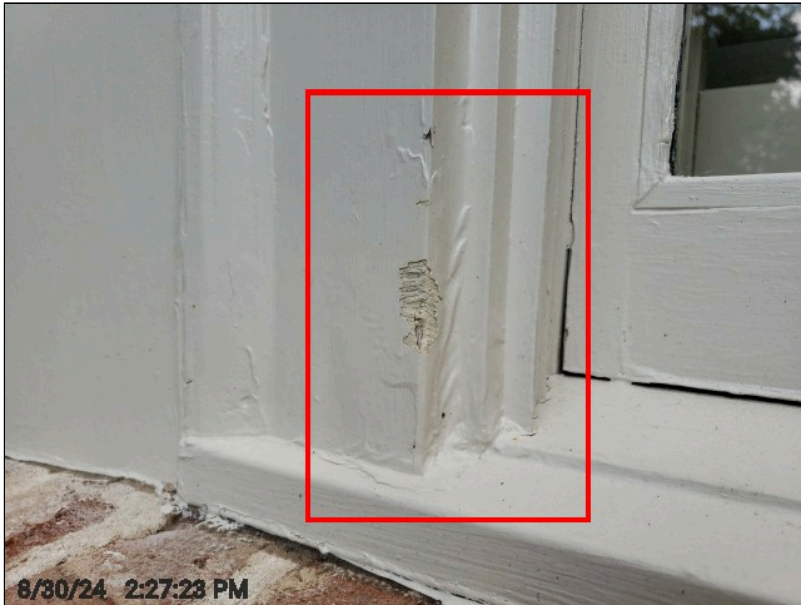
(1) The windows need to be painted where paint is failing. Pictures shown are examples. A qualified contractor needs to paint windows. Location(s): front of the house

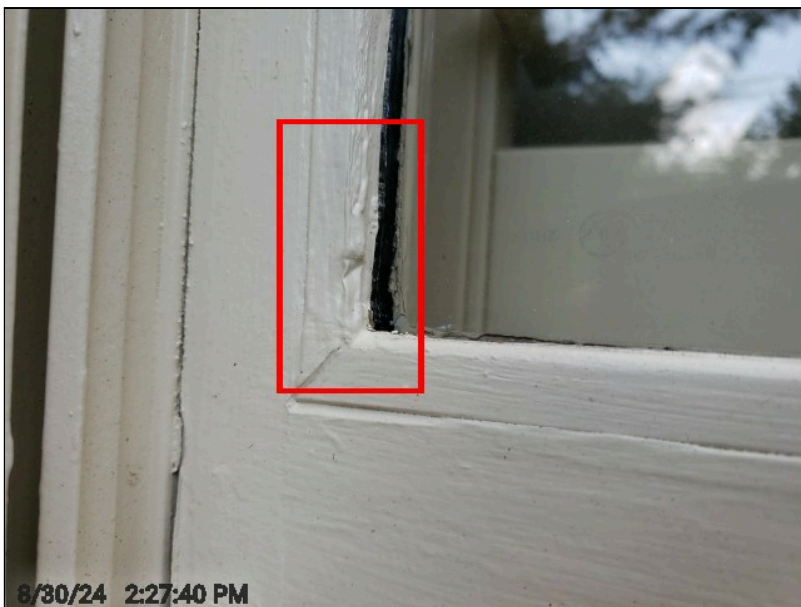
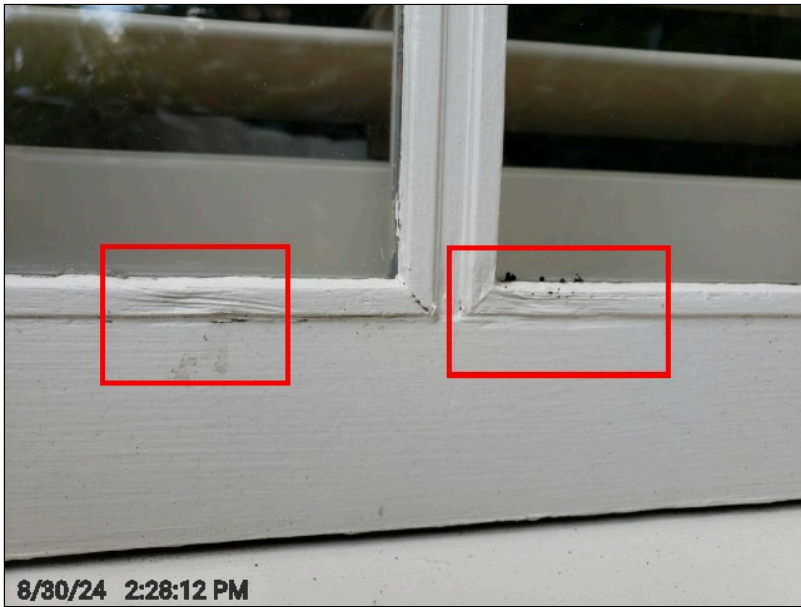
(2) Rotten trim observed on window. A qualified contractor needs to replace rotten trim. Location(s): front of the house

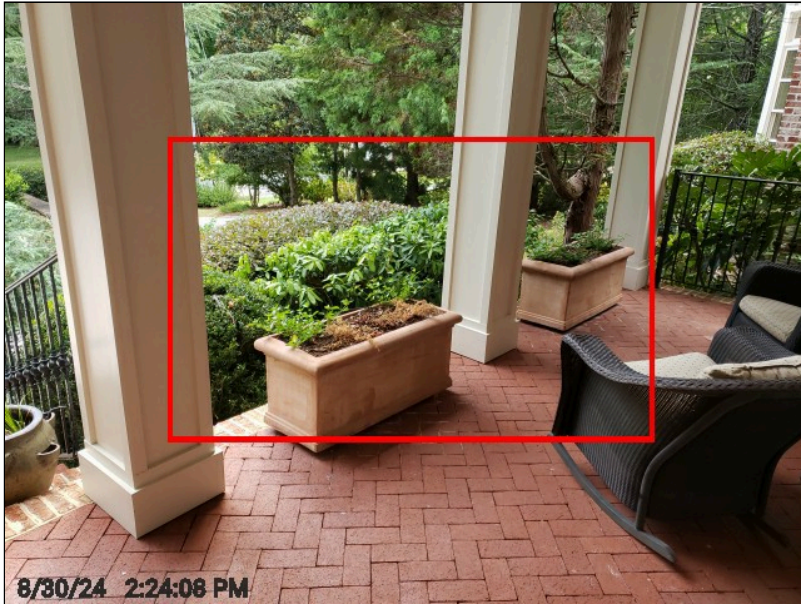
- 🏠 (2) Guard rail and balusters are not installed on front porch. Landings over 30" above the grade and 4 or more steps should have guard rails 34"-36" in height and balusters spaced 4" on flat surfaces and 4 3/8" on steps. This is a safety. A qualified contractor needs to install a guard rail and balusters.

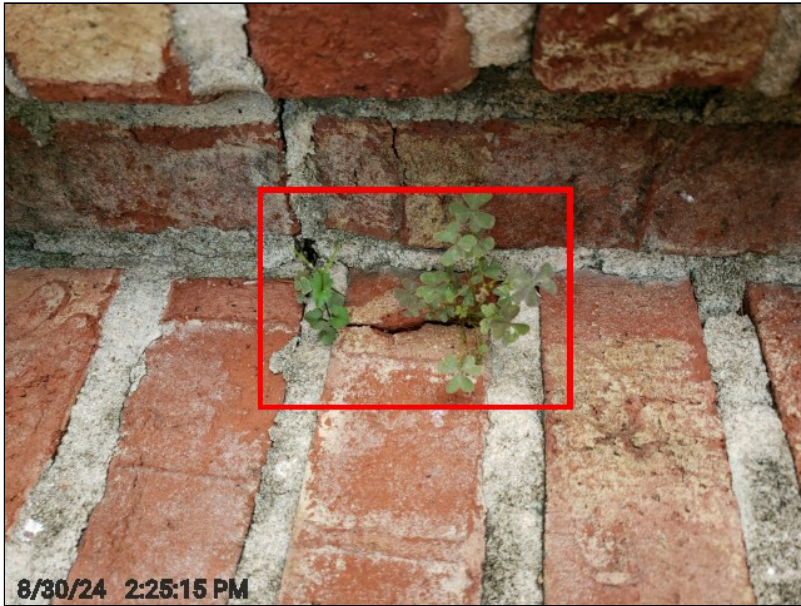
- 🏠 (3) Mortar joints have cracked on the steps. A qualified contractor needs to seal cracked mortar joints with mortar to match existing.

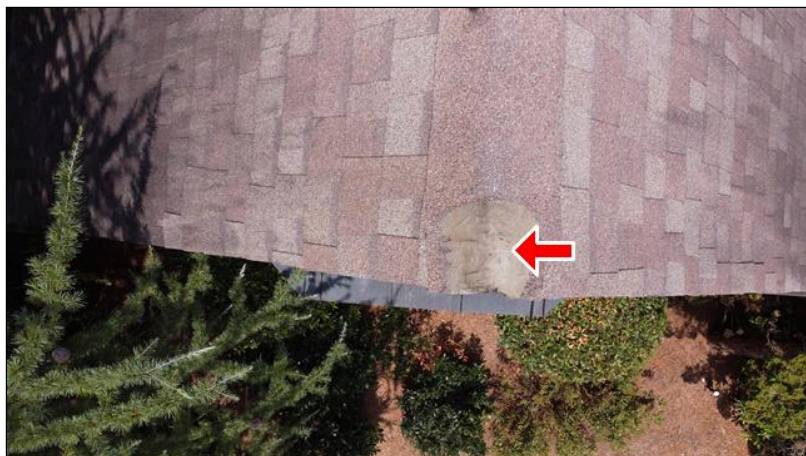
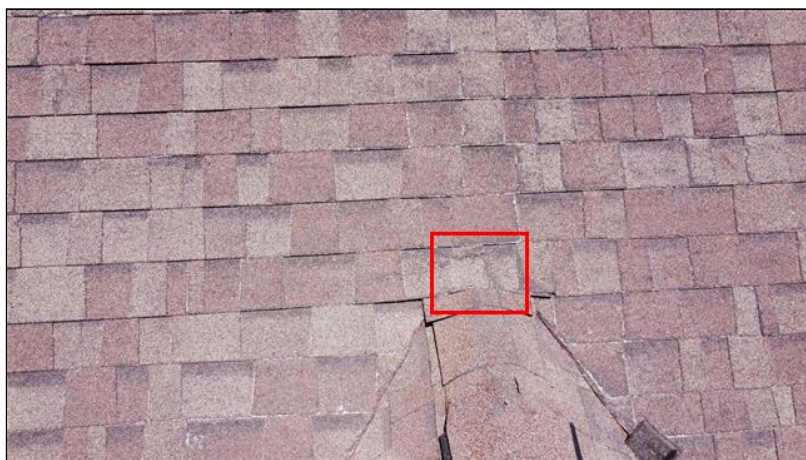
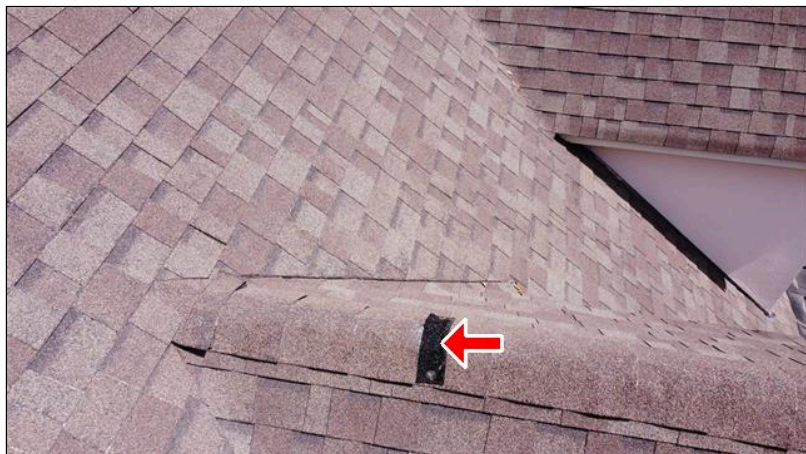
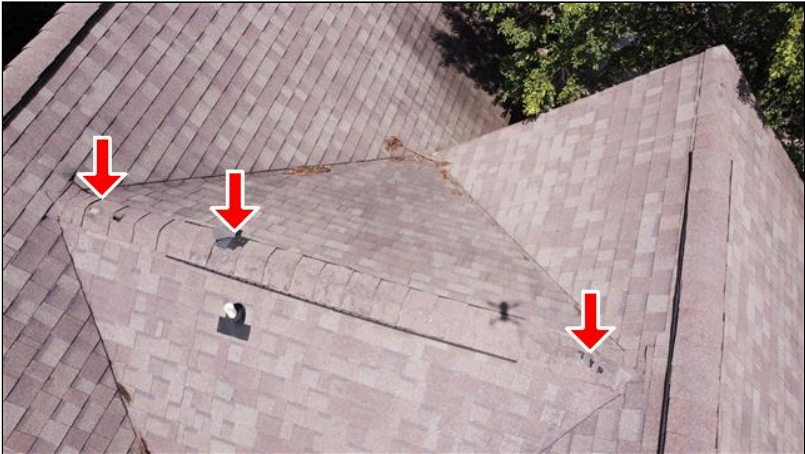
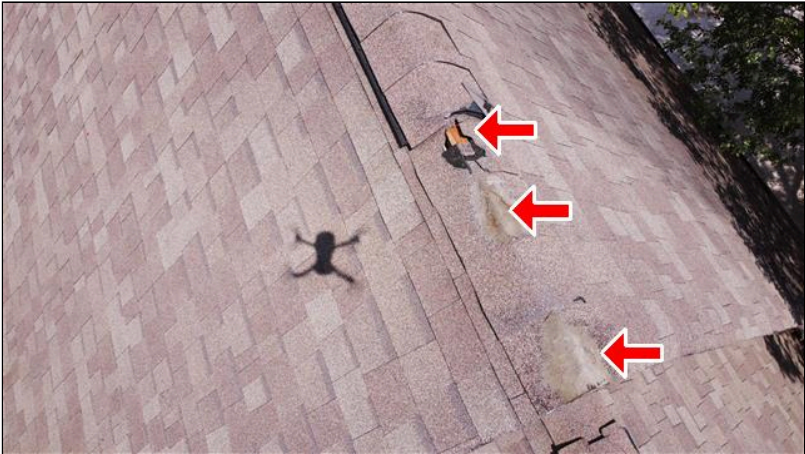
- 🏠 (1) The roof is at or beyond the normal life expectancy. A qualified roofer needs to inspect the roof. See following tabs for issues observed. Future replacement should be anticipated. The inspector makes no warranties or guarantees as to how long the roof will last.
- 🏠 (2) There are cracked ridge shingles on the roof. Holes in roof are visible at some of the cracked ridge shingles. Picture(s) are examples. A qualified roofer needs to repair and replace cracked shingles.

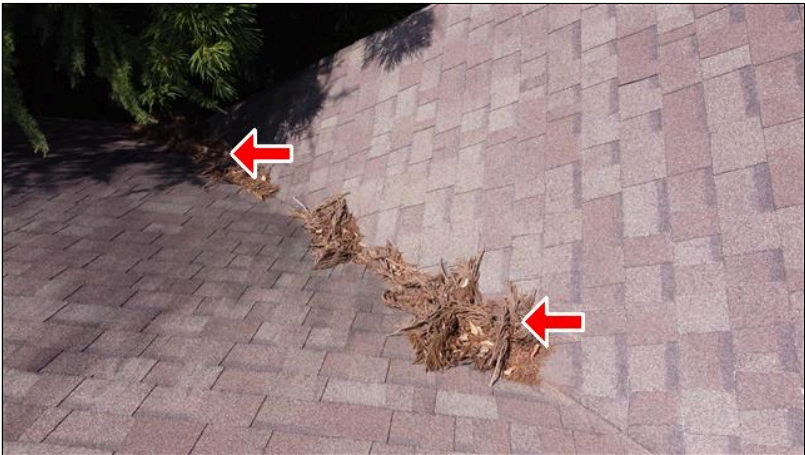
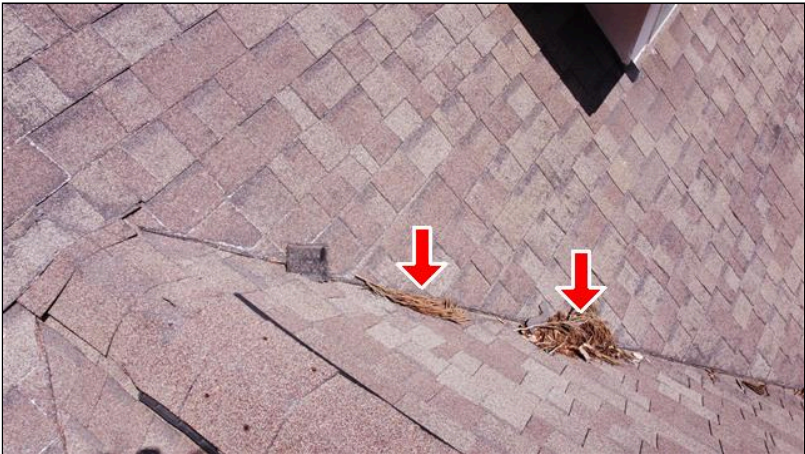
(3) The roof needs to be cleaned off.

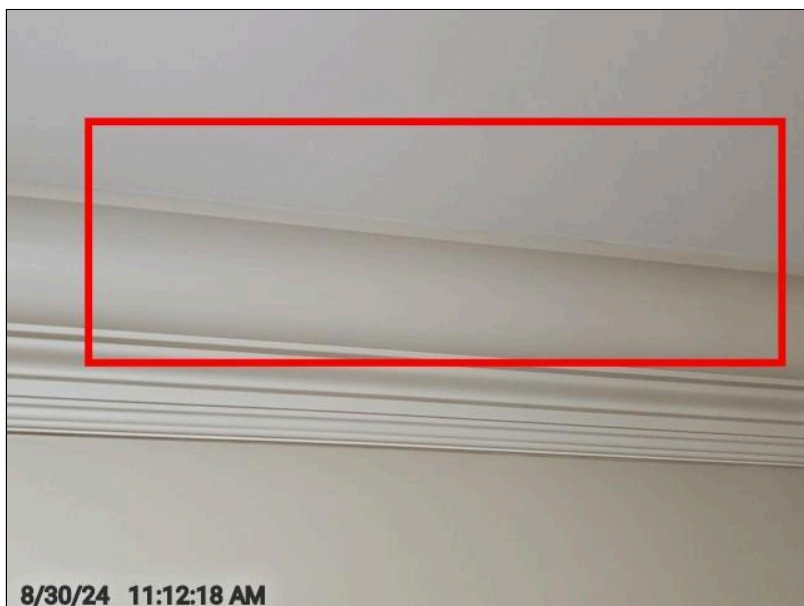
(4) Water stains from a past roof leaks were observed. A qualified roofer needs to inspect roof and verify permanent repairs were made. Location(s): main level bath above door

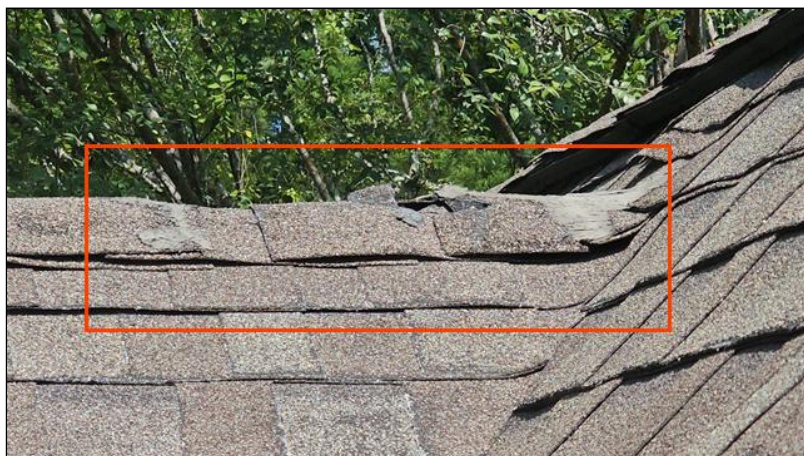
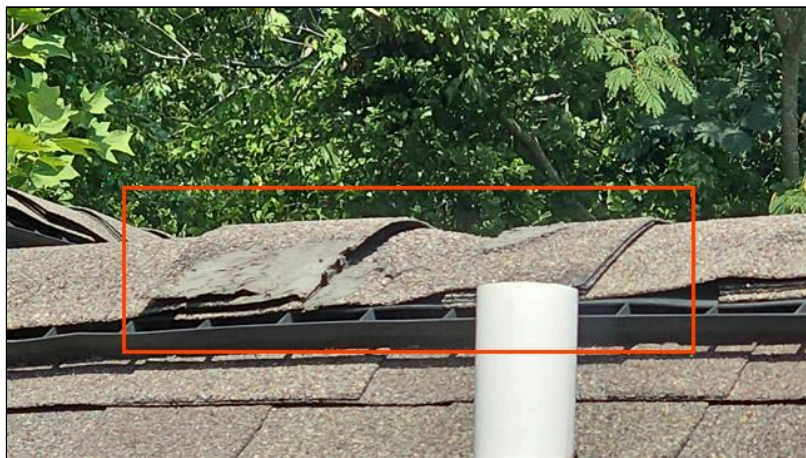
(5) Roof over garage. A qualified roofer needs to repair or replace shingles.

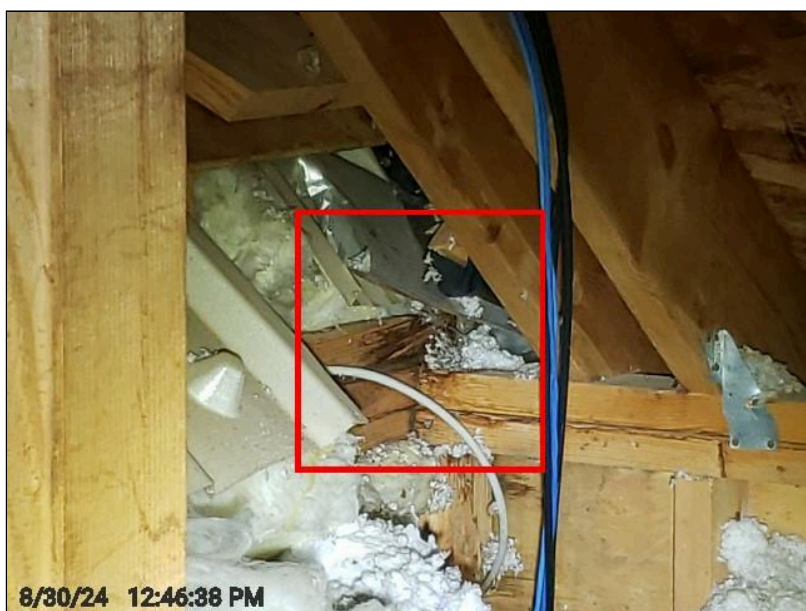
- Water stains from a past leak at the valley flashing observed in the attached garage attic. The flashing does not appear to extend past the corner. A qualified roofing contractor needs to repair.

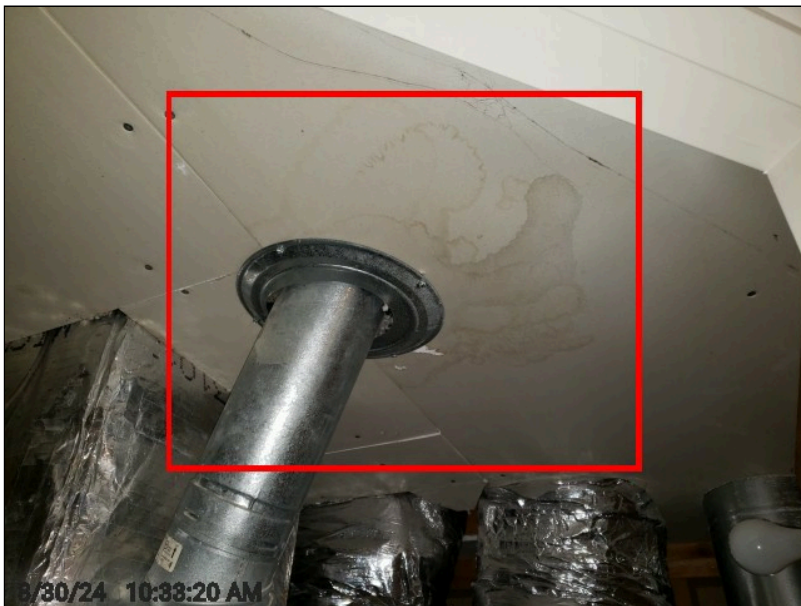
- 🏠 (1) Water stains from past roof leak at furnace vent flashing in the upstairs mechanical closet. A qualified roofer needs to verify repairs have been made to stop leaks. Location(s): furnace vent flashing

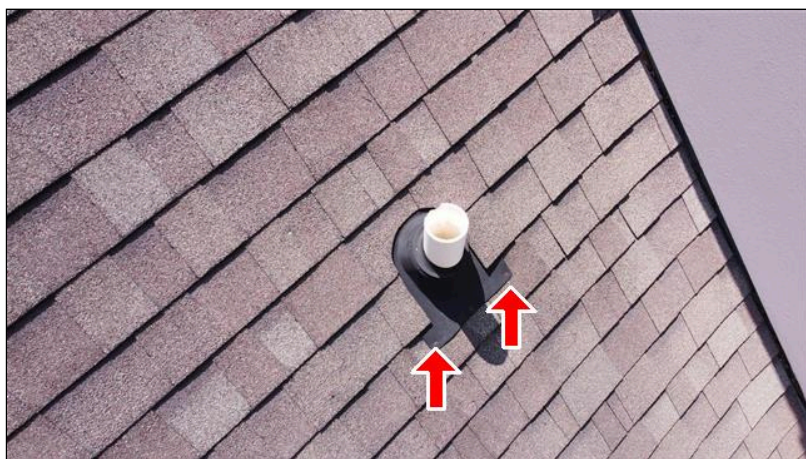
- 🏠 (3) Nail heads on the vent flashings are not sealed. All exposed nail heads should be sealed with a roofing sealant. A qualified roofer needs to repair. Location(s): plumbing boot

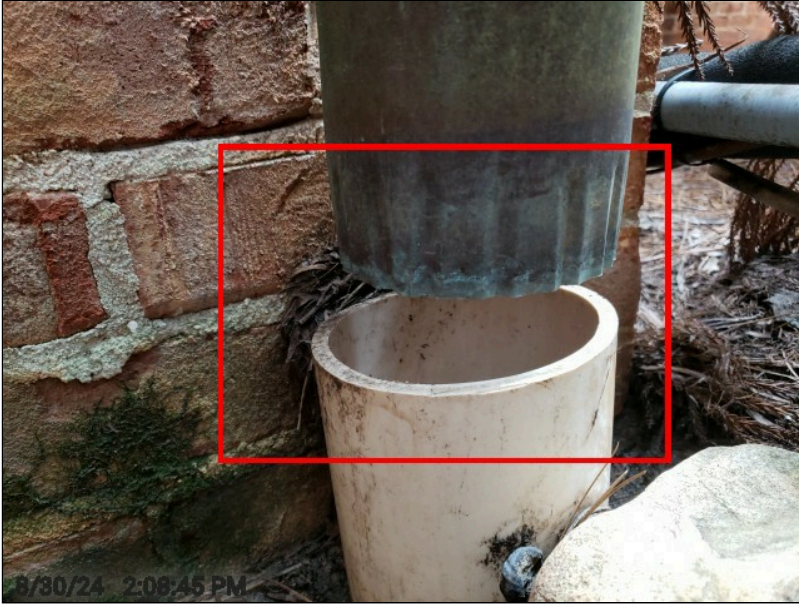
- 🏠 The buried drain line has pulled loose from downspout. The buried drain line should be re-connected to the downspout and attached to downspout with short galvanized screws or rivets. A qualified contractor needs to repair. Location(s): left side of the house

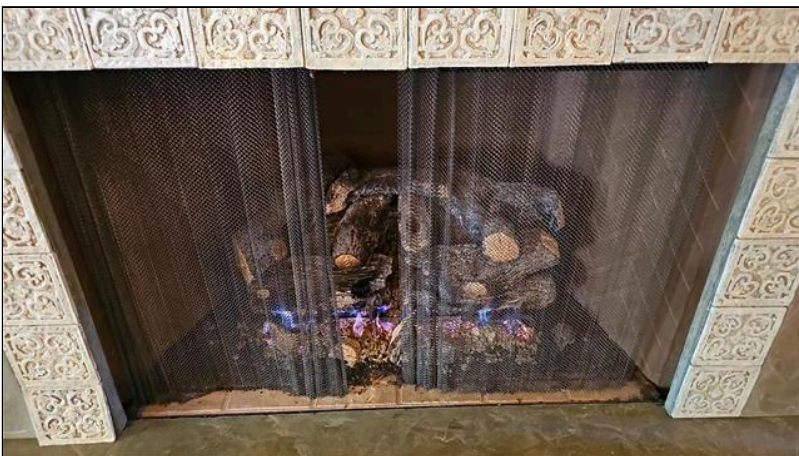
- (2) The family room gas logs were operational at the time of the inspection.

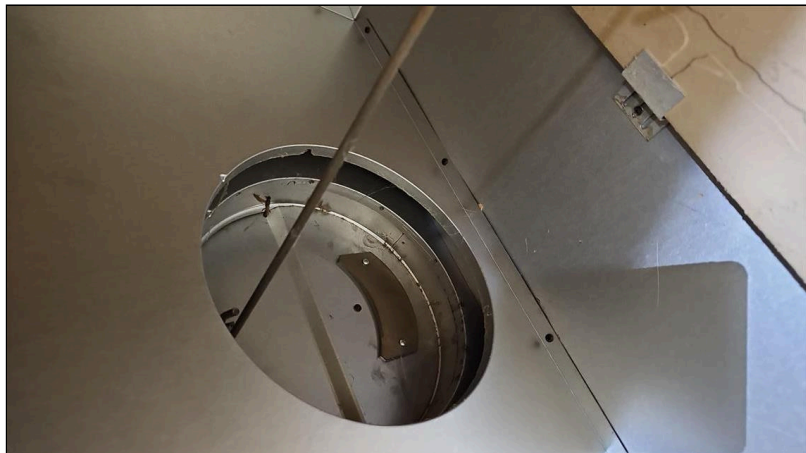
- 🏠 (3) The fuel source for the fireplace is gas logs. The damper on the primary bedroom fireplace needs to be locked in the full open position for ventilation when burning gas logs. This is a safety issue. A qualified contractor needs to lock vent in full open position.

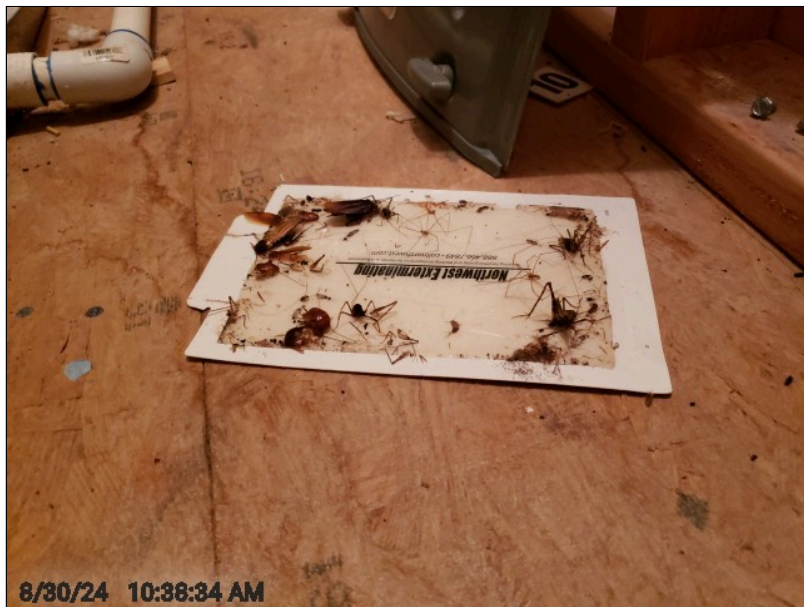
- 🏠 (1) Your home inspection does not include a pest, termite, or wildlife inspection. These inspections are outside the scope of ASHI standards and practices. Any comments or lack thereof in the report are not a part of an in depth inspection. We are not licensed in Georgia or trained as pest, termite, or wildlife inspectors. We recommend with any real estate transaction that you have a pest, termite, and wildlife inspection by a State of Georgia licensed contractor.
- 🏠 (2) There is evidence of bugs inside the structure. A licensed pest control company needs to evaluate further and treat as needed. Picture is example. Location(s): upstairs mechanical closet

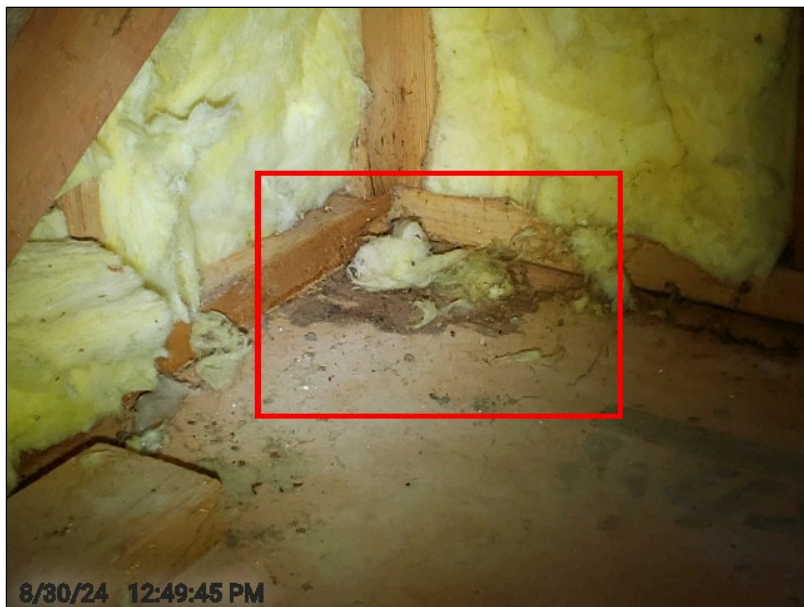
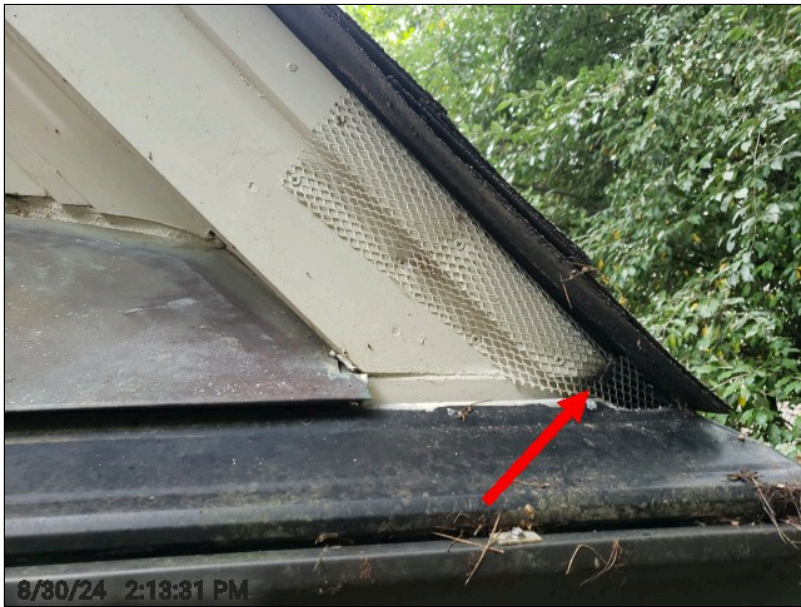
- 🏠 (3) There is evidence of wildlife inside the structure. A licensed wildlife company needs to evaluate further and treat as needed. All droppings need to be removed and area sanitized. Any insulation that is soiled needs to be removed and replaced with R-38 loose fill. Picture is example. Location(s): attached garage attic, detached garage attic, and signs of rodent exclusion on the exterior
