Inspection Report

5678 Main St

Marion Hodges Home Inspection Services

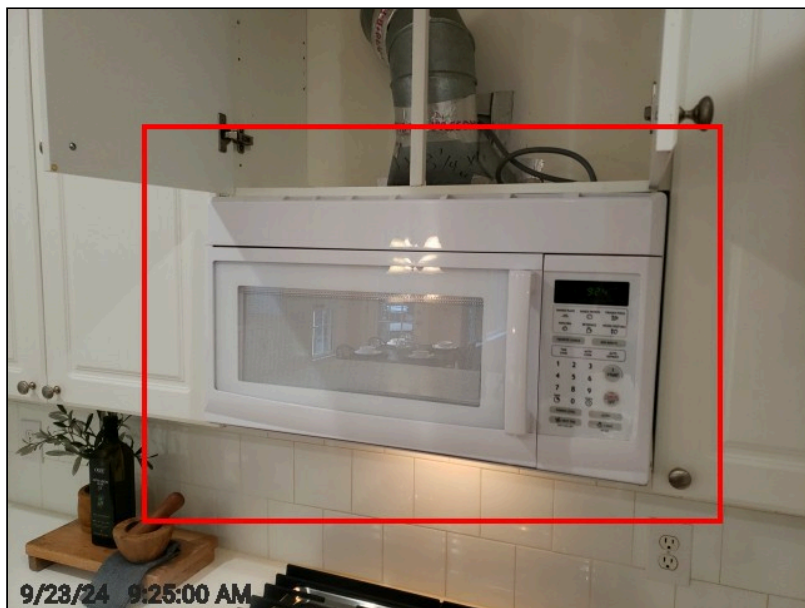
- 🏠 The microwave is not securely fastened to the cabinet. The microwave moves when opening and closing the door. A qualified contractor needs to secure the microwave to the cabinet.

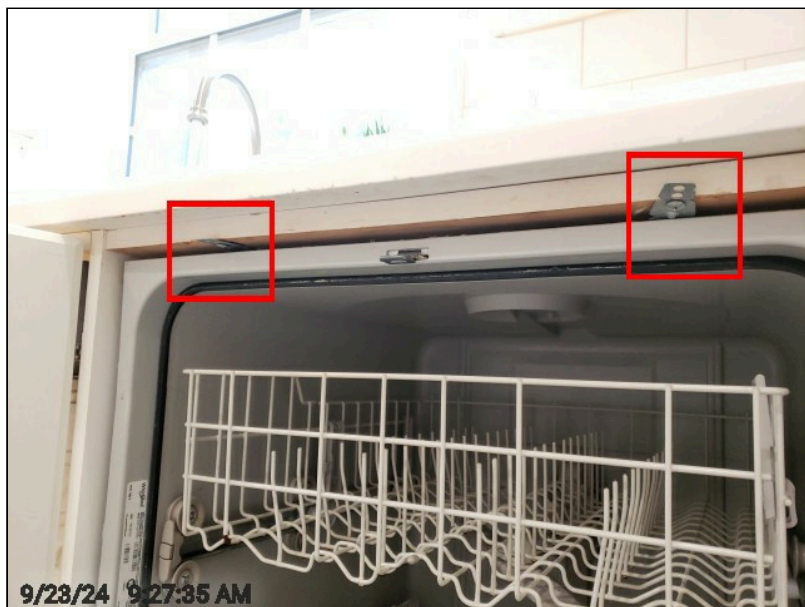
1.4 Dishwasher

- 🏠 (1) The dishwasher is loose where attached to the underside of the kitchen countertop. A qualified contractor needs to secure the dishwasher.

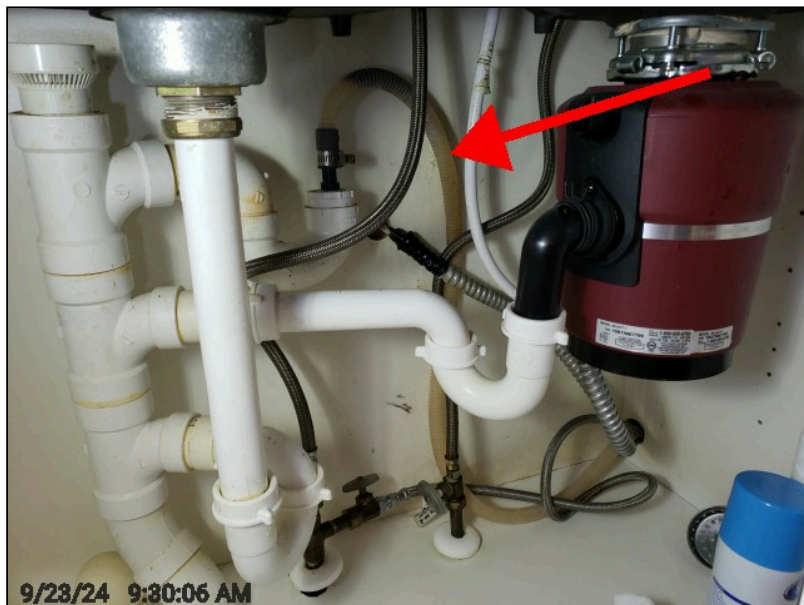
- 🏠 (2) The dishwasher waste line should rise and be securely fastened to the upper side of the counter before connecting to the sink drain or disposal. This will prevent backflow into the dishwasher. A licensed plumbing contractor needs to repair.

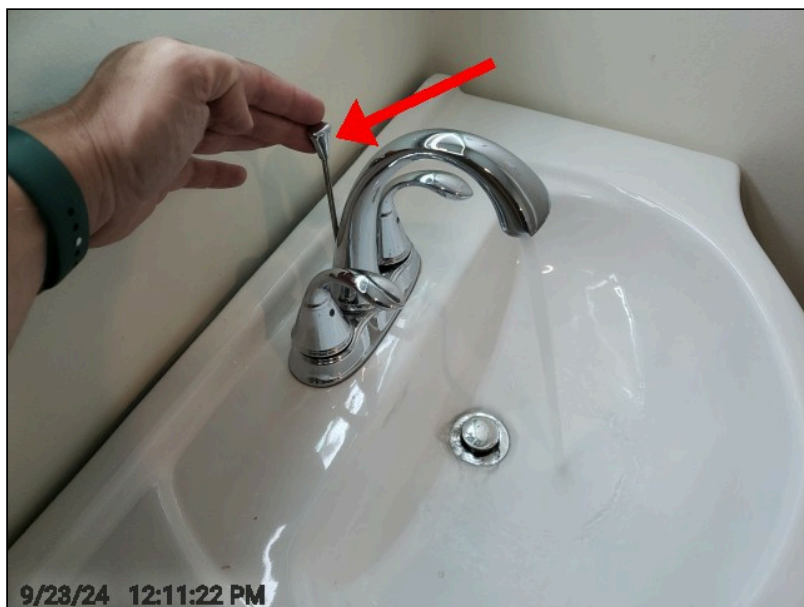
🏠 (1) The sink drain stopper does not hold water. A licensed plumbing contractor needs to repair. Location(s): primary bath (left sink)

🏠 (2) The sink drain stopper rod is disconnected from the drain assembly. A licensed plumbing contractor needs to connect stopper rod. Location(s): basement bath

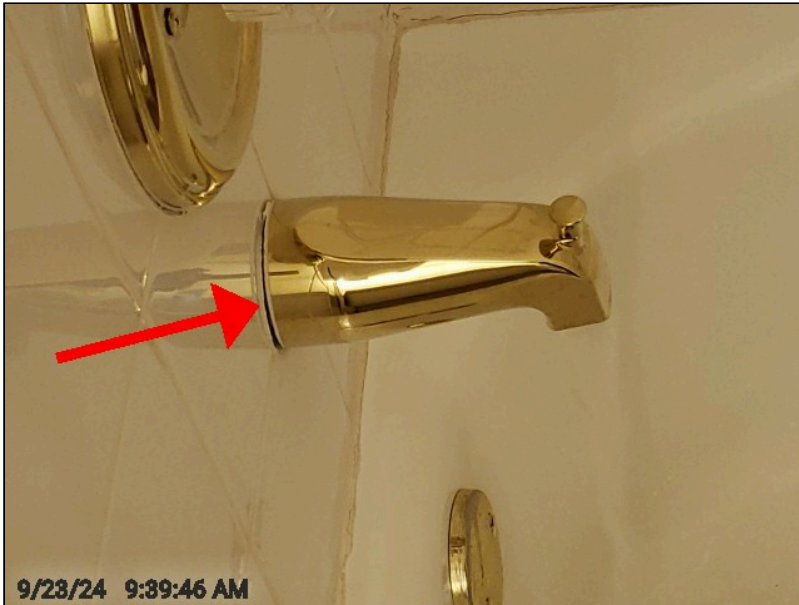
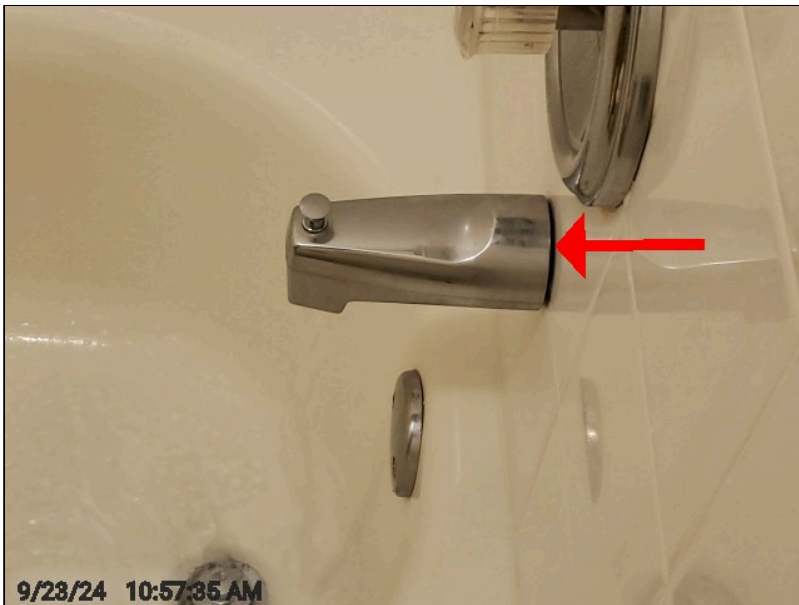
- 🏠 (1) The tub spigot should be caulked to the wall surface to prevent water from entering wall cavity. A qualified contractor needs to repair. Location(s): main level bath, shared bath

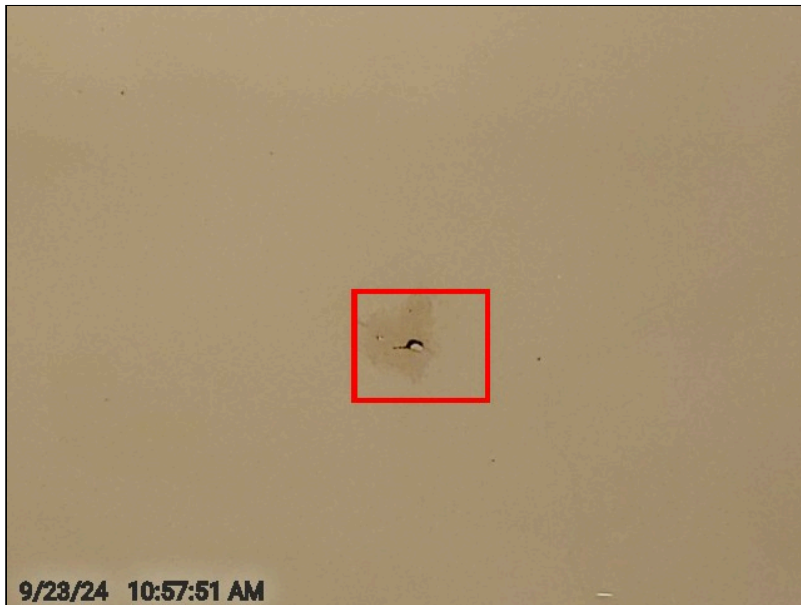
- 🏠 (2) The tub is chipped/cracked. A qualified contractor needs to repair. Location(s): primary bath, shared bath

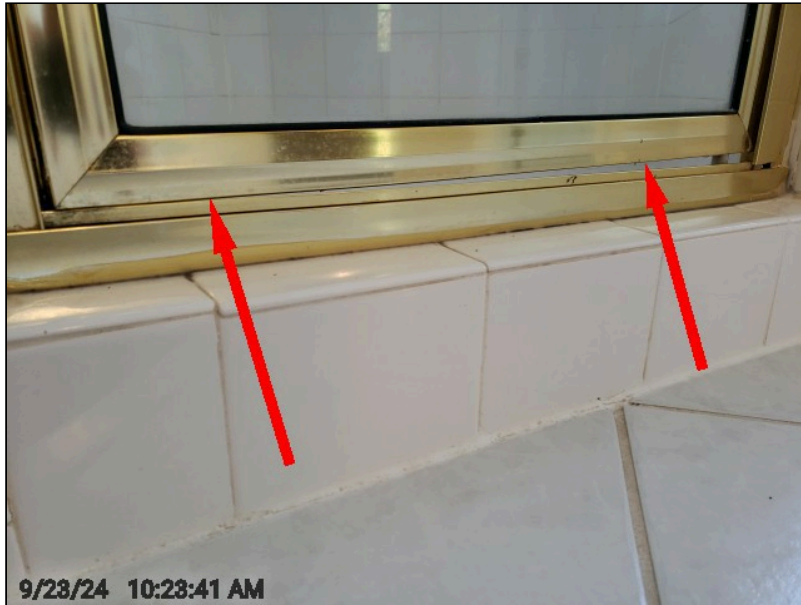
- 🏠 (3) The shower door does not have a sweep on the bottom of the door to prevent water from running out onto the floor. A qualified contractor needs to add sweep to bottom of door. Location(s): primary bath

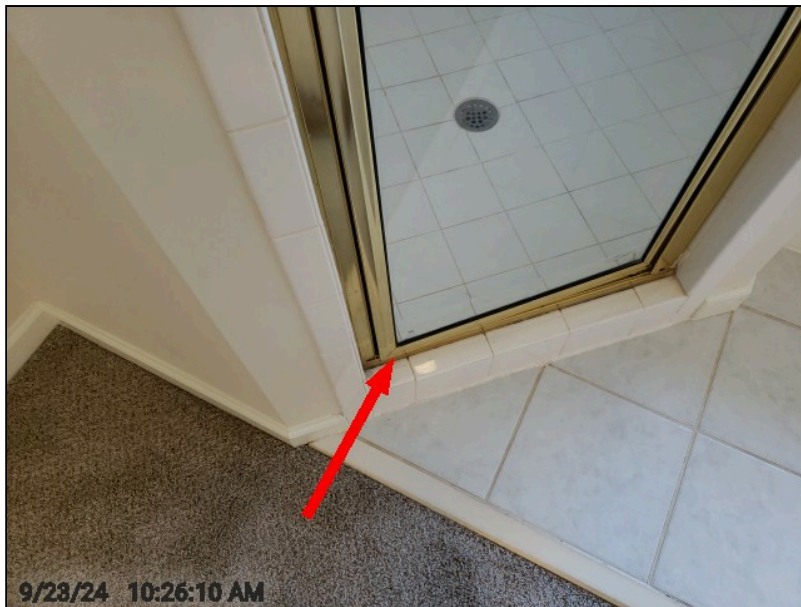
- 🏠 (4) The shower door binds on the door opening. A qualified contractor needs to adjust door. Location(s): primary bath

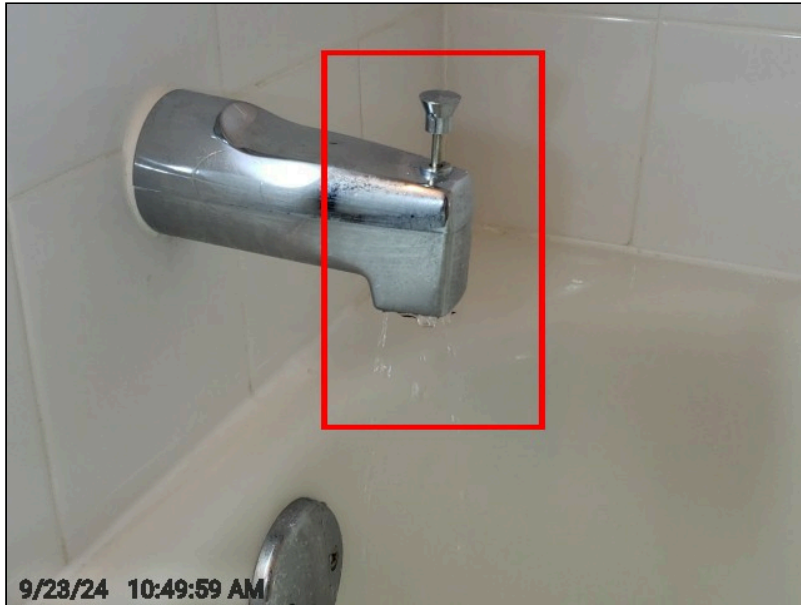
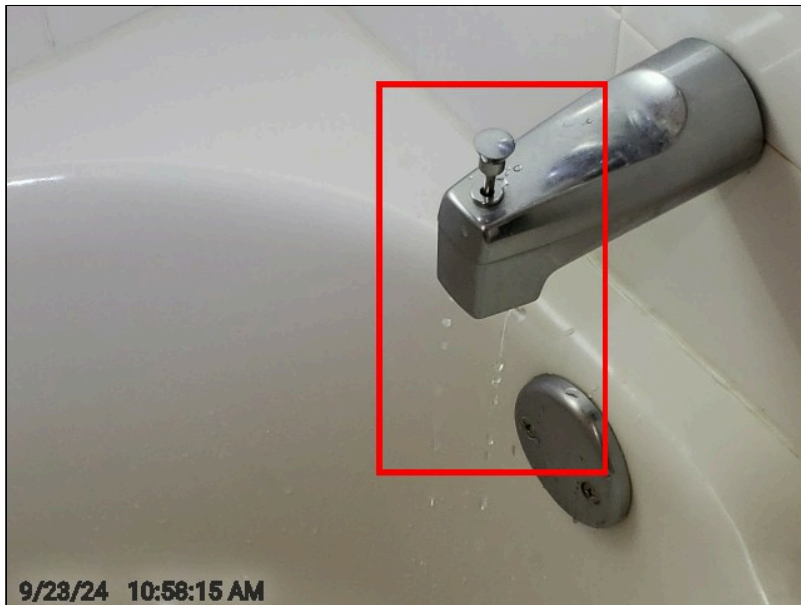
- 🏠 (5) The shower diverter does not divert all water to the showerhead. A licensed plumbing contractor needs to repair. Location(s): private bath (front right bedroom) and shared bath

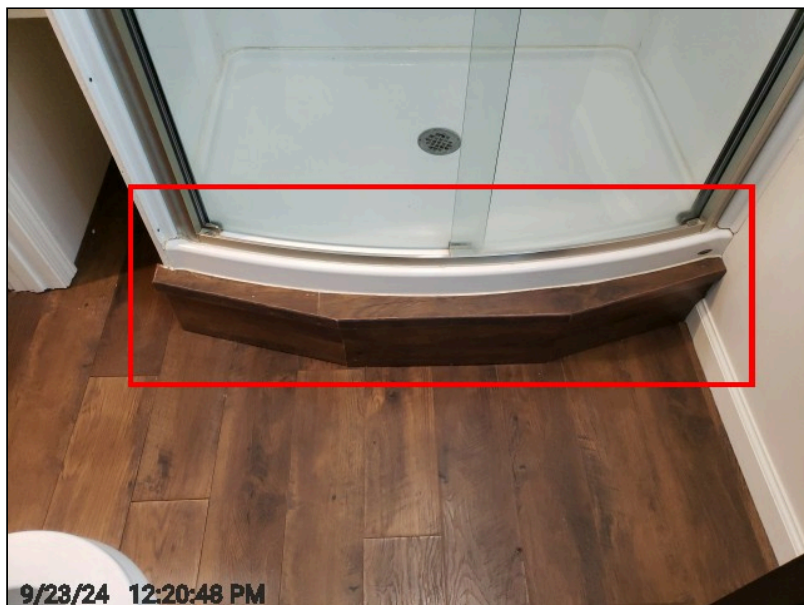
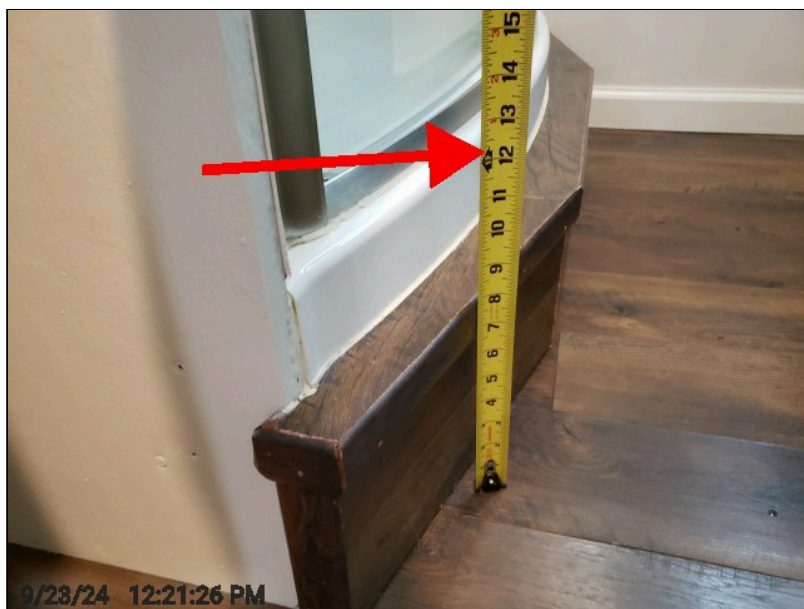
- 🏠 (6) The riser height into the basement bath shower is greater than 7 3/4 inches. This is a potential trip hazard. Location(s): basement bath

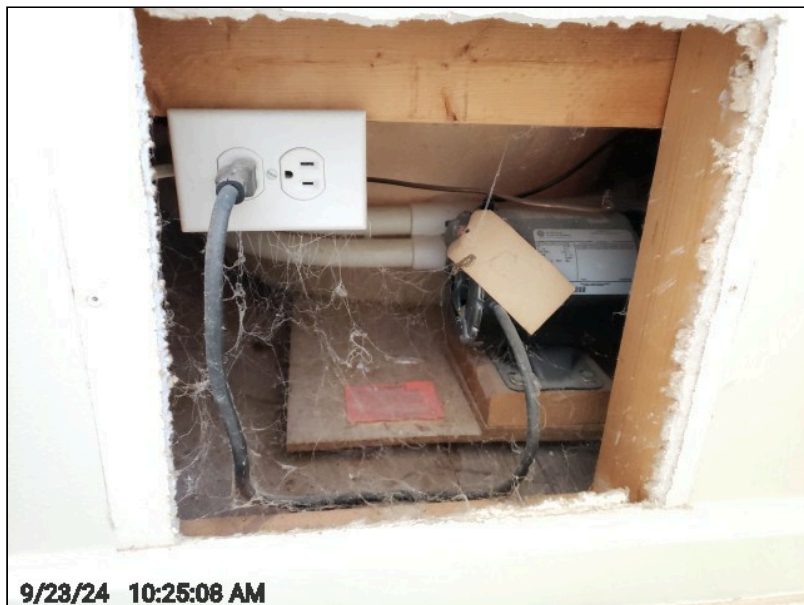
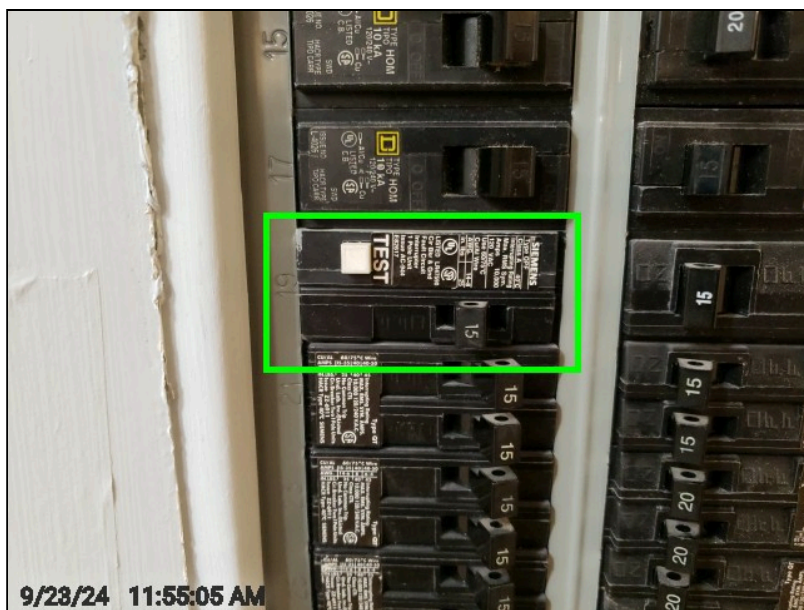
(1) FYI, Access to whirlpool circulation pump and GFCI reset for the whirlpool circulation pump. The pump and piping should be checked periodically for leaks. The GFCI should be tested periodically to verify the GFCI will trip and turn the circulation pump off.

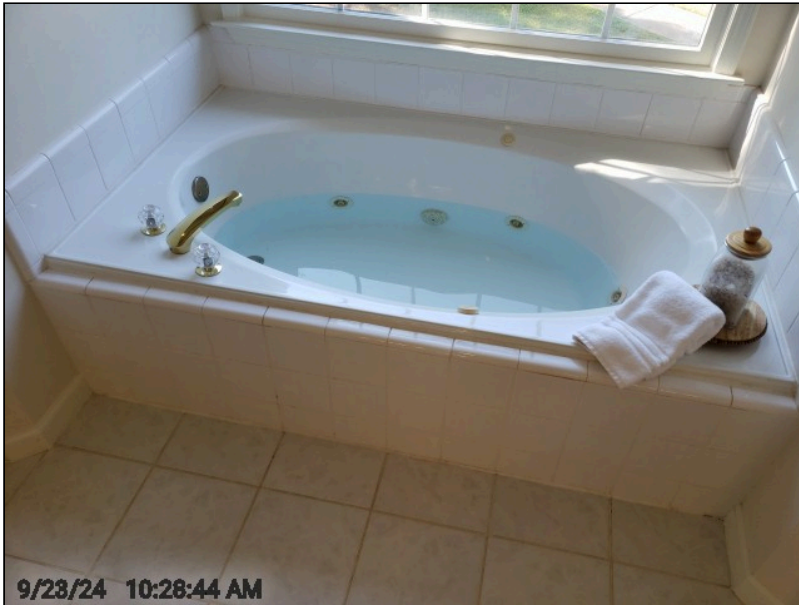
- 🏠 (2) Whirlpool circulation pump motor did not start. A qualified contractor needs put the pump in working order.

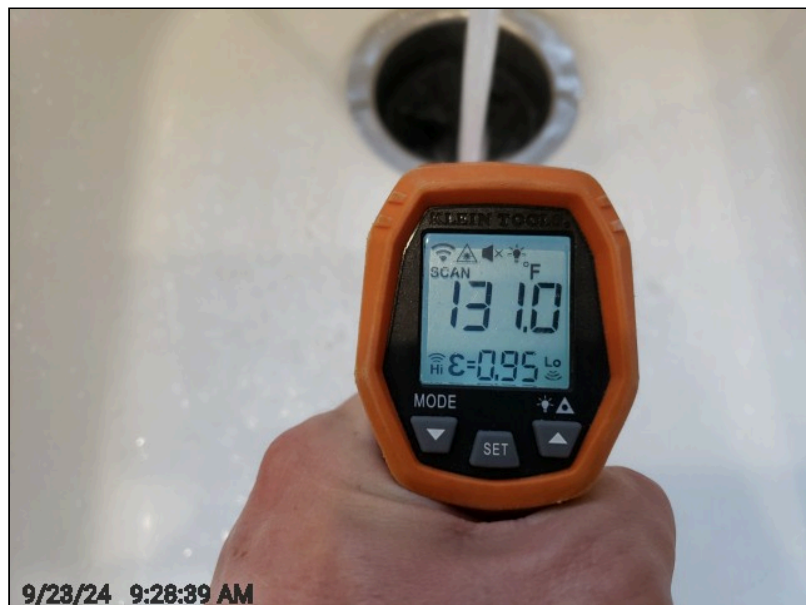
The hot water temperature is too hot. The water temperature at the plumbing fixtures is above 125 degrees farenheit. Water heater manufacturers recommend hot water not be hotter than 125 degrees farenheit to prevent scalding, burning or other injuries. A licensed plumbing contractor needs to evaluate further and repair.

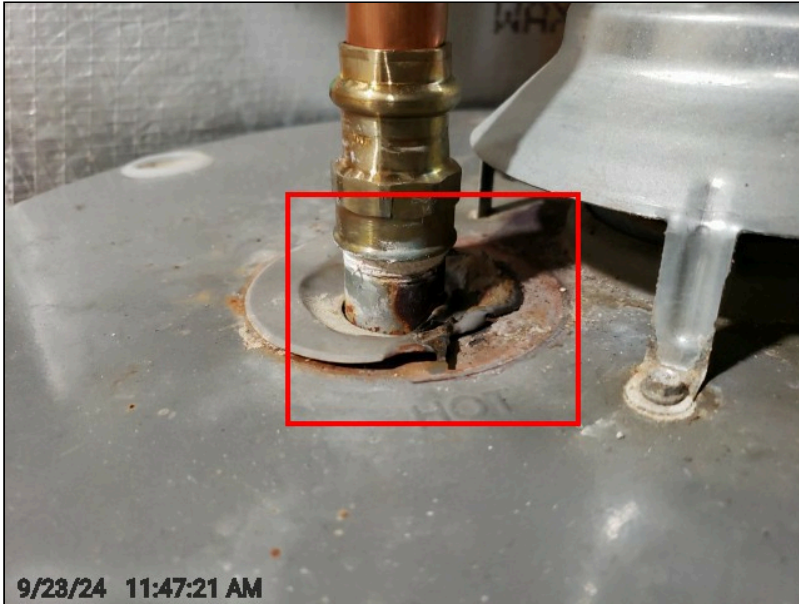
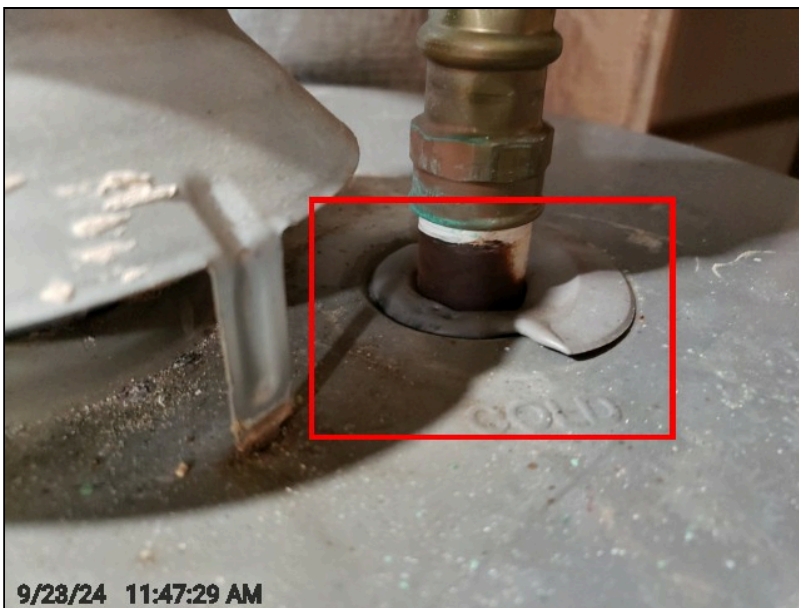
- Signs of back drafting was observed at the water heater vent pipe. There is melted plastic at the draft hood. This is a sign of incomplete burning of combustion gases. Back drafting can lead to increased levels of carbon monoxide. A licensed plumbing contractor needs to inspect further and repair.

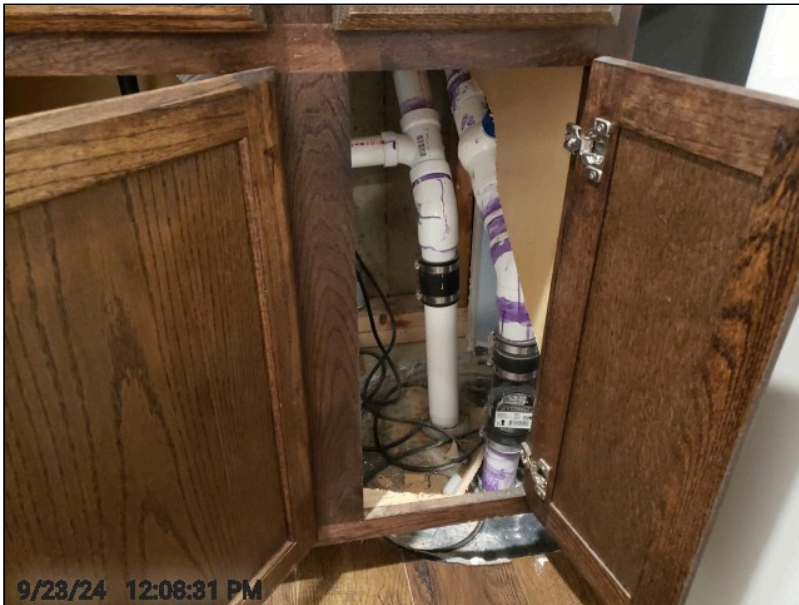
(1) The basement plumbing drains into an "ejector" tank where it is then pumped up into the waste line for disposal. Ejector pumps are required when the drain lines are below the main drain line for the house. Do not use plumbing fixtures in this area during power outages as the pump will not operate, which will cause the system to overflow. Do not flush feminine products, "flushable wipes", toys, rags, etc into the system. These types of items will cause the system to fail.

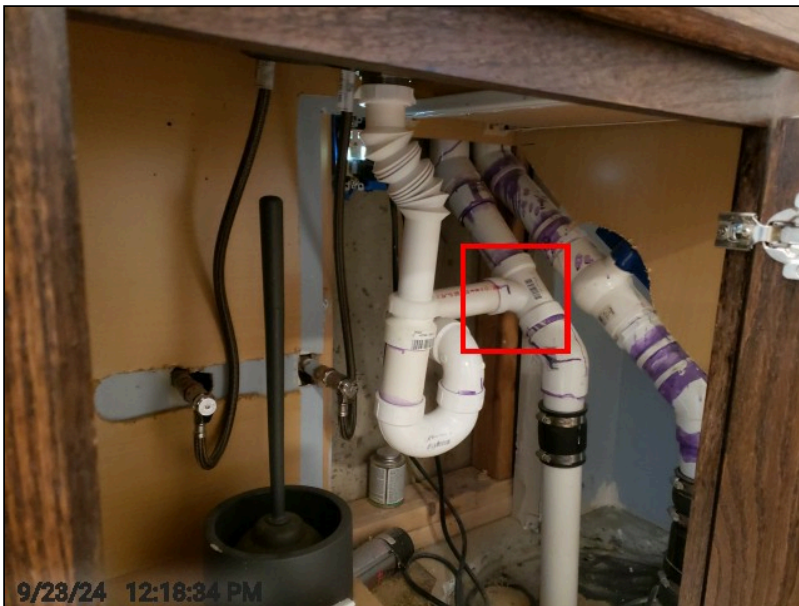
- 🏠 (2) There is a strong sewage odor at the wet bar. The wet bar sink drains into the dry vent from the sewage ejector. The sink drain should drain directly into the ejector pump well. A licensed plumbing contractor needs to repair.

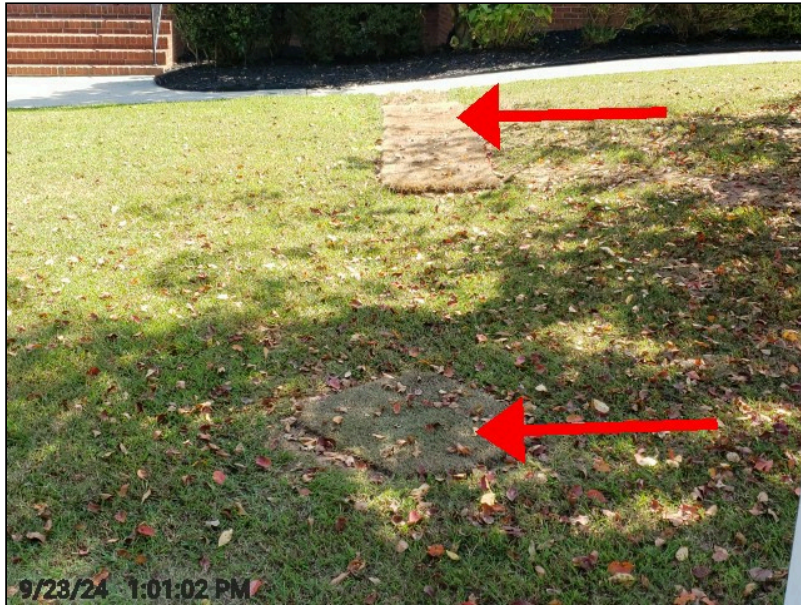
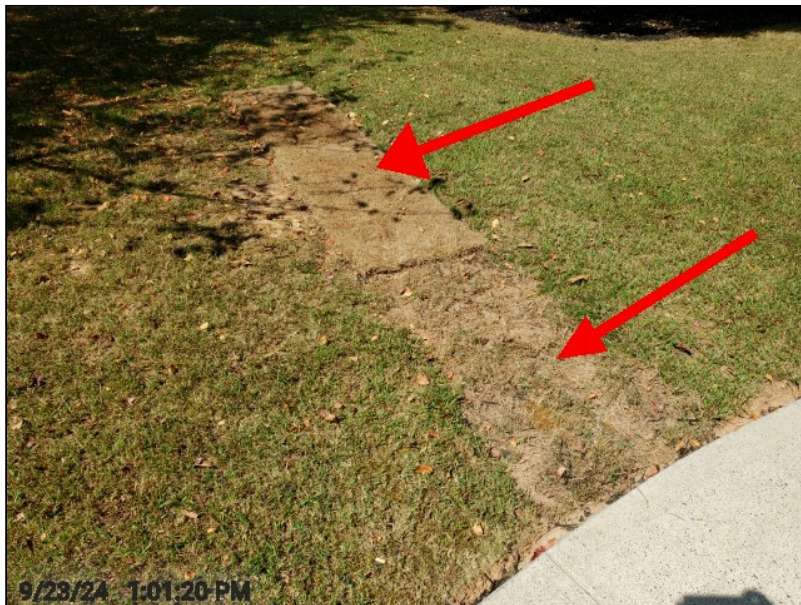
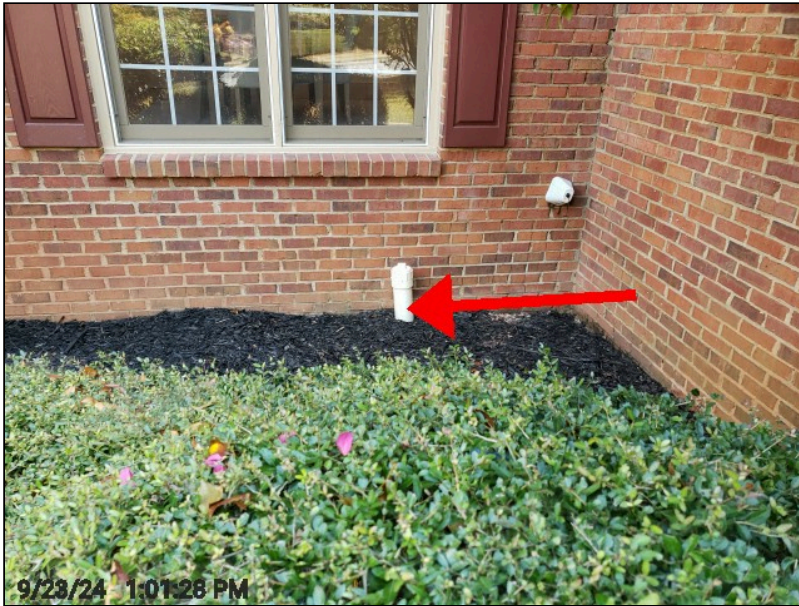
- 🏠 (3) Sod patches in the front yard are in line with the sewer line. Check with seller is there was an issue with sewer line or if only sod replacement

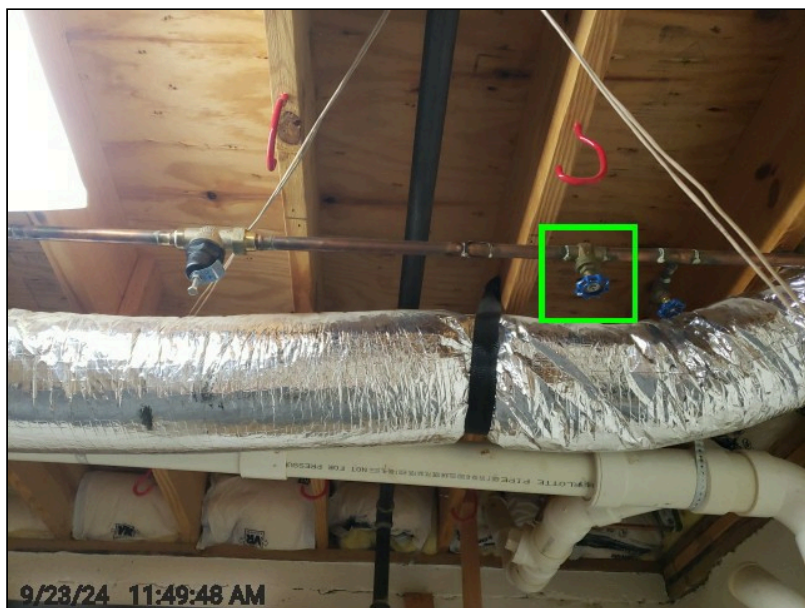
(1) Location of main water cut off (See Photo).

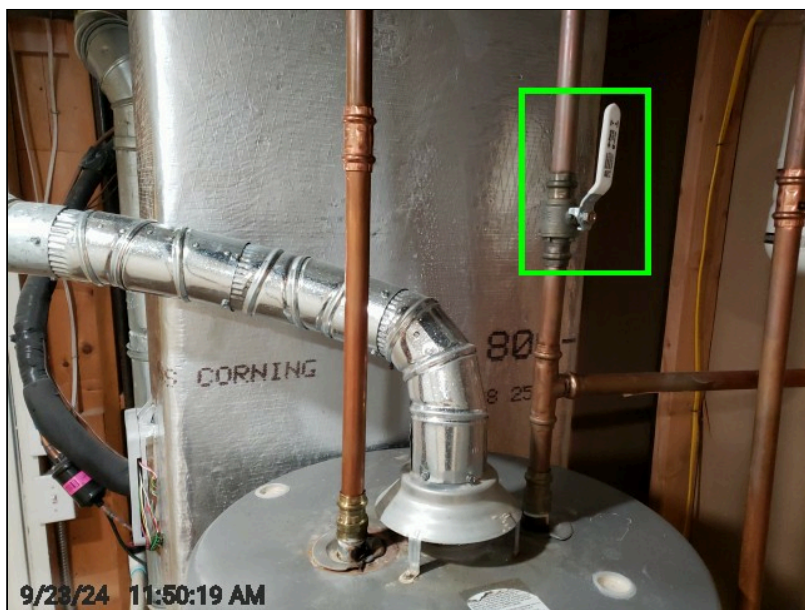
(2) Location of main water cut off to water heater (See Photo).

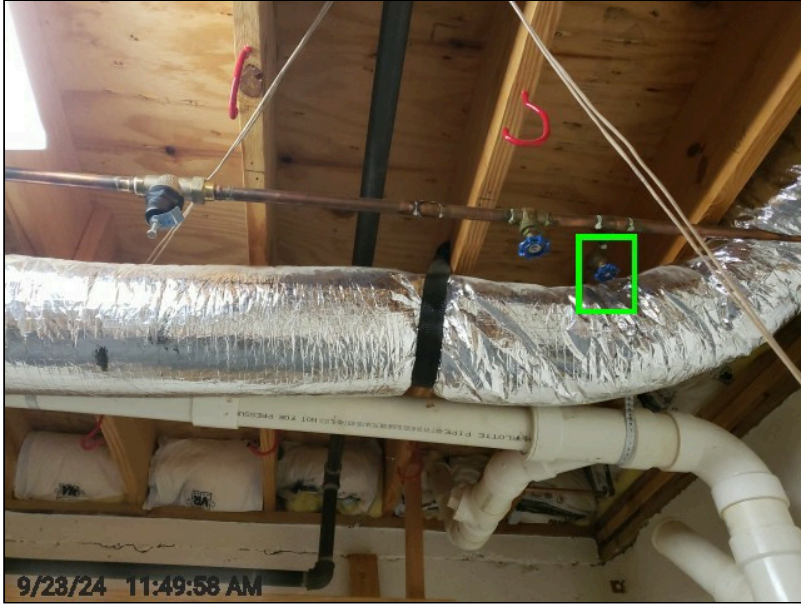
(1) FYI, Location of exterior water faucet shutoff. (See Photo). In the winter time, a good practice is to turn off the water to the exterior faucets and drain exterior faucet to prevent pipe from freezing. This is for your information.

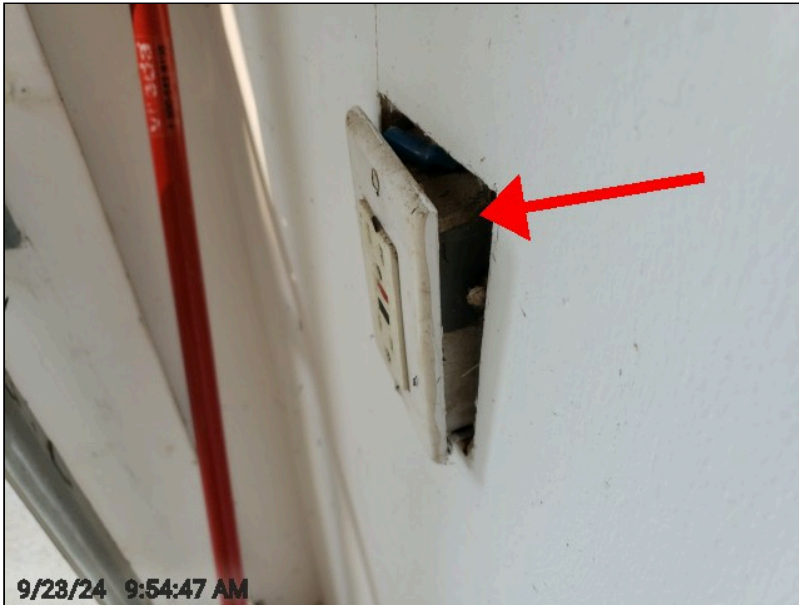
- 🏠 (1) Loose receptacles observed. Receptacles should be securely fastened in place. The top and bottom phalange of the receptacles should be secured to the outlet box. A qualified contractor needs to tighten receptacles. Location(s): throughout the house
- 🏠 (2) Receptacle box not secure to the wall. A licensed electrician needs to secure the outlet box. Location(s): garage

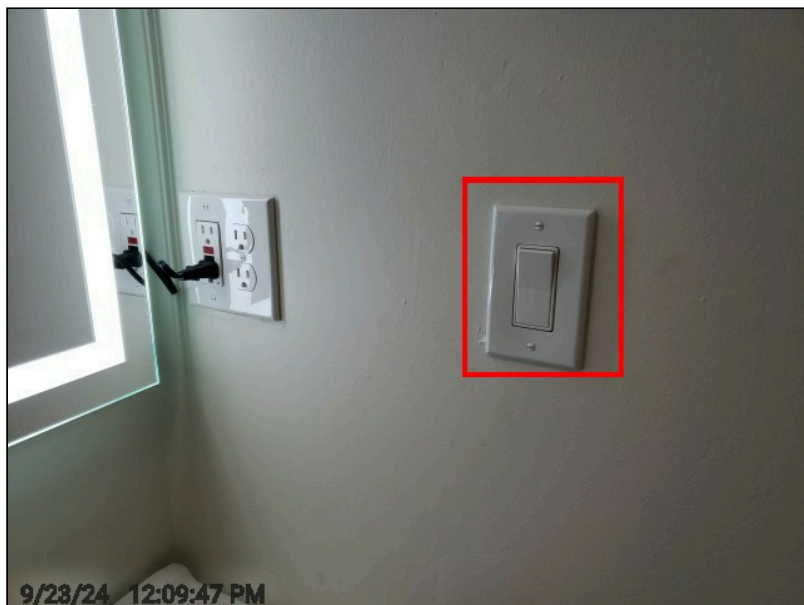
- 🏠 I could not identify the fixture that the switch turns on. Check with the seller for identification.
Location(s): basement bath

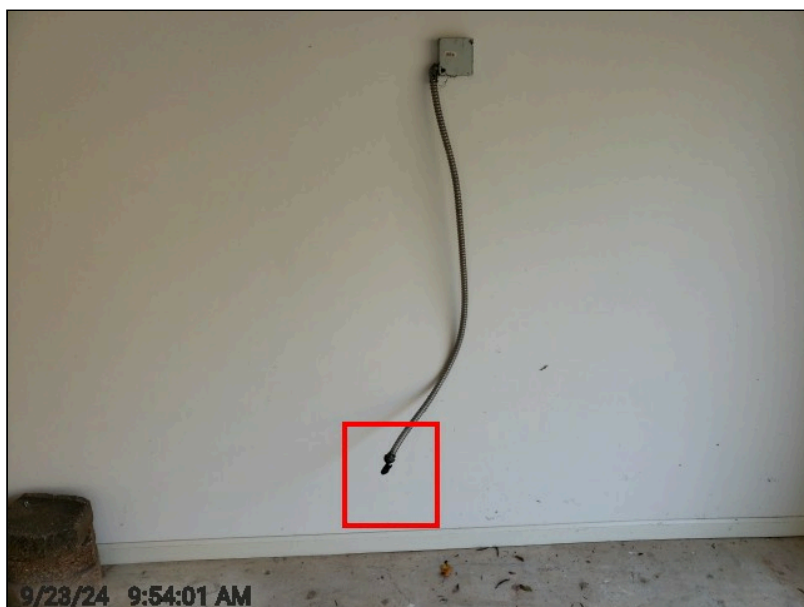
4.2 Connected Devices (junction boxes, wire splices, abandoned wires)

- 🏠 Abandoned cable needs to be in a junction box with cover plate and wire nuts added as needed. A licensed electrician needs to repair. Location(s): garage

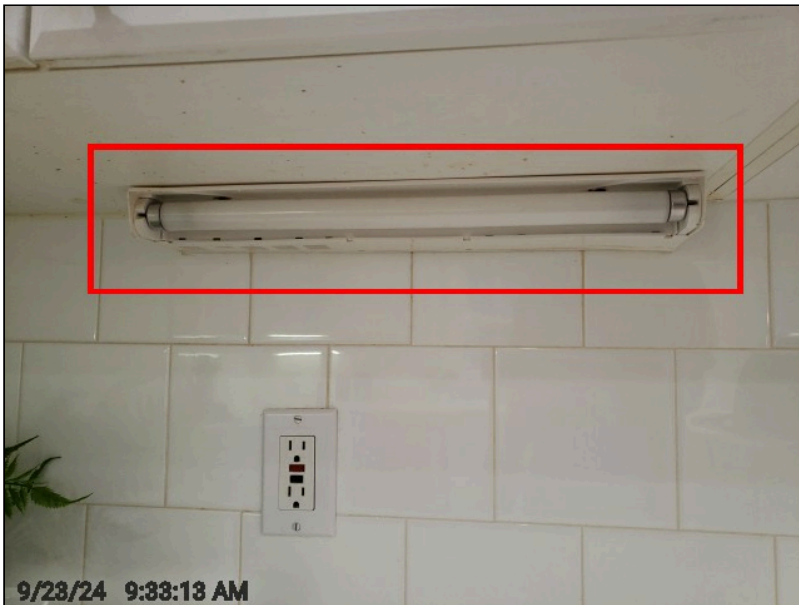
- 🏠 (1) Lens cover needed on light fixture. A qualified contractor needs to install lens cover. Location(s): kitchen

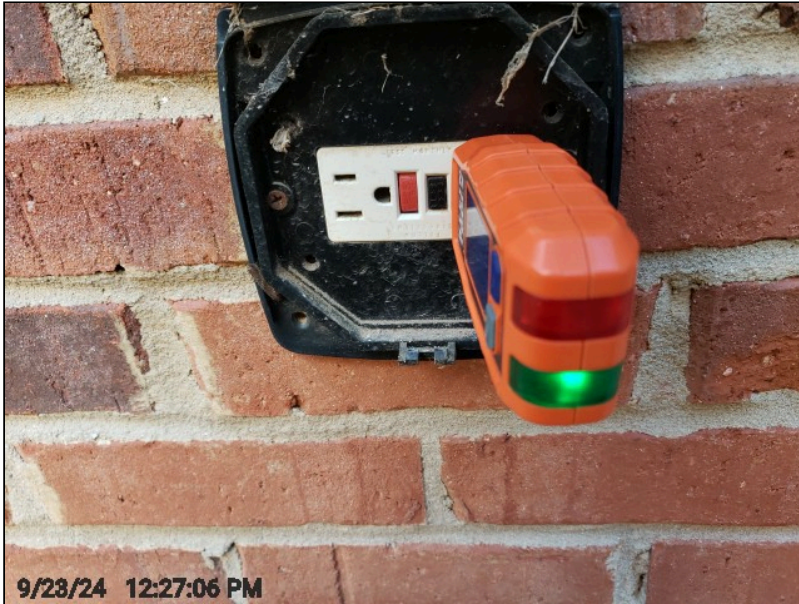
- 🏠 (2) GFCI receptacle did not trip when tested with GFCI receptacle tester. A licensed electrician needs to repair. Location(s): basement door

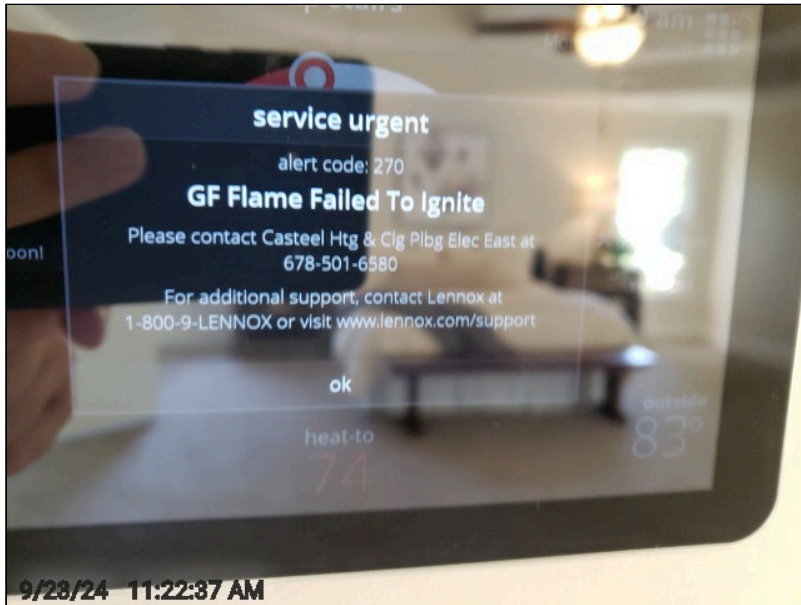
(1) The upstairs furnace did not start. An error code flashed on the thermostat, "Flame Failed To Ignite." A licensed heating and air conditioning contractor needs to evaluate further and put the equipment in working order.

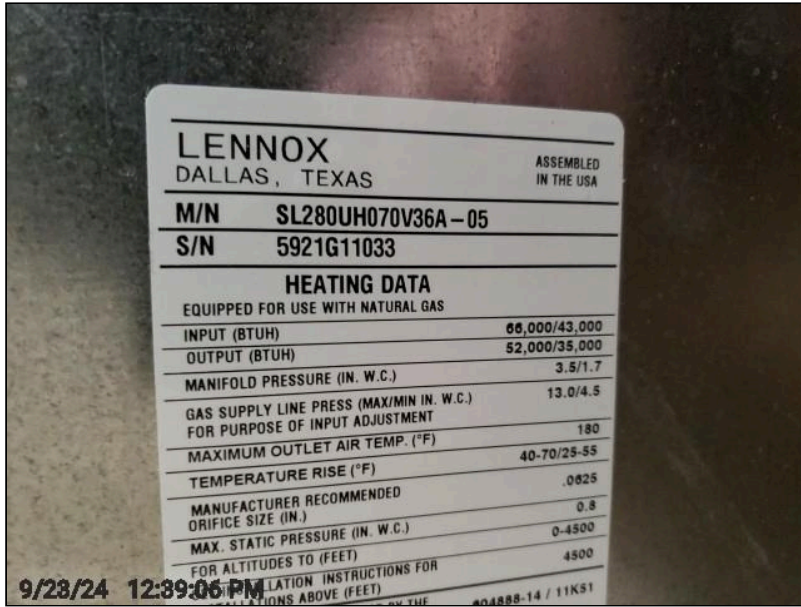
(2) The main level furnace appeared to be in acceptable operating condition. The inspector makes no warranties or guarantees as to how long the heating equipment and components will last.

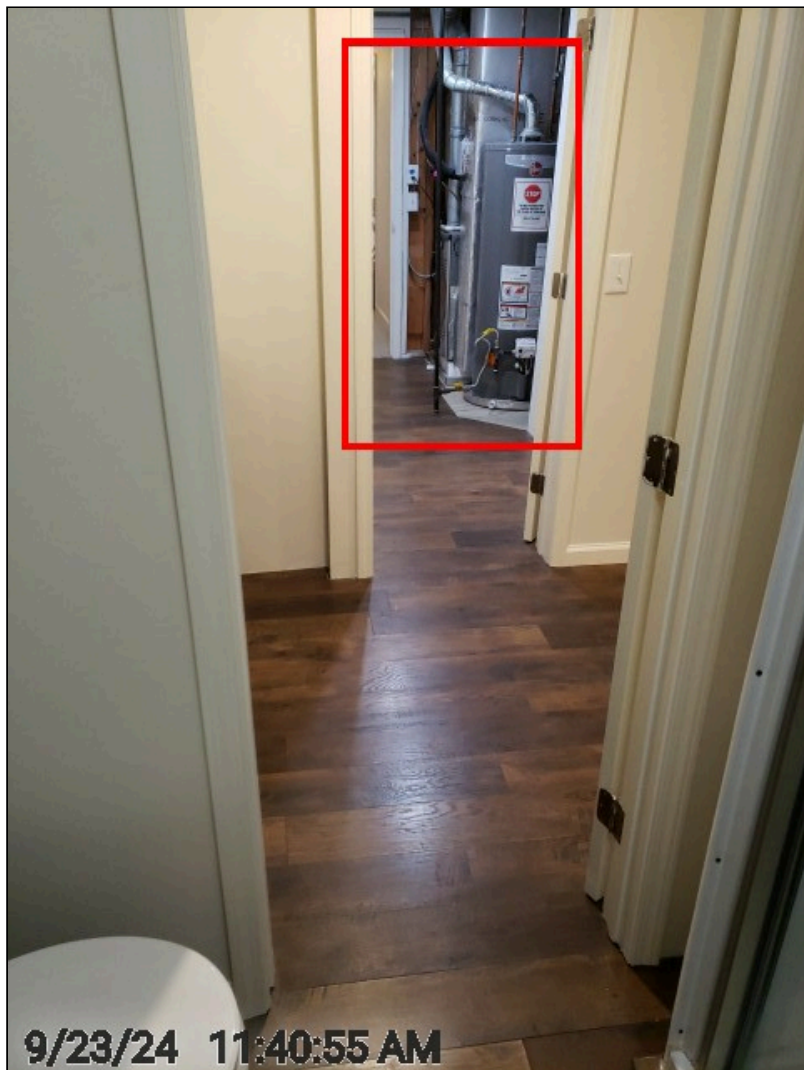
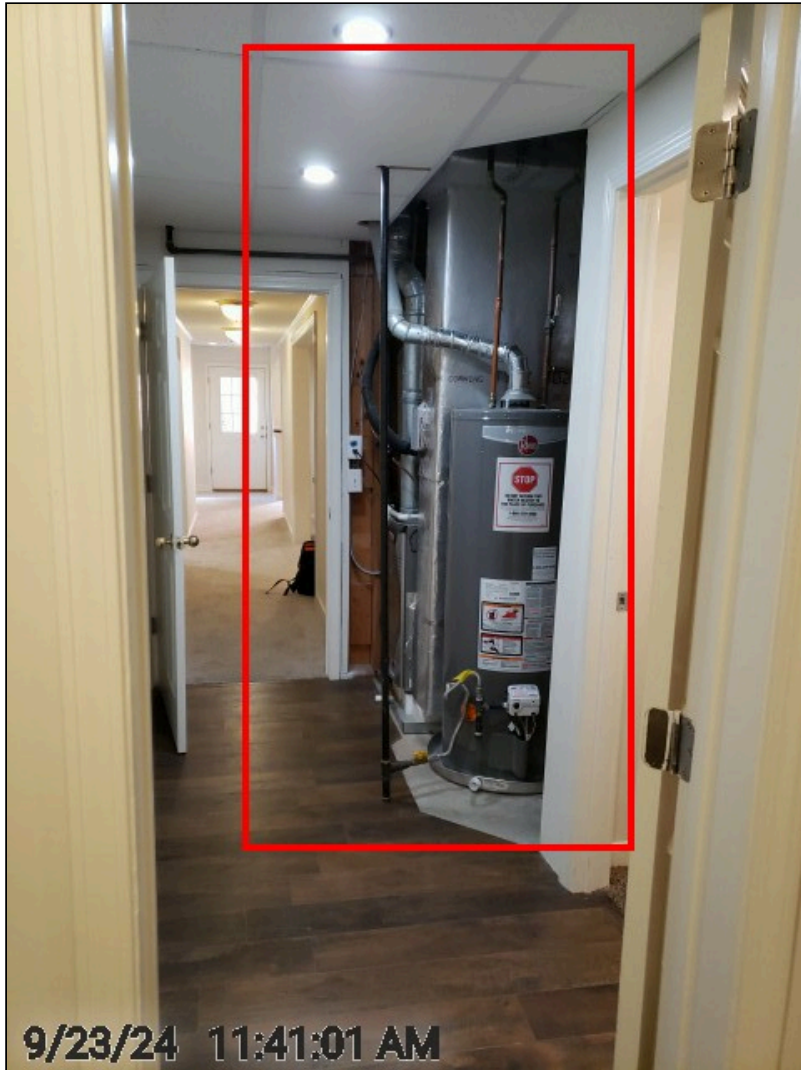
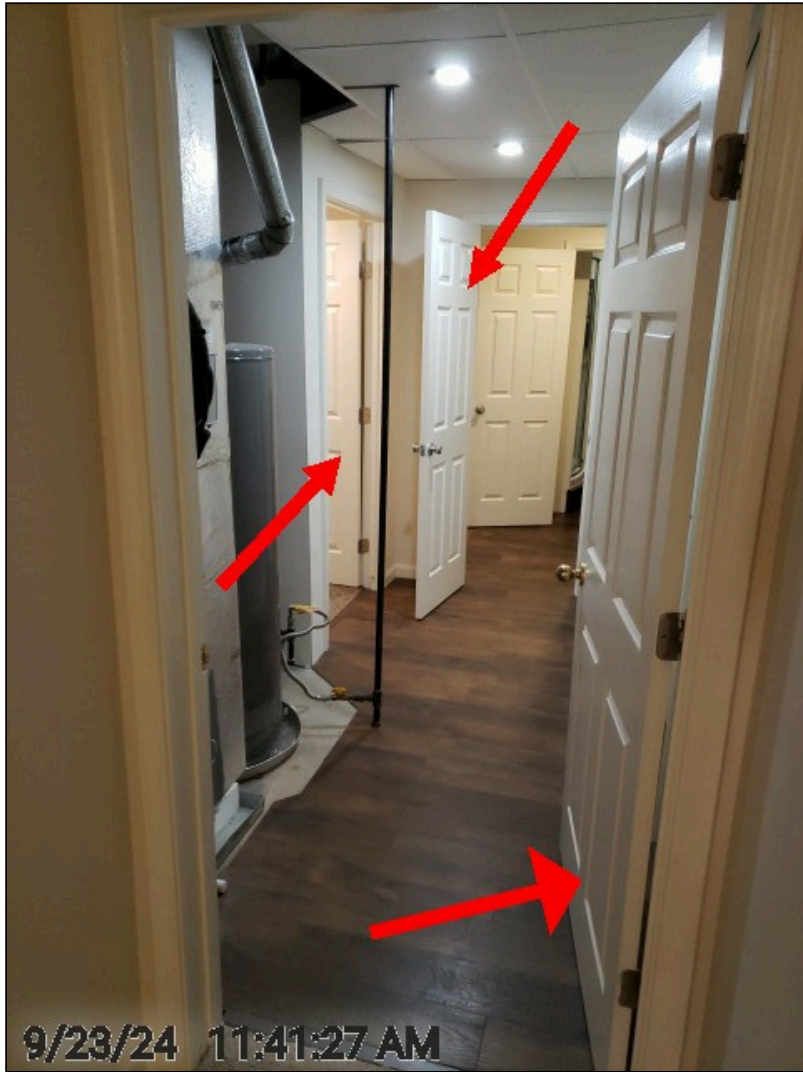
- 🏠 (1) The gas furnace and gas water heater would be in a sealed closet without a source to remove combustion gas if the doors were closed. Appears there needs to be a fresh air source. A licensed heating and air contractor needs to evaluate further and repair as needed.

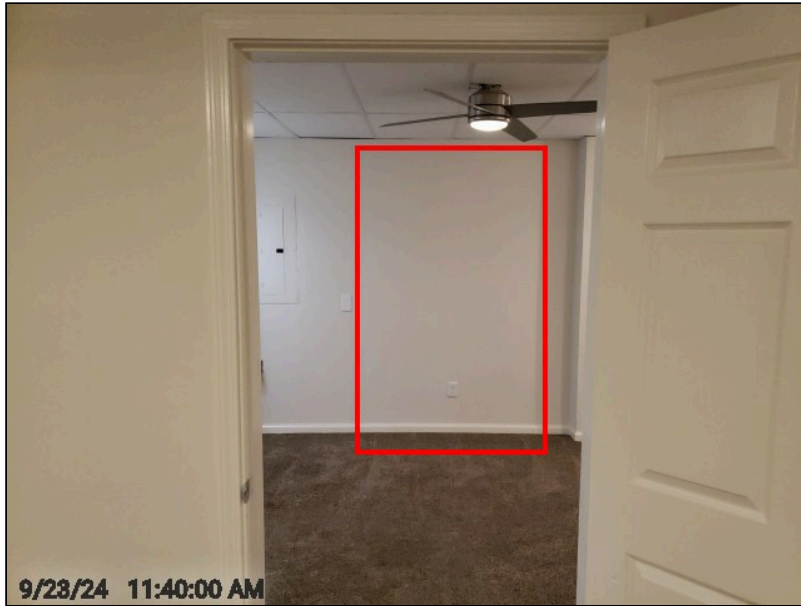
Location where door is needed

- 🏠 (2) The mechanical room for the gas furnace and gas water heater is installed in the middle of the main hallway in the basement. If someone is in the rooms on the right side of the basement they would be trapped, in the event of a fire in the mechanical room. There needs to be an additional door installed on the right side of the basement for emergency exit (refer to pictures for location). A qualified contractor needs to repair.

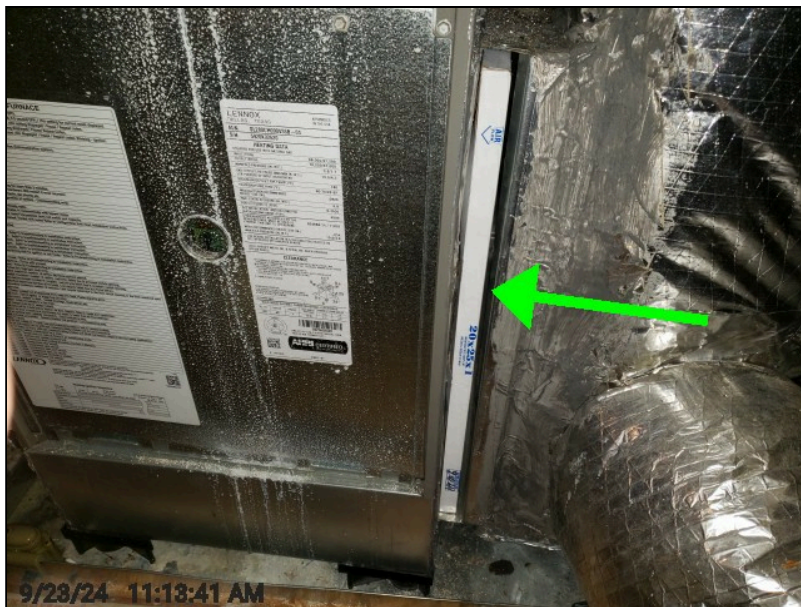
Location of return air filters (see photo). Filters should be changed every 60 to 90 days. Recommend that the filters be changed once you take possession of the house.

Arrow in the direction of air flow

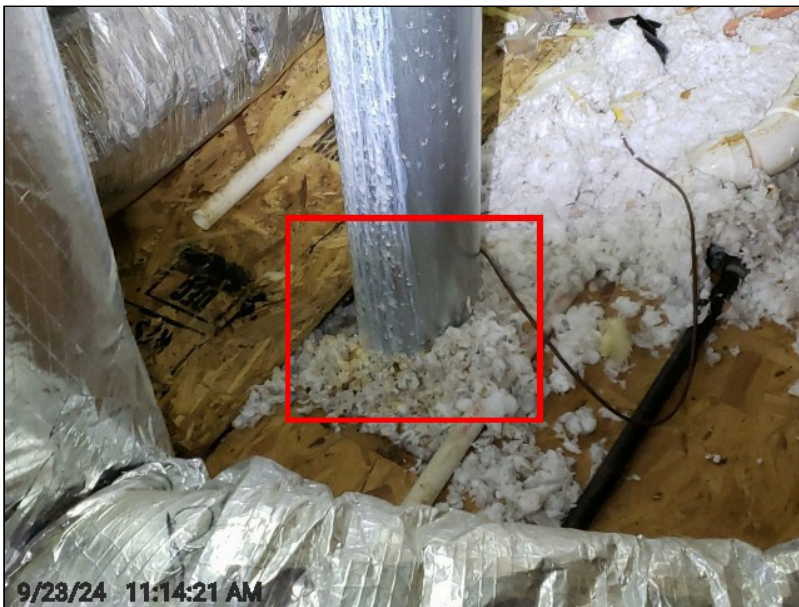
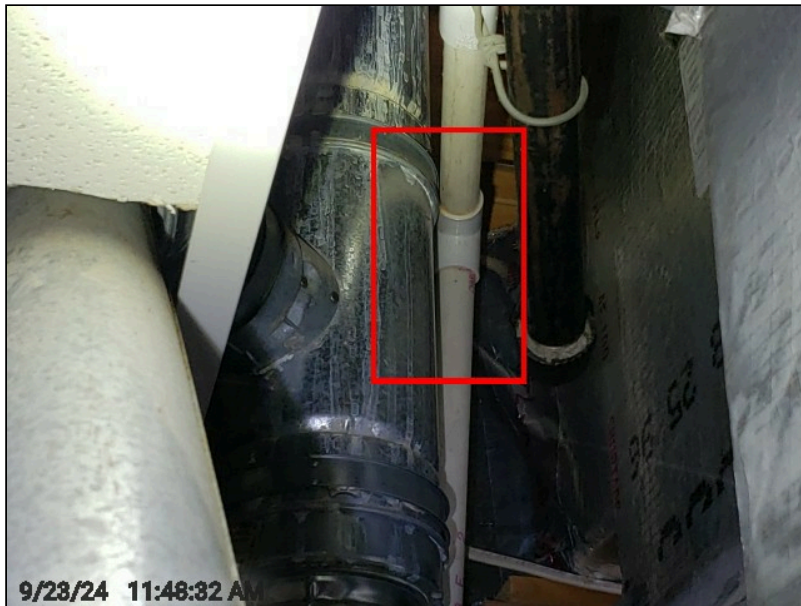
- 🏠 (1) Furnace vent pipe should have a one inch clearance from combustibles. This is a safety issue. A licensed heating and air contractor needs to provide a one inch clearance from the insulation and condensation drain line. Location(s): attic and basement
