Inspection Report

5678 Main St

Marion Hodges Home Inspection Services

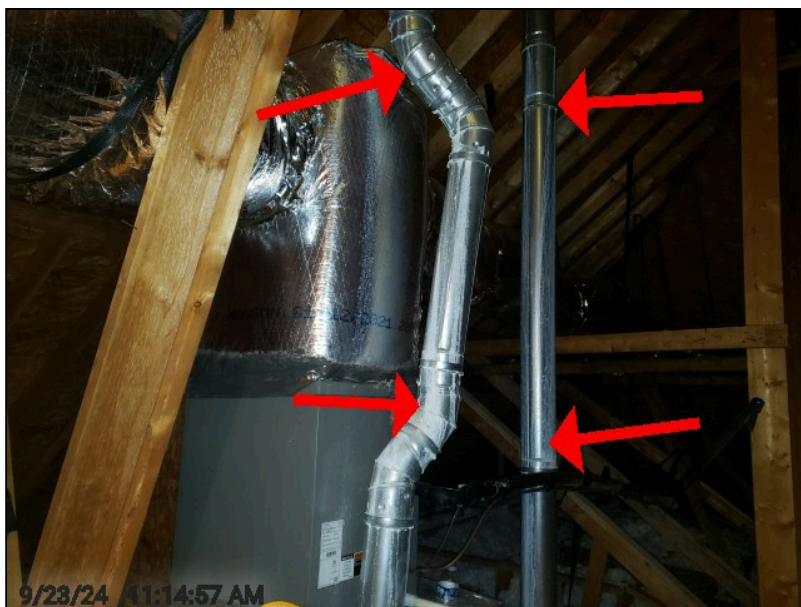
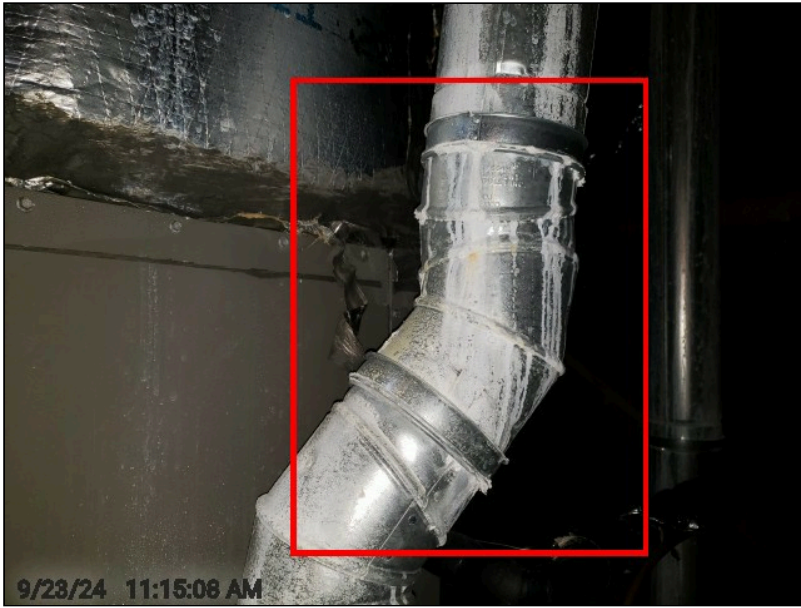
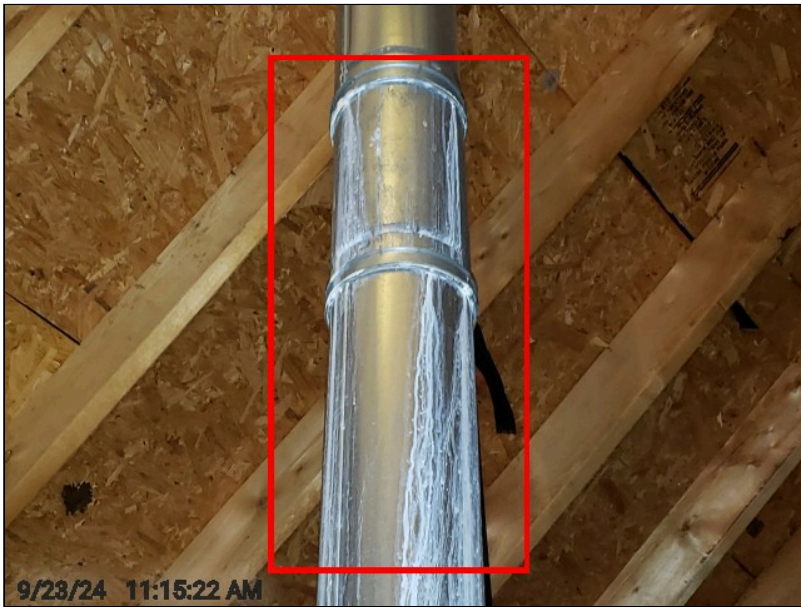
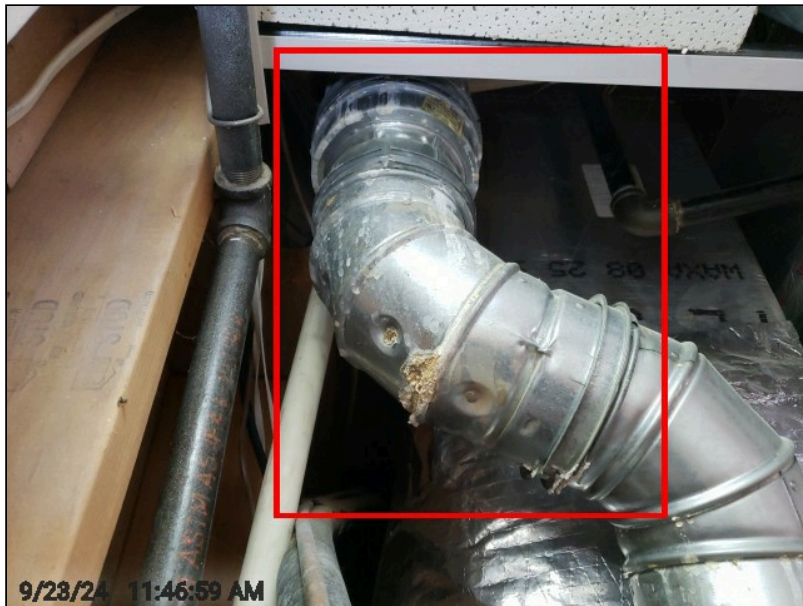
(2) White powder was observed on the furnace vent pipe. This is a sign of an incomplete venting of toxic combustion gases or back drafting. This is a safety issue. A licensed heating and air contractor needs to inspect further and repair. Location(s): attic and basement

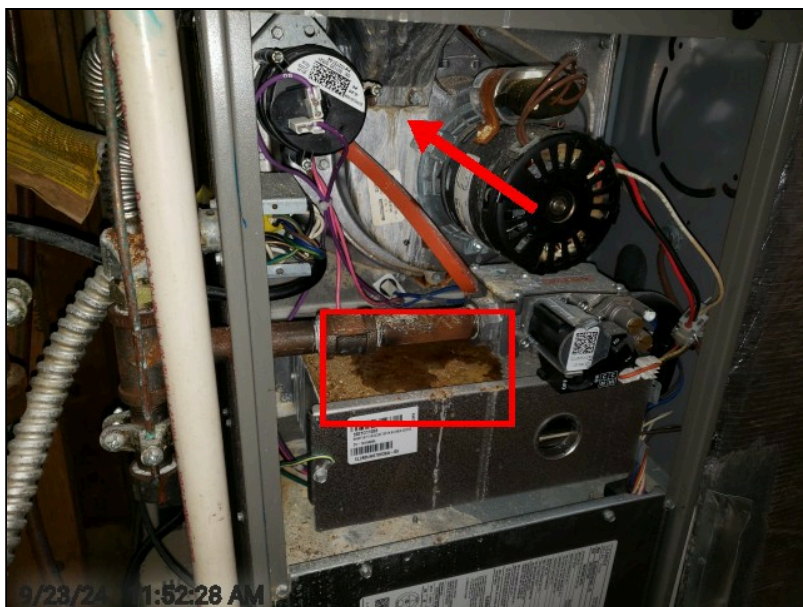
- 🏠 (3) Water was observed dripping from the furnace vent pipe inside the air handler. Only the air conditioning had been running when the leak was discovered by the inspector. A licensed heating and air contractor needs to evaluate further and repair. Location(s): basement

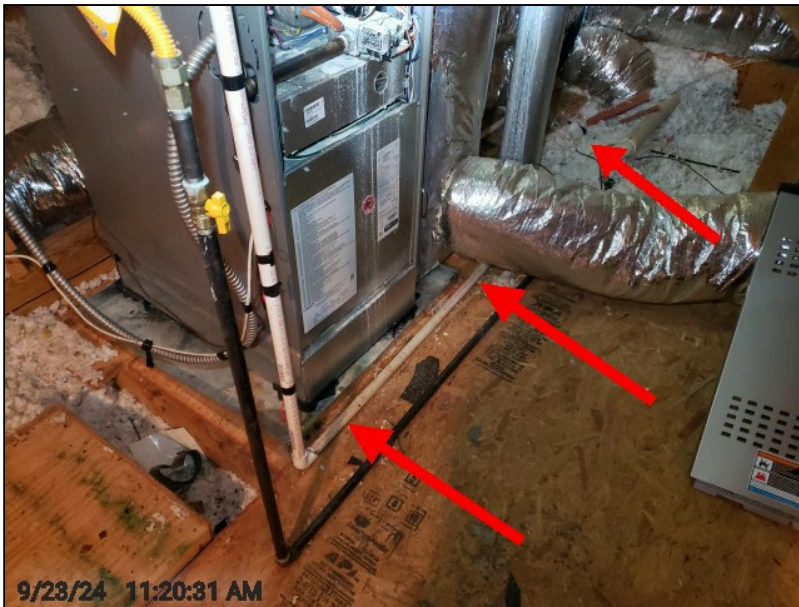
- 🏠 (2) The condensation drain line does not have a gravitational flow to the exterior in the attic. The drain line lays flat without slope in pipe. The pipe should have a 1% slope to prevent backup. A licensed heating and air contractor needs to repair.

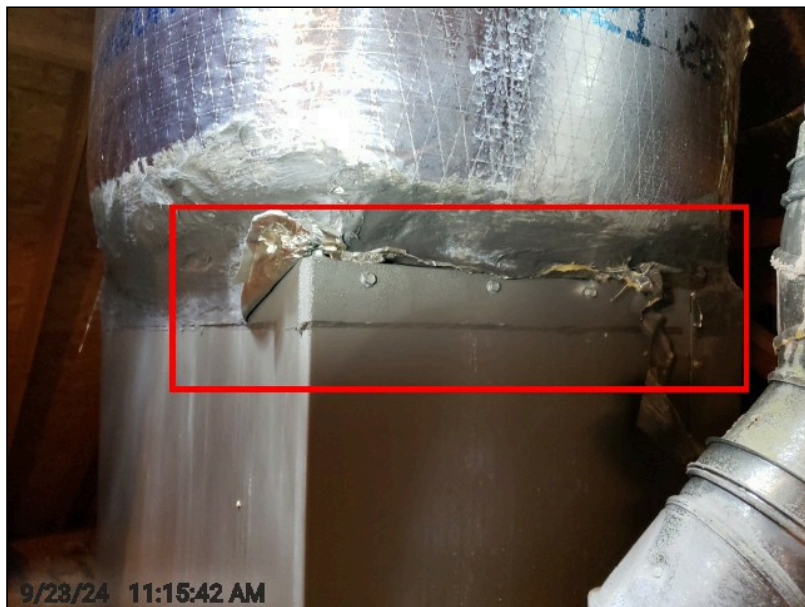
- 🏠 The foil tape has separated on the heating and air system in the attic. The foil tape joint should be sealed to prevent heating and cooling loss. A licensed heating and air contractor needs to tape joints as needed. Pictures shown are examples.

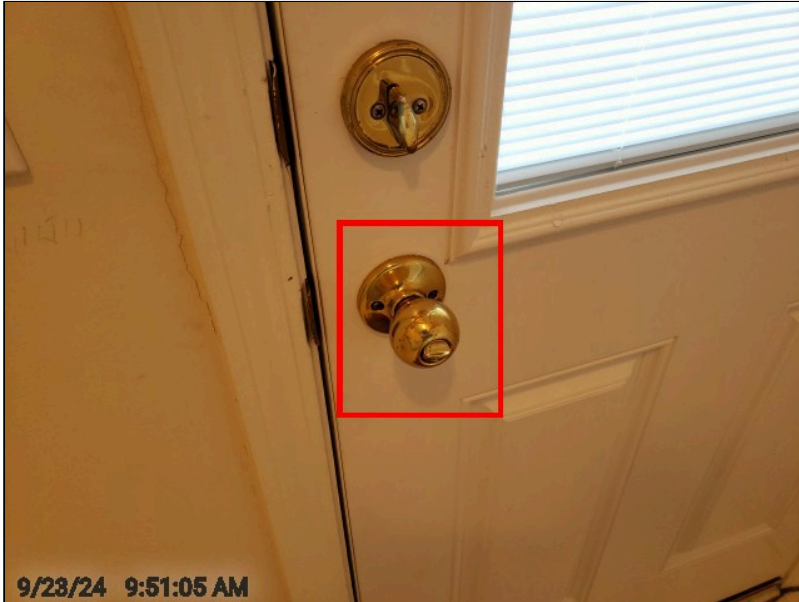
- 🏠 (1) Lock is broken. A qualified contractor needs to repair or replace lock. Location(s): laundry exterior door

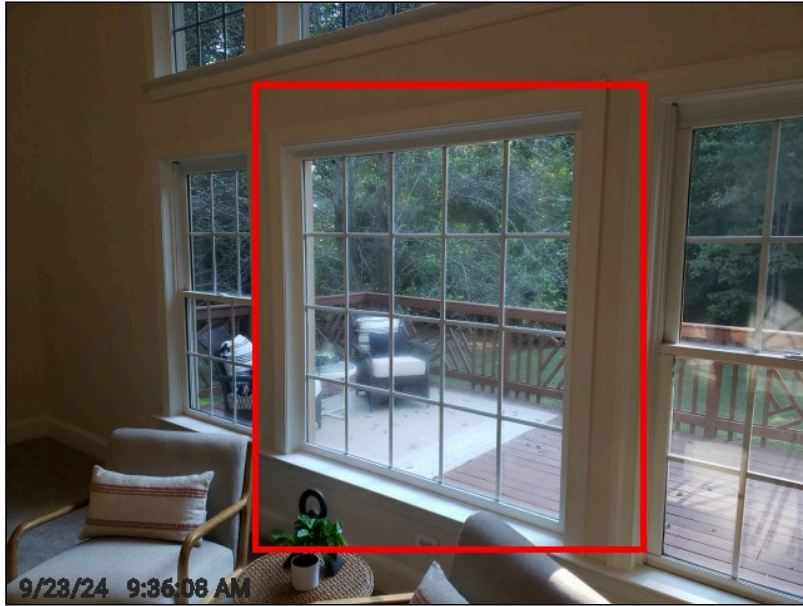
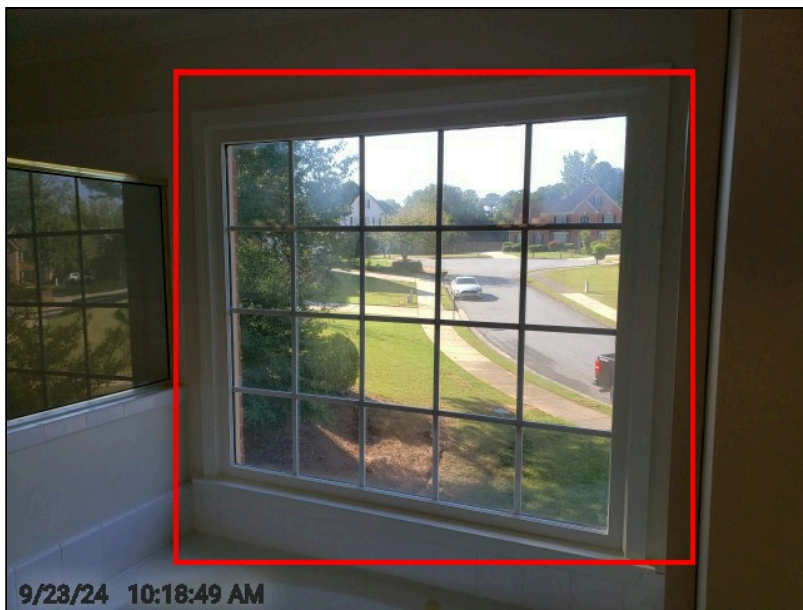
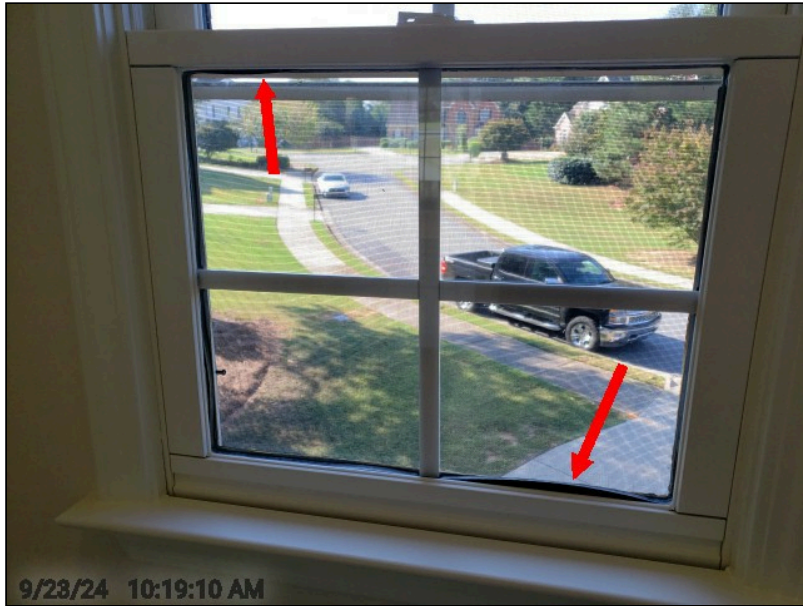
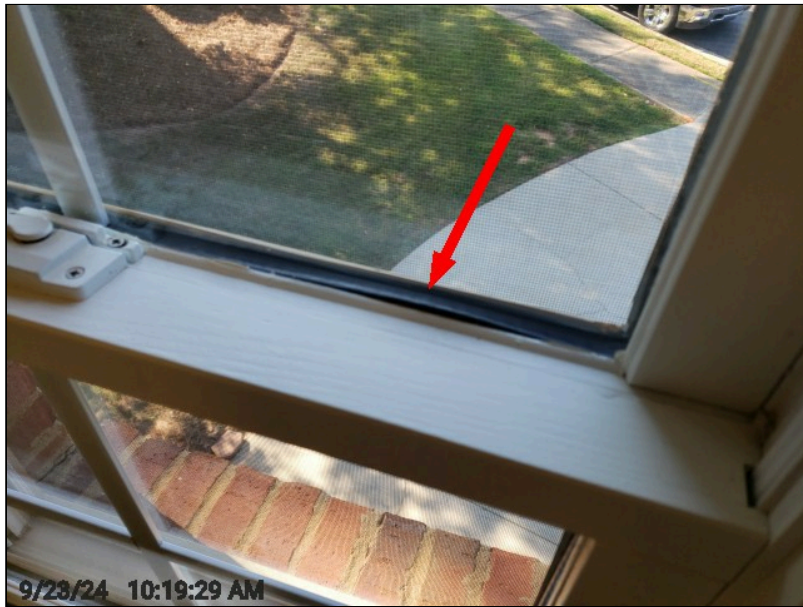
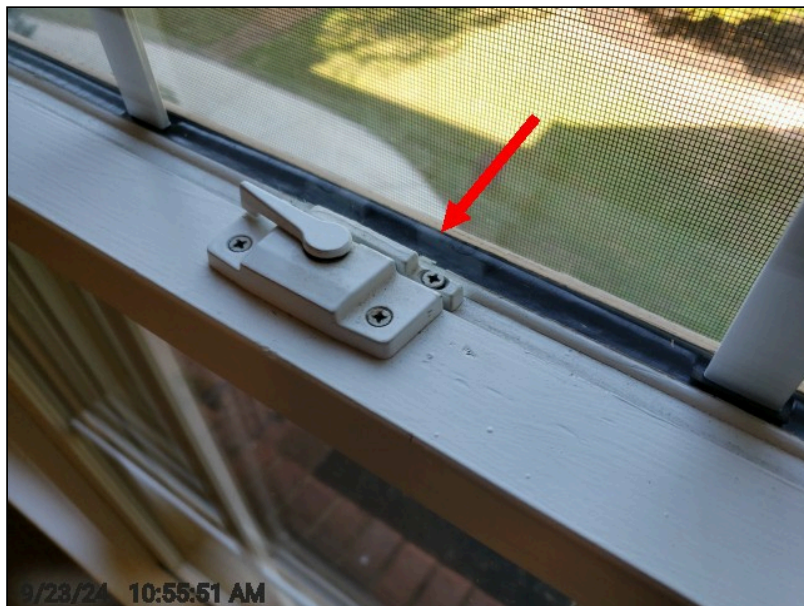
- 🏠 (1) Insulation seals have failed on windows. A qualified contractor needs to replace failed glass.
Location(s): family room, primary bath, primary bath toilet closet, front left bedroom and back left bedroom

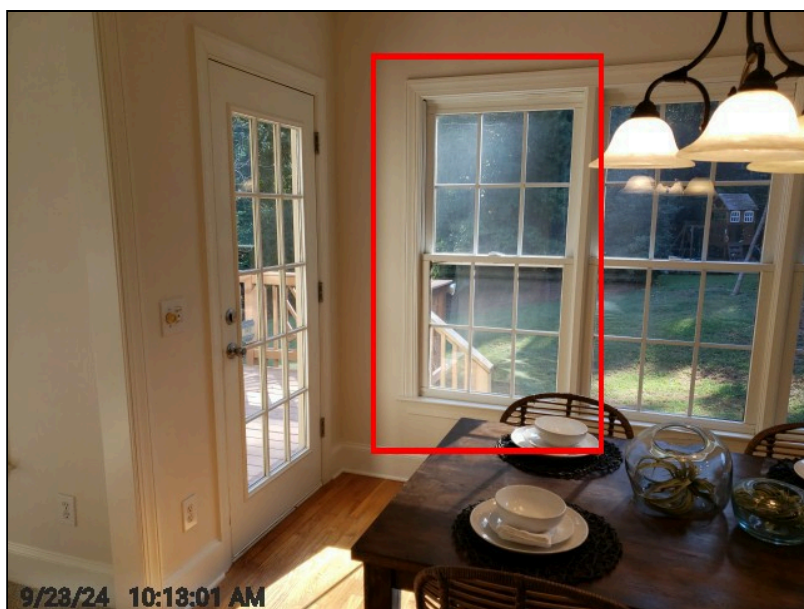
(2) The window sash by the door is not tempered glass. All windows within 24" of either side of a door need to be tempered glass. This is a safety issue. A qualified contractor needs to replace the glass with tempered glass. Location(s): breakfast area door

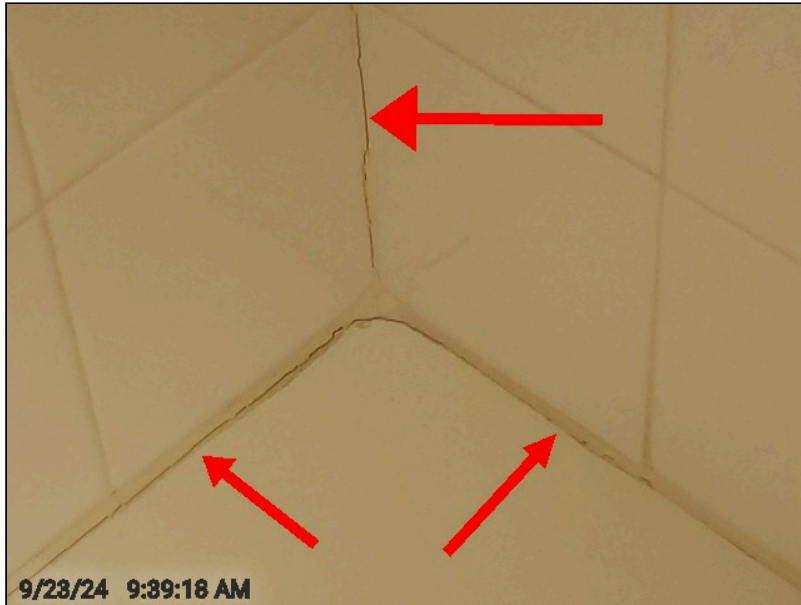
- 🏠 (1) Tub walls need to be caulked or grouted. The pictures shown are examples. A qualified contractor needs to caulk or grout. Location(s): main level bath

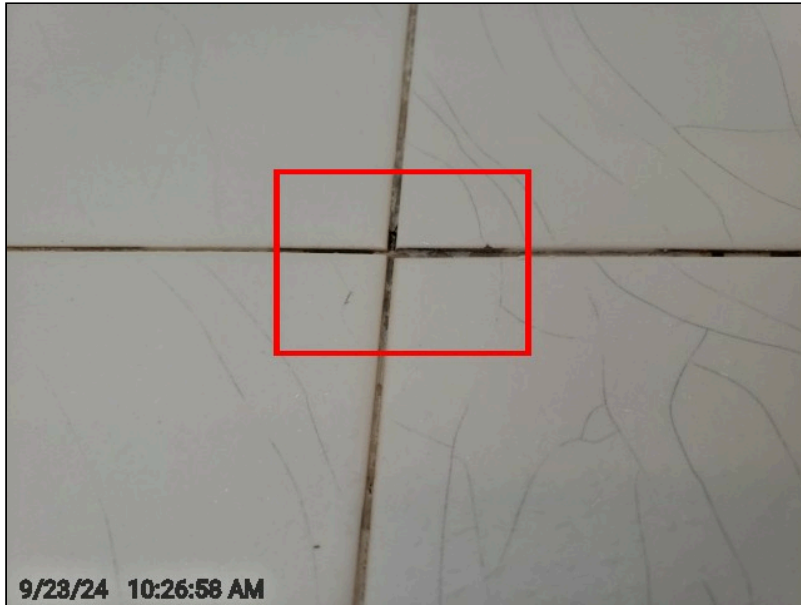
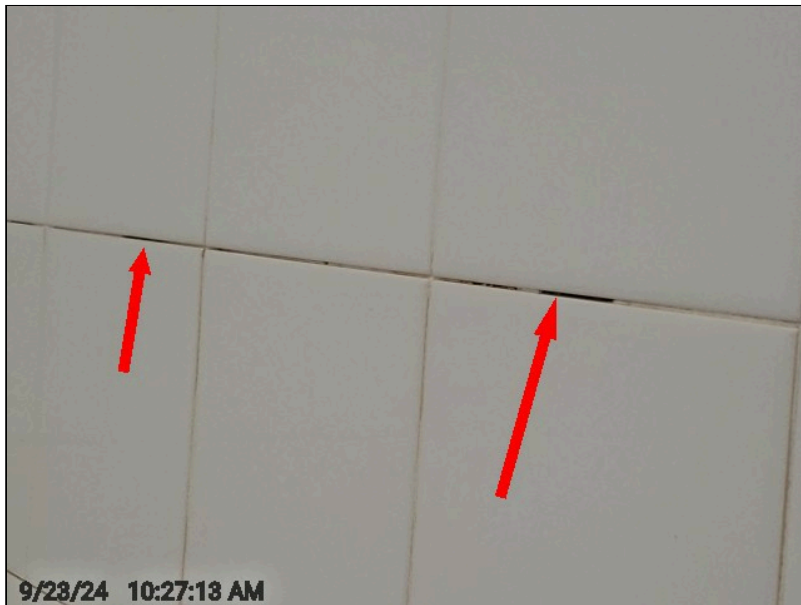
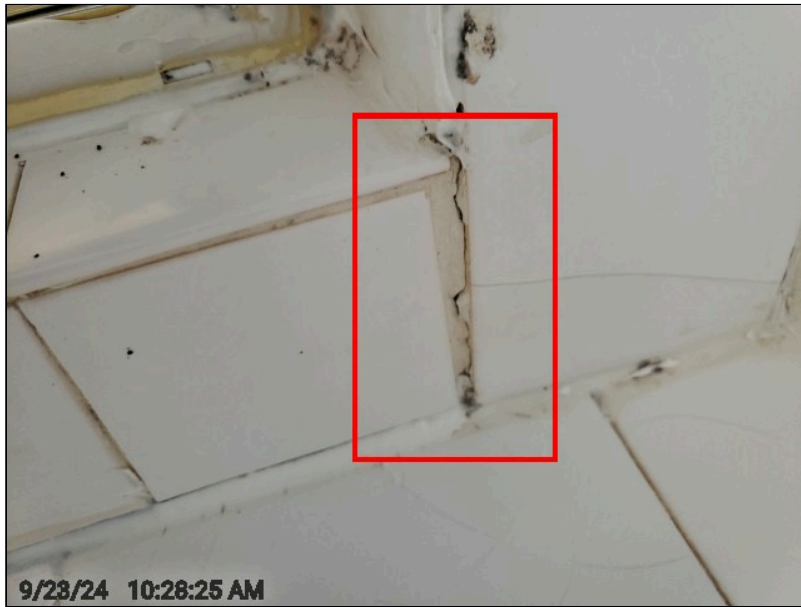
- 🏠 (2) Shower needs to be caulked or grouted. The pictures shown are examples. A qualified contractor needs to caulk or grout shower. Location(s): primary bath

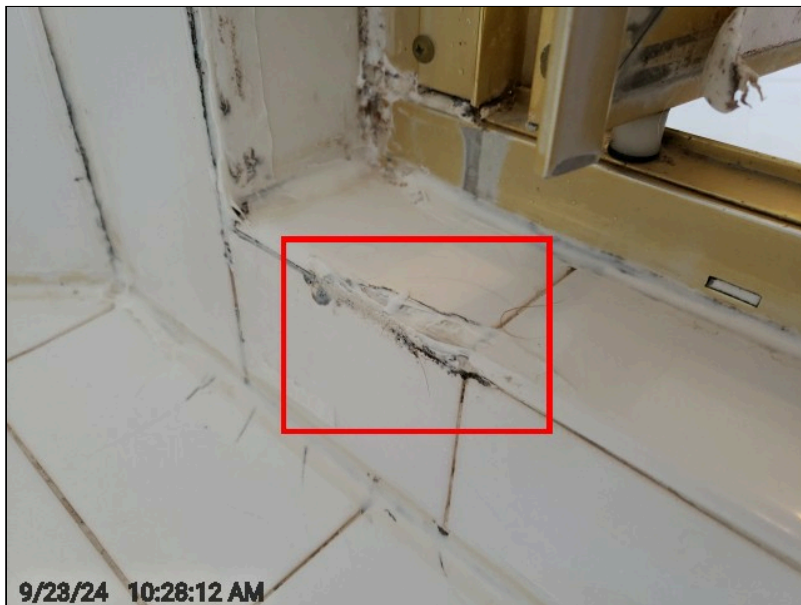
🏠 (3) Tile in shower is cracked. A qualified contractor needs to seal tile. Location(s): primary bath

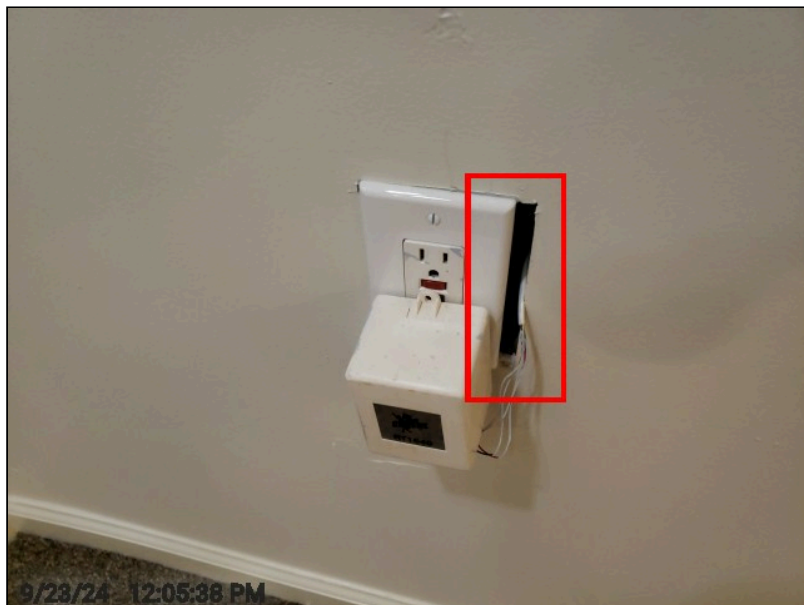
- 🏠 (1) Sheetrock needs to be repaired at outlet cover plate. There should be no opening between cover plate and sheetrock. A qualified contractor needs to repair. Location(s): basement below the electrical panel

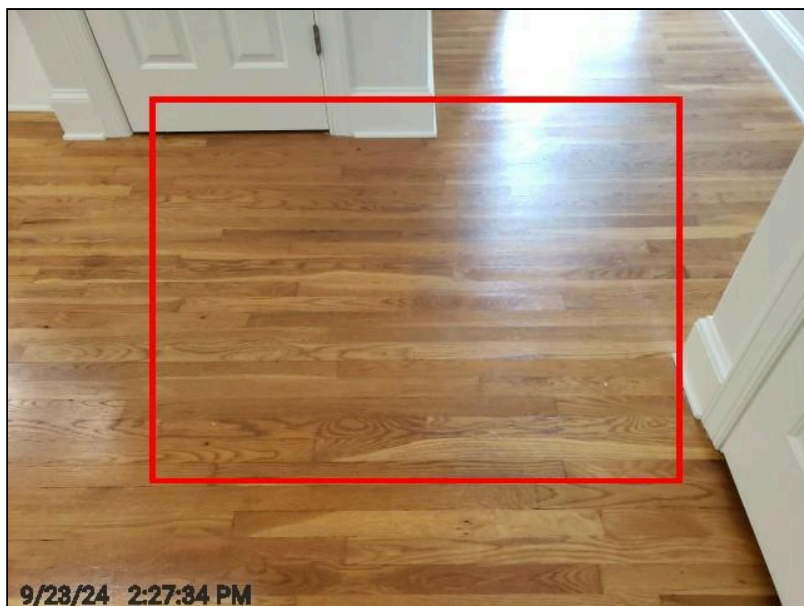
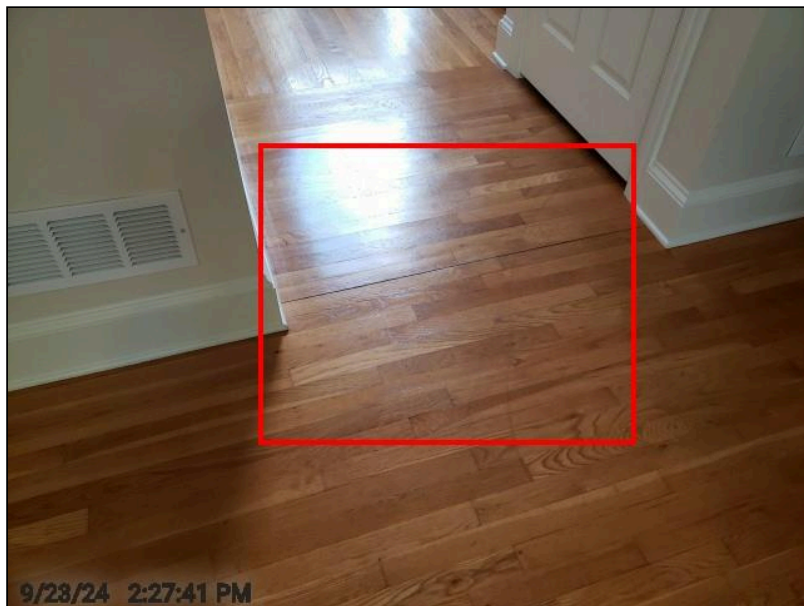
- 🏠 (2) Squeaking floors were noted. A qualified contractor needs to evaluate further and make needed repairs to stop floor from squeaking. Location(s): main level hall

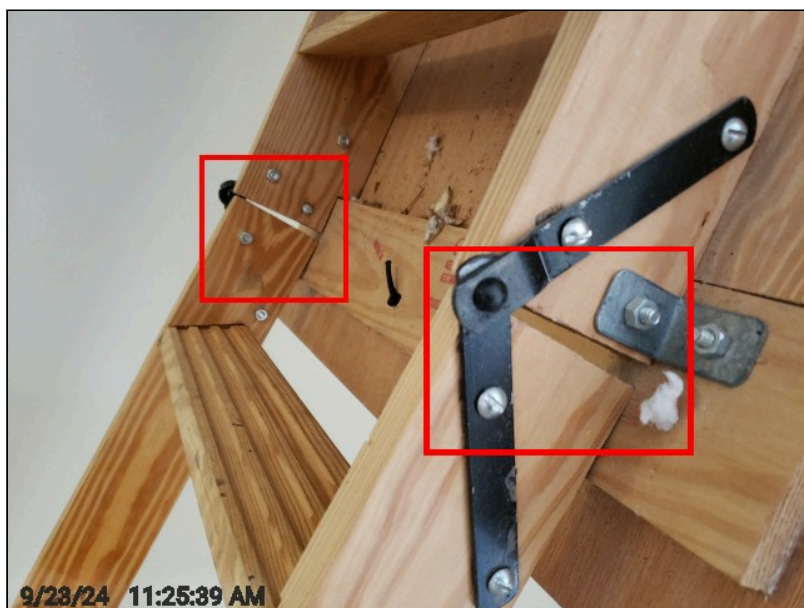
- 🏠 (1) The ladder on the pull down attic stair unit needs to be cut to fit floor at right angle. The legs are bowed. This creates an unsafe condition. The legs could break at the hinges or elsewhere. A qualified contractor needs to cut legs to fit floor.

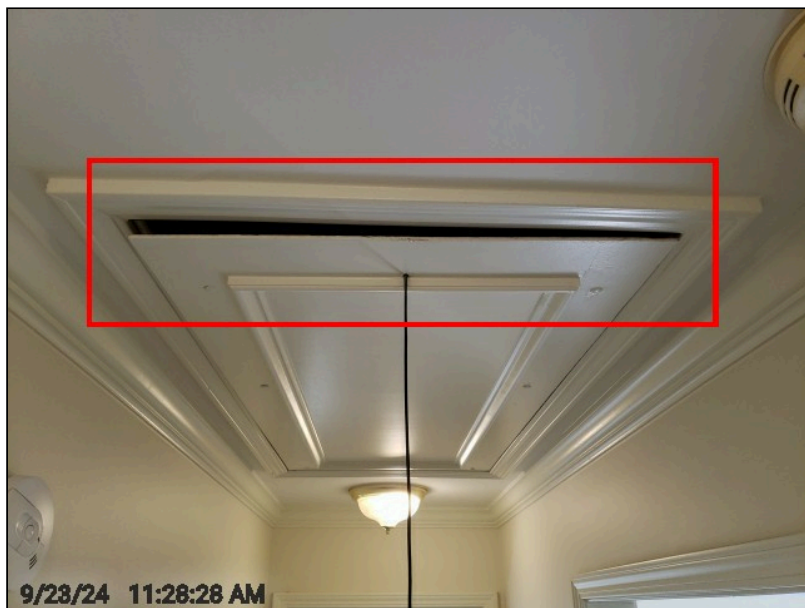
- 🏠 (2) The attic stair unit does not close tight. Heating and air loss can be expected when there is not a tight seal. A qualified contractor needs to make repairs so door can close tight.

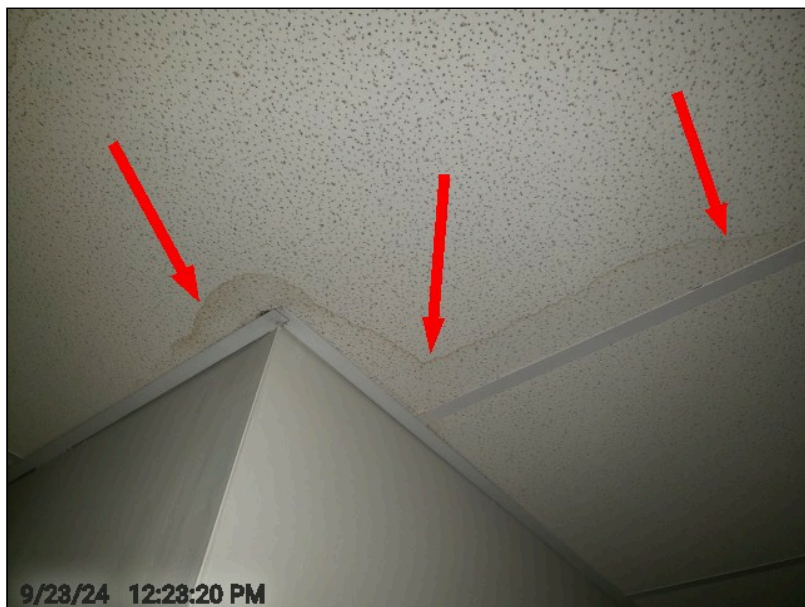
right side of basement

- 🏠 (1) Water stains observed. Check with seller about knowledge of past leak and any repairs. Repairs made as needed. Location(s): basement

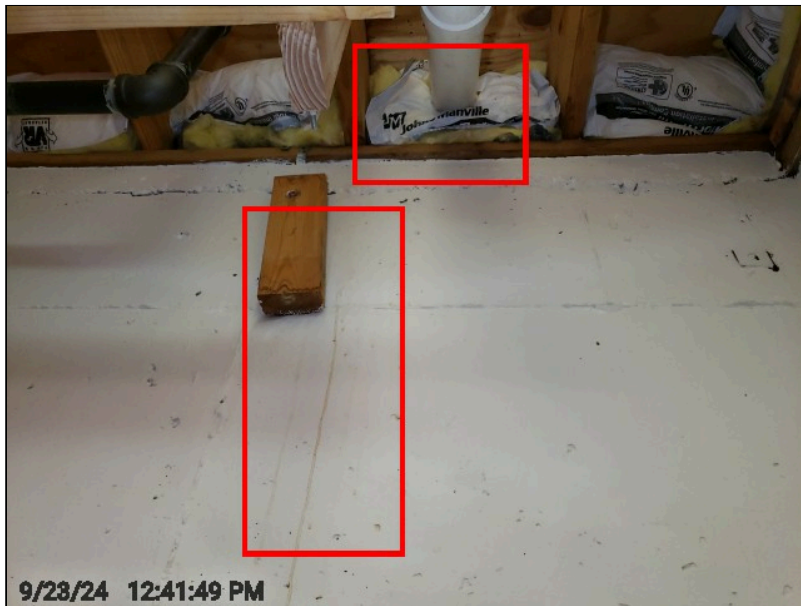
(2) Water stains observed. Check with seller about knowledge of past leak and any repairs. Repairs made as needed. Location(s): basement

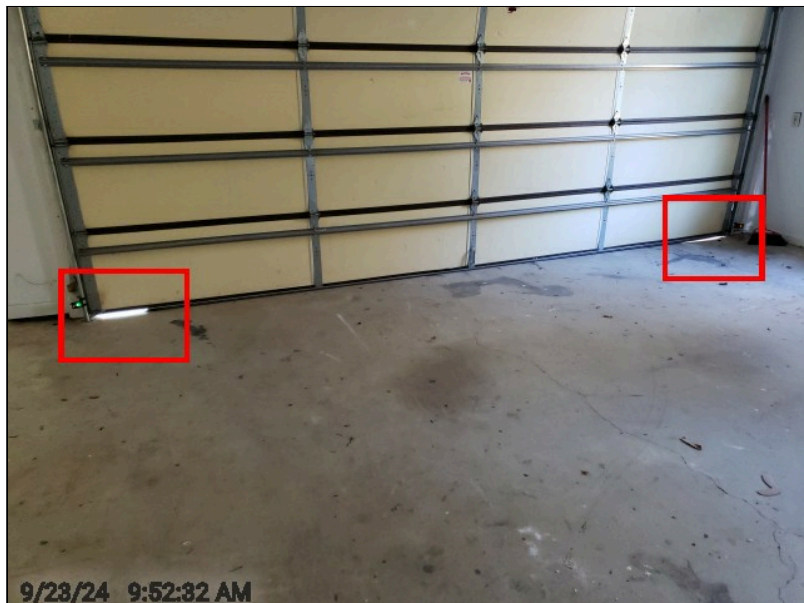
🏠 (1) Door seal is not tight seal at the floor. A qualified contractor needs to repair. Location(s): garage door

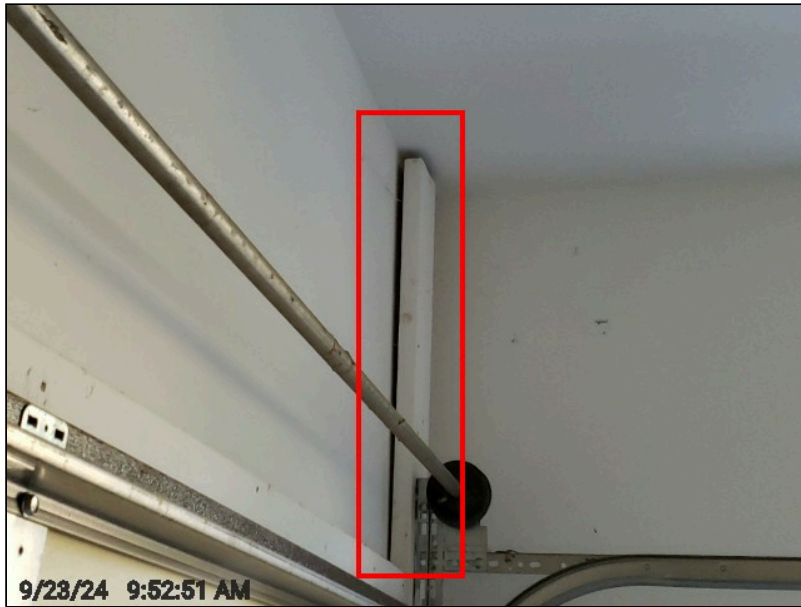
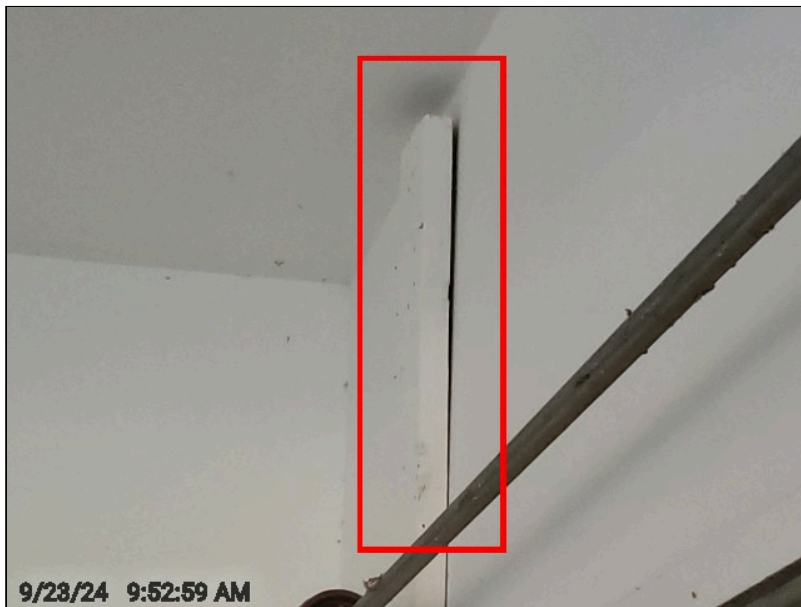
re-nail casings or attach casings with lag screws as needed. Location(s): garage door

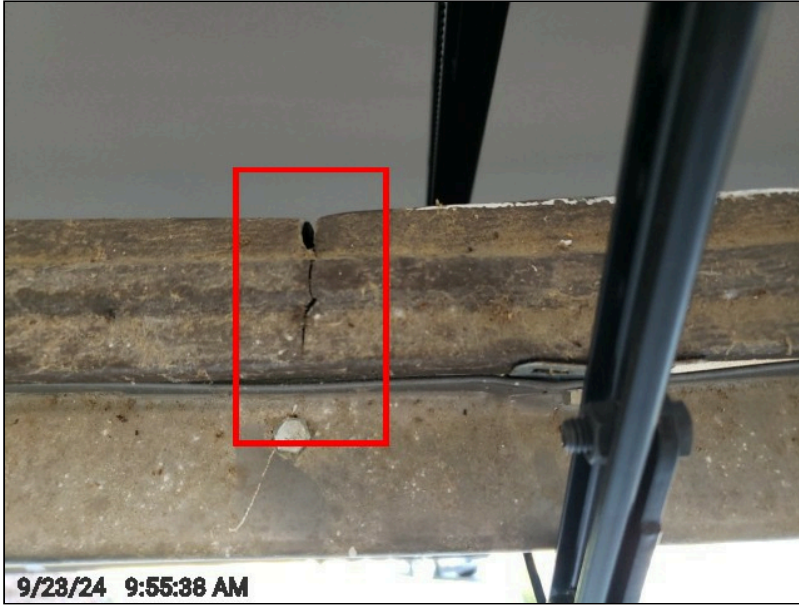
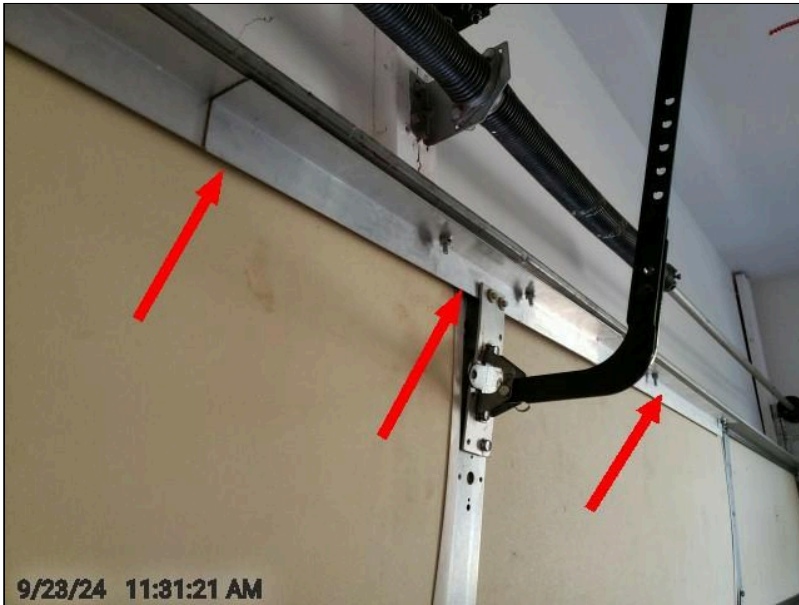
- 🏠 (3) Damaged panel(s) on the garage door(s). A qualified contractor needs to replace panel(s).
Location(s): garage door

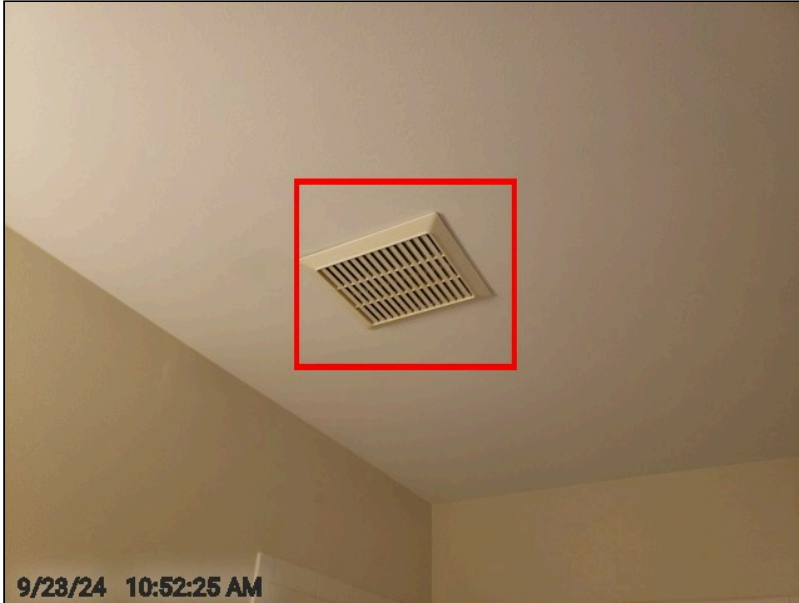
- 🏠 The exhaust fan does not work. A licensed electrician needs to put the fan in working order or replace the fan. Location(s): private bath (front right bedroom)

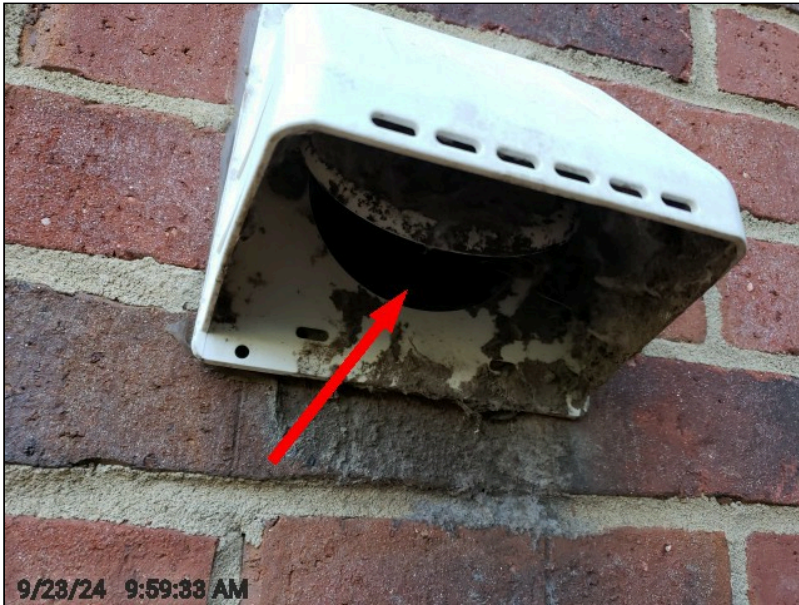
- 🏠 The damper on the dryer vent does not close on the exterior of the house. Outdoor exhausts should have automatic or gravity dampers that close when the ventilation system is not operating. A qualified contractor needs to clean the lint out of the end of duct on the exterior and verify the damper will close.

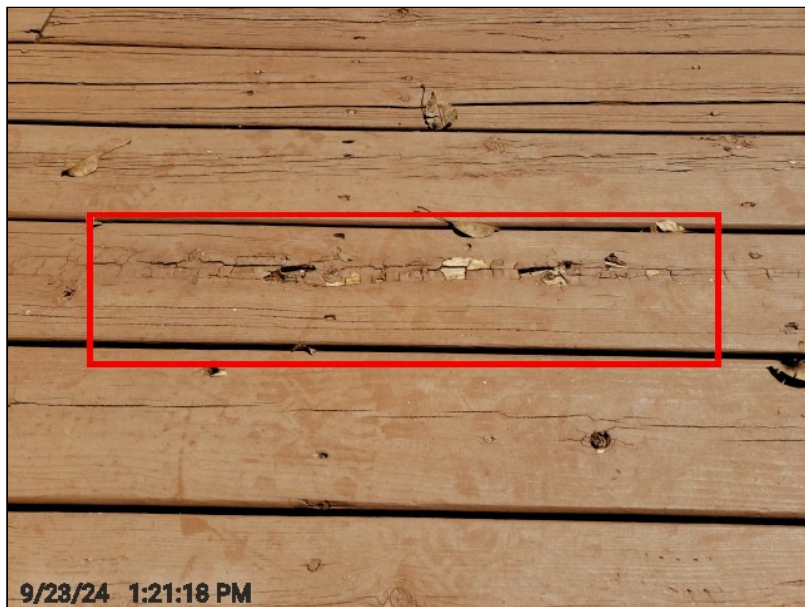
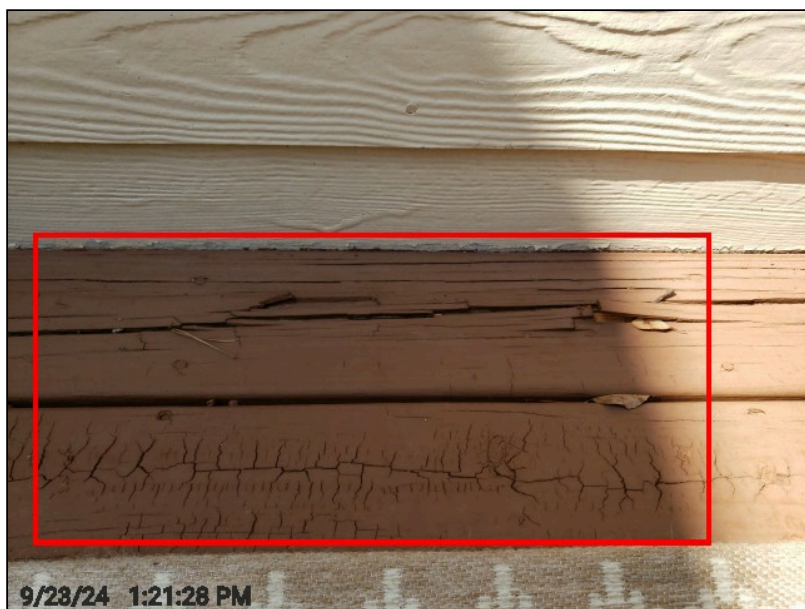
- (1) Rotten decking on the deck needs to be replaced. A qualified contractor needs to replace all rotten decking.

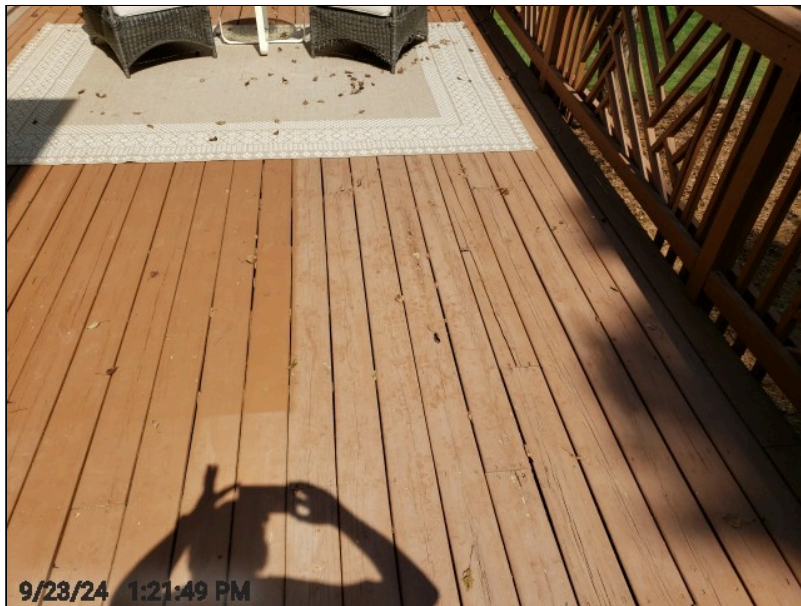
- 🏠 (2) A lot of the decking on the deck is splitting and cracked. Future replacement of the decking should be anticipated.

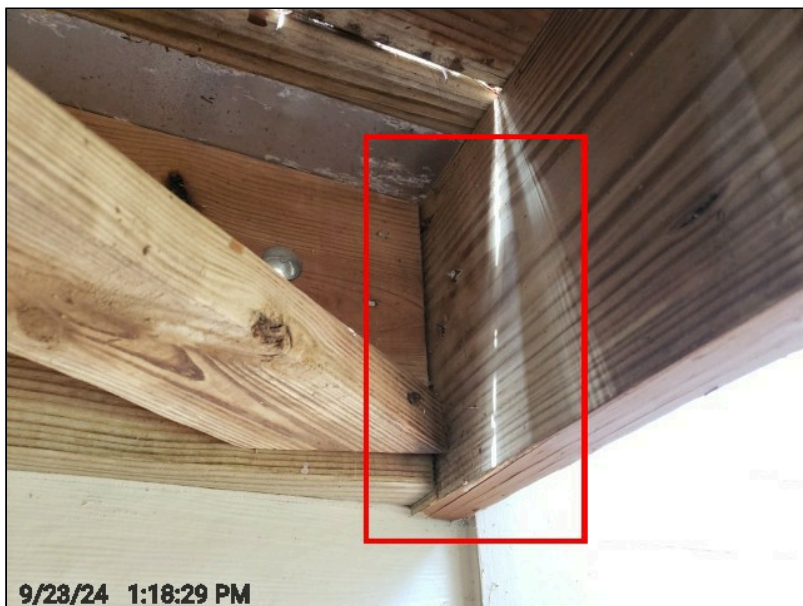
- 📌 The joist on the deck are not supported where the joist are nailed to the ledger board. Joist hangers are needed to provide the vertical support. Pictures shown are examples. A qualified contractor needs to add joist hangers.

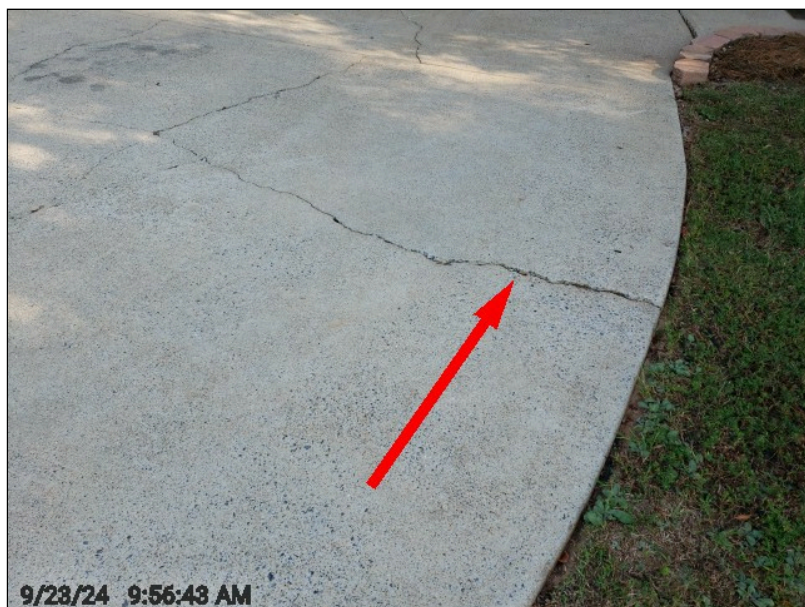
Uplifting of the driveway slab. The uplifting can be a potential trip hazard. A qualified contractor needs to replace the driveway where uplifted.

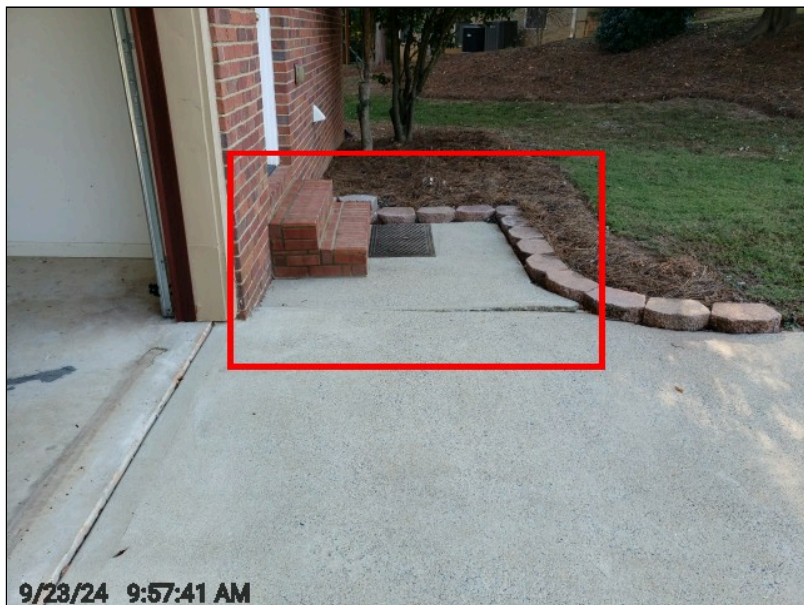
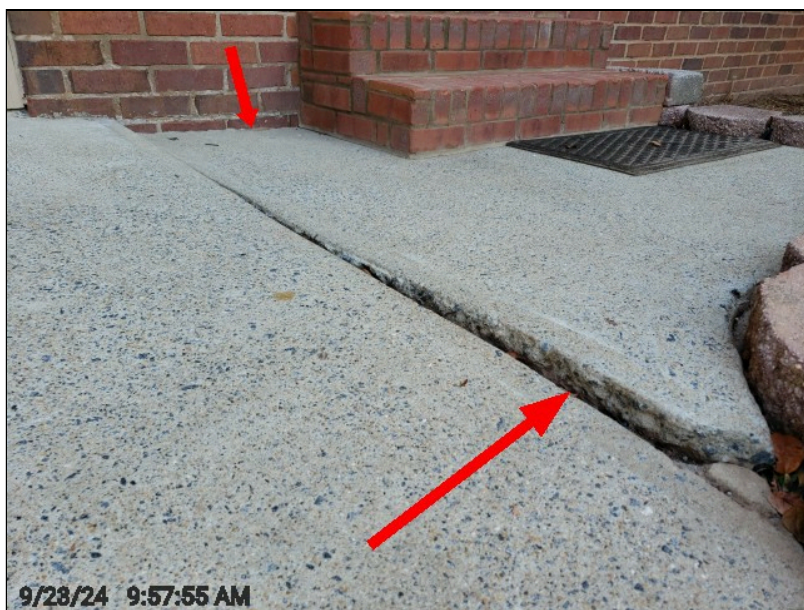
The sidewalk slab and steps have settled and slope towards the foundation. The slab needs to be sloped away from the foundation to prevent water from getting into the finish basement. A qualified contractor needs to repair.

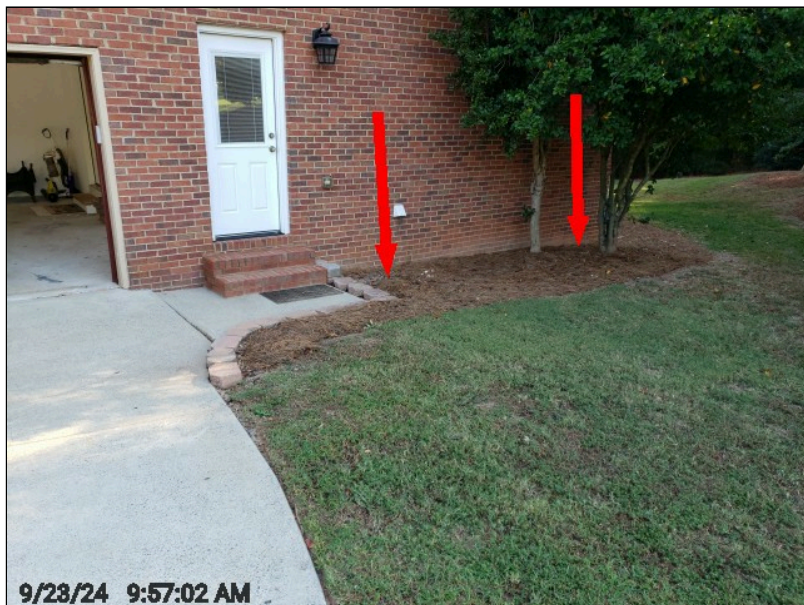
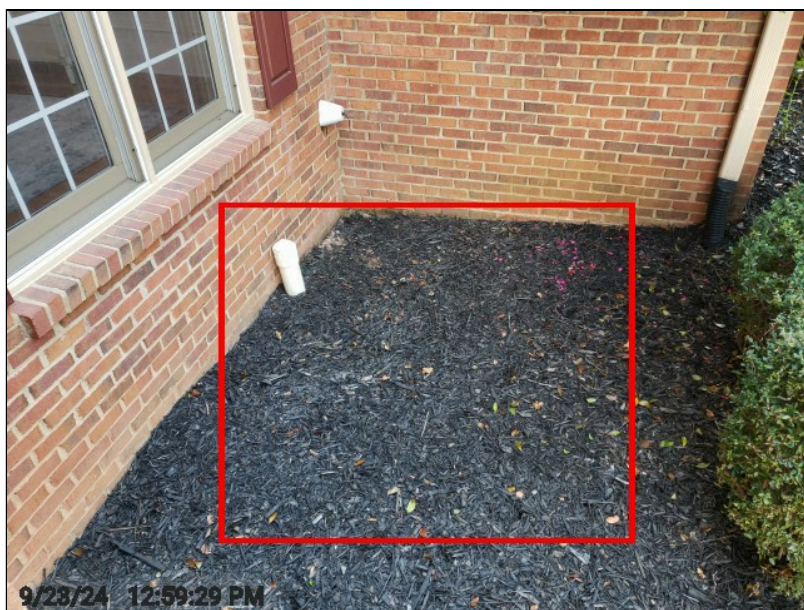
- Grading generally does not provide positive drainage away from the foundation. There should be 6" of fall in the first 10' away from the foundation. A qualified contractor needs to evaluate further and repair. Location(s): right side, front, and back of the house

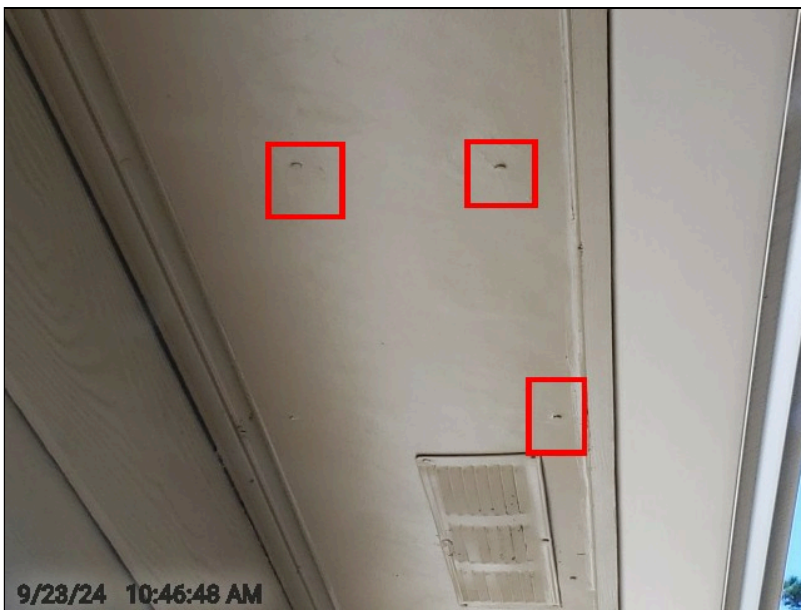
The soffit trim needs to be nailed where the nails are backing out. All exposed nail heads need to be sealed and painted to match existing paint. A qualified contractor needs to repair. Location(s): back of the house
