Inspection Report

5678 Main St

Marion Hodges Home Inspection Services

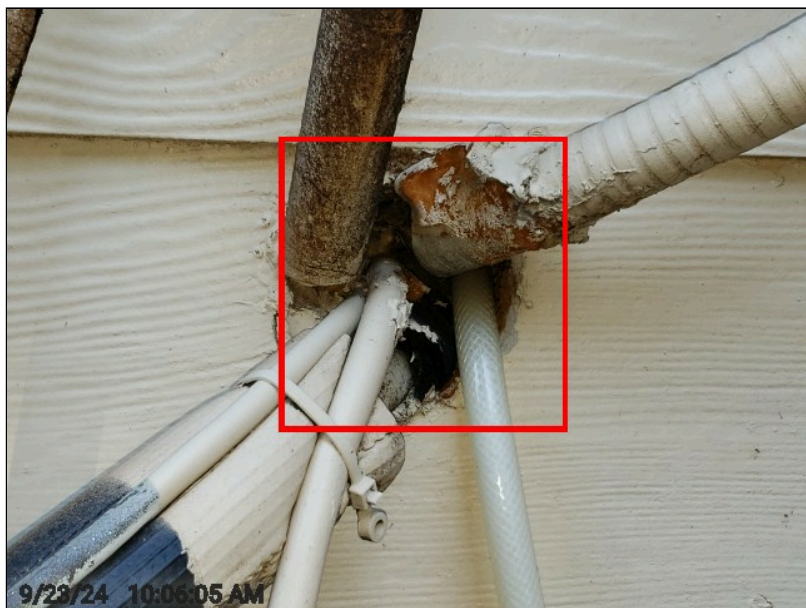
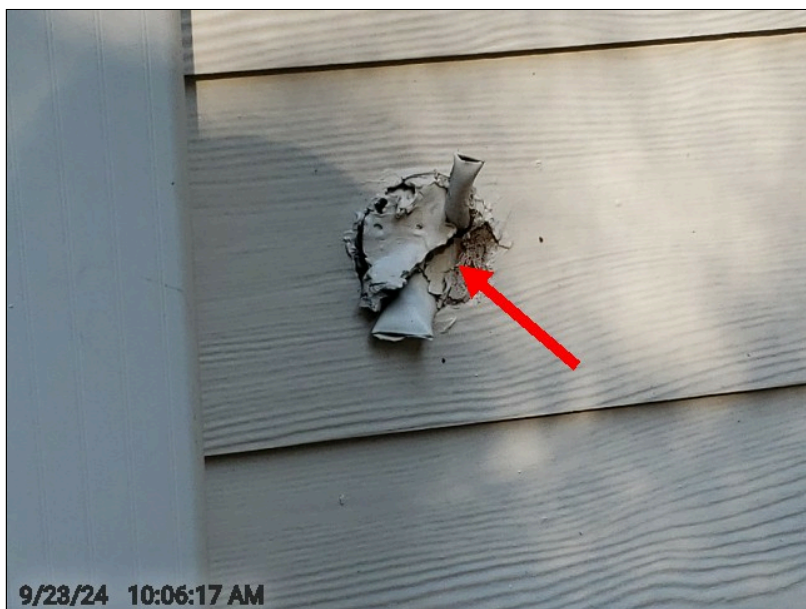
- 🏠 (1) All utility penetrations through the exterior wall should be caulked or filled with foam. The following utility penetrations should be caulked or filled with foam to limit air infiltration: refrigerant lines

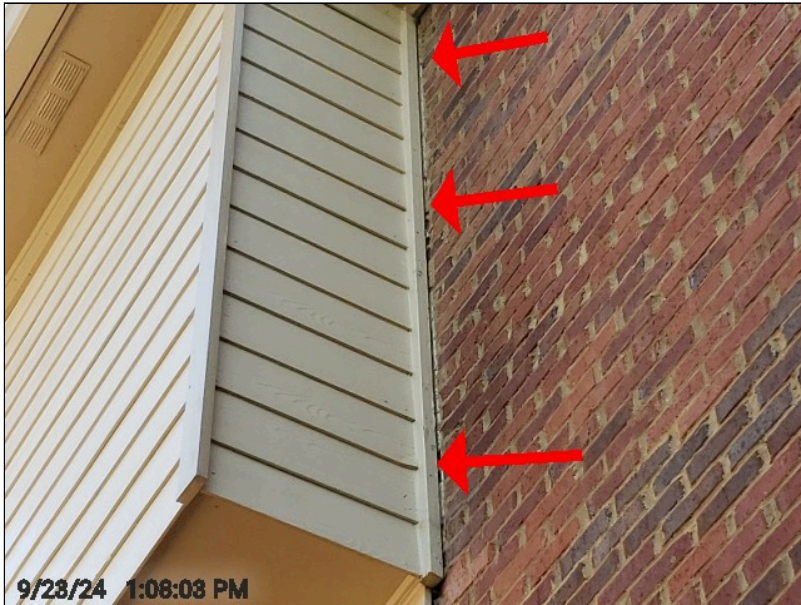
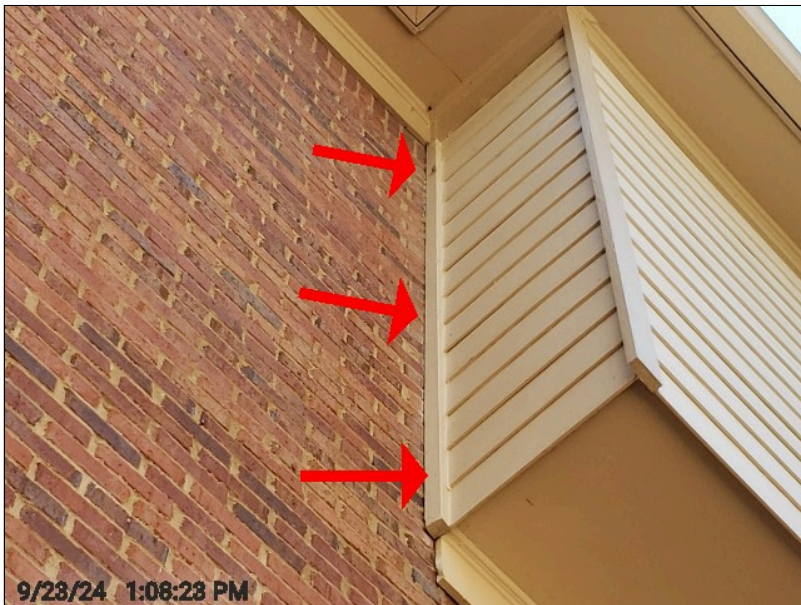
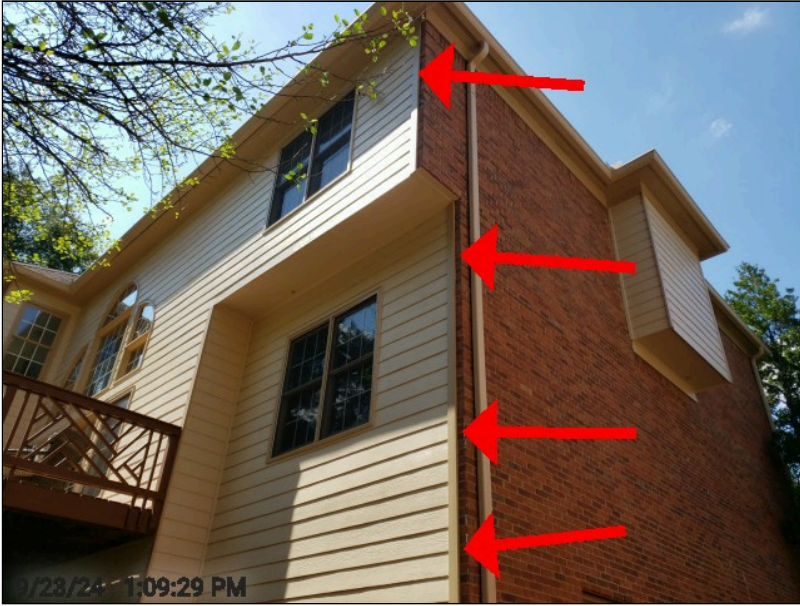
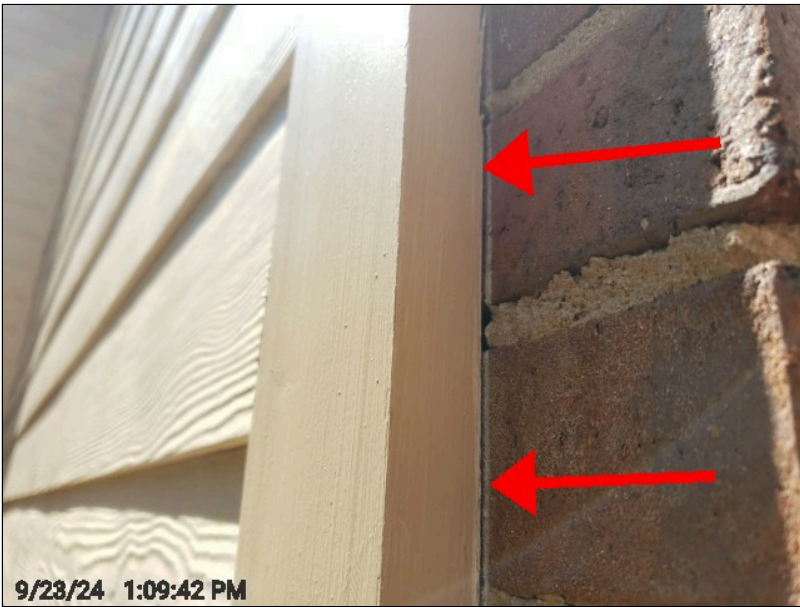
- 🏠 (2) Corner boards need to be caulked and painted. A qualified contractor needs to repair. Location(s): left side and back of the house

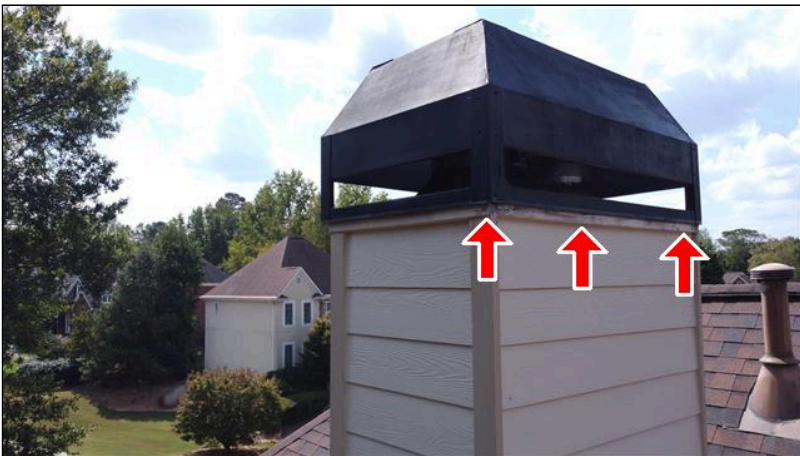
(3) Trim needs primer, paint, and caulk. A qualified contractor needs to repair. Location(s): chimney

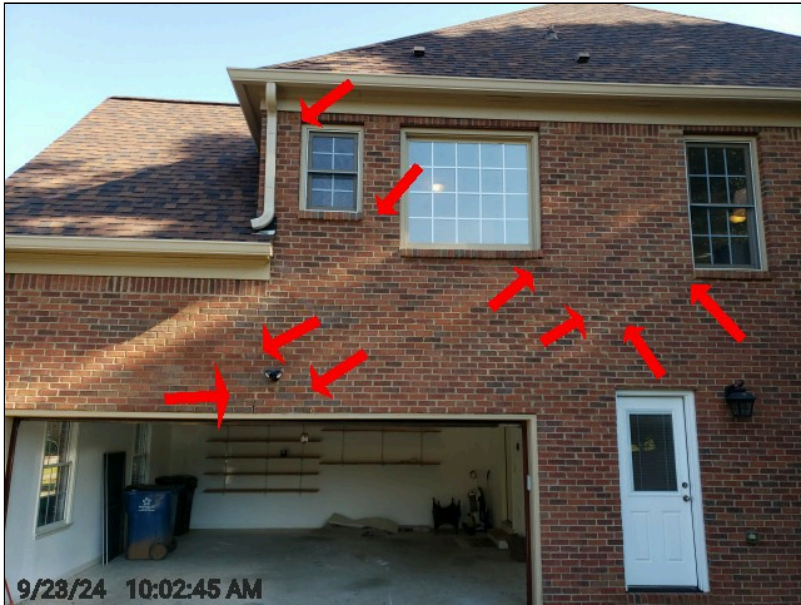
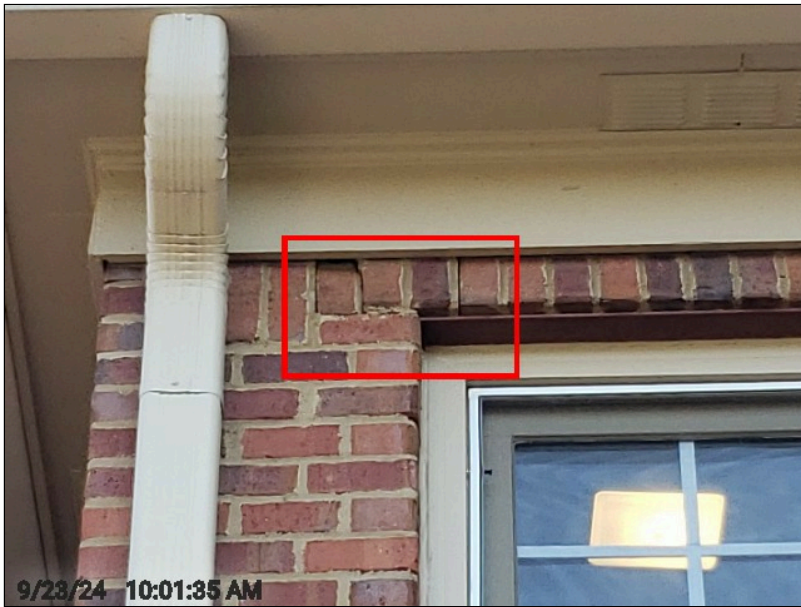
🏠 Mortar and brick cracks were observed. A qualified contractor needs to point cracks. Location(s): left side of the house

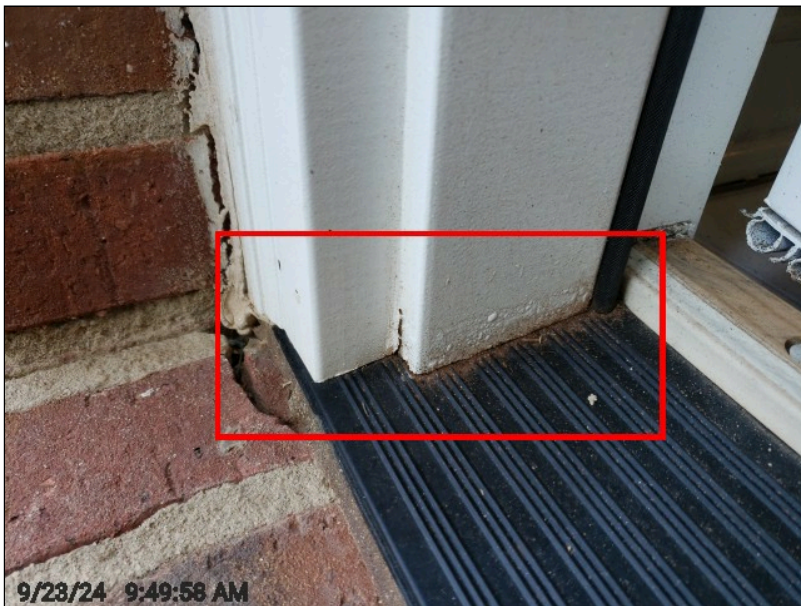
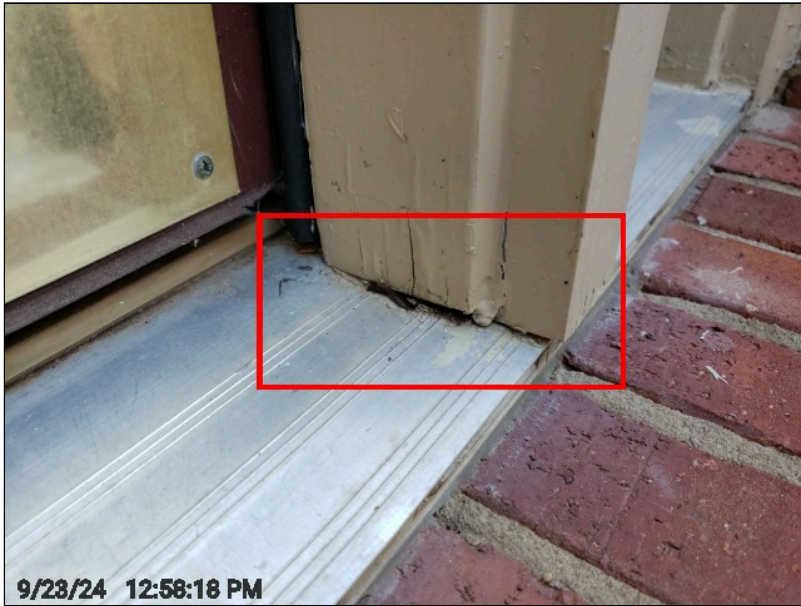
(1) Joint between the door jambs and threshold needs to be caulked. A qualified contractor needs to caulk door jambs and threshold to prevent air intrusion or moisture penetration. Location(s): all exterior doors

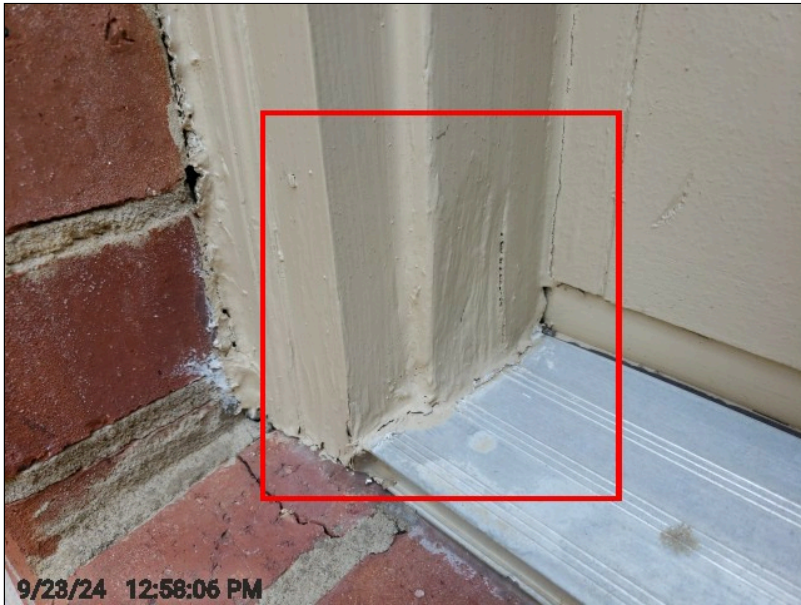
(2) Door jamb is rotten. A qualified contractor needs to replace rotten wood. Location(s): front door

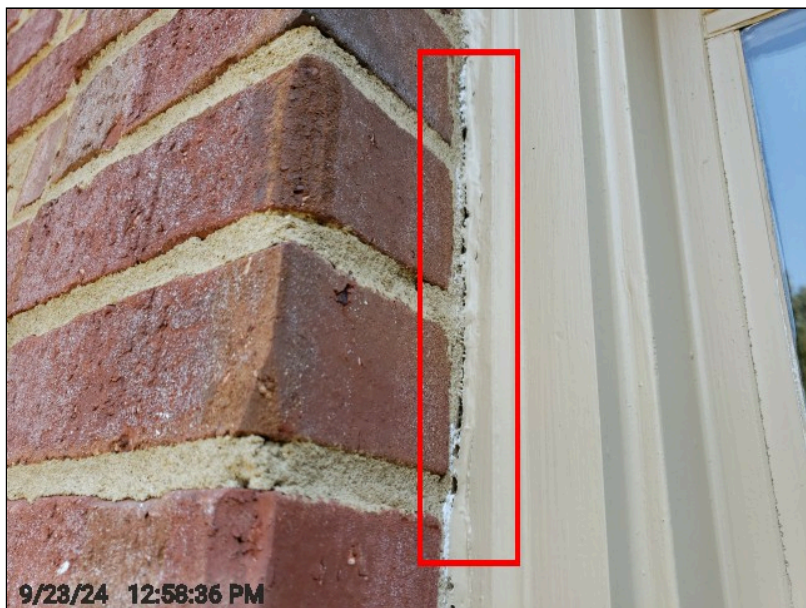
- 🏠 (3) Door trim needs to be caulked. A qualified contractor needs to caulk trim to prevent air intrusion or moisture penetration. Location(s): front door

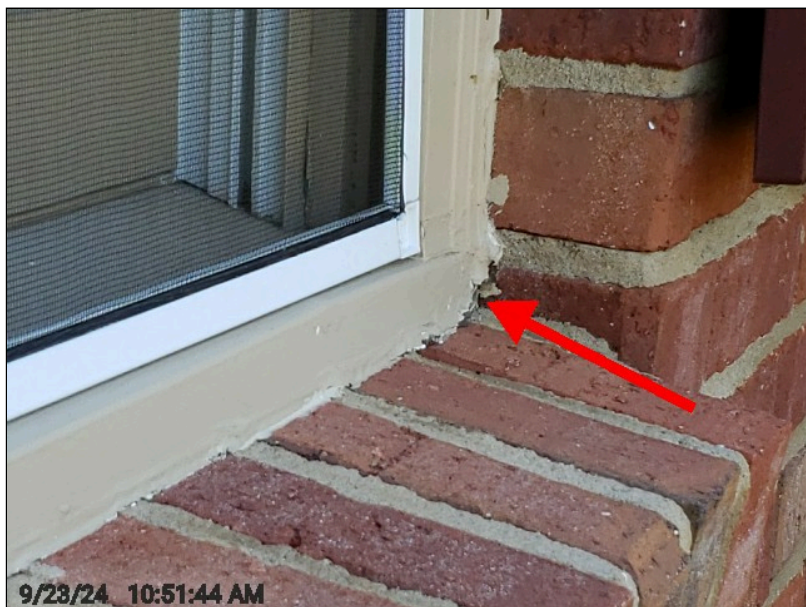
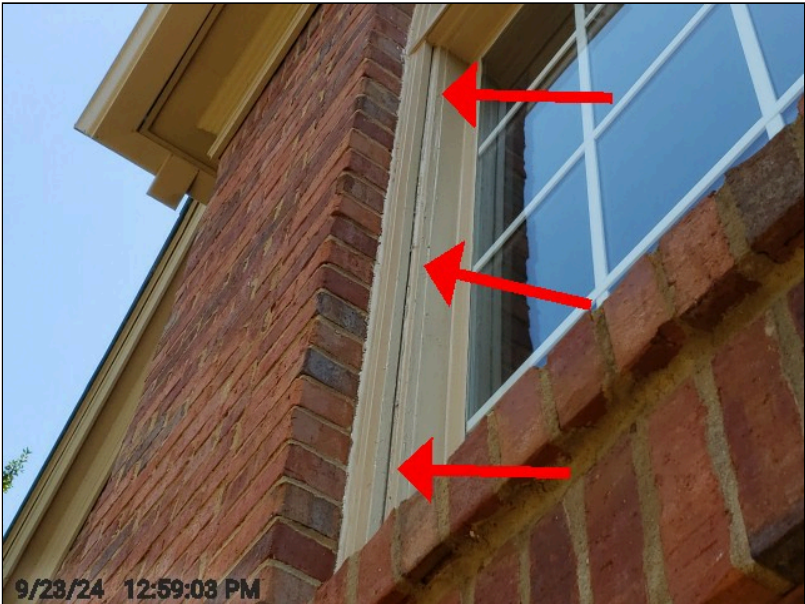
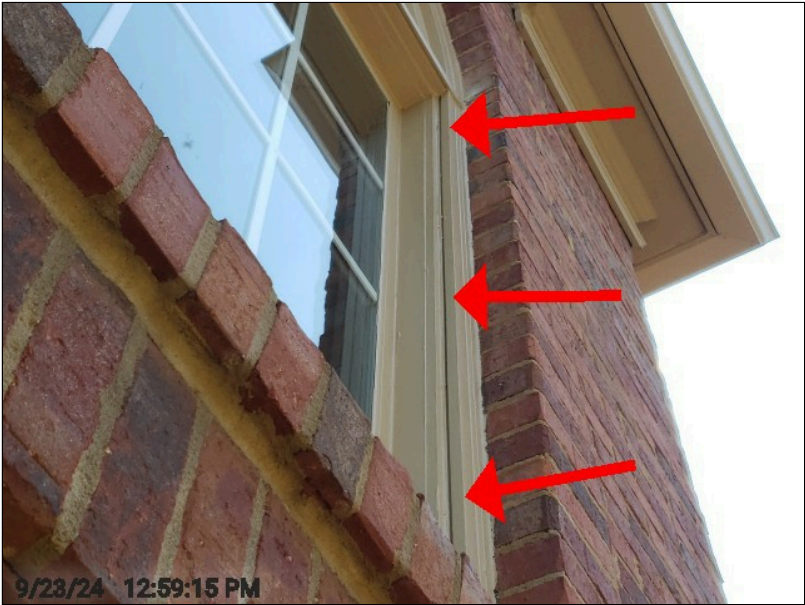
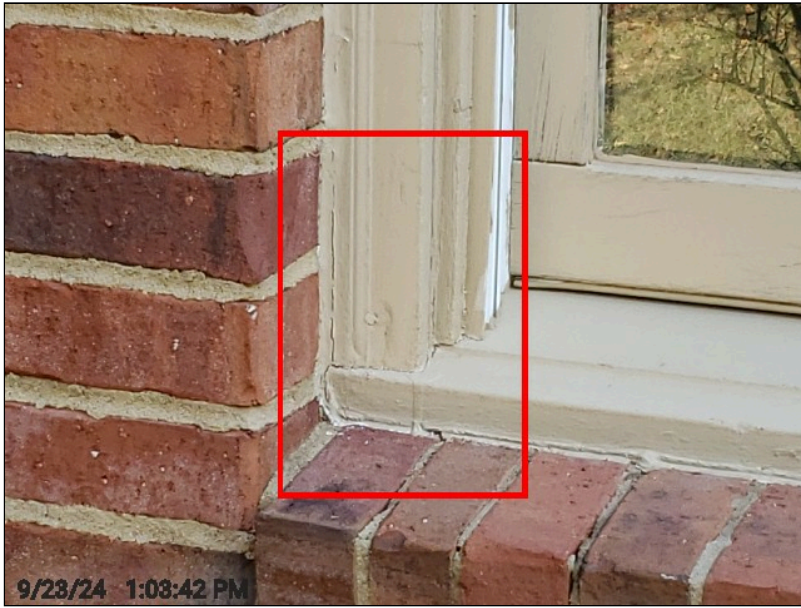
- 🏠 (1) Windows need to be caulked. A qualified contractor needs to caulk windows to prevent air intrusion or moisture penetration. Location(s): front of house

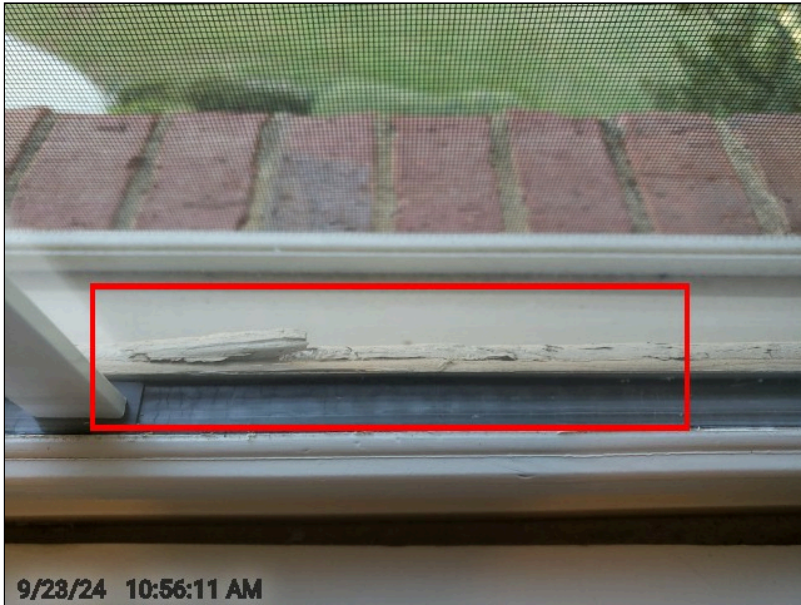
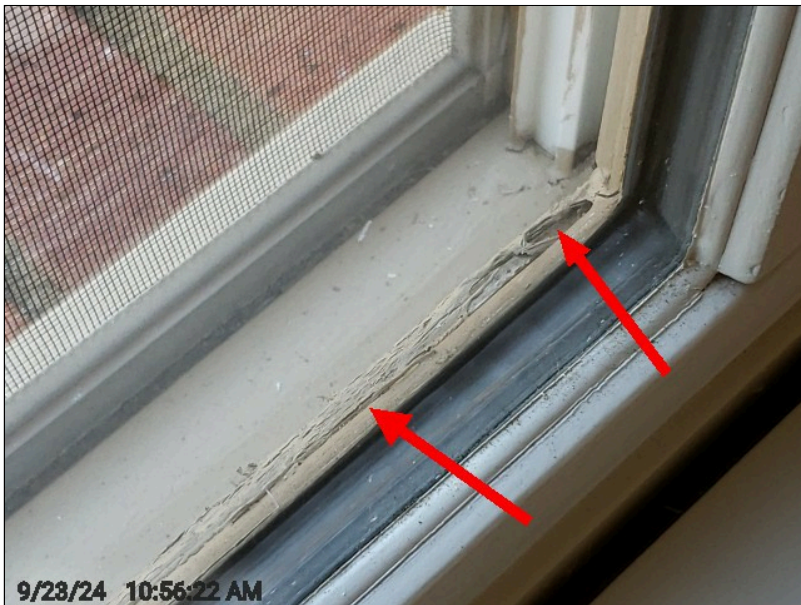
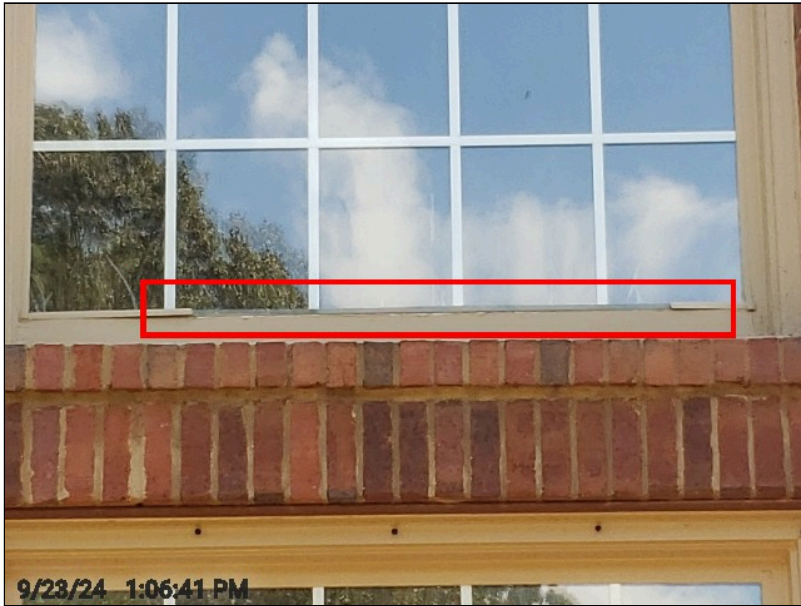
- 🏠 (2) Rotten window sash(es) observed. A qualified contractor needs to replace window sash(es).
Location(s): front of the house

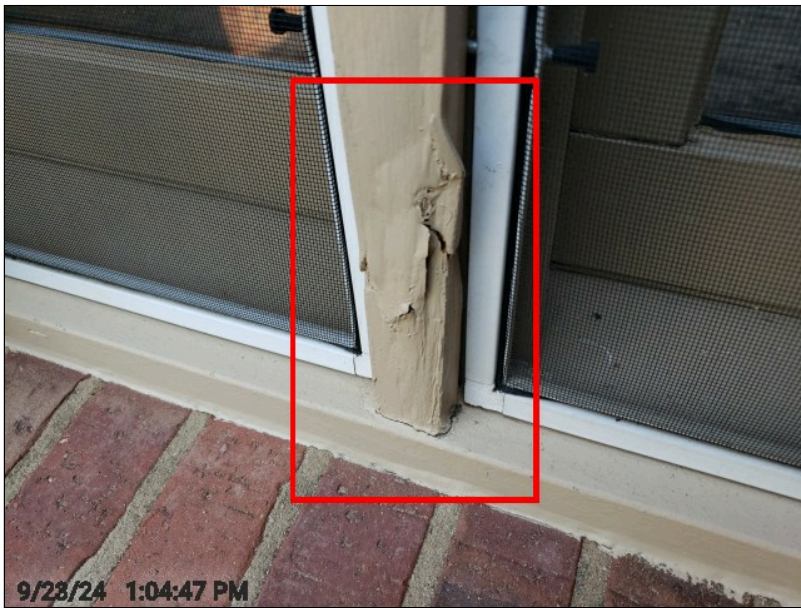
(3) Window trim is rotten. A qualified contractor needs to replace rotten window trim. Location(s): front and back of the house

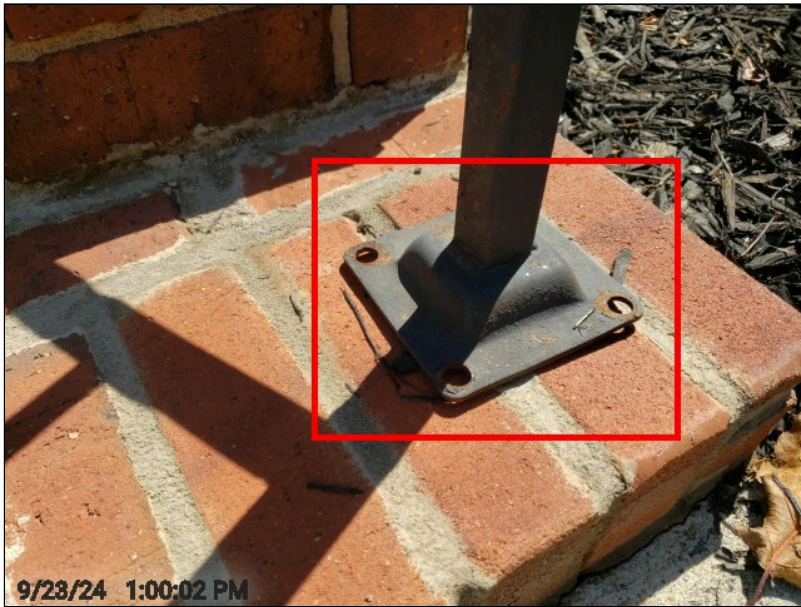
The guard rail on the steps and landing is loose. A qualified contractor needs to tighten guard rail.

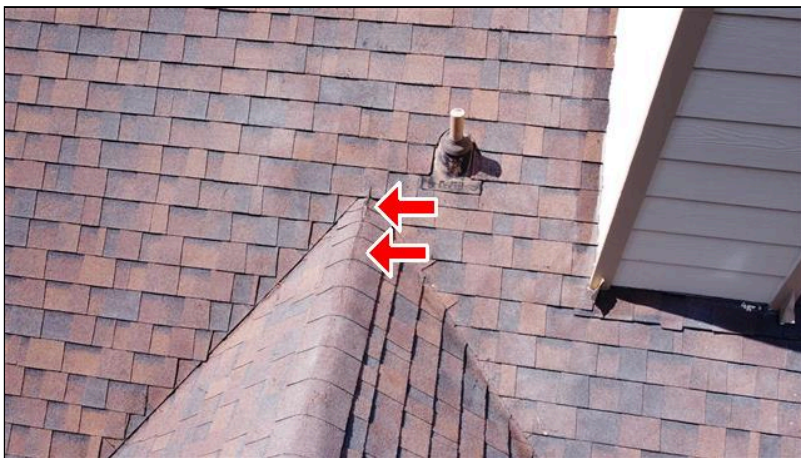
There are cracked ridge shingles on the roof. Picture(s) are examples. A qualified roofer needs to repair or replace cracked shingles.

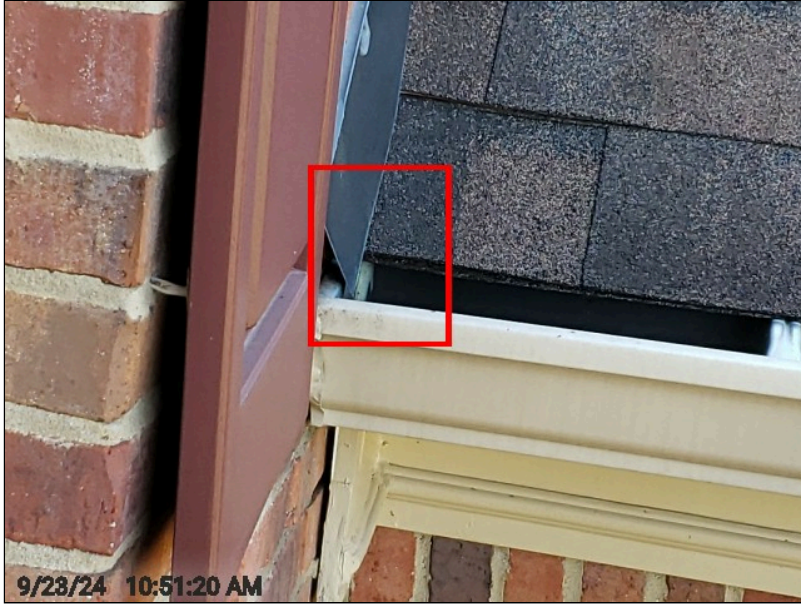
- 🏠 Kickout flashing needs to be installed to divert water into the gutters. Flashing is needed to prevent water from penetrating into the wall structure. Picture(s) are examples. A qualified roofer needs to repair.

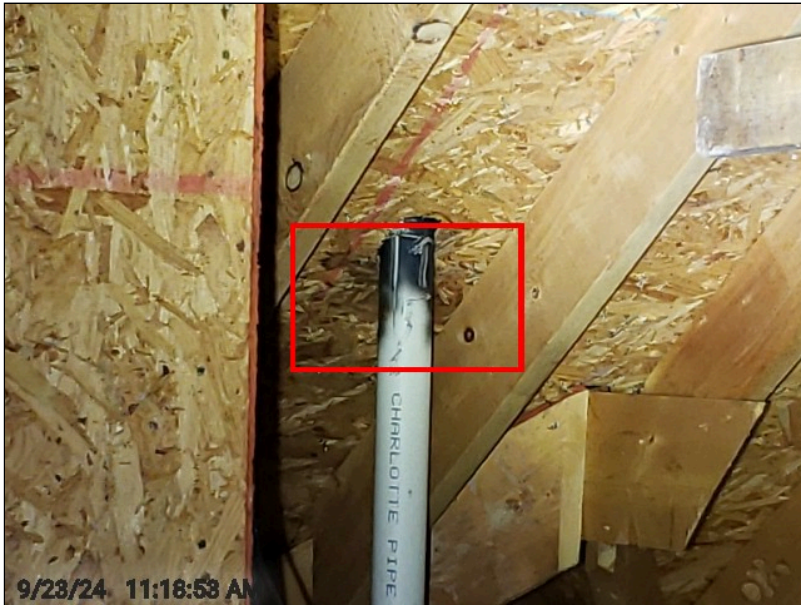
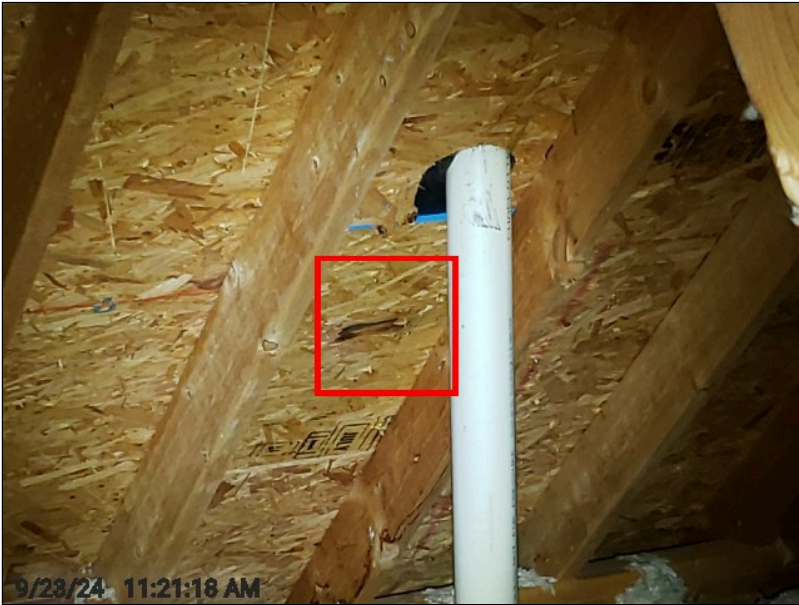
- 🏠 (1) Water stains from past roof leak at vent flashing in the attic at plumbing boot. A qualified roofer needs to verify repairs have been made to stop leaks. Location(s): plumbing boot

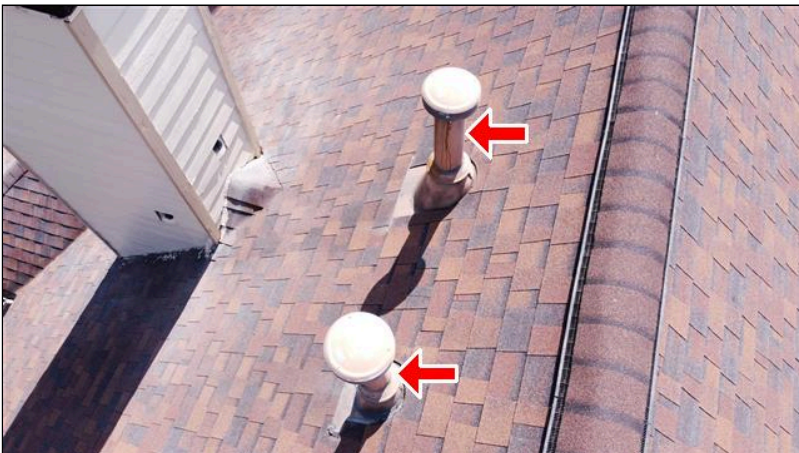
🏠 (2) Rusted vents need to be painted with corrosion resistant paint or replaced if there are holes in the vent. A qualified contractor needs to repair. Location(s): furnace vent

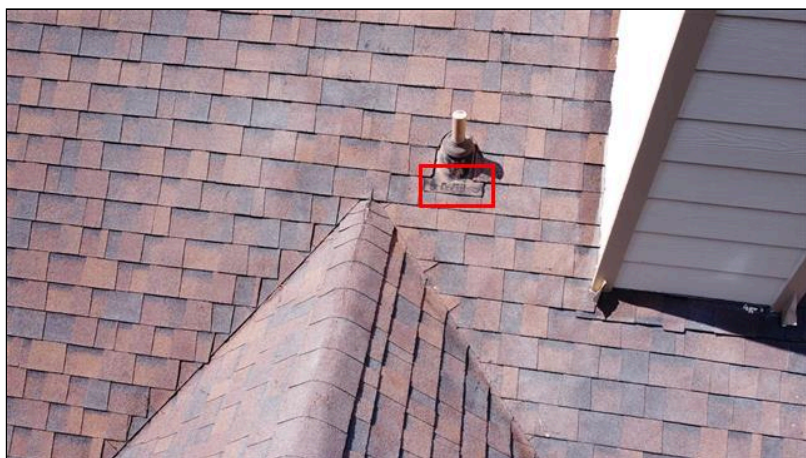
🏠 (3) Nail heads on the vent flashings are not sealed. All exposed nail heads should be sealed with a

roofing sealant. A qualified roofer needs to repair. Location(s): plumbing boot

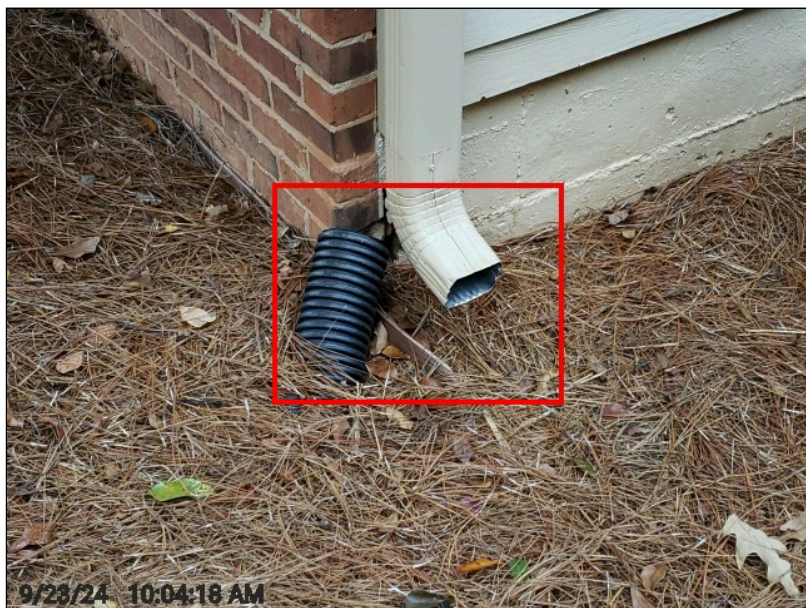
(1) The buried drain line has pulled loose from downspout. The buried drain line should be re-connected to the downspout and attached to downspout with short galvanized screws or rivets. A qualified contractor needs to repair. Location(s): back of the house

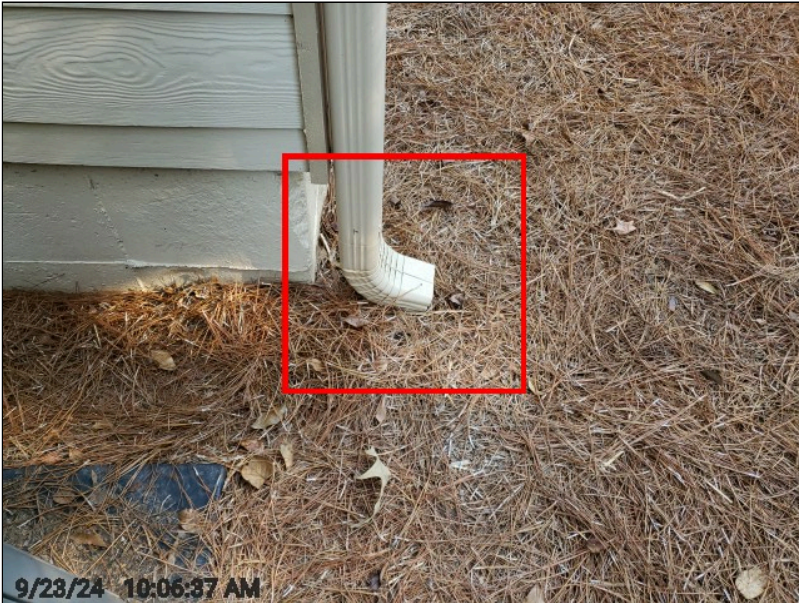
- 🏠 (2) All downspouts that do not discharge onto a driveway or patio should be piped at least 10 feet away from the foundation. Improper gutter drainage can lead to water in basement or crawl space. If the pipe extensions are buried, PVC pipe should be used. Flexible pipe is subject to clogging, cannot be cleaned out without damaging the pipe, and is subject to damage from roots.

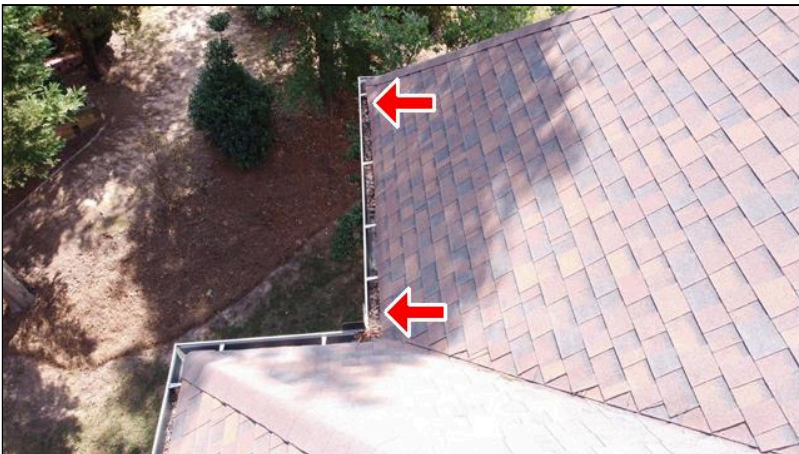
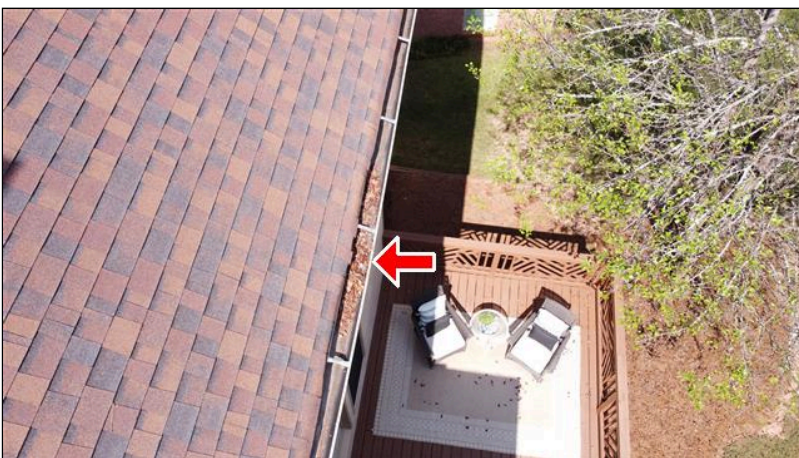
- 🏠 (3) The gutters and downspouts need to be cleaned.

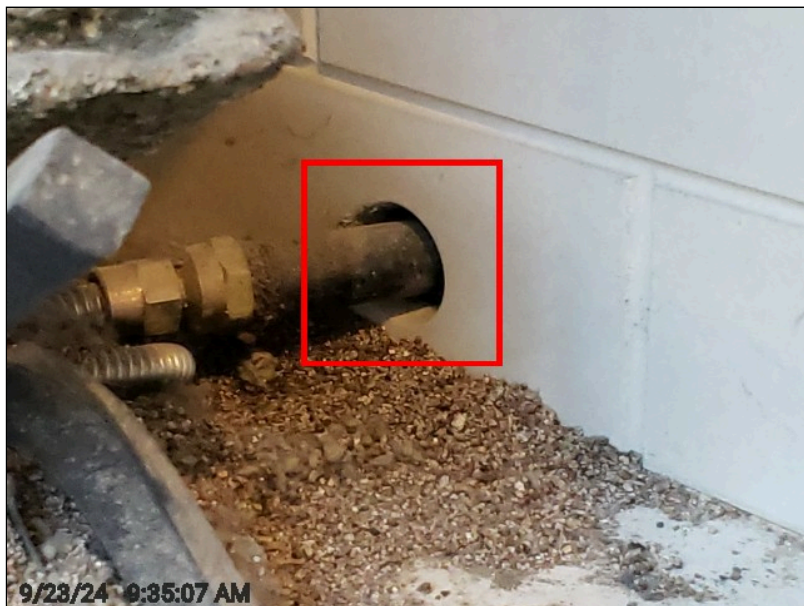
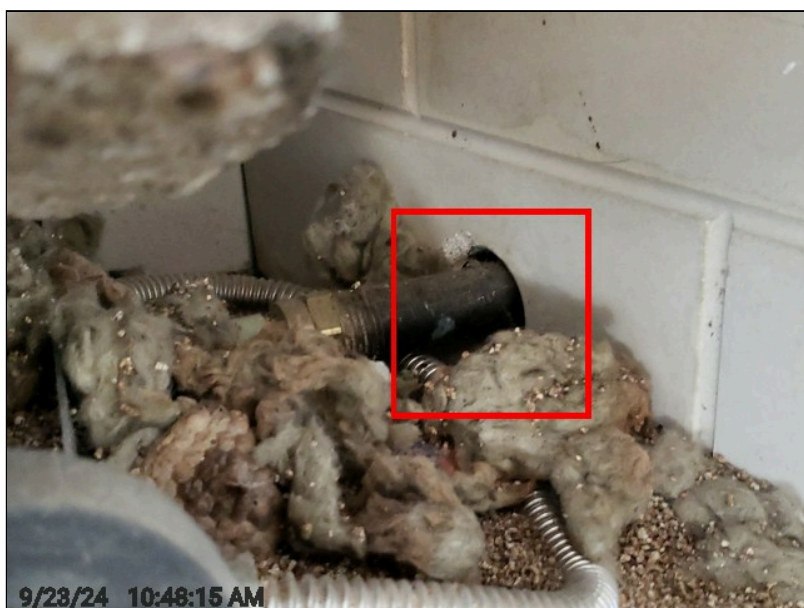
- 🏠 (1) A qualified chimney sweep contractor needs to clean the chimney flue and leak test the gas valve. The inspector does not operate gas valves that are turned off. Leak checking gas valves is part of a standard chimney cleaning. Repairs made as needed.
- 🏠 (2) The gas line opening into the firebox is not sealed. The opening should be sealed with refractory sealant to prevent back drafting of heat. A qualified contractor needs to seal opening around gas pipe. Location(s): family room and primary bedroom

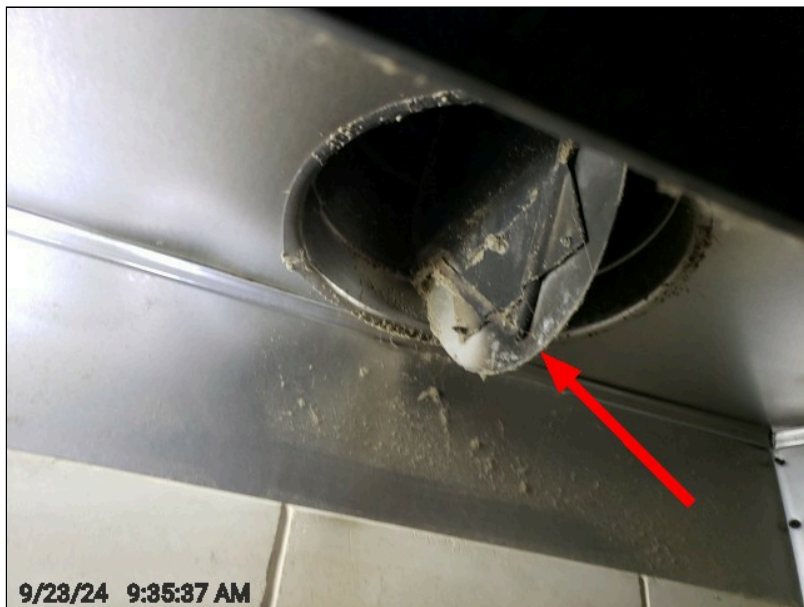
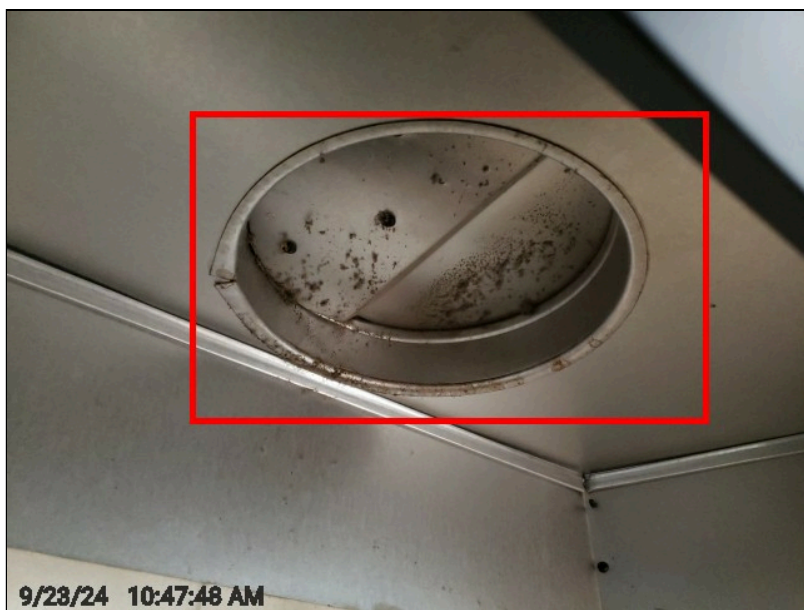
- 🏠 (3) The fuel source for the fireplace is gas logs. The damper on the fireplace needs to be locked in the full open position for ventilation when burning gas logs. This is a safety issue. A qualified contractor needs to lock vent in full open position. Location(s): family room and primary bedroom

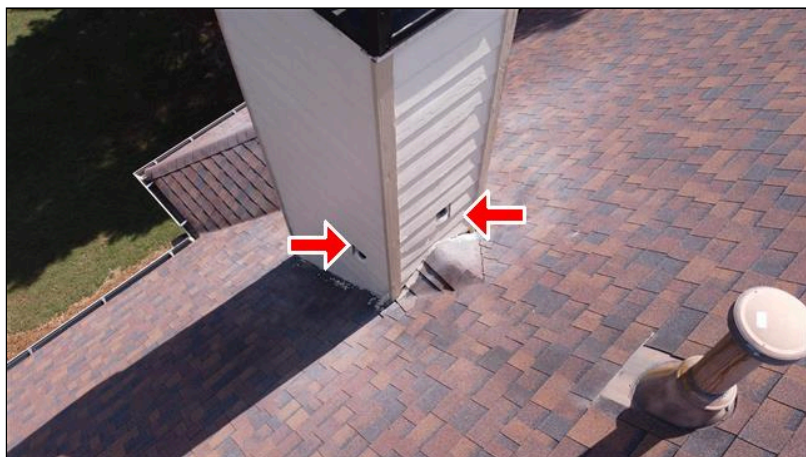
- 🏠 (4) A fresh air vent draft hood with 1/4" screen wire is needed at fresh air duct at duct termination for fireplace to keep water or wildlife out of duct. A qualified contractor needs to repair.

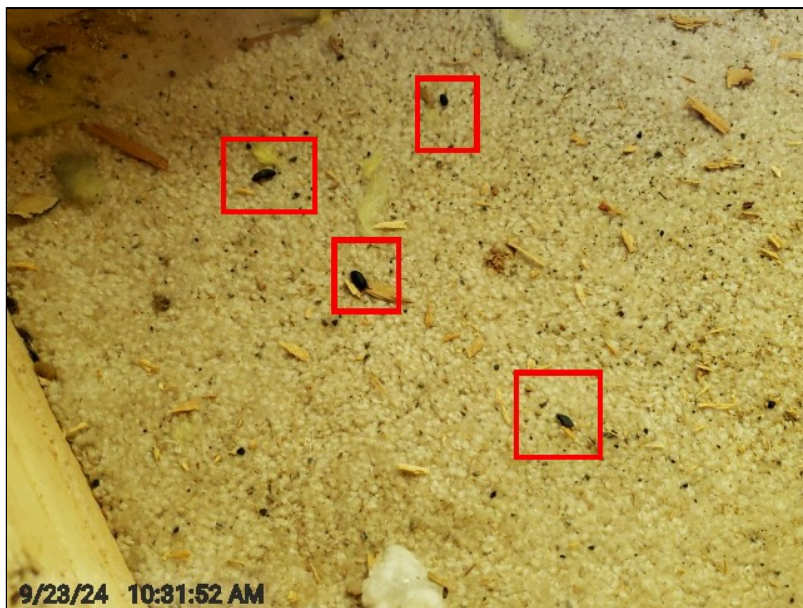
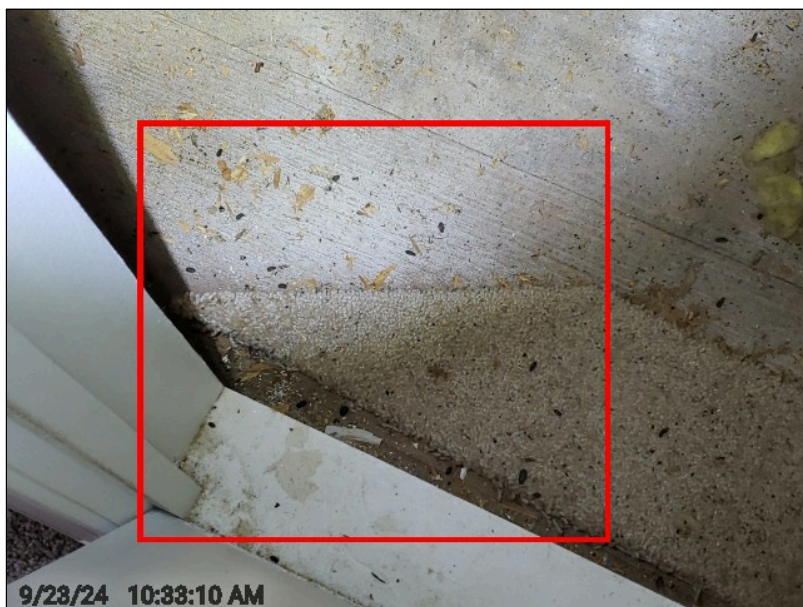
- 🏠 (1) Your home inspection does not include a pest, termite, or wildlife inspection. These inspections are outside the scope of ASHI standards and practices. Any comments or lack thereof in the report are not a part of an in depth inspection. We are not licensed in Georgia or trained as pest, termite, or wildlife inspectors. We recommend with any real estate transaction that you have a pest, termite, and wildlife inspection by a State of Georgia licensed contractor.
- 🏠 (2) There is evidence of wildlife inside the structure. A licensed wildlife company needs to evaluate further and treat as needed. All droppings need to be removed and area sanitized. Any insulation that is soiled needs to be removed and replaced with R-38 loose fill. Picture is example. Location(s): primary bedroom attic accesses, main attic
