Inspection Report

8910 Main St

Marion Hodges Home Inspection Services

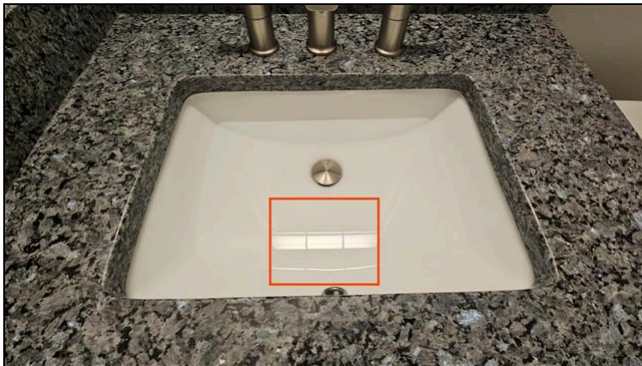
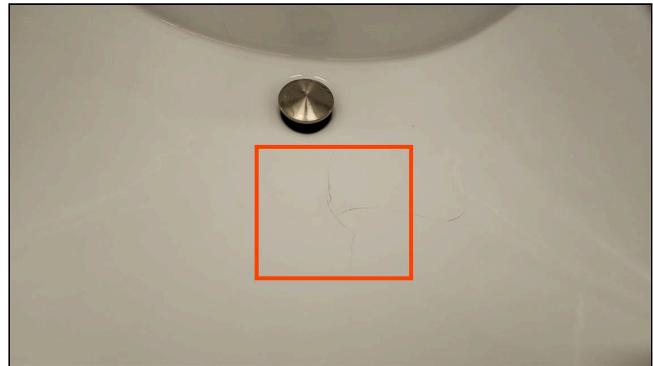
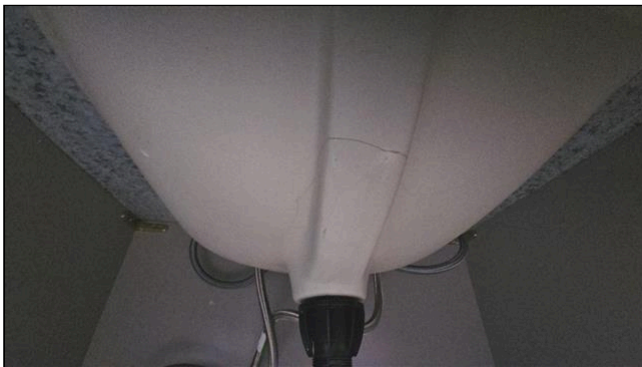
The sink bowl is cracked. At the time of the inspection, the sink bowl was not leaking. Location(s): basement bath

The sink bowl is cracked. At the time of the inspection, the sink bowl was not leaking. Location(s): basement bath

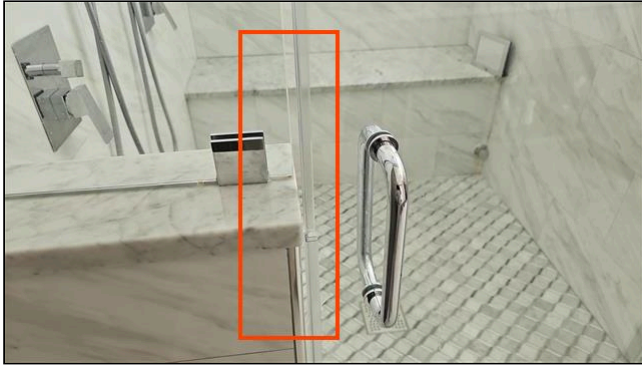
- 🏠 (1) The shower door binds on the door opening. A qualified contractor needs to adjust door. Location(s): powder bath

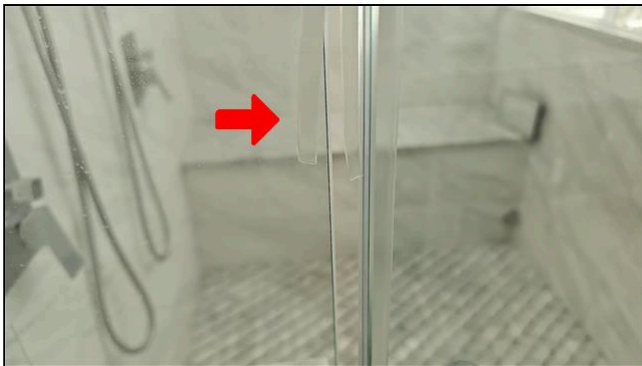
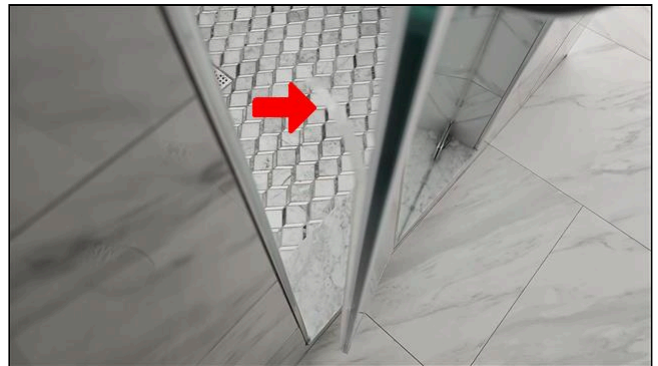
- 🏠 (2) The shower door seal is torn. Water could leak out door. A qualified contractor needs to replace seal. Location(s): primary bath

(2) The shower door seal is torn. Water could leak out door. A qualified contractor needs to replace seal. Location(s): primary bath
-

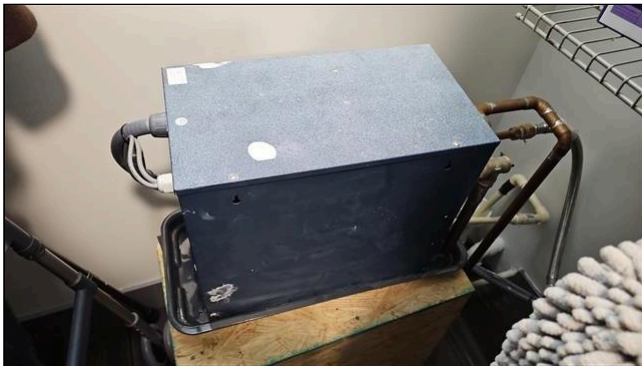
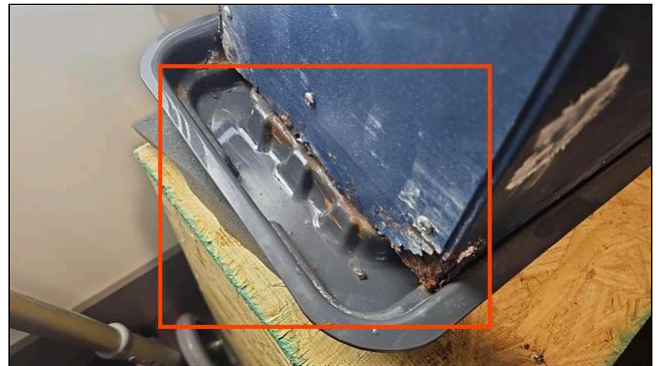
- 🏠 (3) The steam shower generator is leaking. Water in the pan. The steam shower was not tested. The generator needs to be replaced and steam shower tested for operation. A licensed plumbing contractor needs to repair.

(3) The steam shower generator is leaking. Water in the pan. The steam shower was not tested. The generator needs to be replaced and steam shower tested for operation. A licensed plumbing contractor needs to repair.

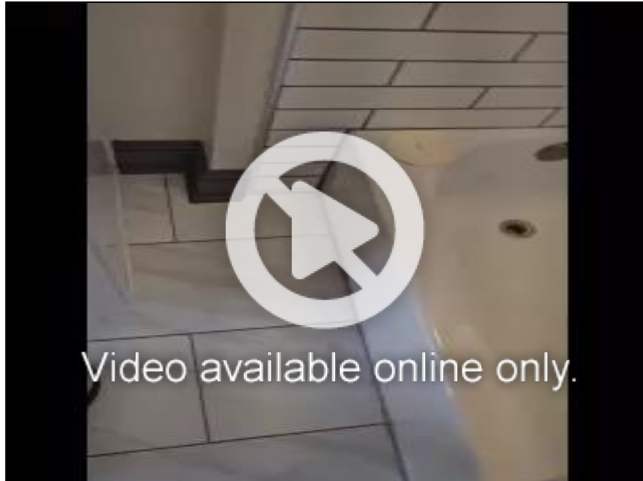
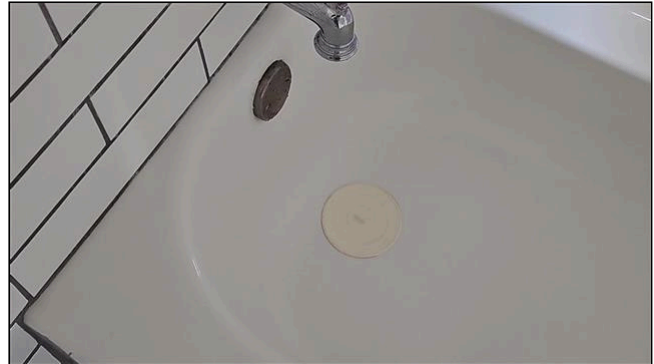
- 🏠 (4) I could hear water flowing at private bath tub drain when whirlpool tub in primary bath was draining. This could be from lack of plumbing use and dried out trap. A licensed plumbing contractor should evaluate.

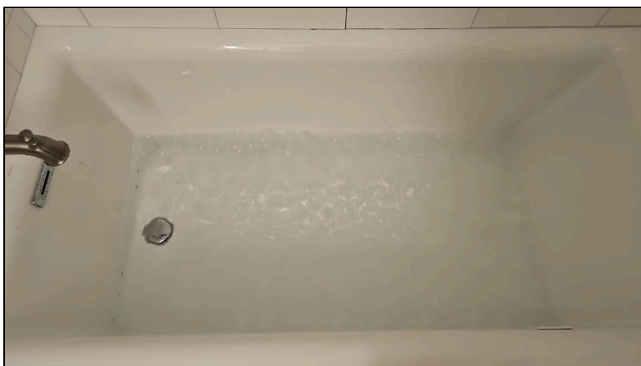
(2) FYI, Whirlpool tub in basement bath was operational.

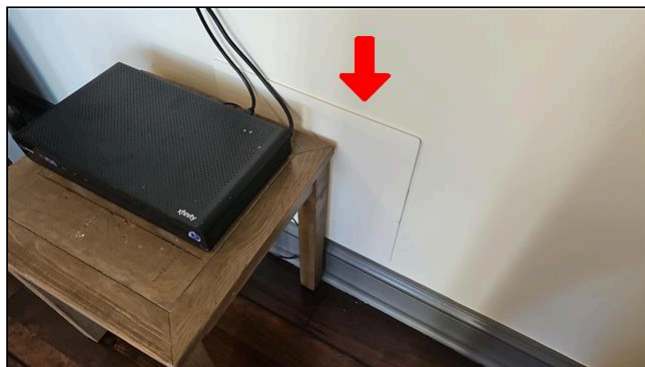
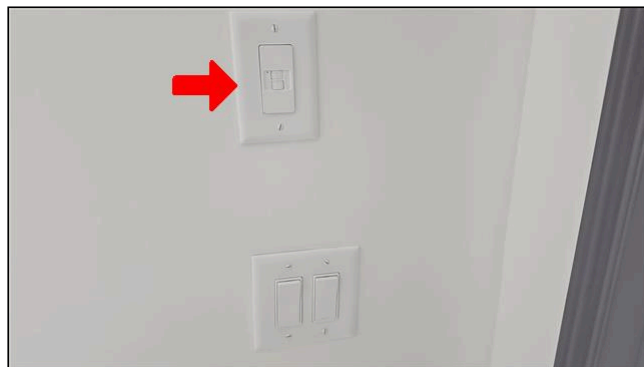
(3) FYI, Access to primary bath whirlpool circulation pump and GFCI reset for the whirlpool circulation pump. The pump and piping should be checked periodically for leaks. The GFCI should be tested periodically to verify the GFCI will trip and turn the circulation pump off.

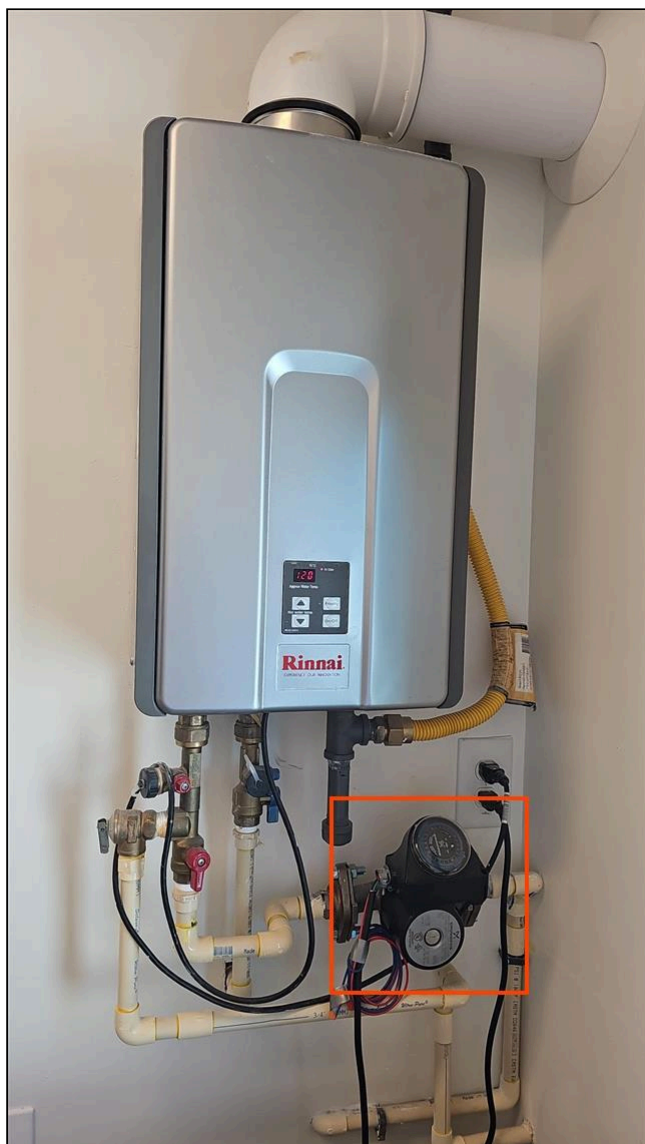
FYI, A hot water re-circulating pump is connected to the tankless hot water supply lines to provide hot

water at fixtures faster.

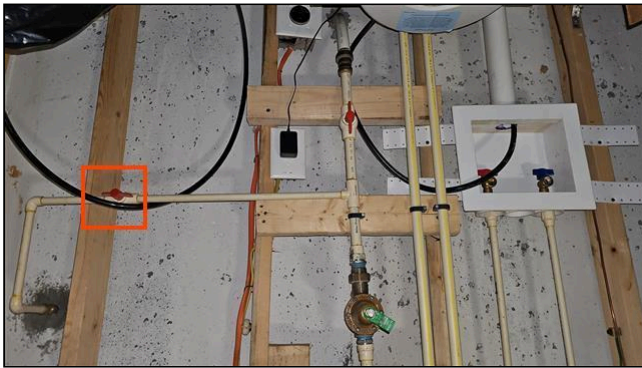
FYI, Location of exterior water faucet shutoff. (See Photo). In the winter time, a good practice is to turn off the water to the exterior faucets and drain exterior faucet to prevent pipe from freezing. This is for your information.

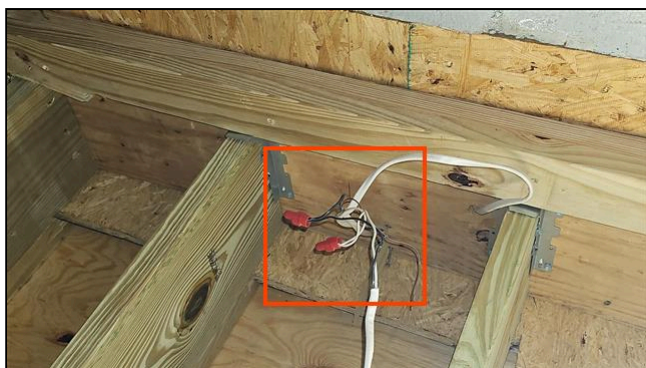
- 🏠 Wire splice in the basement closet under porch needs to be in a junction box with cover plate and wire nuts added as needed. A licensed electrician needs to repair. A licensed electrician needs to repair.

Wire splice in the basement closet under porch needs to be in a junction box with cover plate and wire nuts added as needed. A licensed electrician needs to repair. A licensed electrician needs to repair.

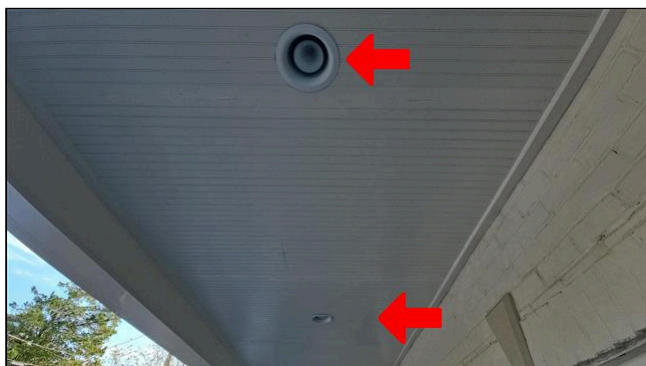
- 🏠 Exterior light fixture did not turn on. Replace bulb and verify operation of light fixture. In the event the light fixture does not work, a licensed electrician needs to repair. Location(s): under front porch at garage door

Exterior light fixture did not turn on. Replace bulb and verify operation of light fixture. In the event the light fixture does not work, a licensed electrician needs to repair. Location(s): under front porch at garage door

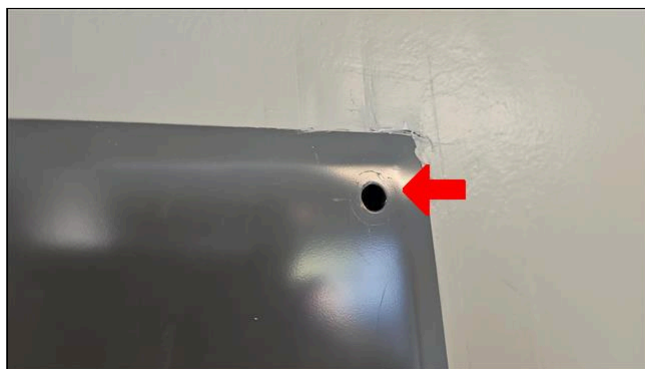
Missing screws need to be installed on the sub panel front to secure panel cover to panel box. Only blunt end screws should be used. A licensed electrician needs to repair.

Missing screws need to be installed on the sub panel front to secure panel cover to panel box. Only blunt end screws should be used. A licensed electrician needs to repair.

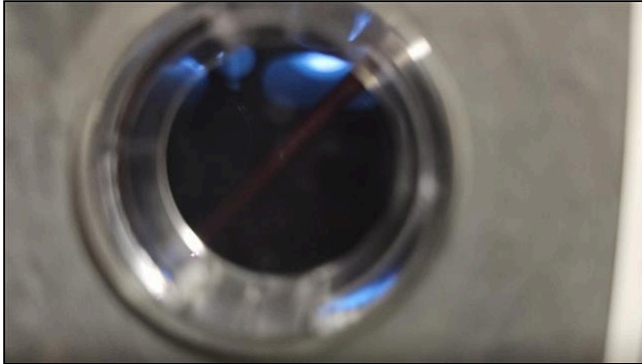
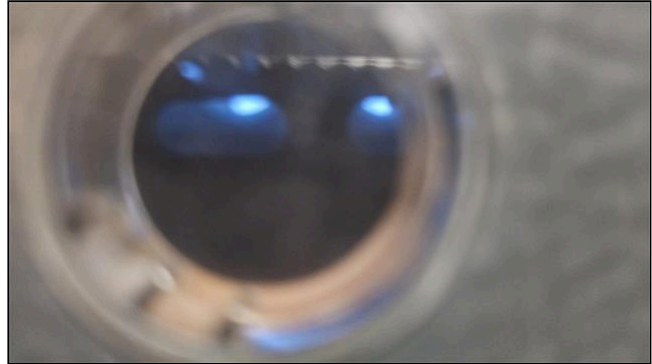
The furnaces were operational. Underlying issues can still exist with an operating system. A licensed heating and air contractor should do annual service based on manufacturers specs and repair as needed. The inspector makes no warranties or guarantees as to how long the heating equipment will last.

The furnaces were operational. Underlying issues can still exist with an operating system. A licensed heating and air contractor should do annual service based on manufacturers specs and repair as needed. The inspector makes no warranties or guarantees as to how long the heating equipment will last.

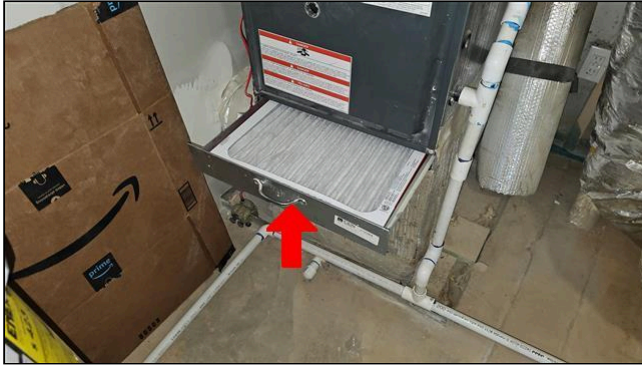
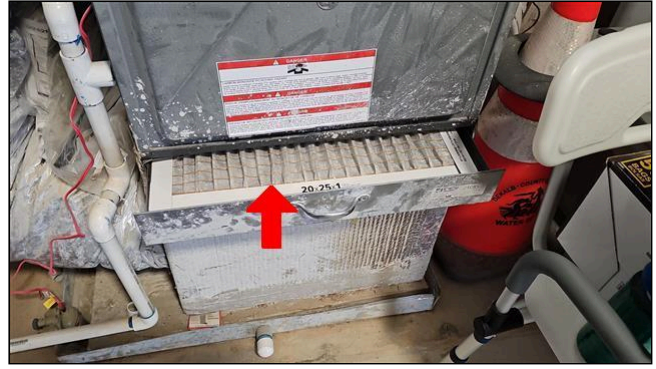
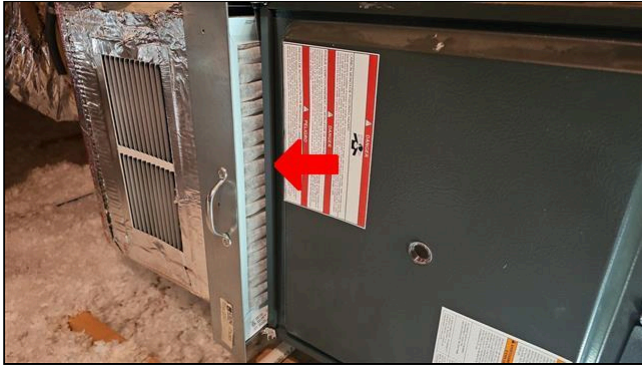
Location of return air filters (see photo). Filters should be changed every 60 to 90 days. Recommend that the filters be changed once you take possession of the house.

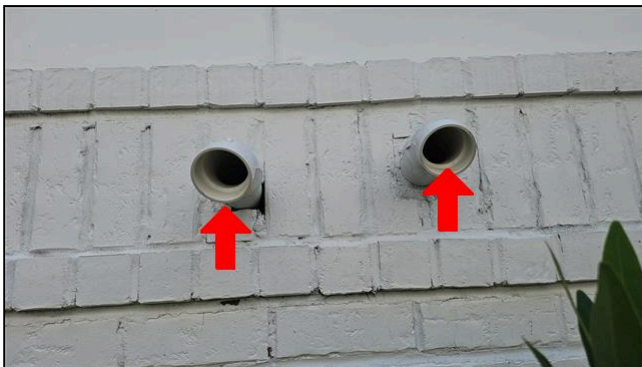
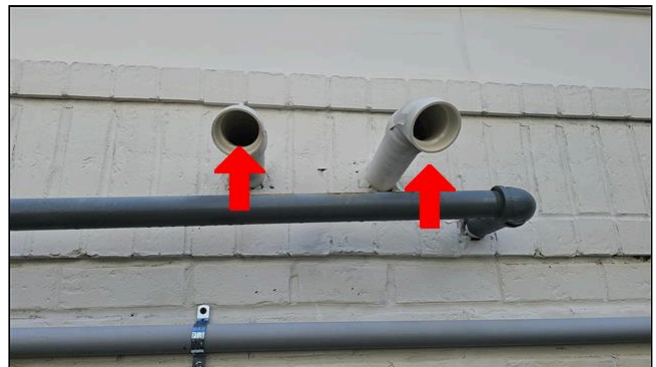
The end of the furnace vents on the side of the house need to be screened to keep wildlife out. A licensed heating and air contractor needs to repair.

The end of the furnace vents on the side of the house need to be screened to keep wildlife out. A licensed heating and air contractor needs to repair.

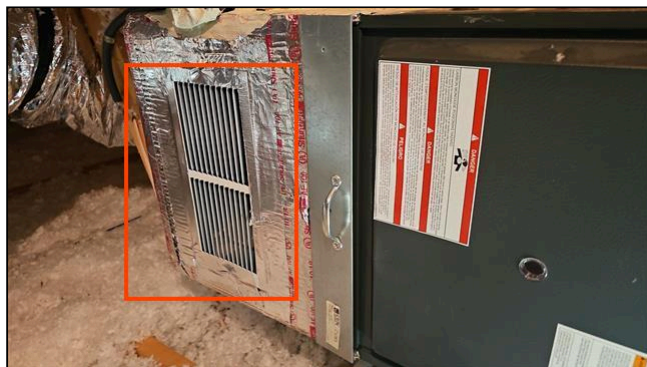
- Why is there a return vent built to the return air plenum in the attic. The return would seem to cause attic air to be recirculated through the house. A licensed heating and air contractor needs to evaluate and advise.

Why is there a return vent built to the return air plenum in the attic. The return would seem to cause attic air to be recirculated through the house. A licensed heating and air contractor needs to evaluate and advise.

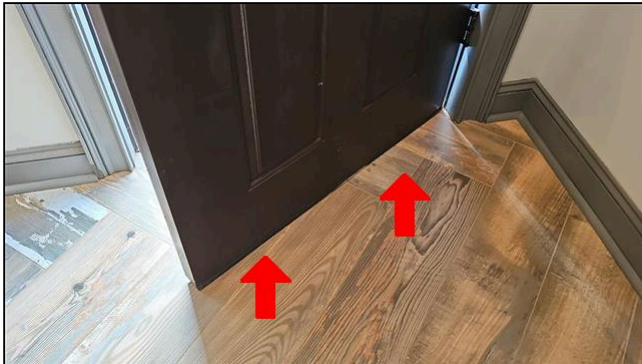
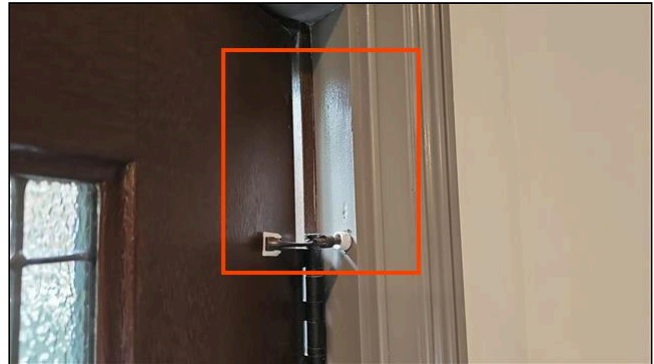
- 🏠 (1) The basement door binds on the floor and the jamb near the upper hinge is not tight due to the binding on floor. A qualified contractor needs to put the door in working order.

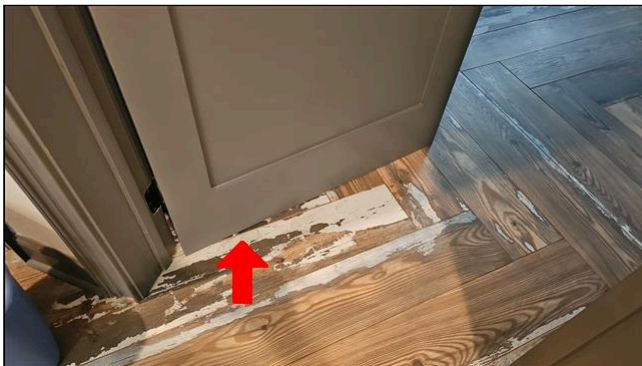
- 🏠 (2) Door needs to be cut about a half inch so the door can open without dragging on the flooring. A qualified contractor needs to cut door bottom. Location(s): basement bedroom

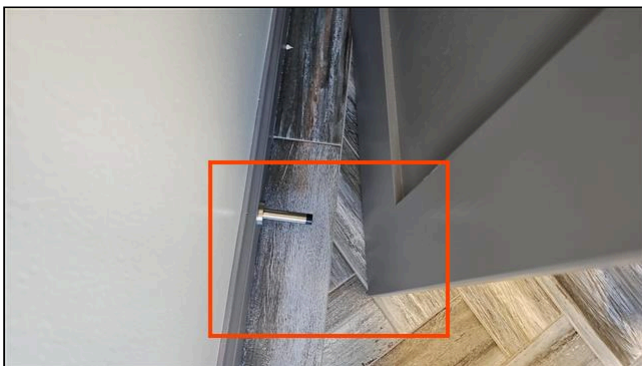
- 🏠 (4) The door in the laundry needs a magnetic catch on the bottom of the door to keep the door open. The door closes on its own. A qualified contractor needs to repair.

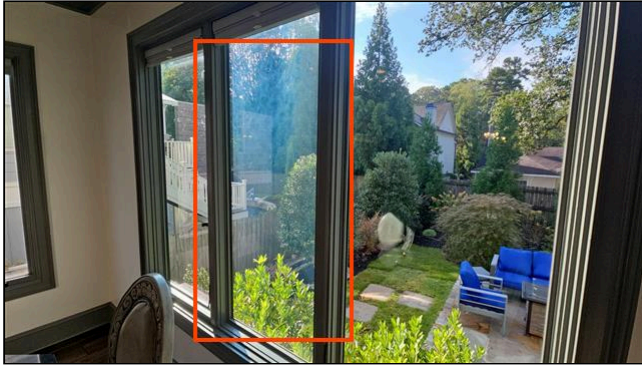
- Insulation seal has failed on window. A qualified contractor needs to replace failed glass. Location(s): breakfast area

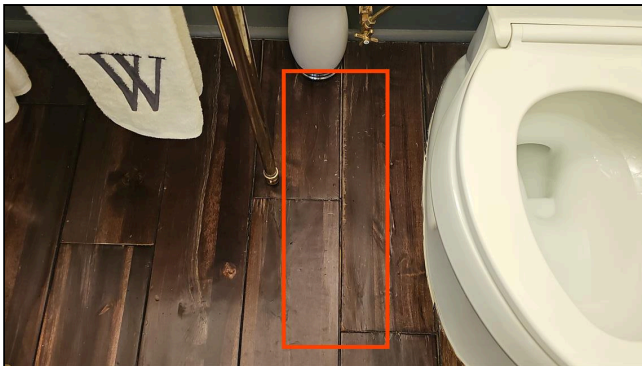
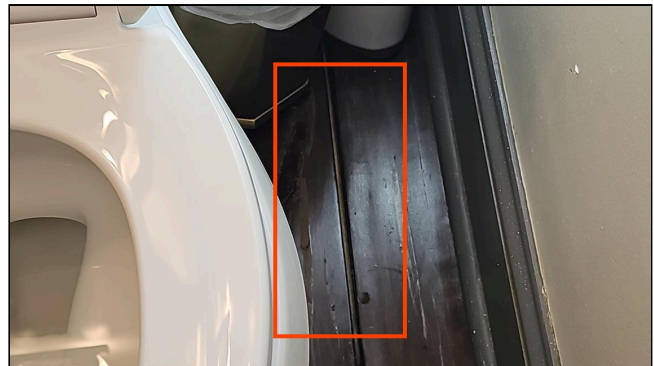
- The flooring by the toilet in the powder bath appears to have past water damage by the toilet. No leaked were observed at the time of the inspection.

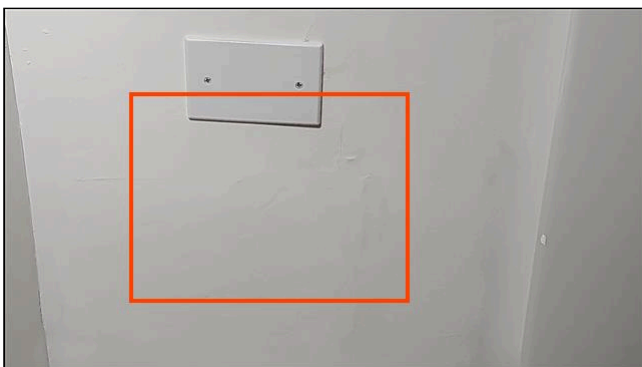
- Water stains/repair observed. Check with seller about knowledge of past leak and any repairs. Repairs made as needed. Location(s): pantry under shared bath toilet. The toilet has been replaced.

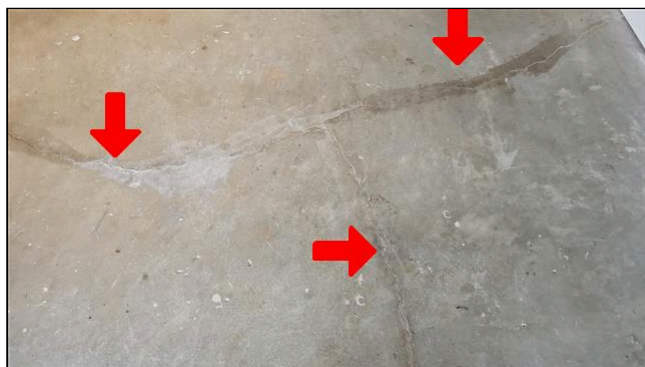
Shrinkage cracks were noted in the garage slab. Shrinkage cracks are usually a result of the curing process of concrete, expansion, and contraction.

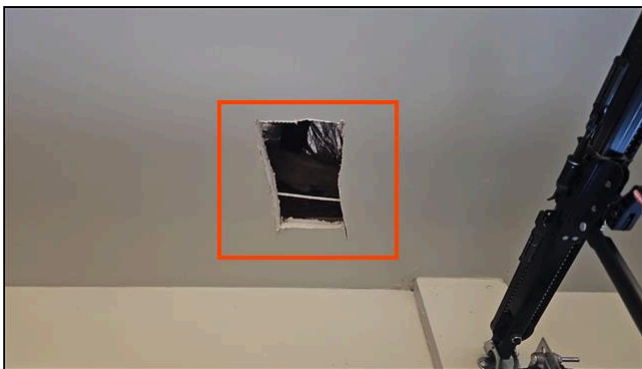
(2) The holes in the sheetrock in the garage need to be repaired. The holes compromise the fire separation between the house and garage. A qualified contractor needs to repair holes and paint to match existing.

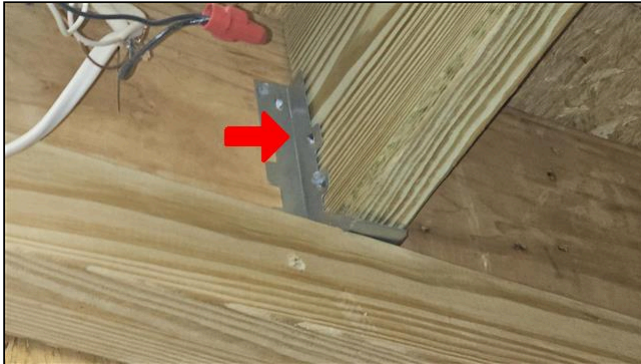
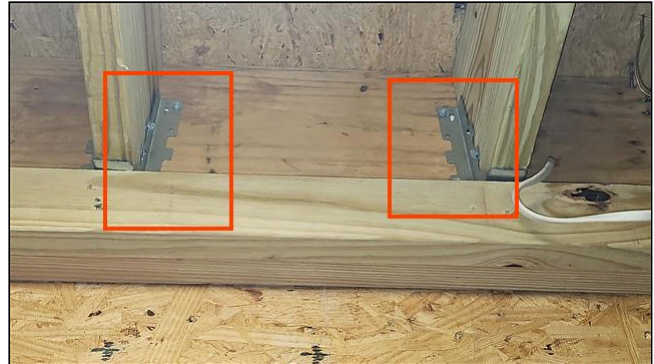
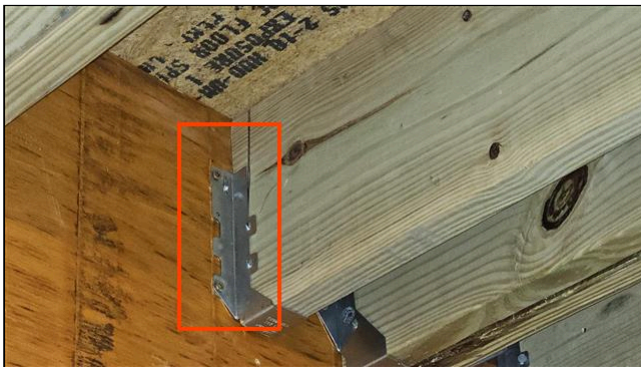
- 🏠 The joist hangers supporting the front porch joist in closet are not nailed at all eyelet holes. The joist hangers provide vertical support at point of attachment to the ledger board. Manufacture specs require all eyelet holes to be nailed. Pictures are examples. A qualified contractor needs to nail off all joist hangers.

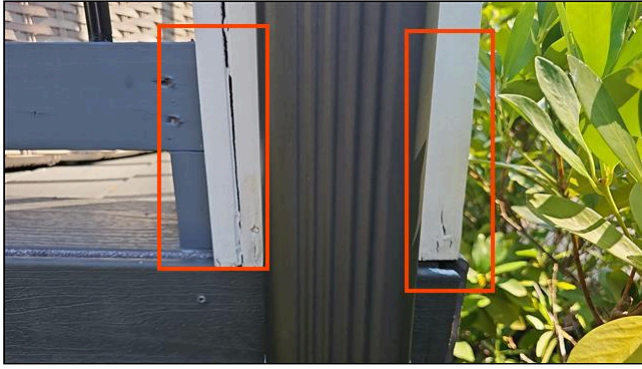
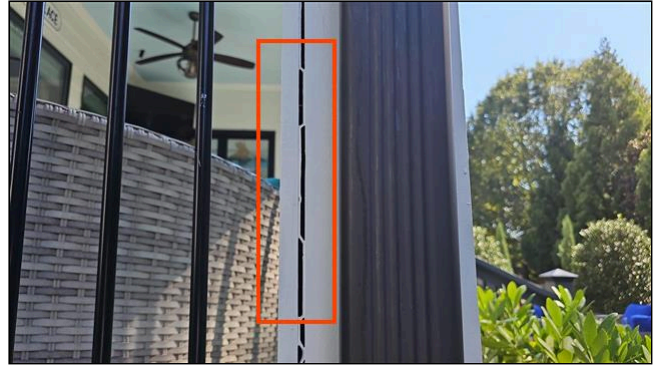
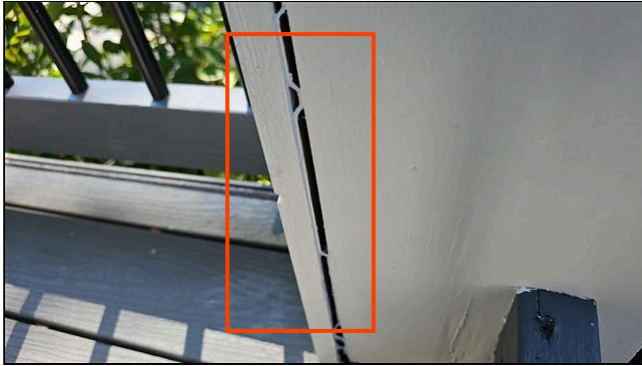
- 🏠 (1) . The column on the back porch needs to be caulked and painted. Any rotten wood on column needs to be replaced. A qualified contractor needs to repair.

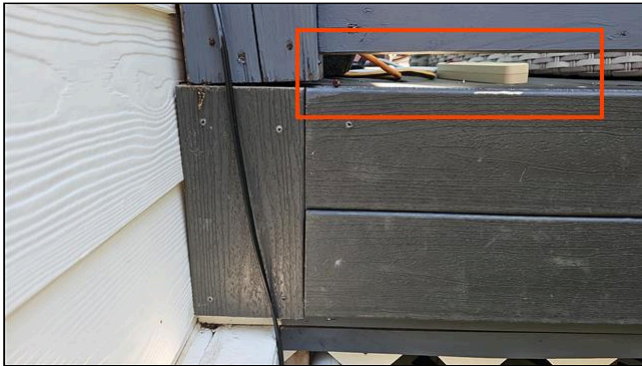
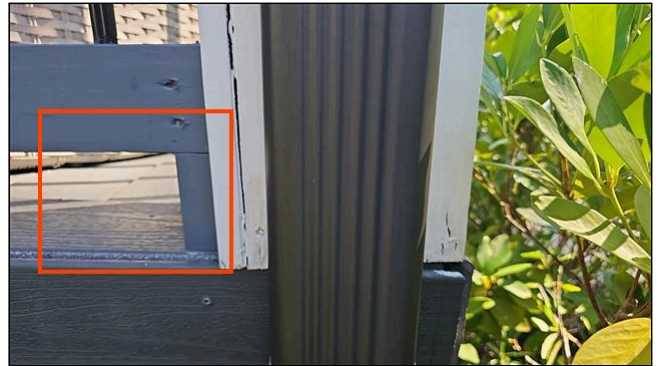
- (2) The back porch slopes toward the right corner. The deck appears to have been built that way. The margin under the guardrail is wider at the post.

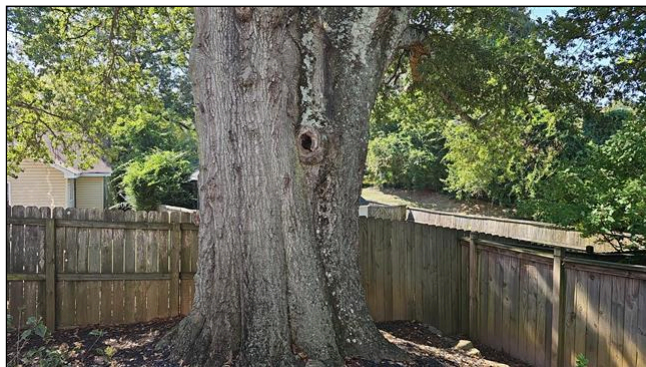
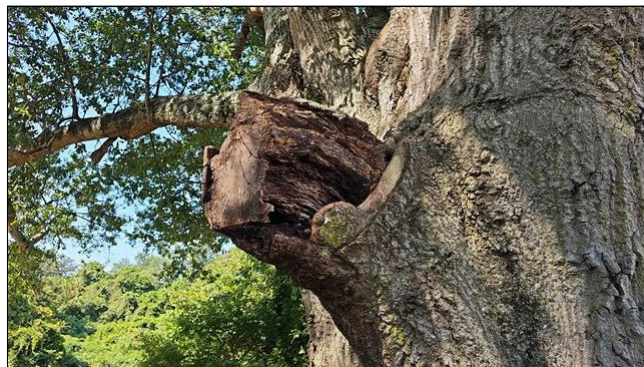
Recommend having an arborist evaluate the big oak tree in the back yard.

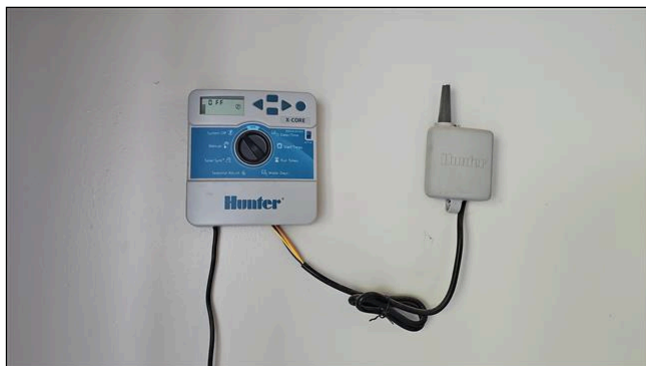
The lawn sprinkler system was not tested. Testing the system is outside the ASHI standards of inspections. A qualified contractor needs to leak check and test the system. Repairs made if needed.

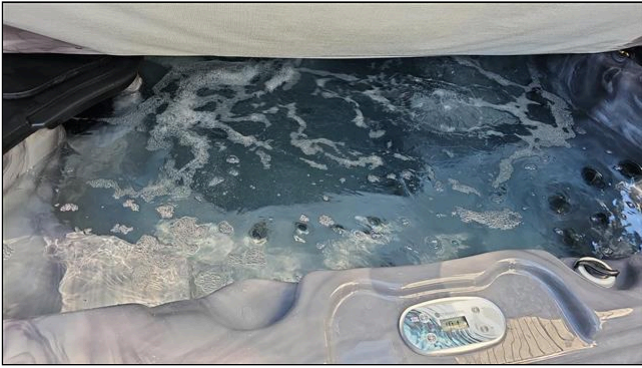
Per seller disclosure, the hot tub is being removed. The hot tub was operational .

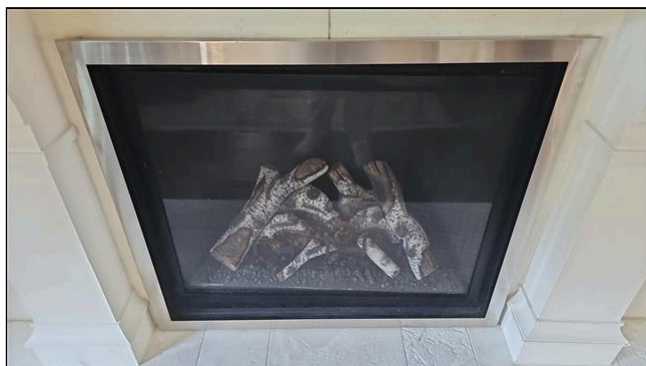
The pilot light was off at fireplace. The inspector does not turn on appliances that are not in working order. The seller should demonstrate normal operation of the fireplace.
