Inspection Report

Property Address:
4321 Main St
GA

Marion Hodges Home Inspection Services

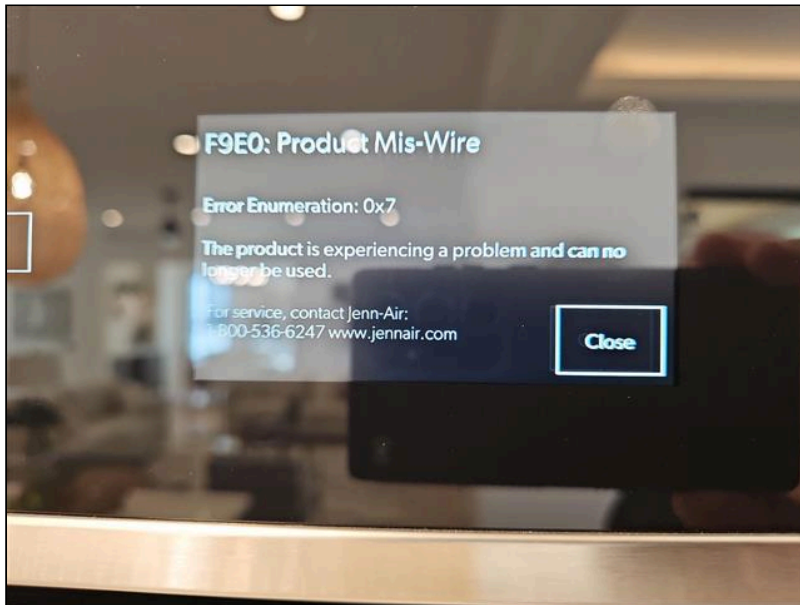
Error message on oven display, "Product Mis-Wire". The oven was not tested. Power turned off in panel for safety. The builder needs to evaluate and repair as needed.

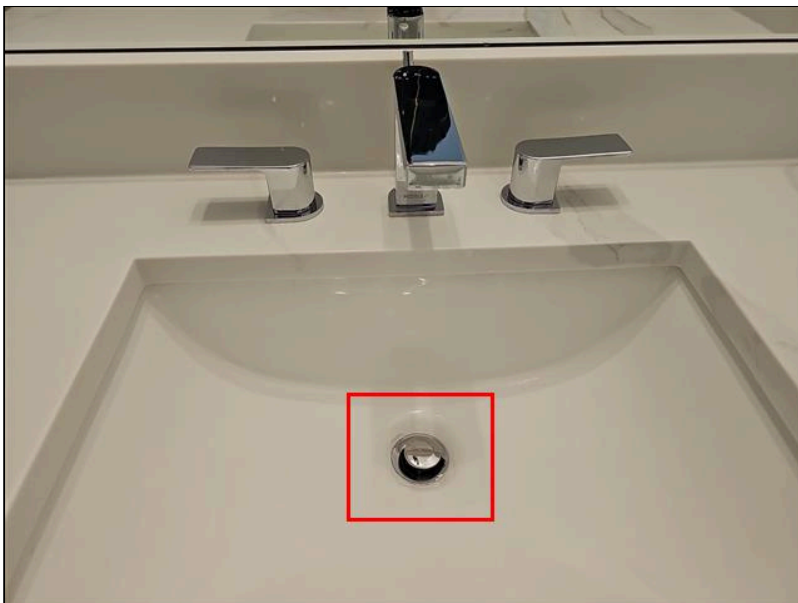
The sink drain stopper will not close. A licensed plumbing contractor needs to repair. Location(s): private bath

Code Violation.

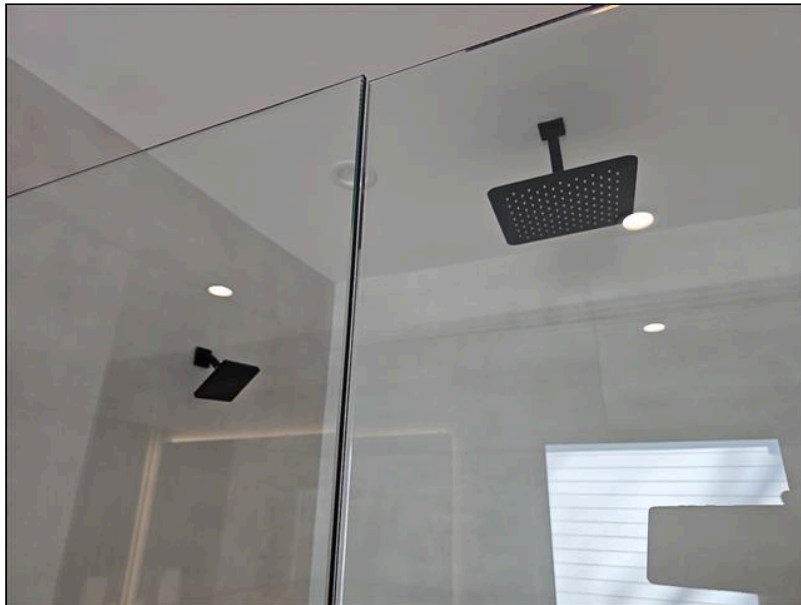
The shower door needs adjusted. The door hit the stationary panel. A qualified contractor needs to adjust door. Location(s): master bath

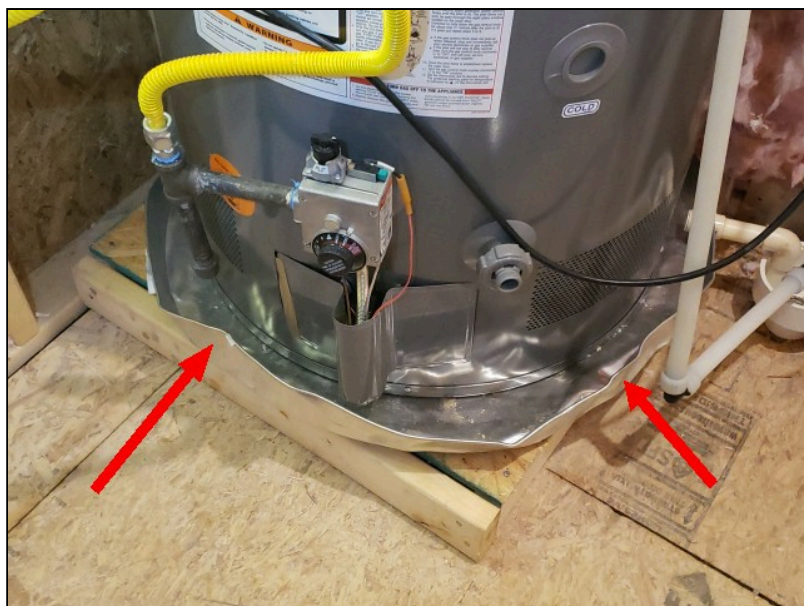
- 🏠 (3) Combustion air vents are obstructed with insulation. Combustion air vents need to have a 1 inch air clearance per manufacturers specs. A licensed plumbing contractor needs to repair.

Violation of manufacture installation specs.

(3) Combustion air vents are obstructed with insulation. Combustion air vents need to have a 1 inch air clearance per manufacturers specs. A licensed plumbing contractor needs to repair.

Violation of manufacture installation specs.

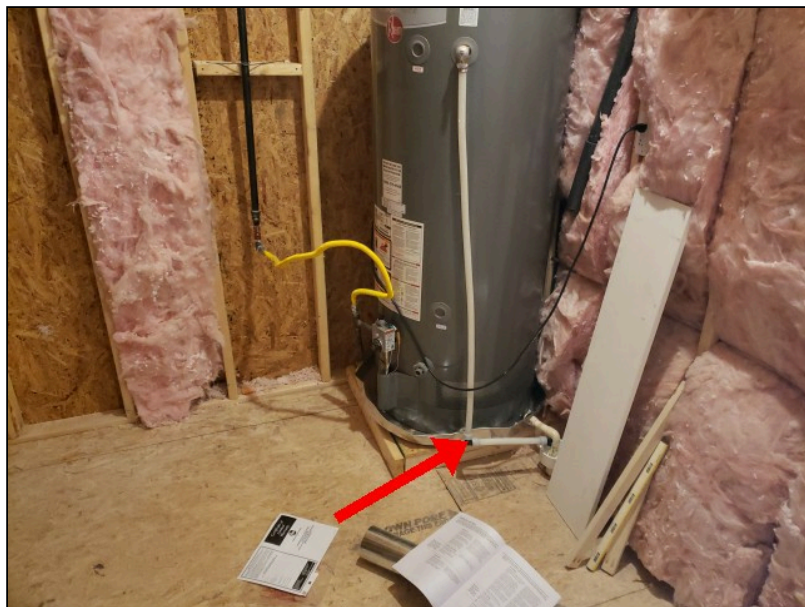
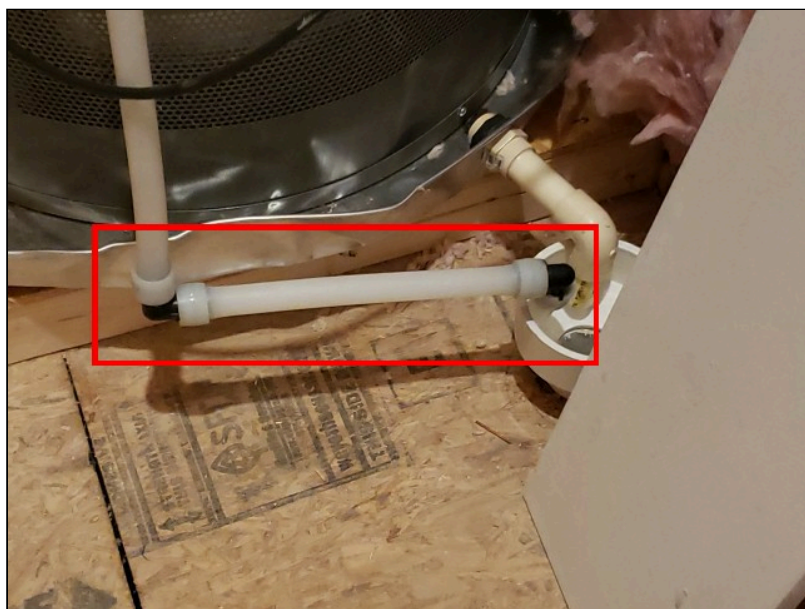
🏠 The end of the discharge pipe is not protected against freezing for the water heater pressure relief valve. Per manufacturer's specs, the end of the discharge pipe needs to be protected against freezing. The water heater is installed in the attic. A licensed plumbing contractor needs to repair.

Violation of manufacture installation specs.

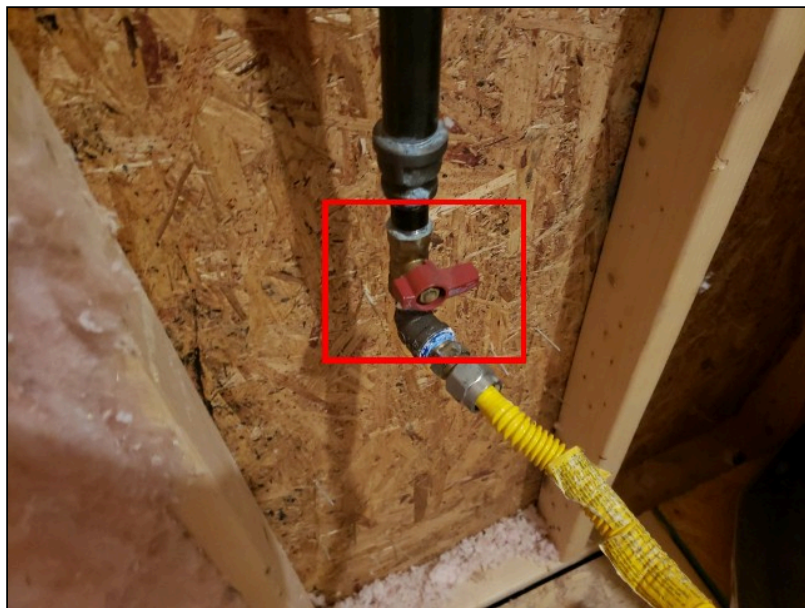
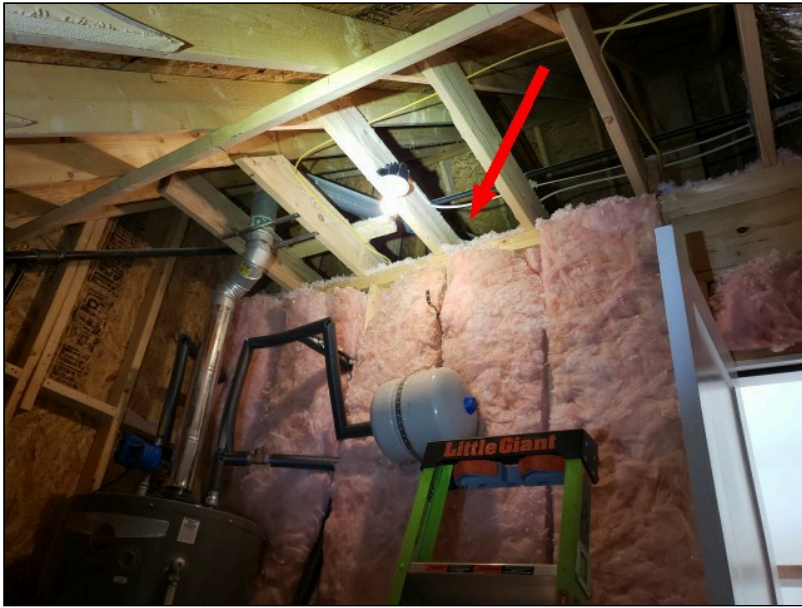
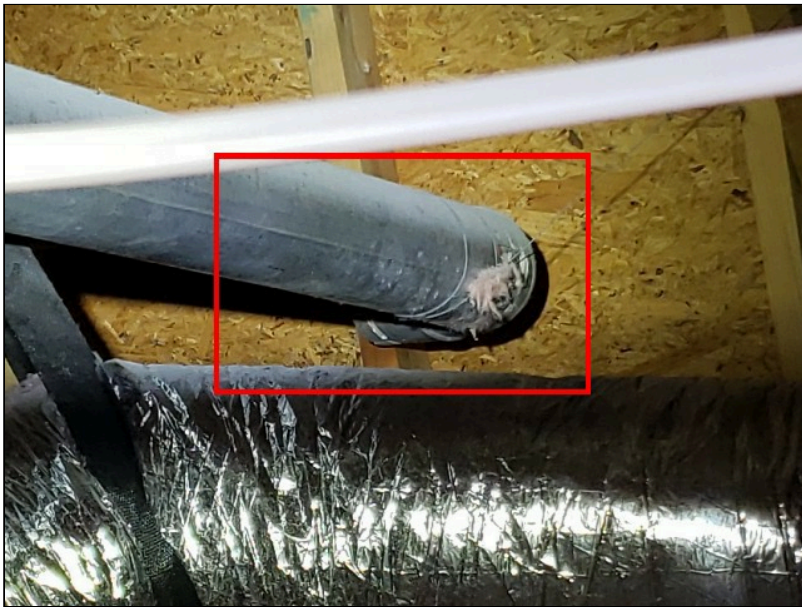
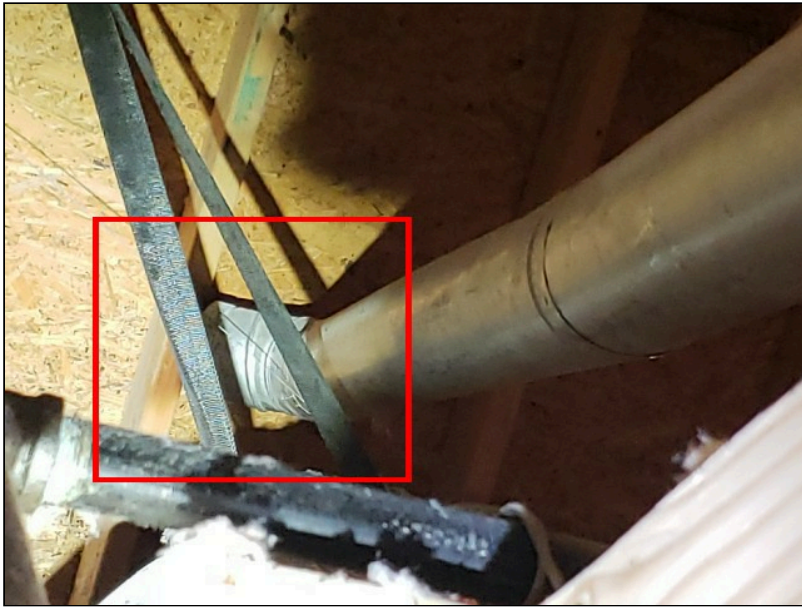
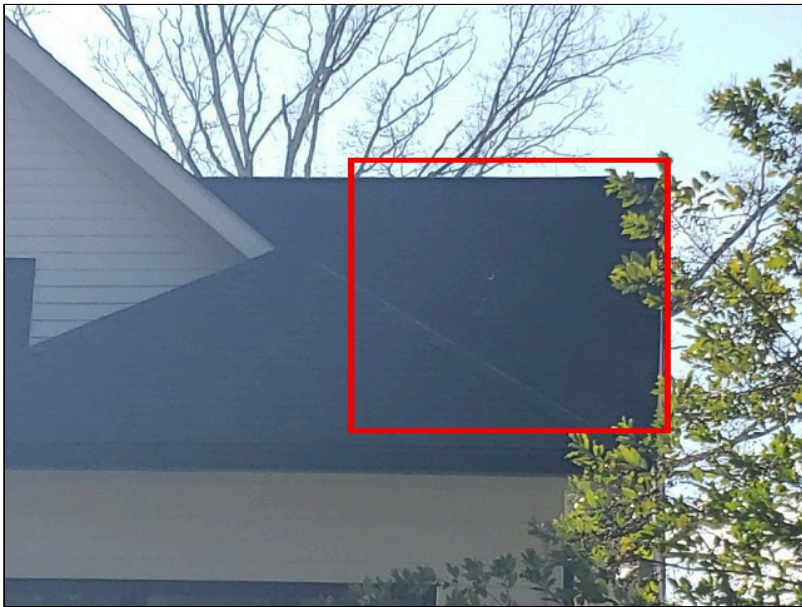
(1) The water heater vent pipe is not vented to the exterior. The water heater vents into the attic. This is a carbon monoxide safety issue. The water heater vent pipe must be vented to the exterior through the roof. The inspector turned gas off to the water heater for safety. A licensed plumbing contractor needs to repair.

Code violation and life safety issue

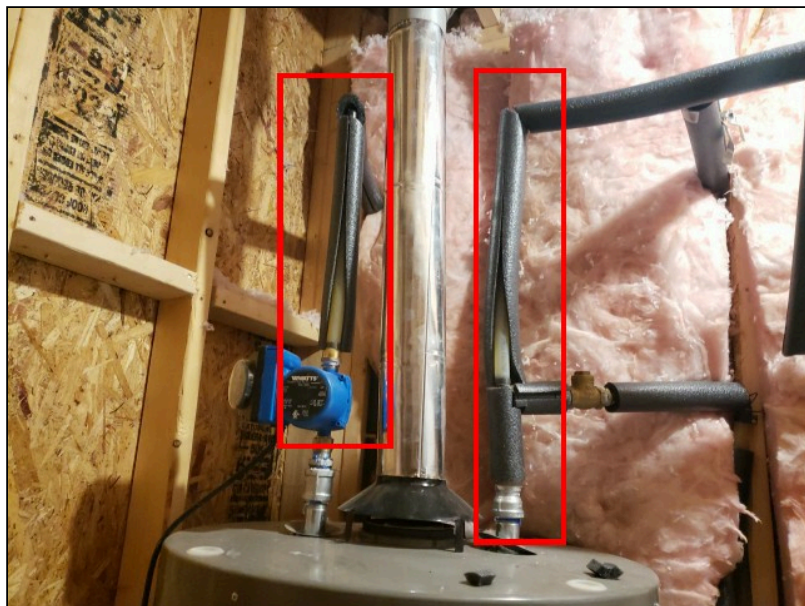
- 🏠 (2) Single wall vent pipe originates from the water heater in the attic. Single wall vent pipe is not allowed to originate in attic spaces. A licensed plumbing contractor needs to replace vent pipe with double wall pipe. The first 18 inches of the hot and cold line on a gas water heater need to be copper. A licensed plumbing contractor needs to repair.

Code violation

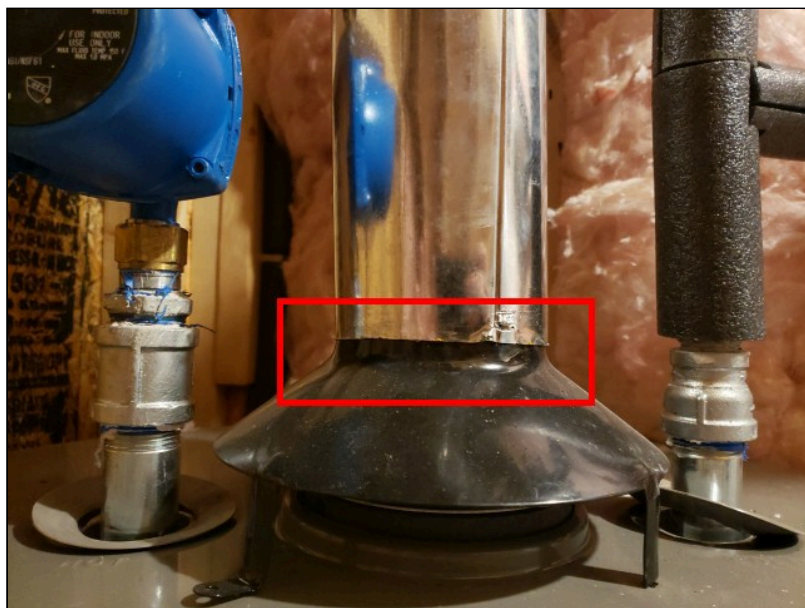
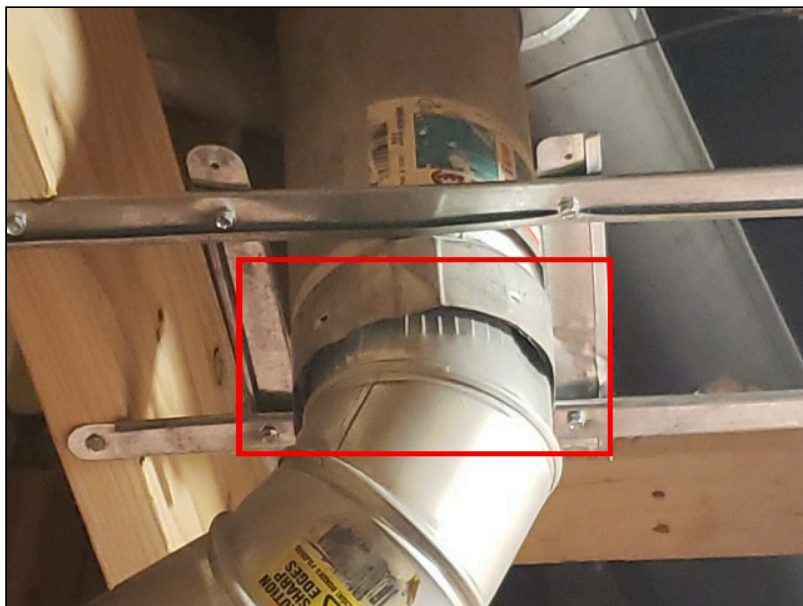
- 🏠 (3) The joints on the water heater vent pipe are not fastened together with screws. The vent piping from the water heater should be screwed together at the joints or connected in accordance with the manufacturers instructions. A licensed plumbing contractor needs to repair.

Code violation

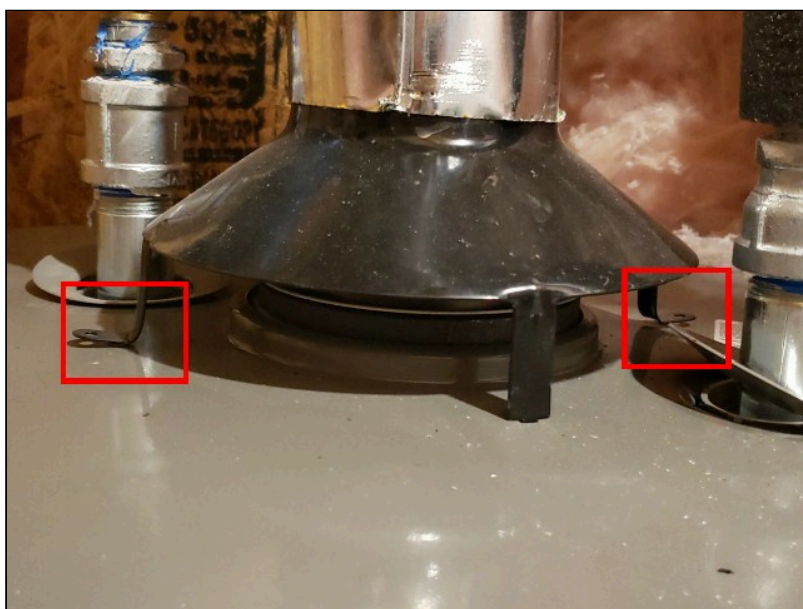
(4) The draft hood legs on the water heater vent assembly need to be connected to the water heater. Proper connections prevent carbon monoxide from entering the structure. A licensed plumbing contractor needs to attach draft hood legs.

Code violation

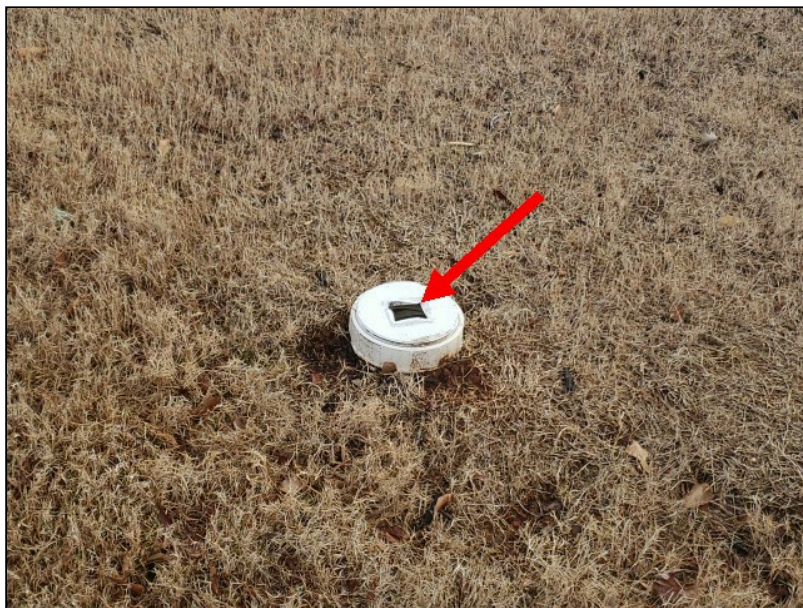
Cleanout cap is broken. A qualified contractor needs to replace. Location(s): front yard

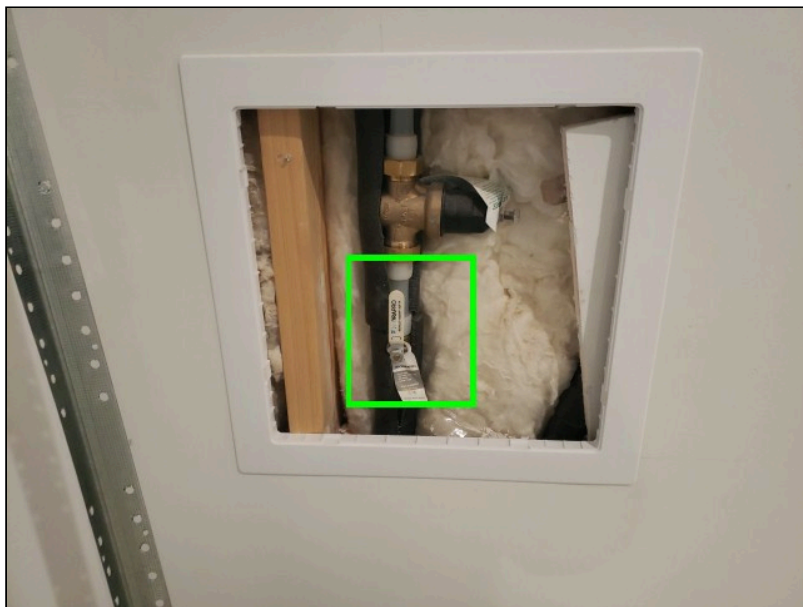
Location of main water cut off (See Photo).

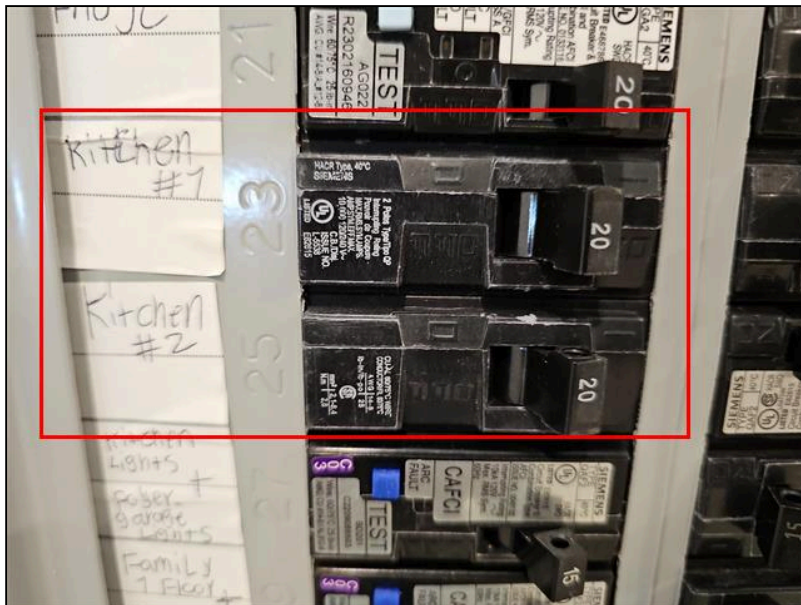
- 🏠 The receptacles in the kitchen that serve the countertops are not GFCI protected. A licensed electrician needs to put all receptacles in the kitchen on a GFCI protected circuit.

Code violation

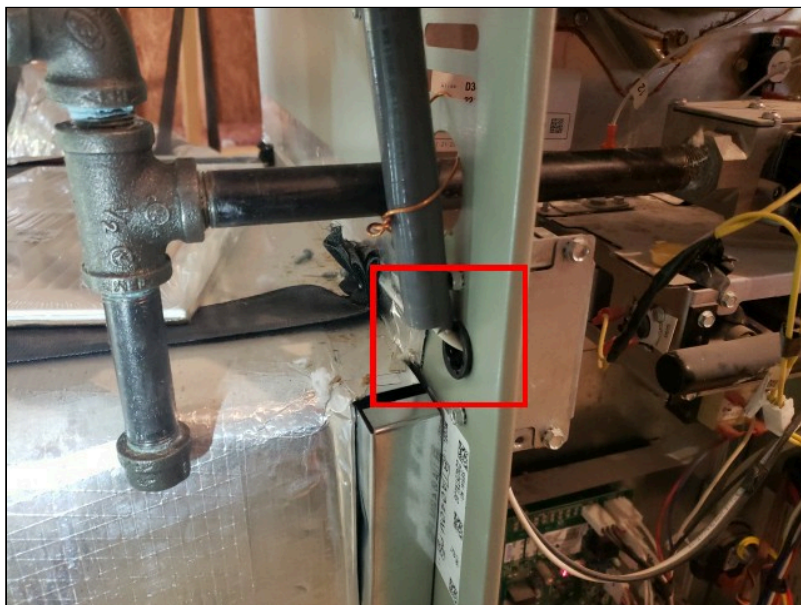
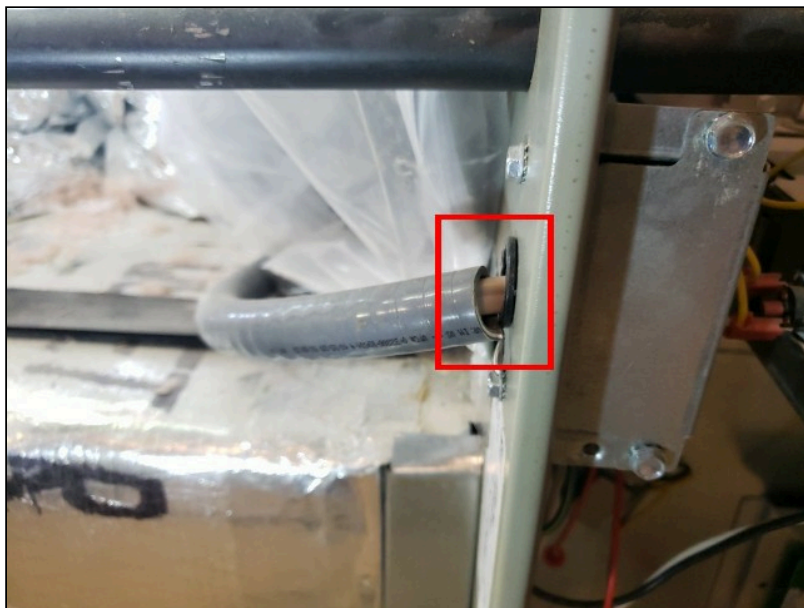
- 🏠 Electrical conduit is not secure to the junction box. A licensed electrician needs to repair. Location(s): both air handlers in attic

Code violation

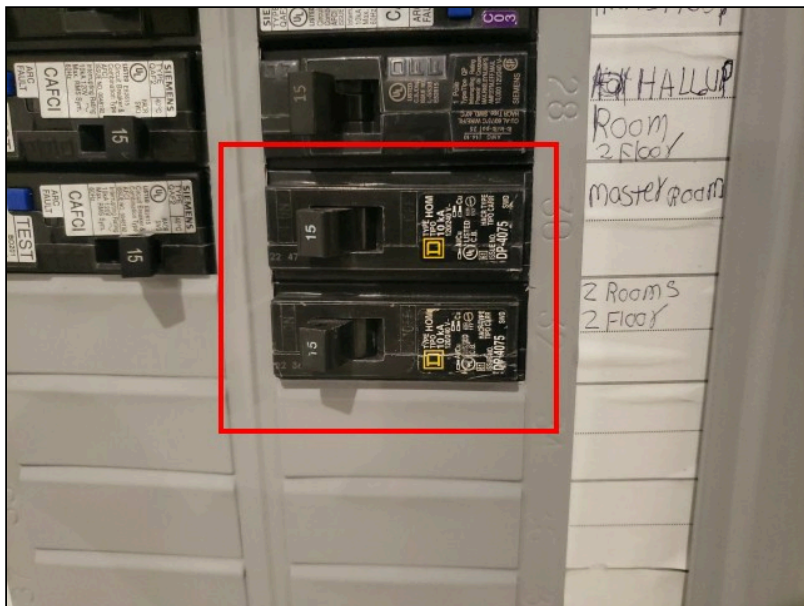
- ➦ (1) There are mismatched breakers in the main distribution panel. Manufacturers legend label requires that only the panel manufacturers breakers be used in the panel or a compatible replacement is allowed to be used inside the panel. A licensed electrician needs to inspect further and replace any breaker that is not compatible with the panel.

Violation of manufacture installation specs.

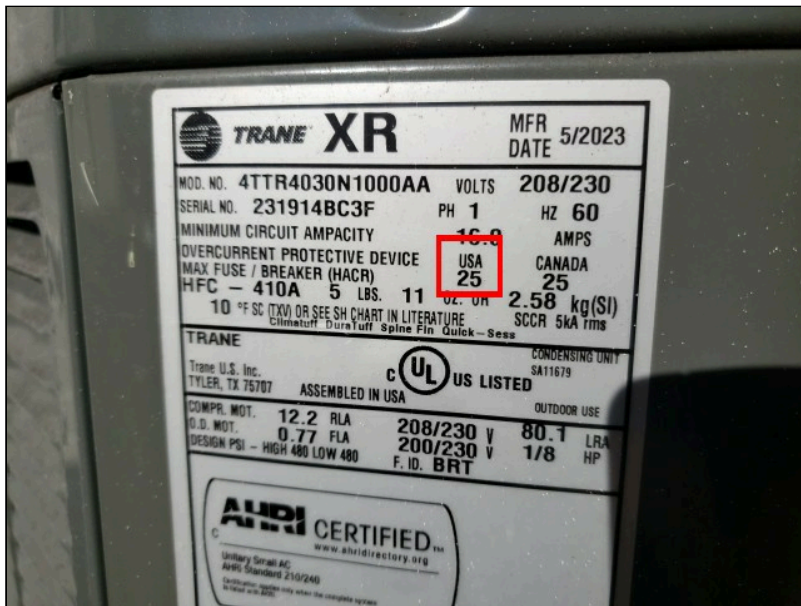
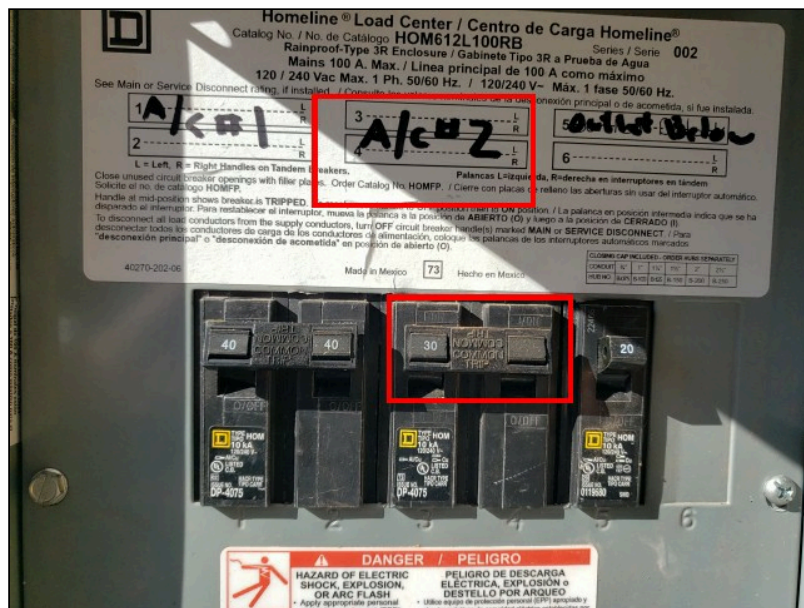
(2) Per manufacturers specs on the condensing unit, the maximum size breaker permitted is 25 AMPS. The breaker in the panel is 30 AMPS. A licensed electrician needs to install correct size breaker.

Violation of manufacture installation specs.

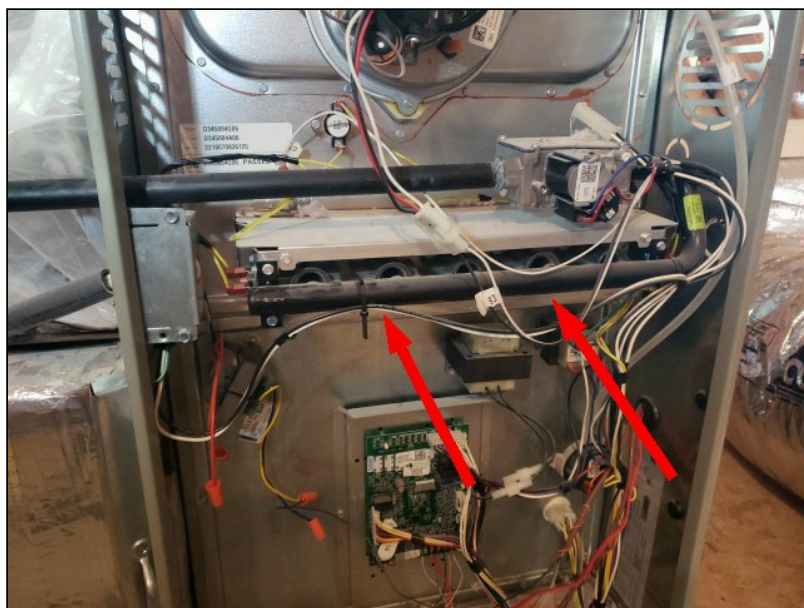
- (2) The inside of the furnace burner housing is filled with insulation. This is on the same furnace that makes a buzzing sound. The inspector turned power off the the furnace for safety. All insulation needs to be removed from the inside of the furnace. The furnace needs to be put in normal working order. A licensed heating and air contractor needs to repair.

Fire safety issue.

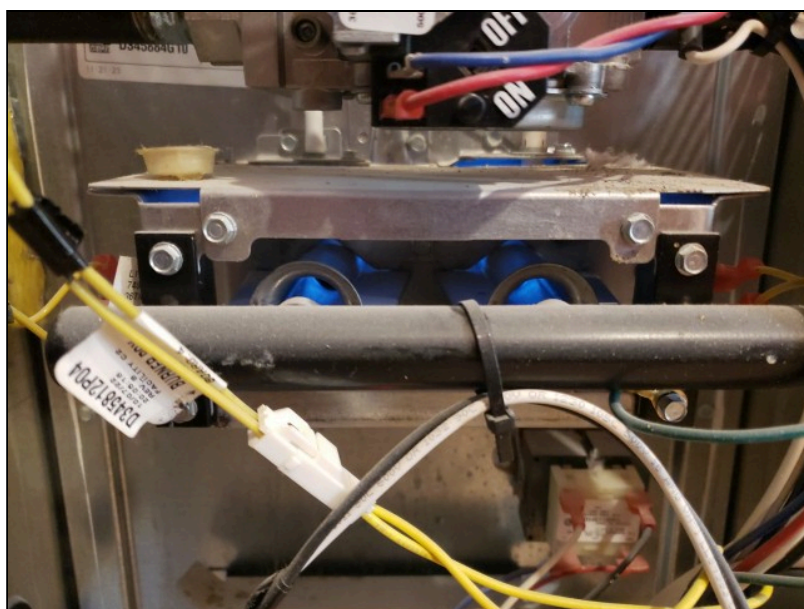
(3) The main level furnace started at the time of the inspection. The furnace should not be used until the vent pipe issues are fixed (refer to comment 5.4). The inspector makes no warranties or guarantees as to how long the heating equipment and components will last.

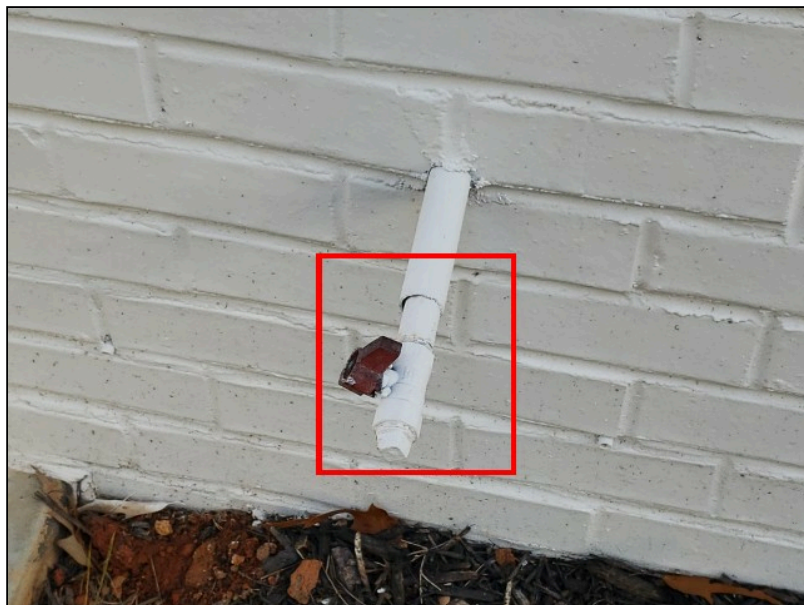
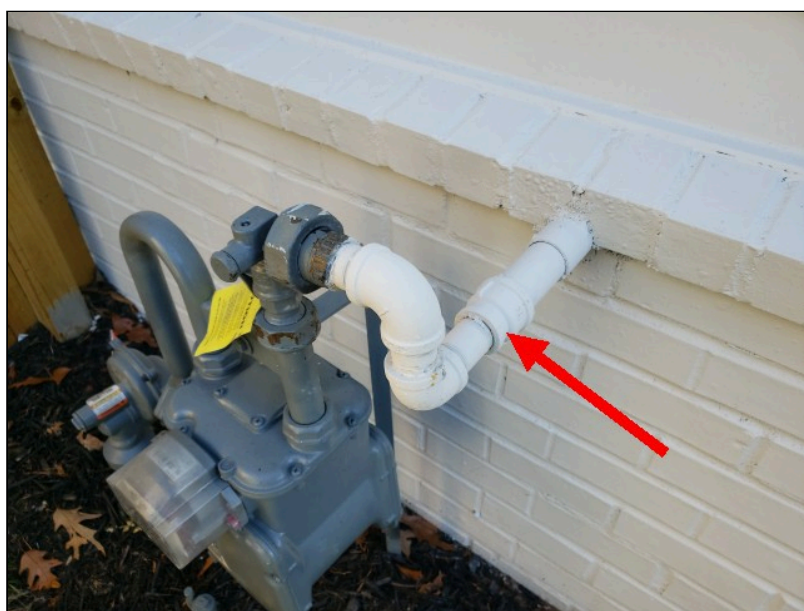
🏠 The gas pipe is not protected from corrosion. Latex paint was used to paint the gas pipe. Exterior gas piping should be protected from corrosion with corrosion resistant paint. A qualified contractor needs to paint the gas pipe with corrosion resistant paint. Location(s): gas grill connection, gas meter

Code Violation

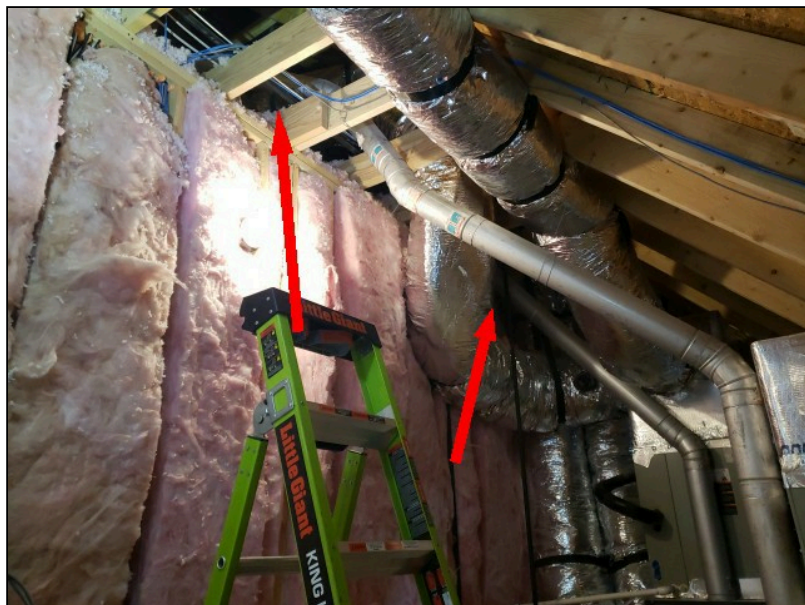
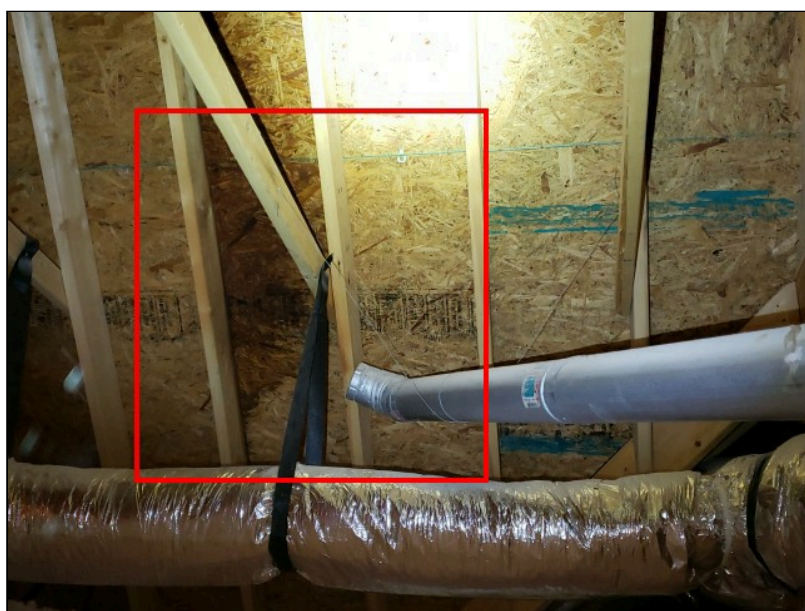
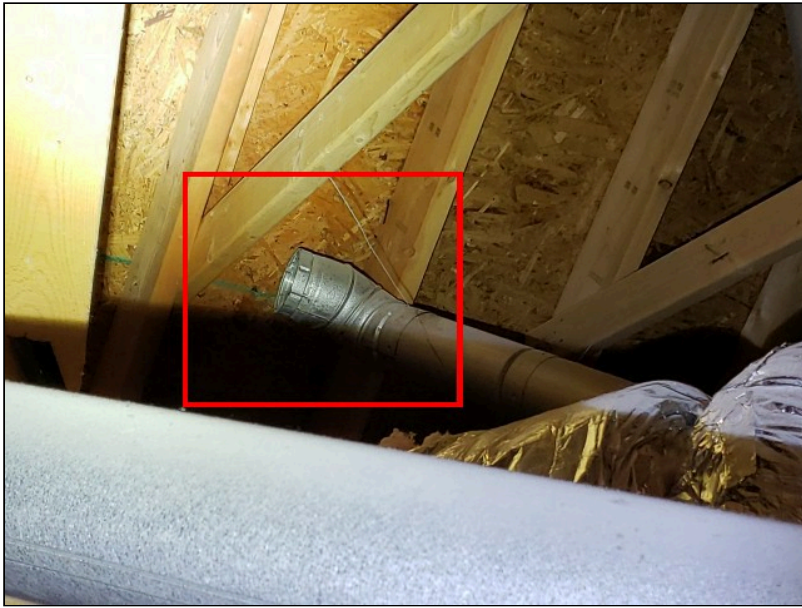
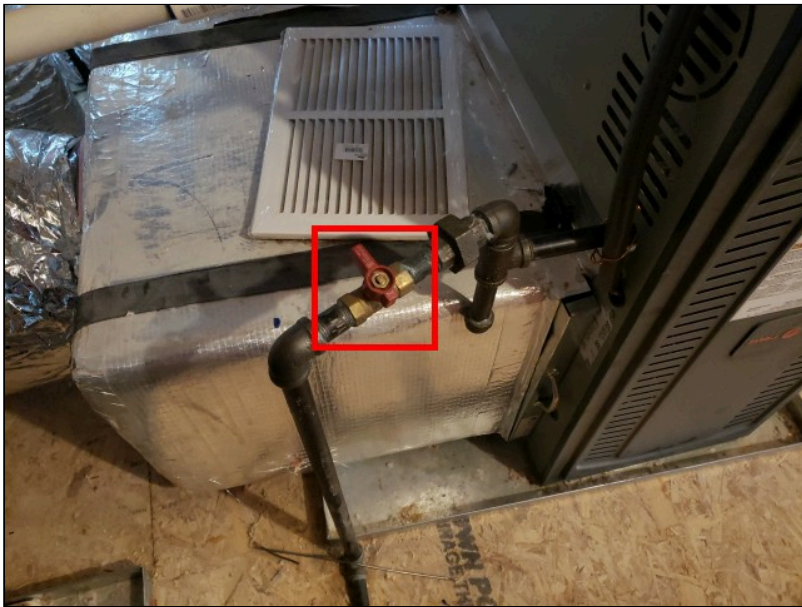
🏠 The furnace vent pipes are not vented to the exterior. The furnaces vent into the attic. This is a carbon monoxide safety issue. The furnace vent pipes must be vented to the exterior through the roof. The inspector turned gas off to the furnaces for safety. A licensed heating and air contractor needs to repair.

Code violation and life safety issue

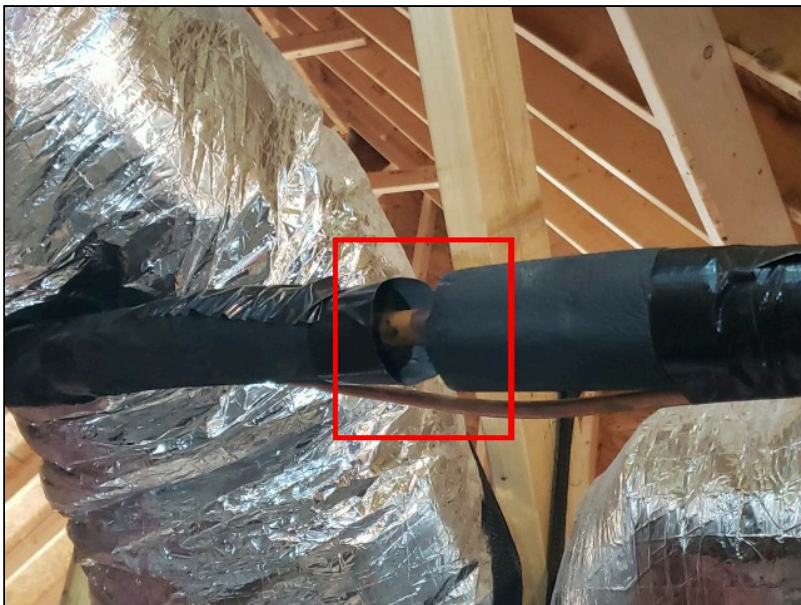
(2) Missing insulation on the refrigerant line in the attic. The refrigerant line should be completely insulated. A licensed heating and air contractor needs to add insulation where insulation is missing.

Code violation

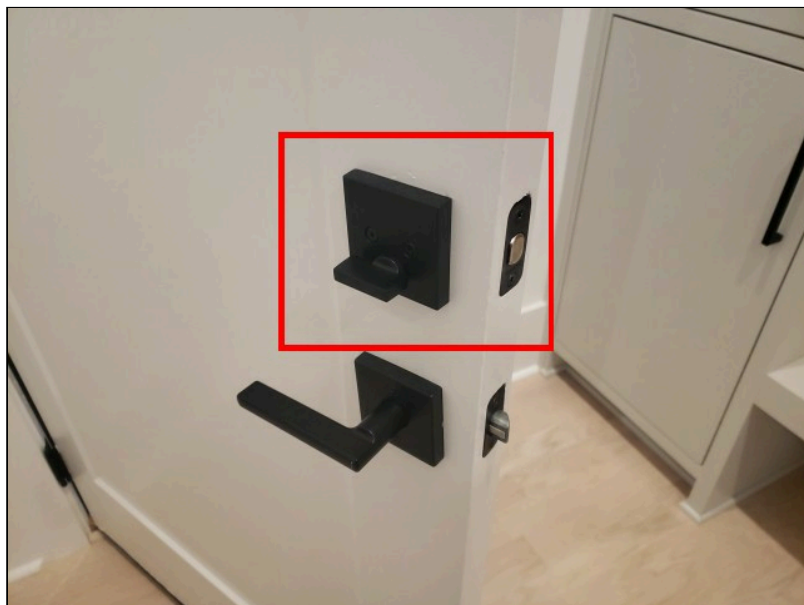
Lock needs to be tightened. Location(s): garage

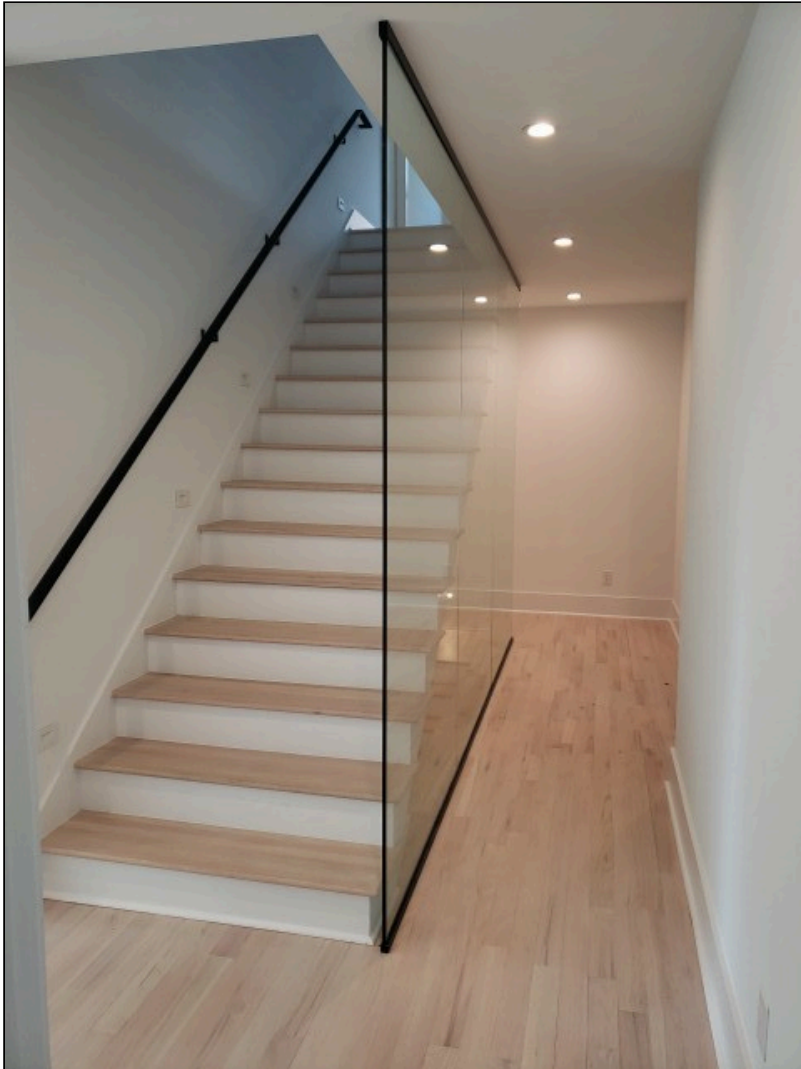
🏠 The glass guard rails along the stairs wobble. The glass could need stabilization. Check with the builder.

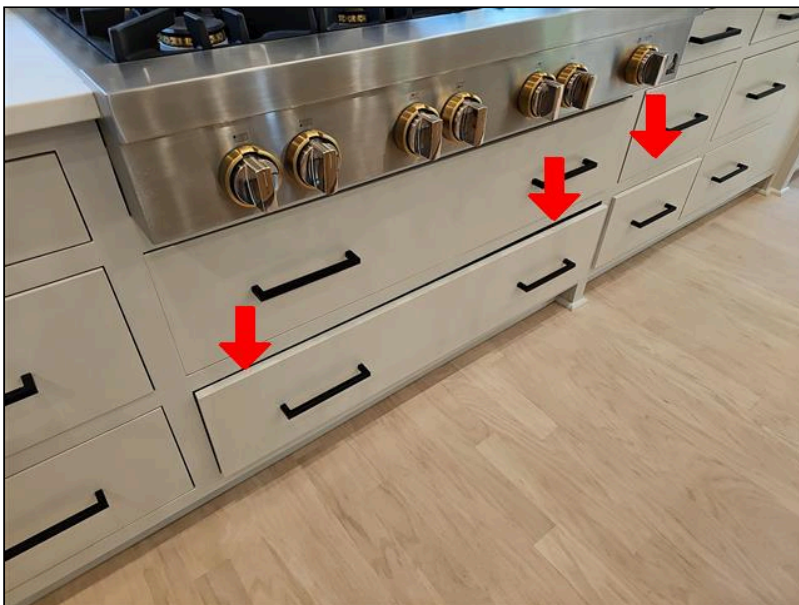
Bottom drawer under the surface unit and drawer to the right need adjustment to open and close.

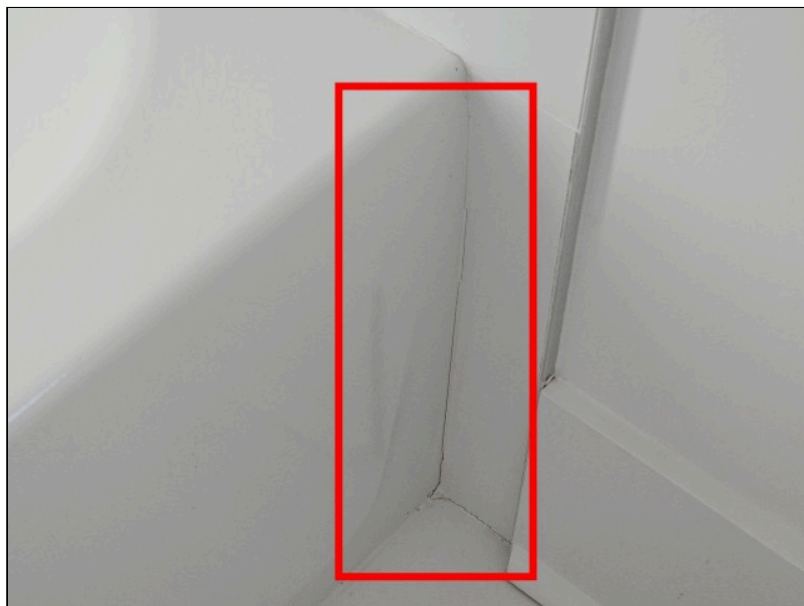
- 🏠 (1) Tub walls need to be caulked or grouted. The pictures shown are examples. A qualified contractor needs to caulk or grout. Location(s): shared bath

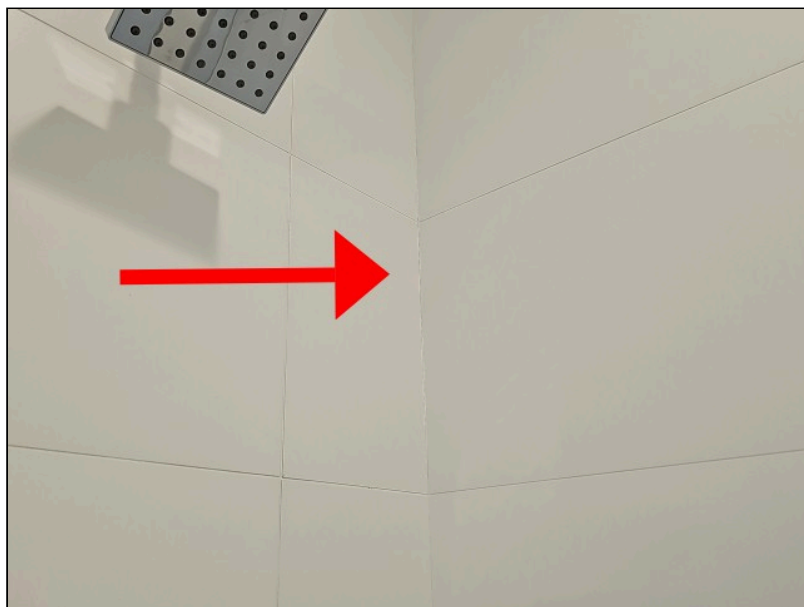
- 🏠 (2) Tub walls need to be caulked or grouted. The pictures shown are examples. A qualified contractor needs to caulk or grout. Location(s): bonus room bath

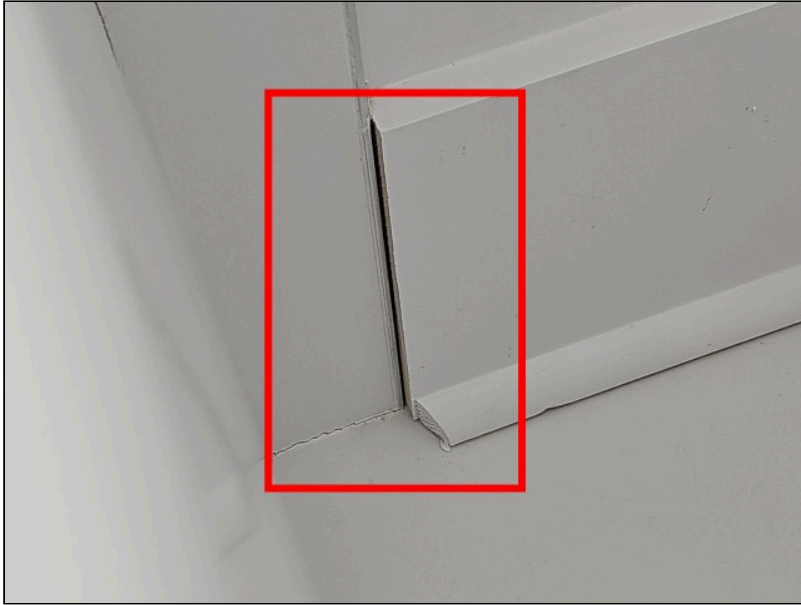
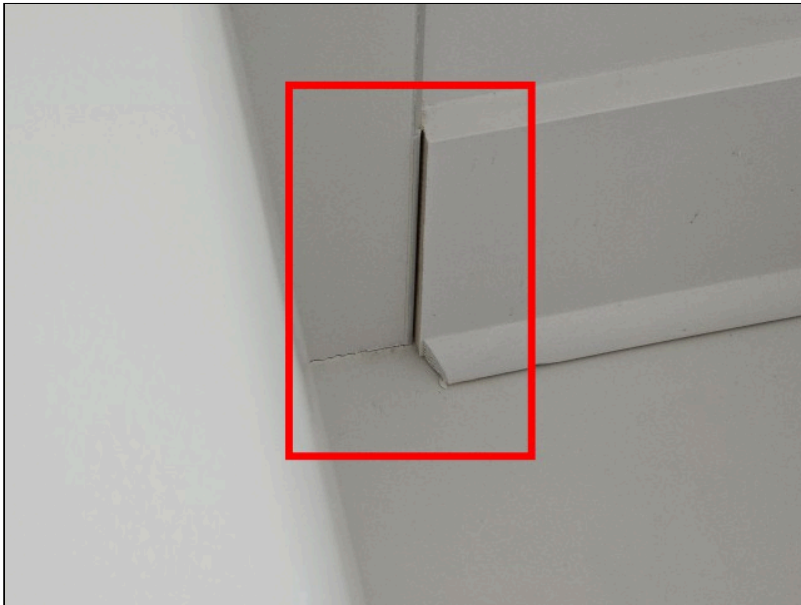
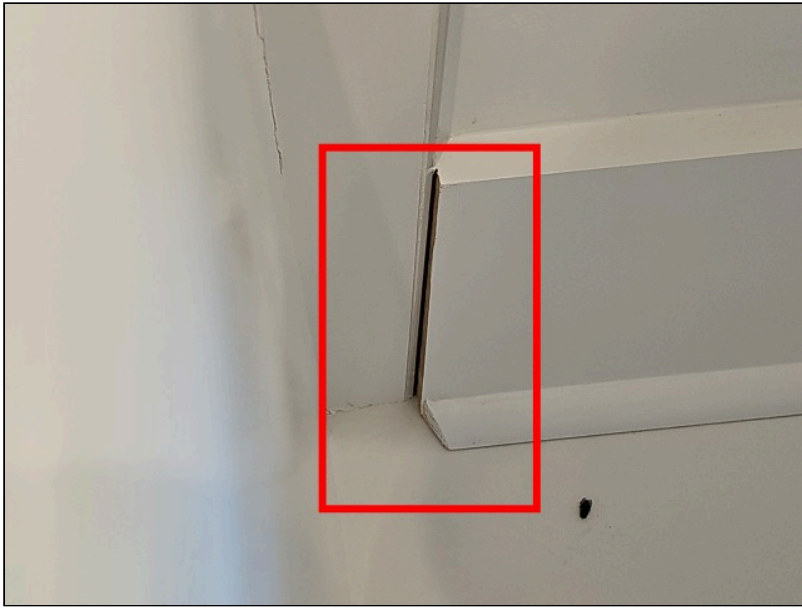
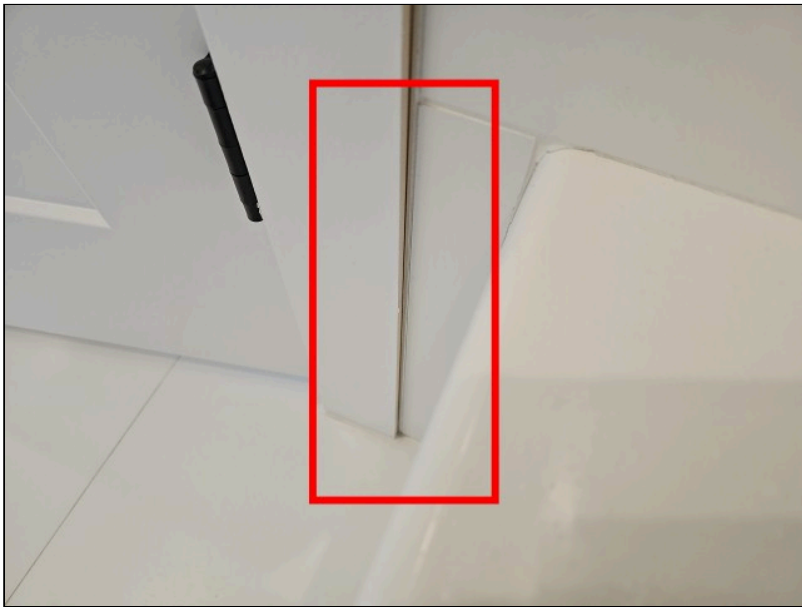
- 🏠 (1) End of base trim by the tub is not painted. Paint trim to prevent water damage to the trim.
Location(s): shared bath, bonus room bath

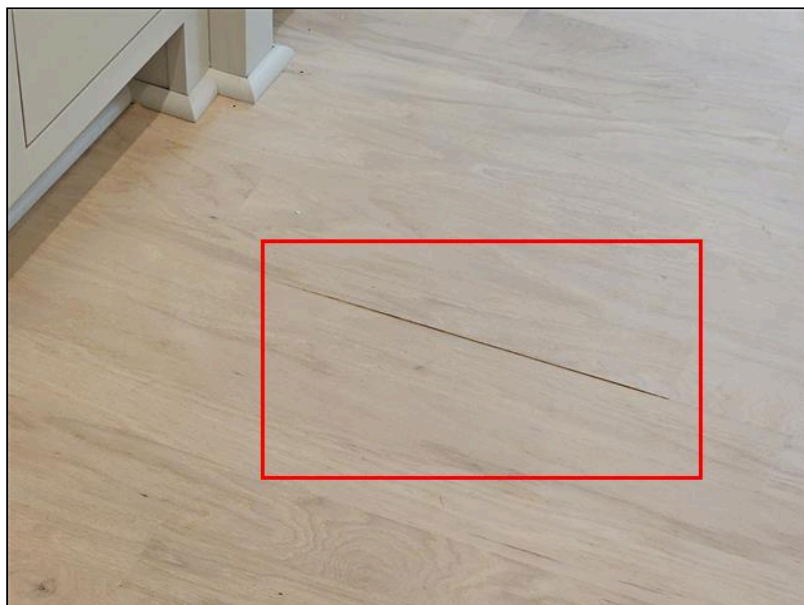
- 🏠 (2) The flooring needs to be secured to the floor in front of the oven. A qualified contractor needs to repair.

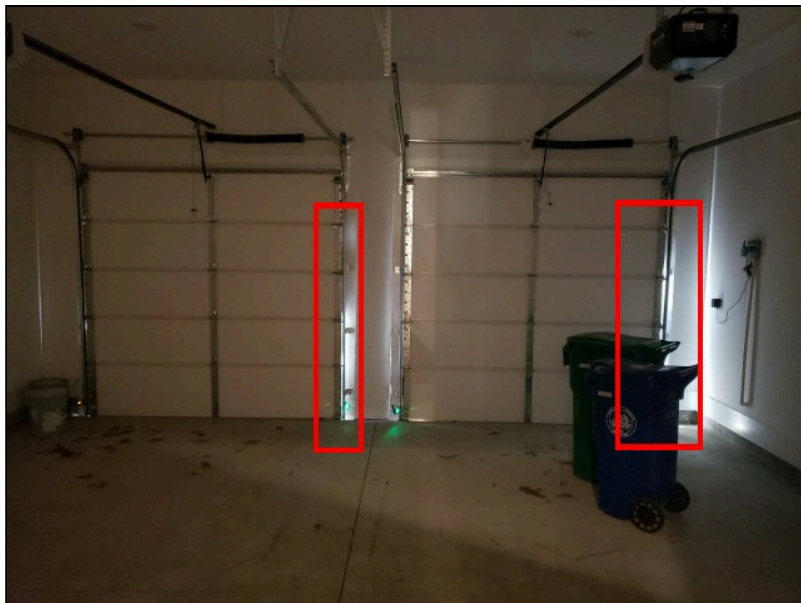
Door does not have a tight seal against the garage door casing. A qualified contractor needs to adjust door for a tight fit or add an additional piece of trim to obtain a tight seal. Location(s): garage doors
