Inspection Report

Property Address:
4321 Main St
GA

Marion Hodges Home Inspection Services

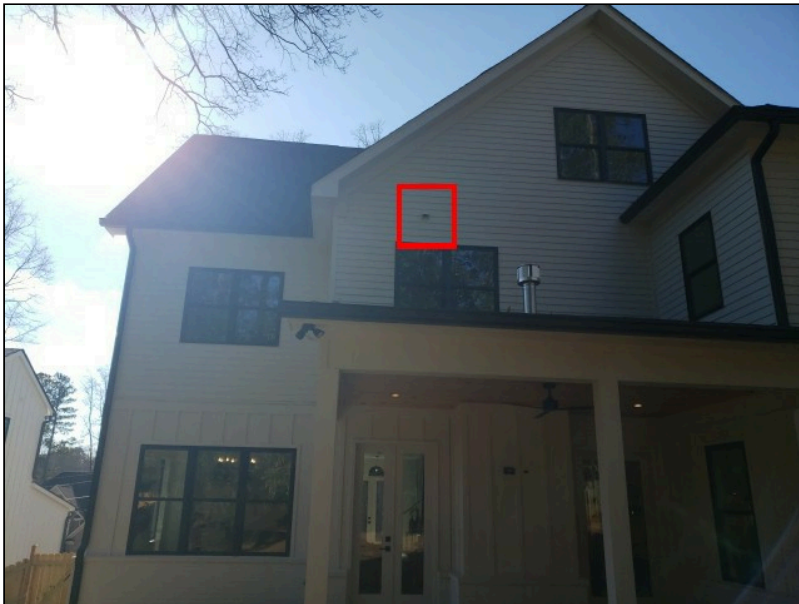
The backdraft damper at the bathroom exhaust duct termination does not close on the back of the house. Outdoor air intakes and exhausts should have automatic or gravity dampers that close when the ventilation system is not operating. A qualified contractor needs to adjust damper so damper can close or replace damper.

Code violation

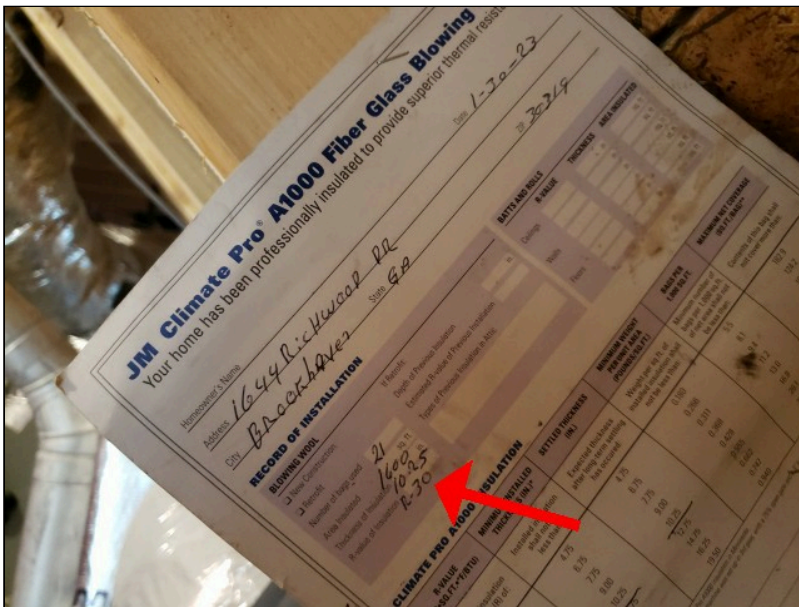
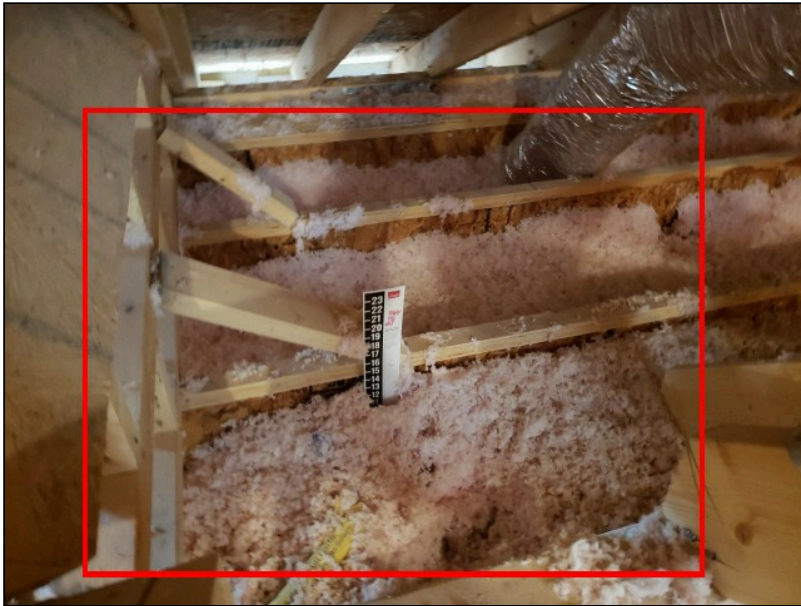
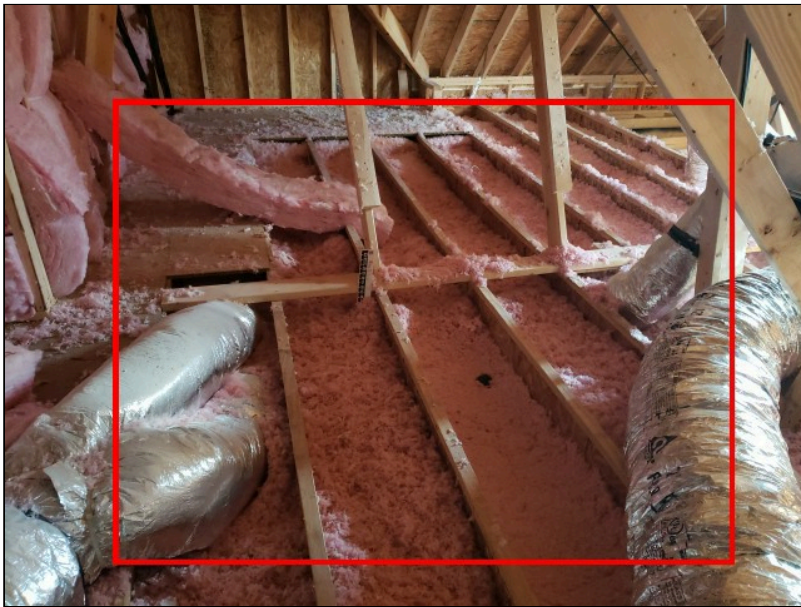
The insulation in the attic is less than today's standard of R-38. Per Georgia Energy Code, the insulation should have a heat resistant value (R value) of 38. A qualified contractor needs to install insulation in accordance to current Georgia Energy Code.

Georgia Energy Code violation

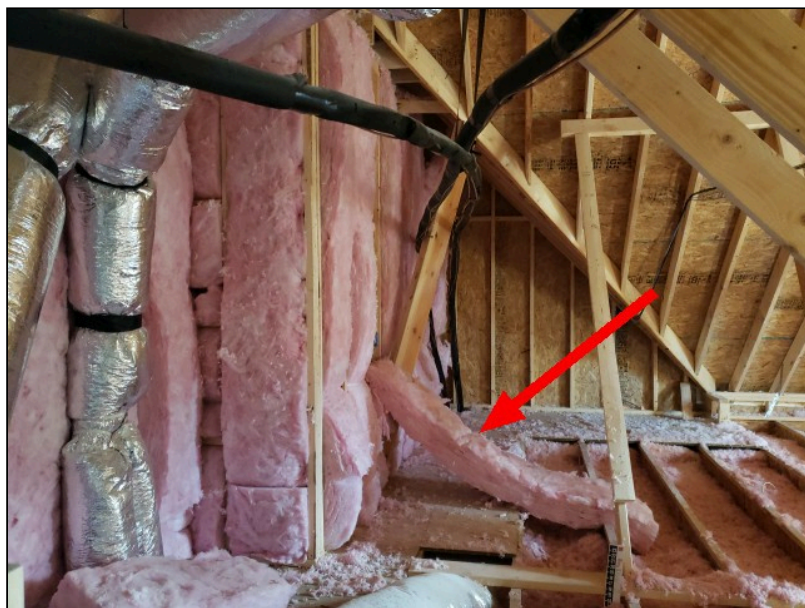
- Missing insulation between the studs was observed in the attic. A qualified contractor needs to install insulation where missing.

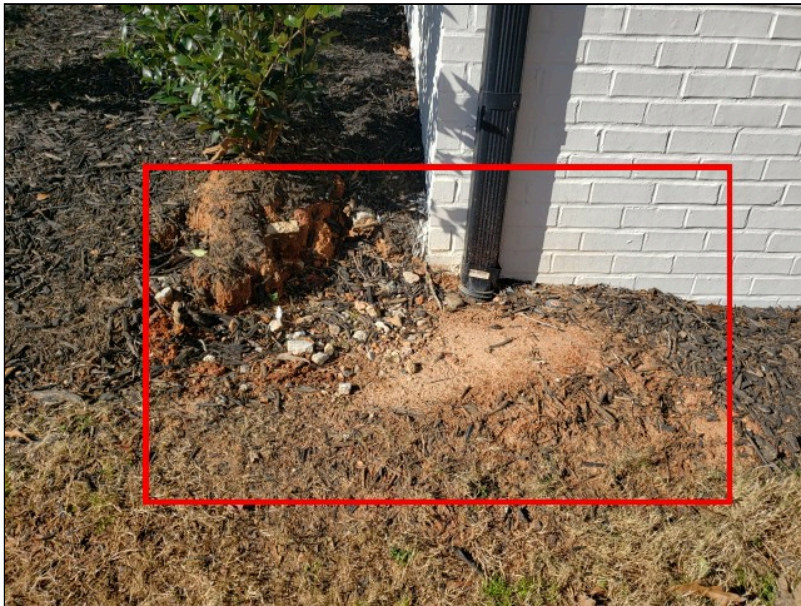
(1) Water runoff is washing out soil. A qualified contractor needs to evaluate further and make repairs to control water runoff. Location(s): right side of the house

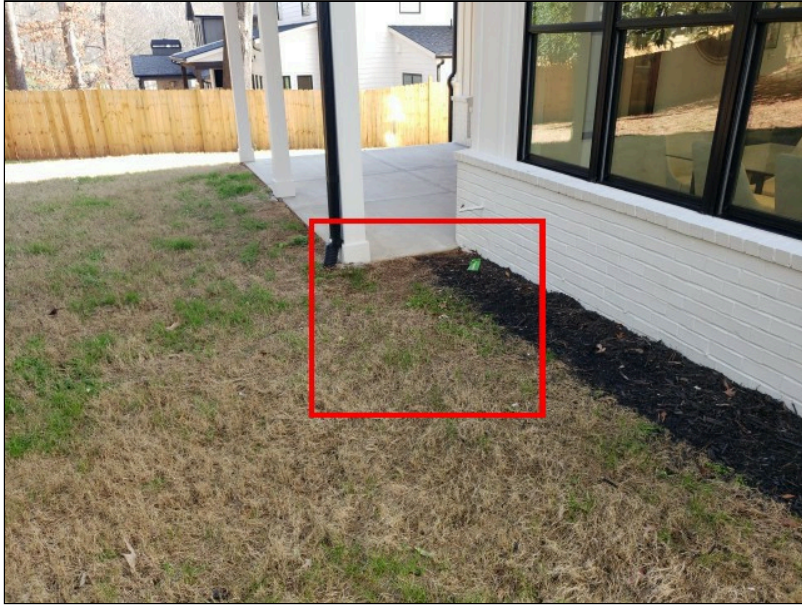
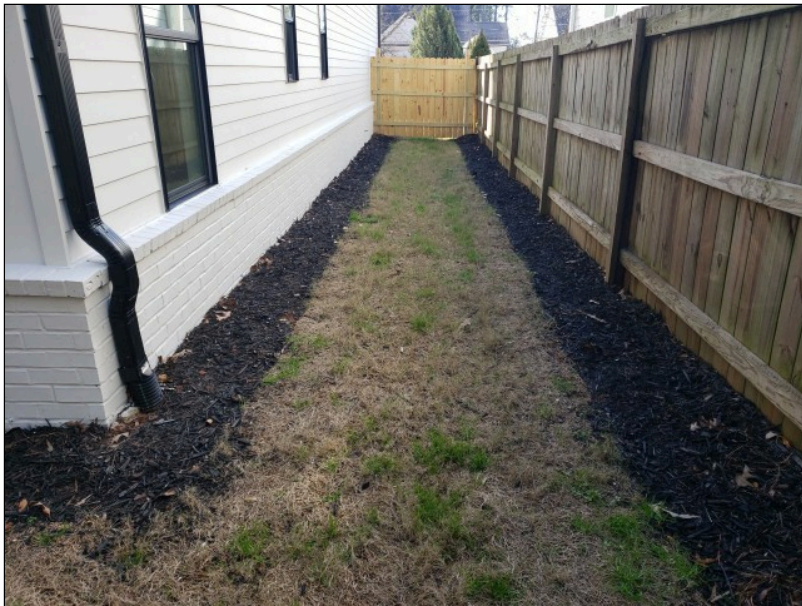
- 🏠 (2) The grading generally does not provide positive drainage away from the foundation. There should be 6" of fall in the first 10' away from the foundation. A qualified contractor needs to evaluate further and repair. Location(s): back and left side of the house

Code violation

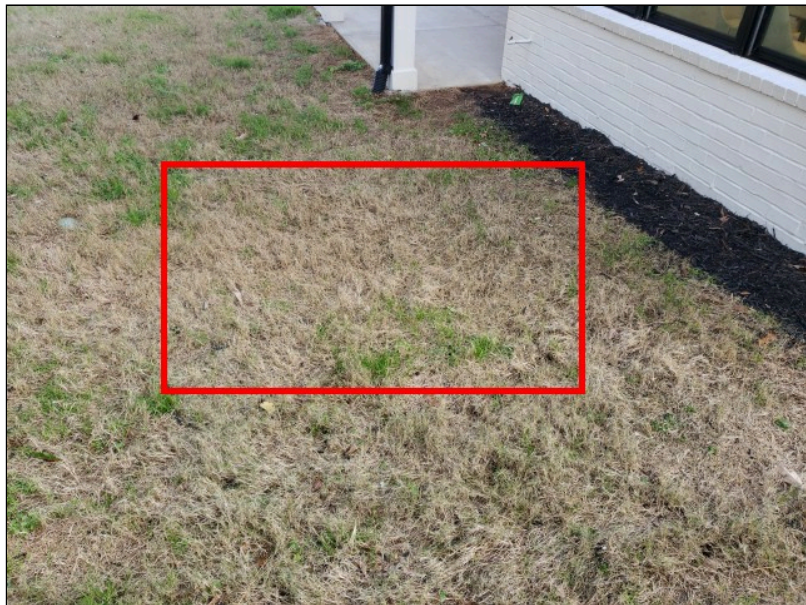
- 🏠 (3) Water appears to pool after rain. Some additional dirt, light grading, and yard drain boxes may be needed to drain the water off of the lot if water stands for more than 48 hours. Location(s): back of the house

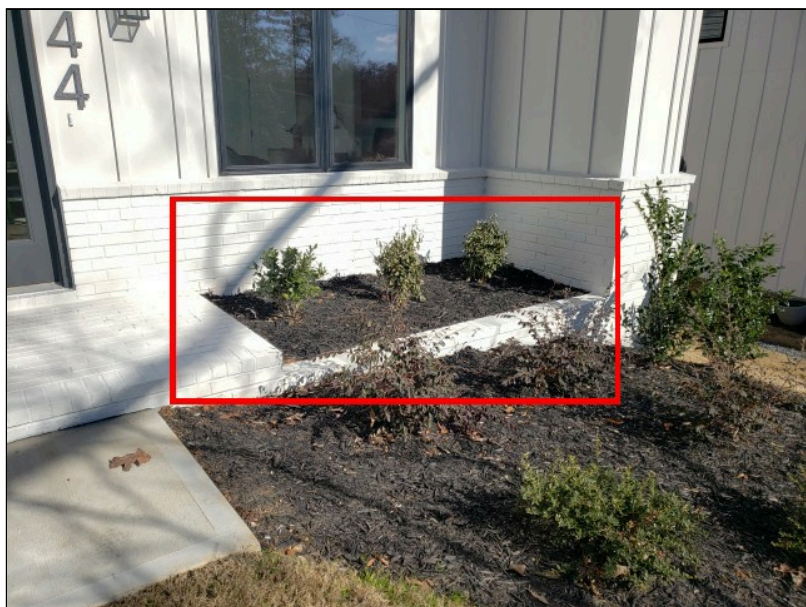
- 🏠 (4) Where does water drain in the front planter box? There needs to be a drain in the front planter box to prevent water from collecting around the foundation. Check with builder to see if drainage is installed. If there is no drainage, a qualified contractor needs to install a drain source.

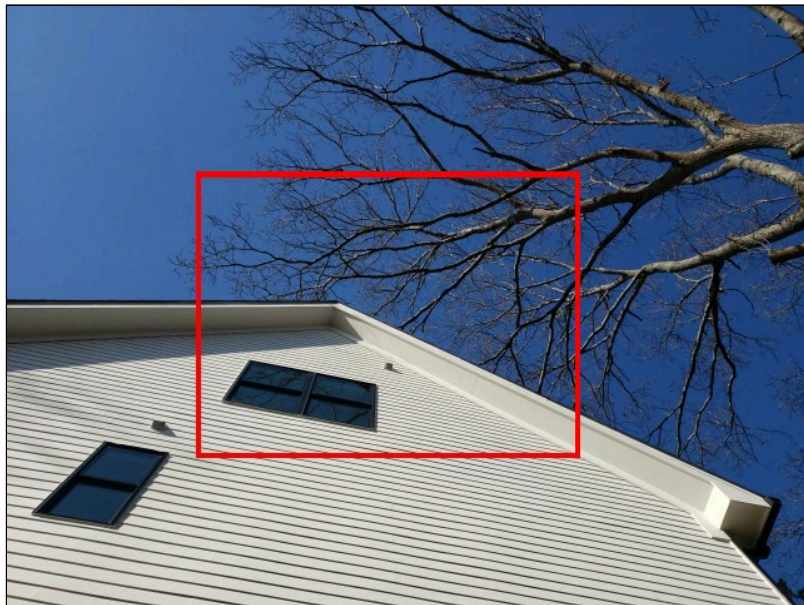
Tree limbs that are in contact with the roof or hanging over the roof need to be trimmed at least 5 feet away from the house.

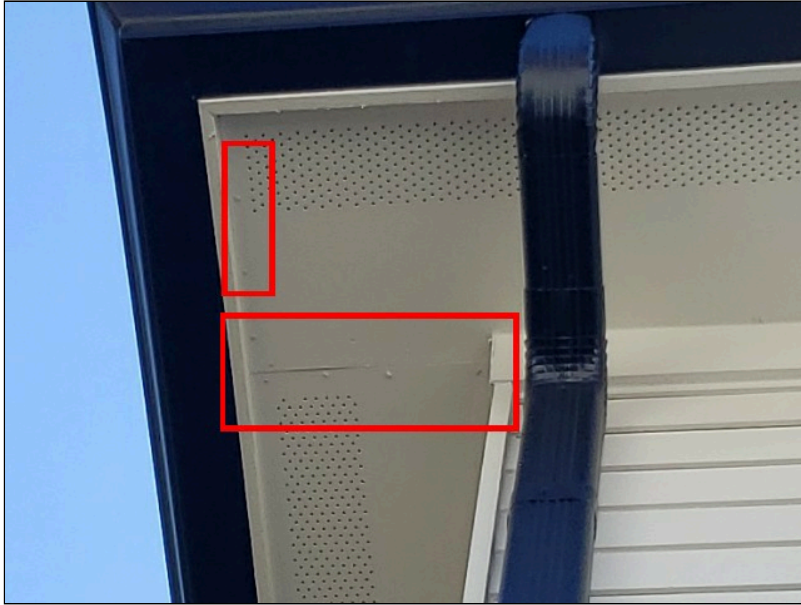
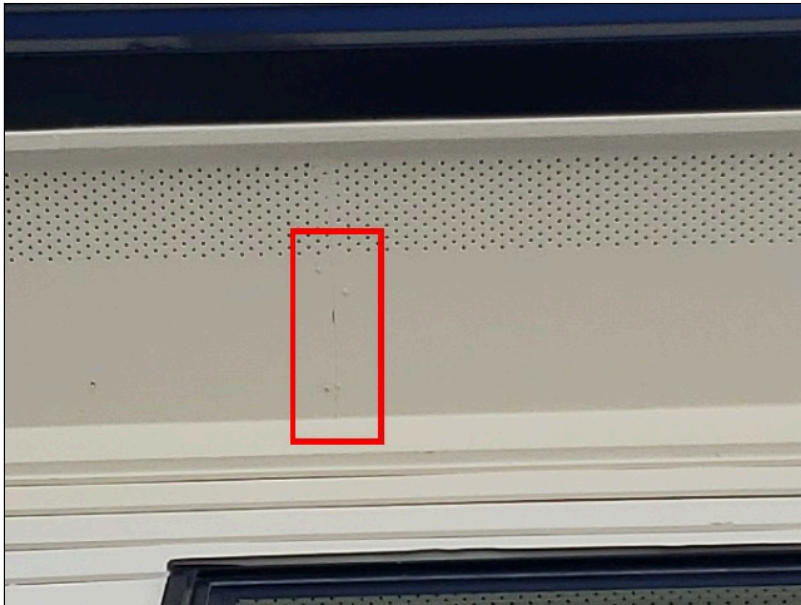
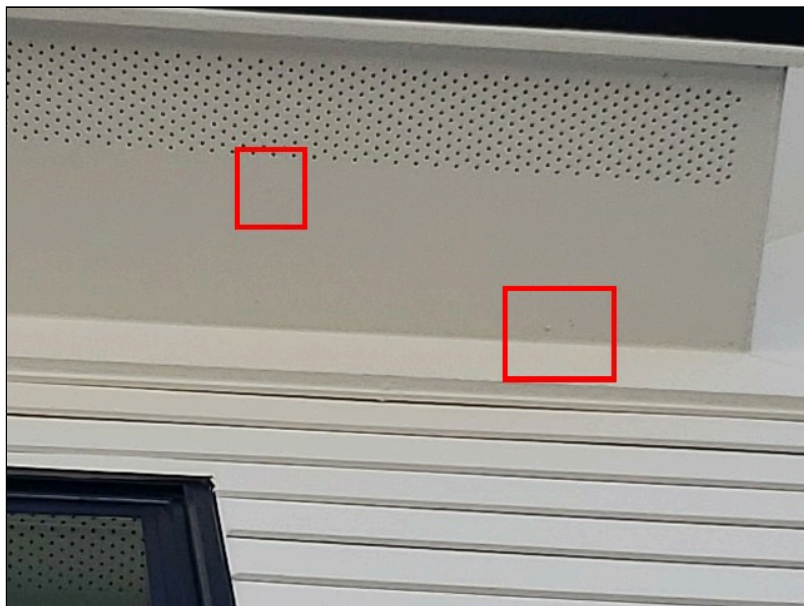
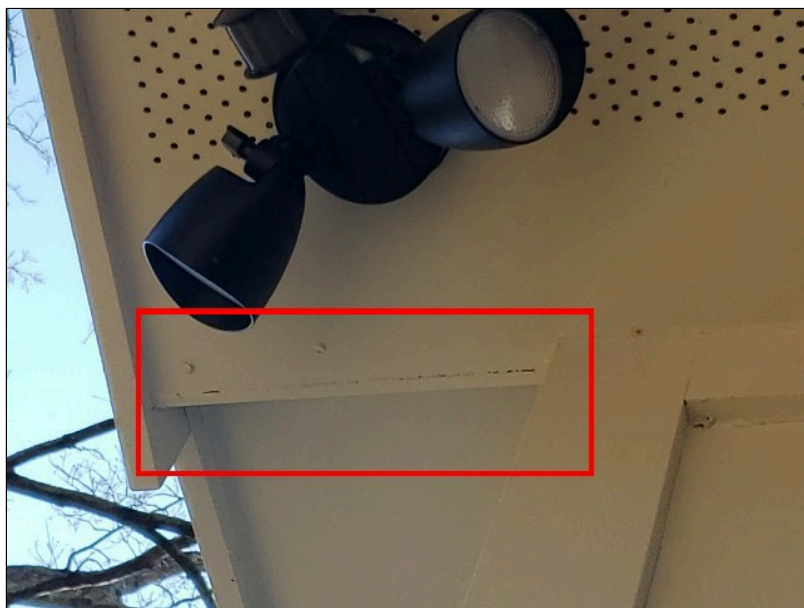
🏠 Exposed nail heads in the soffit need to be nailed, caulked, and painted. A qualified contractor needs to repair. Location(s): back and left side of the house

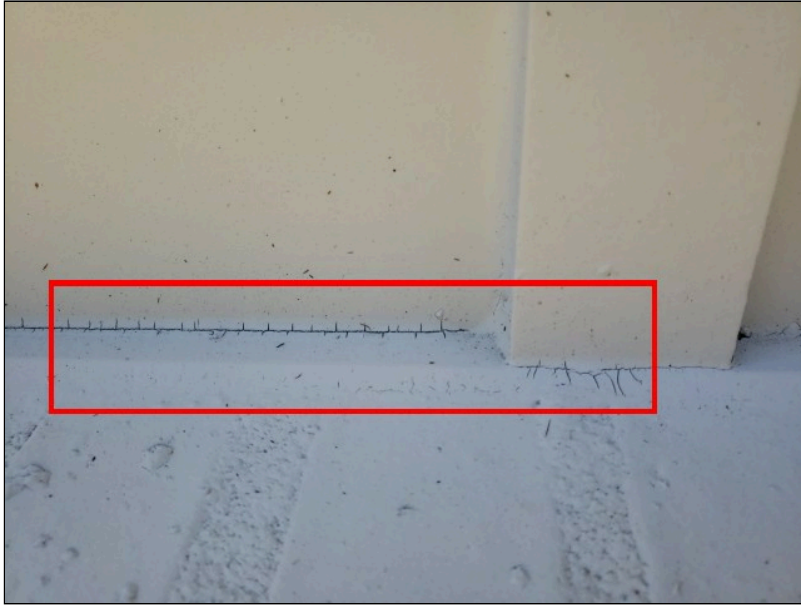
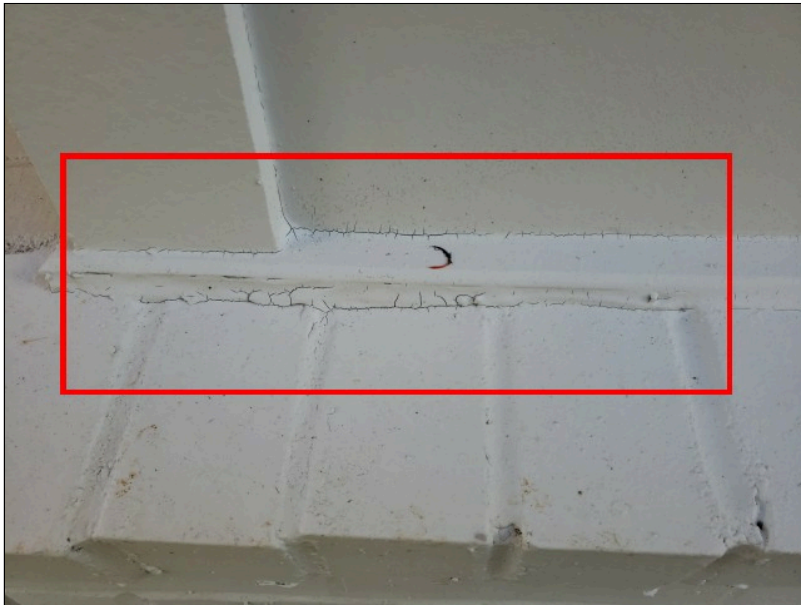
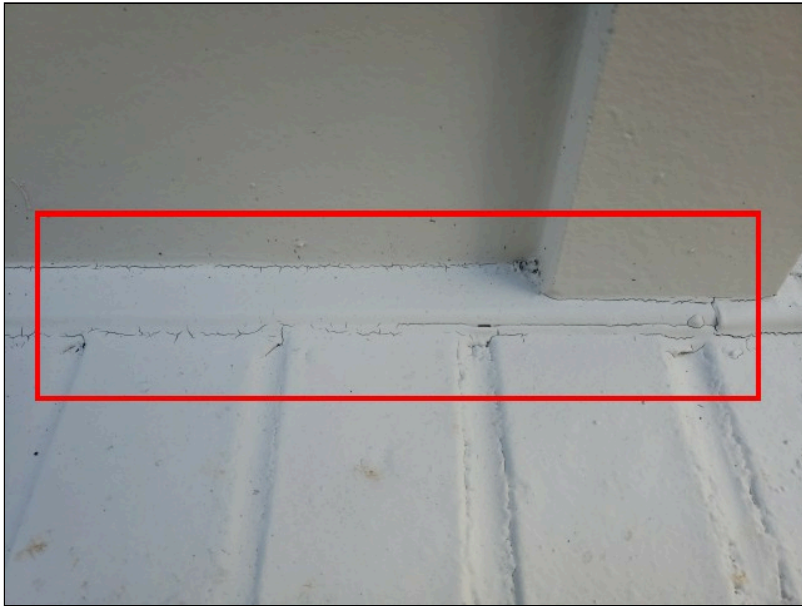
- 🏠 (1) Siding needs to be caulked. See pictures for examples. A qualified contractor needs to caulk siding and paint to match existing as needed. Location(s): back of the house

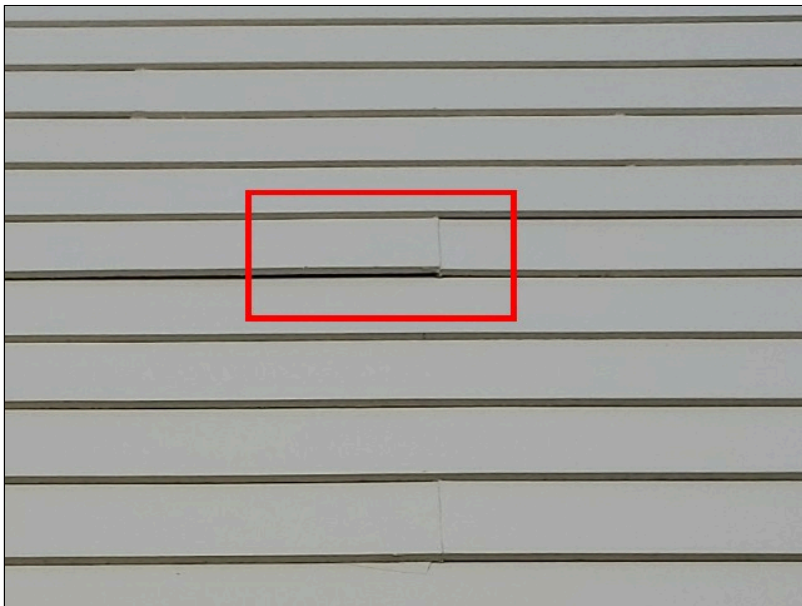
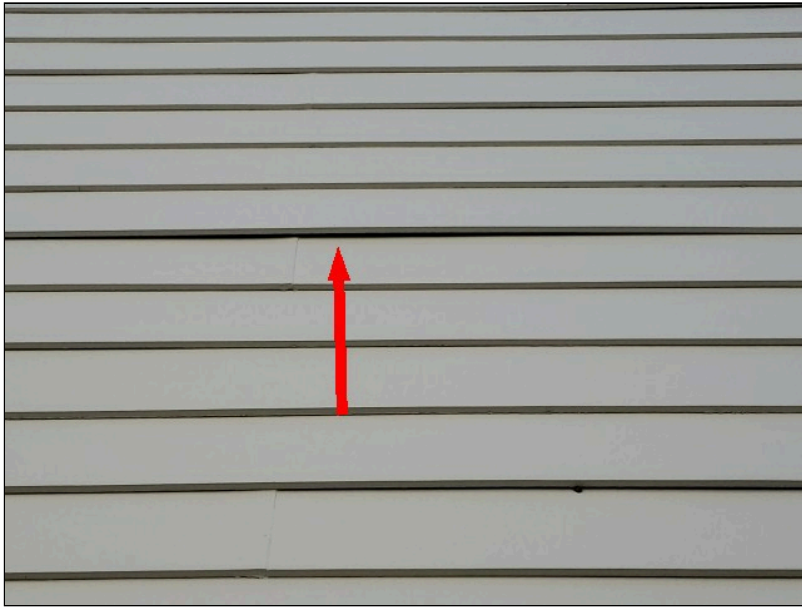
(2) Siding needs to be nailed/re-nailed. A qualified contractor needs to repair. Location(s): left side of the house

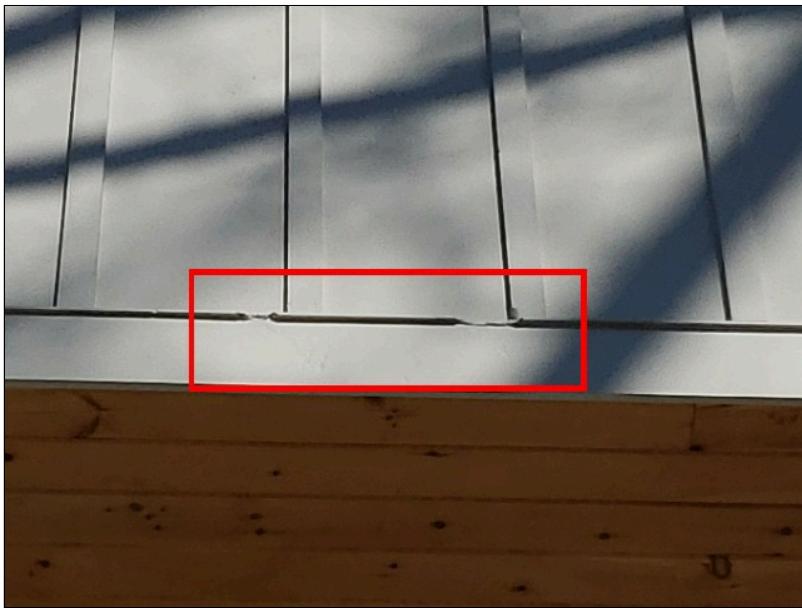
(3) Drip edge trim is damaged. A qualified contractor needs to replace damaged trim. Location(s): front of the house

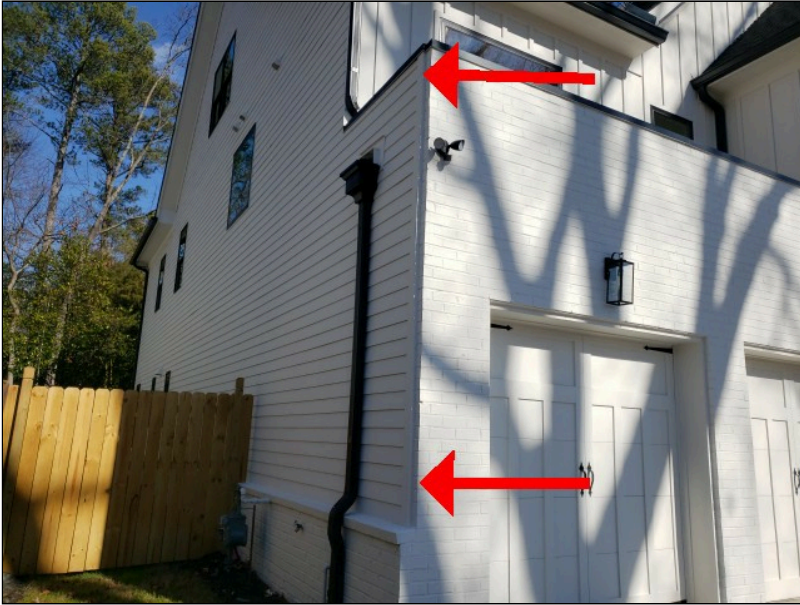
- 🏠 (4) Corner boards need to be caulked and painted. A qualified contractor needs to repair. Location(s): front left corner

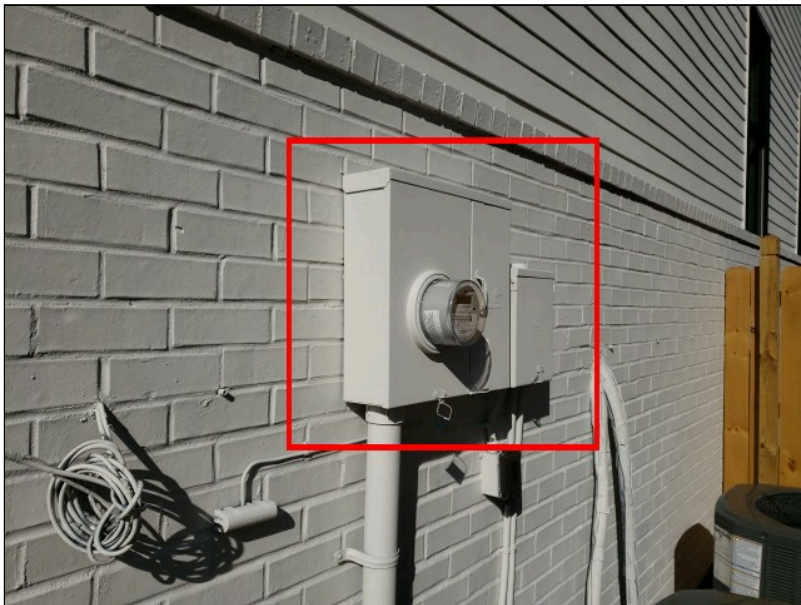
All utility penetrations through the exterior wall should be caulked or filled with foam. The following utility penetrations should be caulked or filled with foam to limit air infiltration: meter base

Code violation

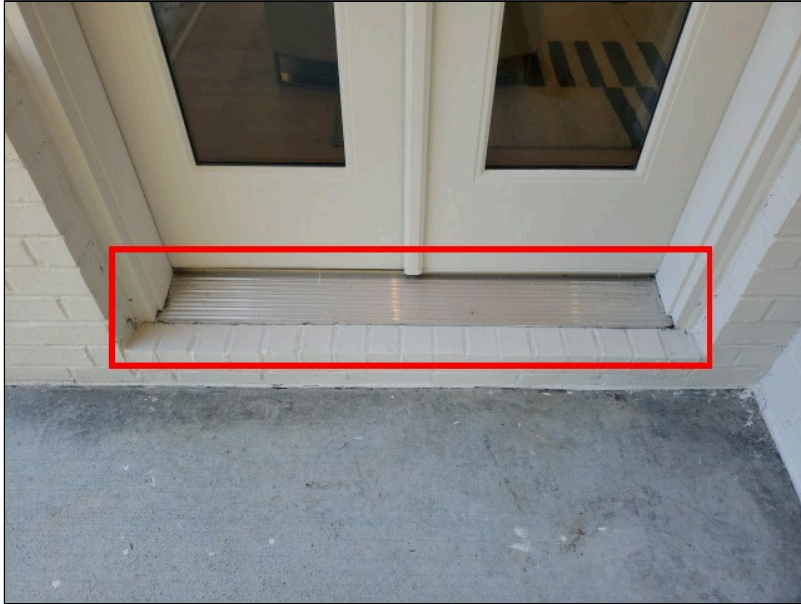
🏠 Joint between the door jambs and threshold needs to be caulked. A qualified contractor needs to caulk door jambs and threshold to prevent air intrusion or moisture penetration. Location(s): back doors, front door

Code violation

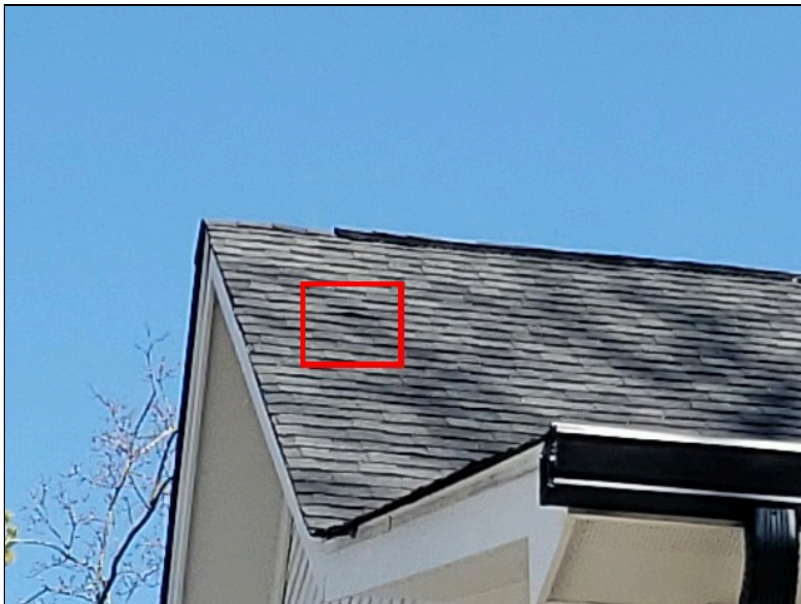
There are uplifted shingles on the roof. Picture(s) are examples. A qualified roofer needs to repair.

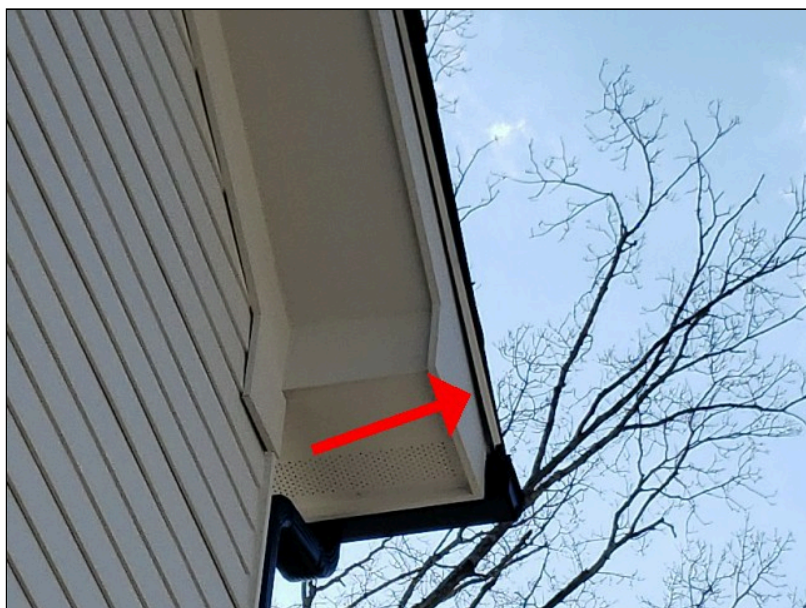
- 🏠 (1) Drip edge flashing is loose. A qualified contractor needs to repair. Location(s): front left corner

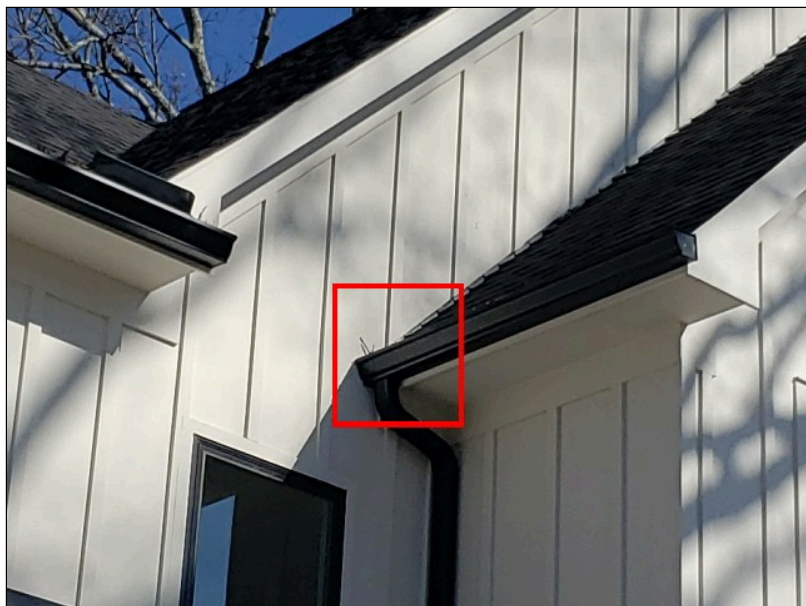
- 🏠 (2) Kickout flashing needs to be installed to divert water into the gutters. Flashing is needed to prevent water from penetrating into the wall structure. Picture(s) are examples. A qualified roofer needs to repair.

Code violation

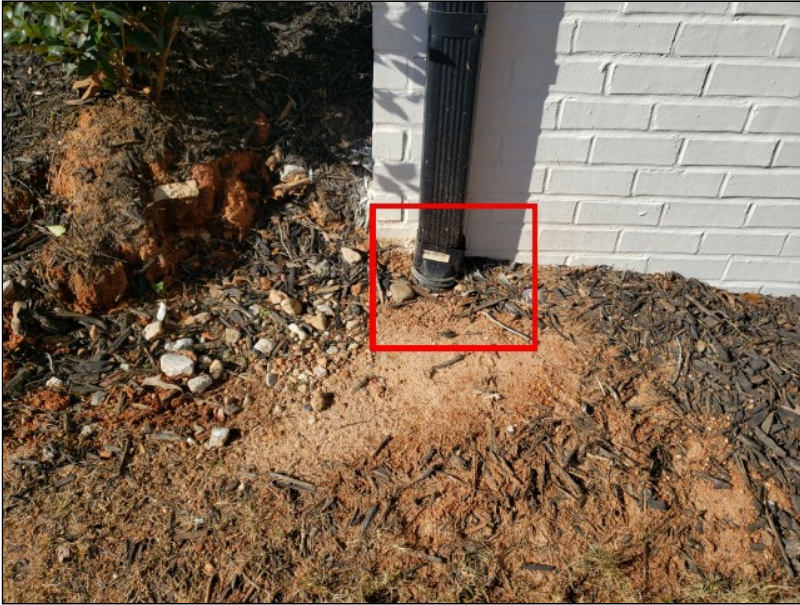
- (1) The downspouts are piped away from the house. The builder needs to identify where pipes drain. The pipes could drain to a dry well.

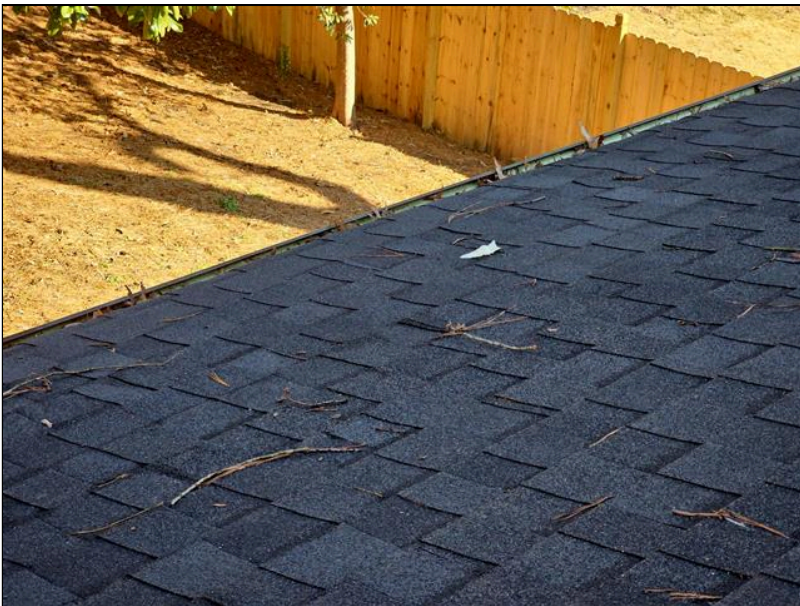
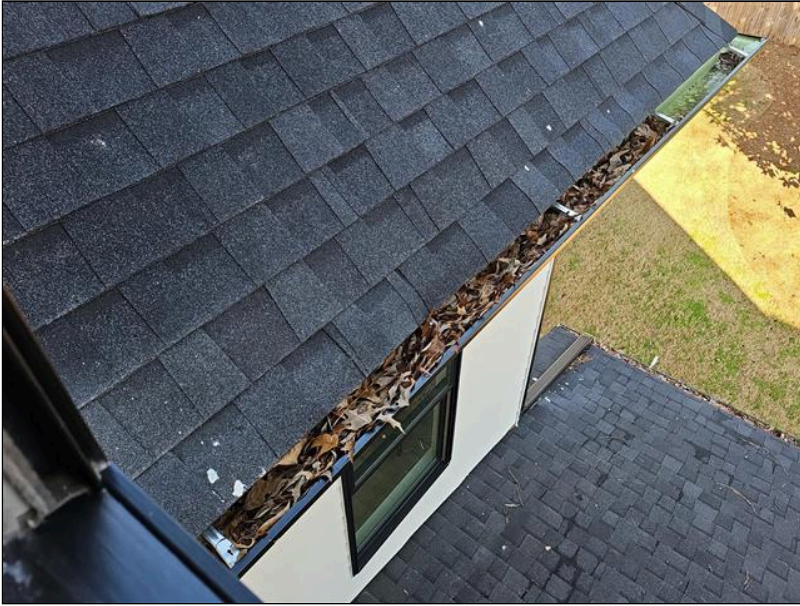
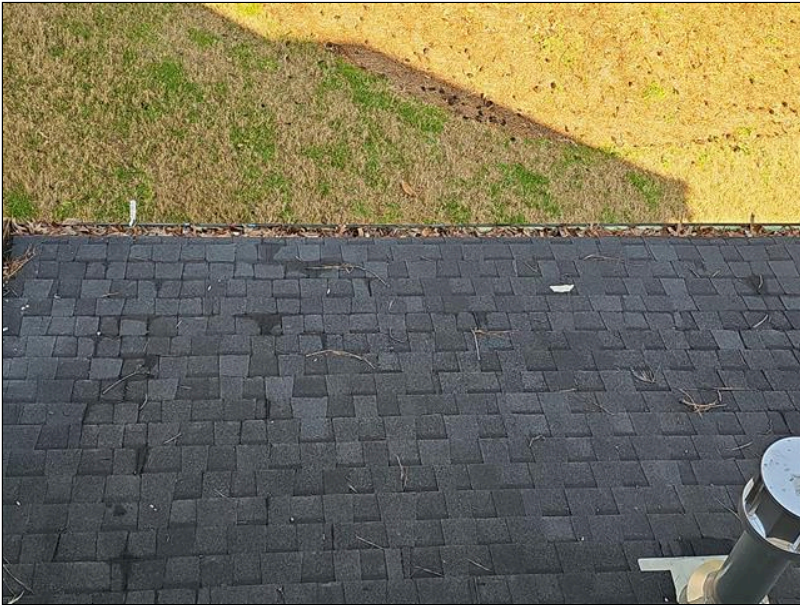
- (2) The gutters and downspouts need to be cleaned.

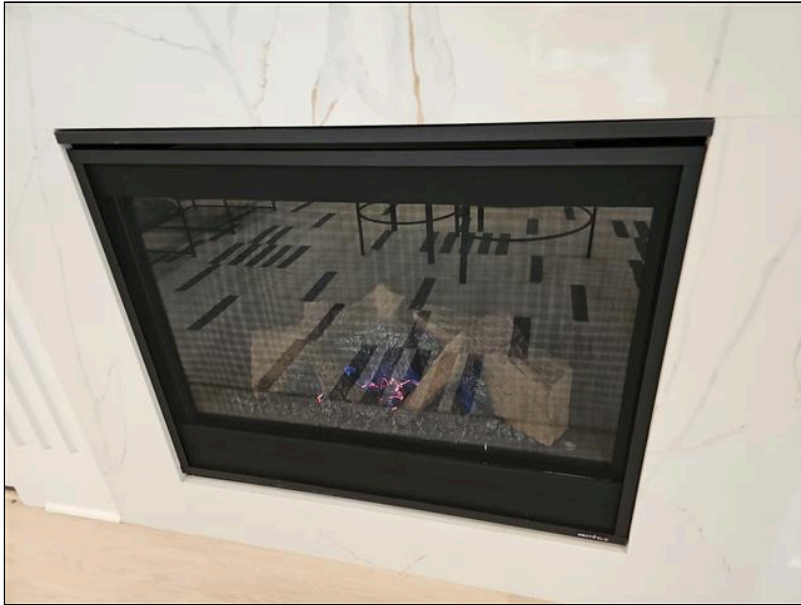
The gas logs were operational at the time of the inspection.
