Inspection Report

Marion Hodges Home Inspection Services

6731
GA

Single Family (2 story)

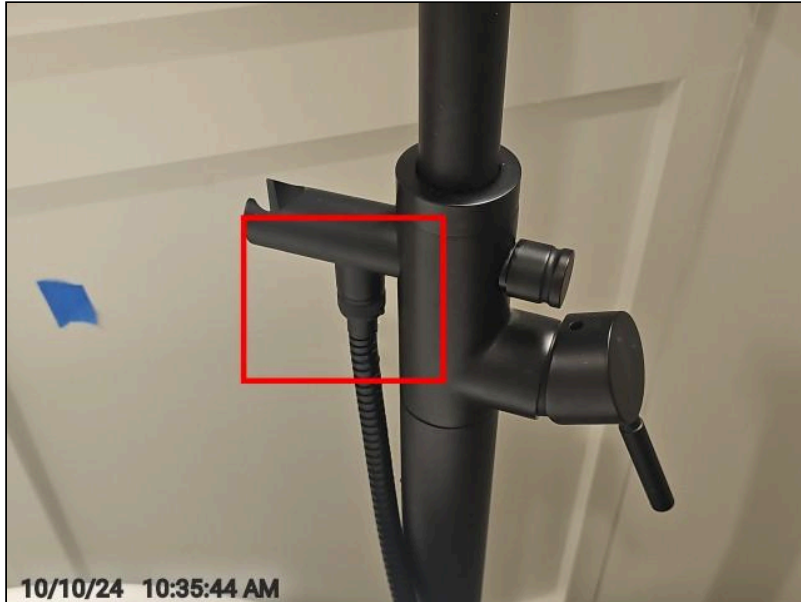
🏠 The tub wand leaks at connection when water turned on to tub wand. A licensed plumbing contractor needs to repair. Location(s): primary bath

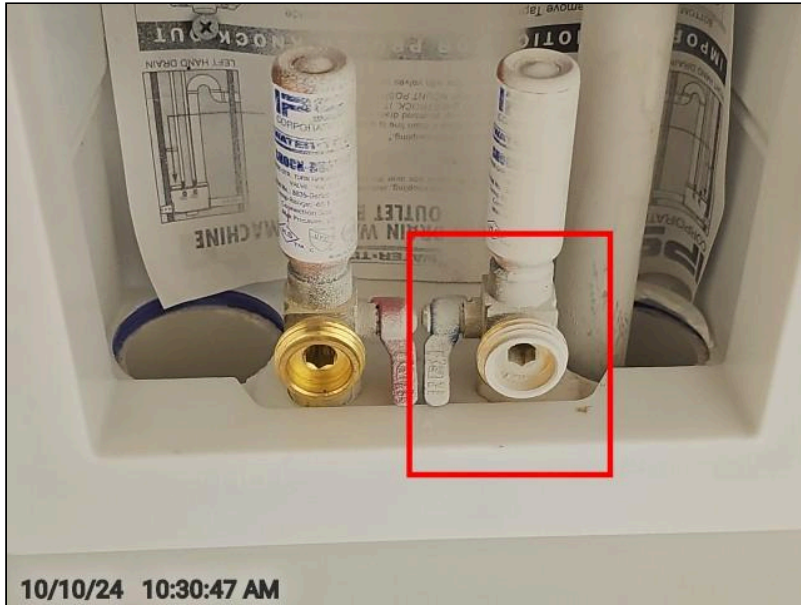
- 🏠 The threads on washer valves need to be cleaned. All plumbing connections should be clean. A licensed plumbing contractor needs to repair.

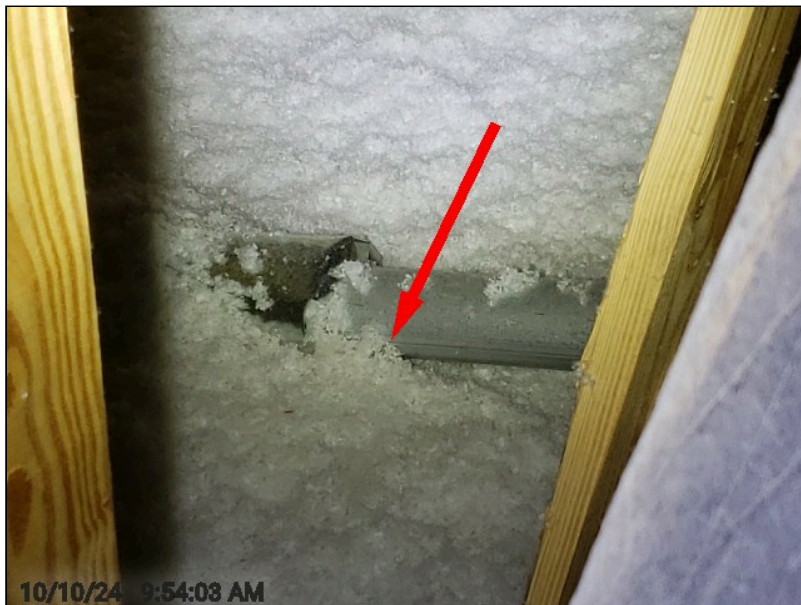
🏠 Water heater vent pipe needs to have a one inch clearance from combustable materials. This is a safety issue. A qualified contractor needs provide a one inch clearance from insulation.

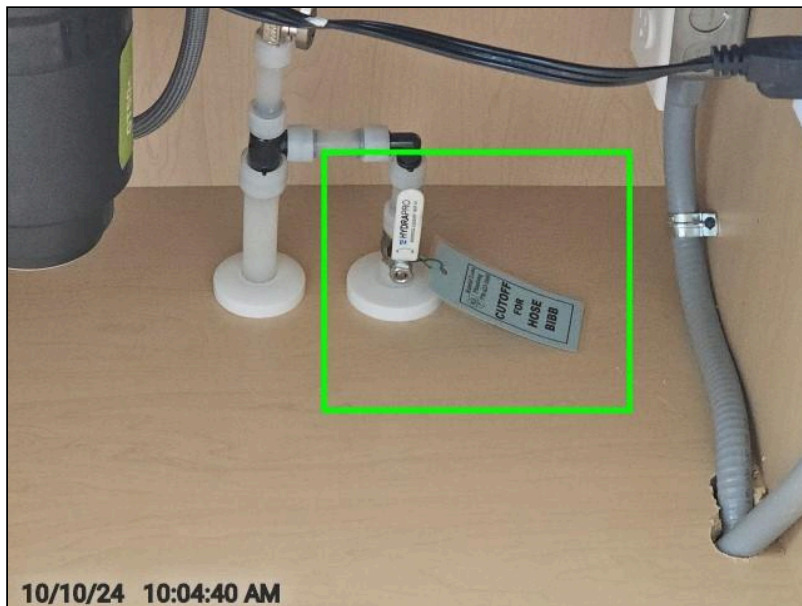
In Kitchen Sink Cabinet

FYI, Location of exterior water faucet shutoff. (See Photo). In the winter time, a good practice is to turn off the water to the exterior faucets and drain exterior faucet to prevent pipe from freezing. This is for your information.

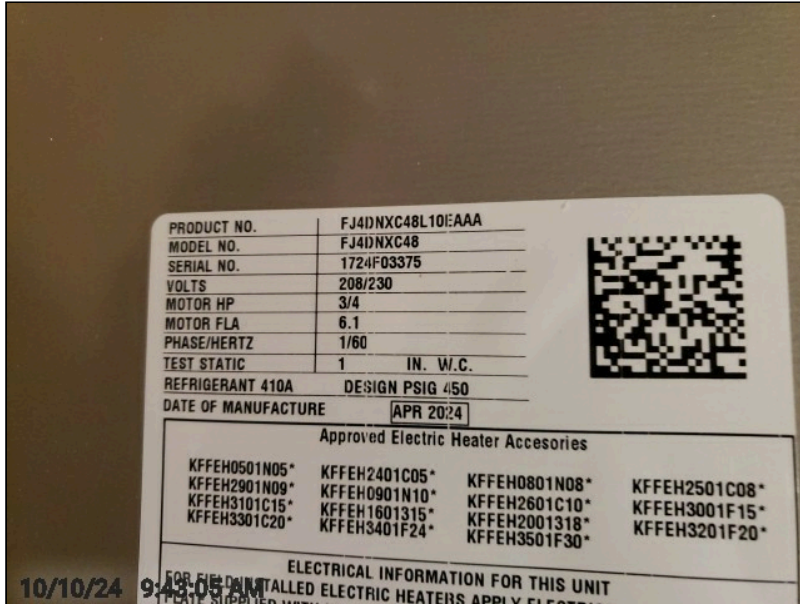
🏠 The heat pump was not tested. The outside air temperature has been greater than 65 degrees. Operating the heat pump condensing unit when the outside air temperature has been greater than 65 degrees can damage the equipment. The builder needs to warrant normal operation of the equipment.

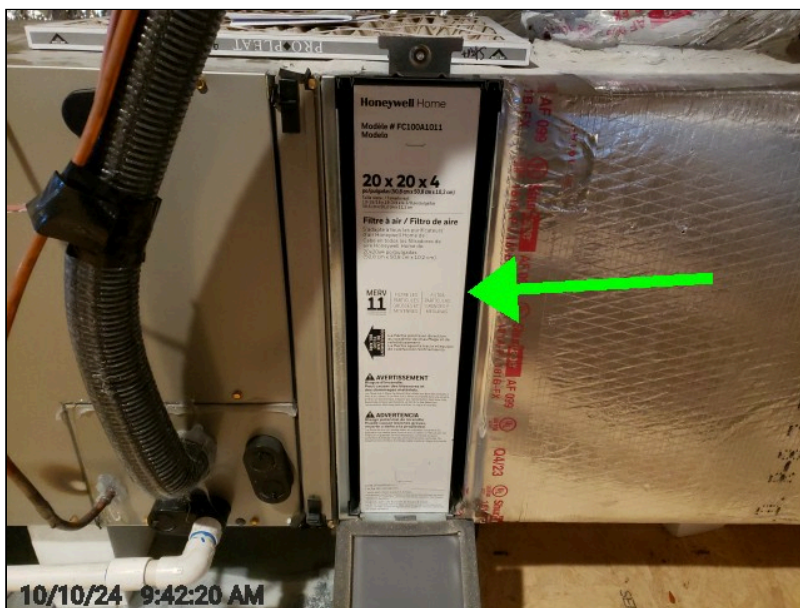
Location of return air filter(s) for heating and air equipment. The filter(s) should be changed every 9 to 12 months. Recommend that the filters be changed once you take possession of the house.

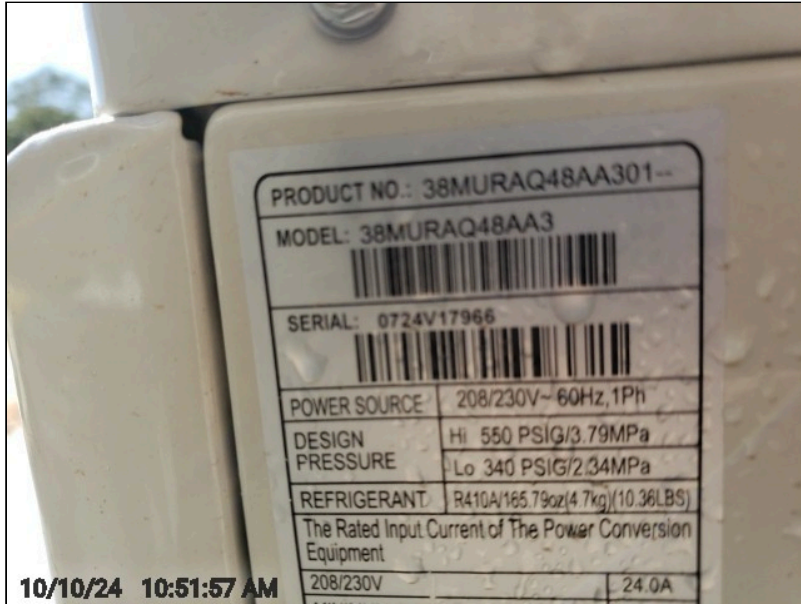
(1) Condensing unit serial plate for your records.

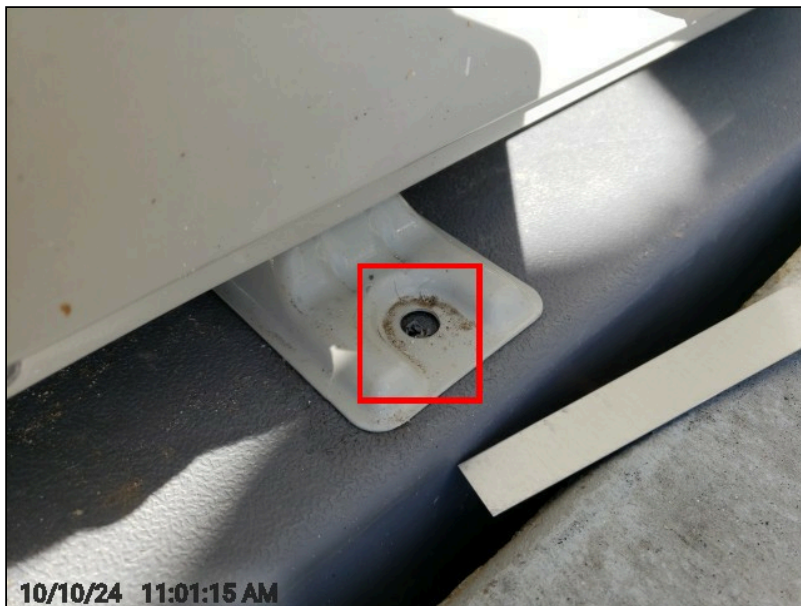
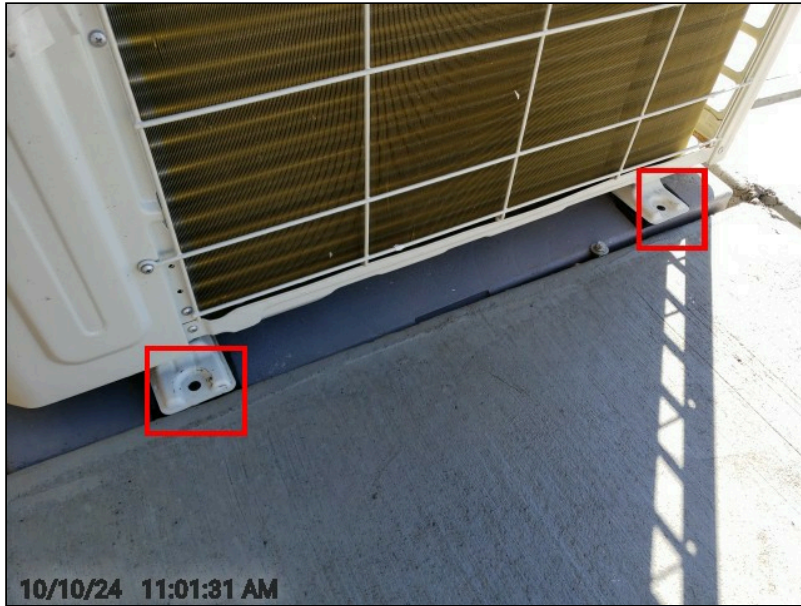
(2) The condensing unit needs to be anchored to the pad. A qualified contractor needs to repair.

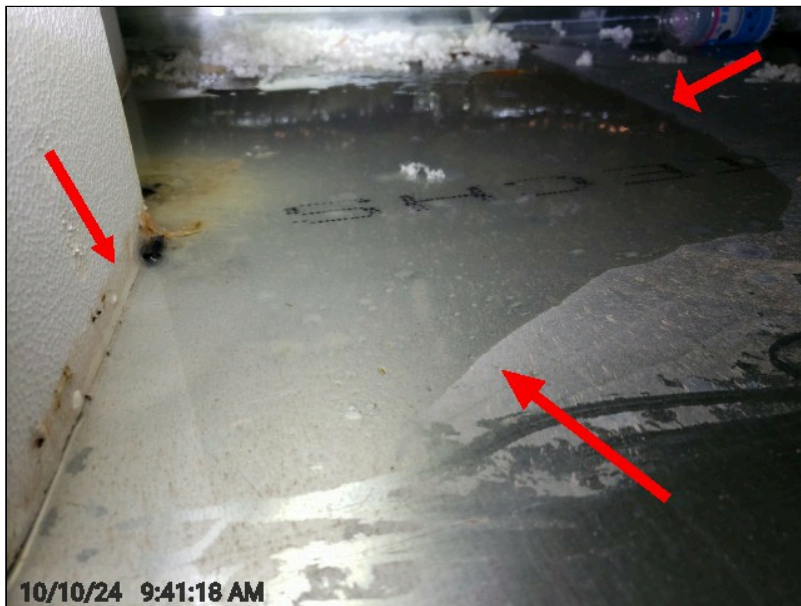
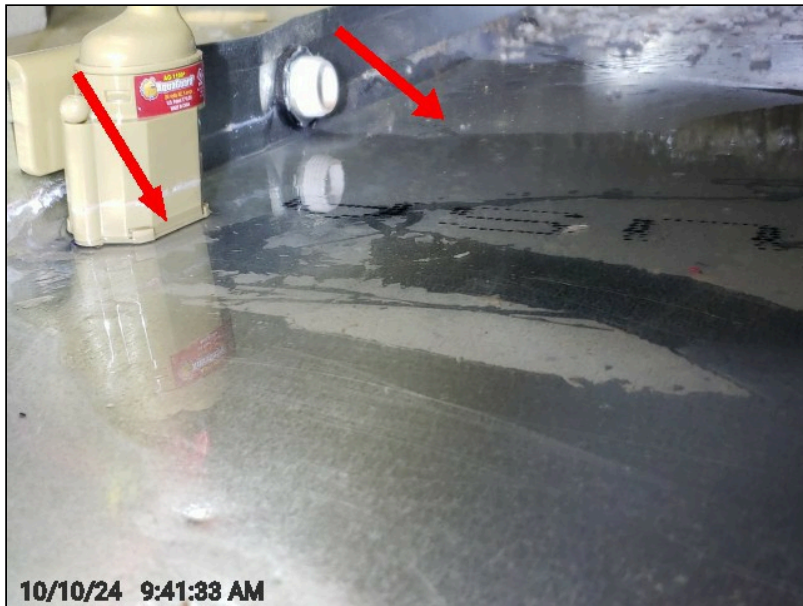
- 📌 (1) Water is in the condensation overflow pan in the attic. A licensed heating and air contractor needs to evaluate further and make repairs as needed.

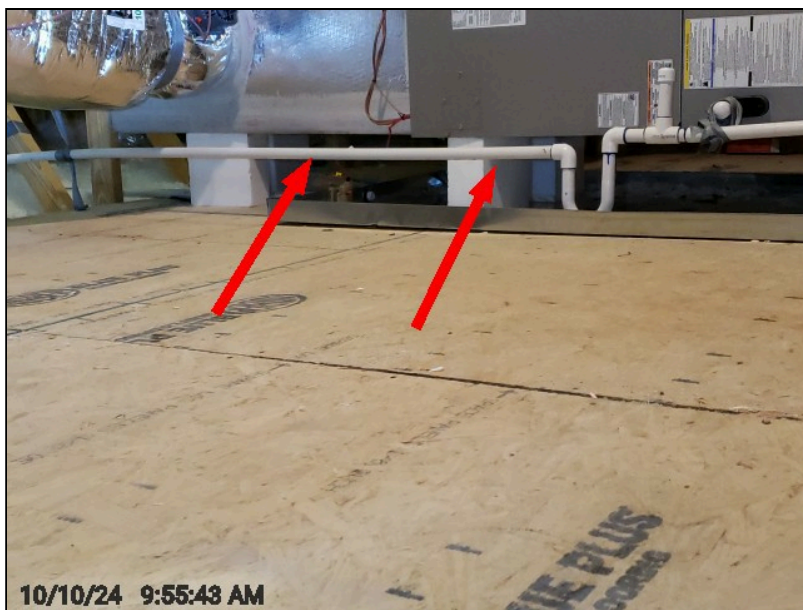
- 🏠 (2) The condensation drain line does not have a gravitational flow to the exterior in the attic. The drain line lays flat without slope in pipe. The pipe should have a 1% slope to prevent backup. A licensed heating and air contractor needs to repair.

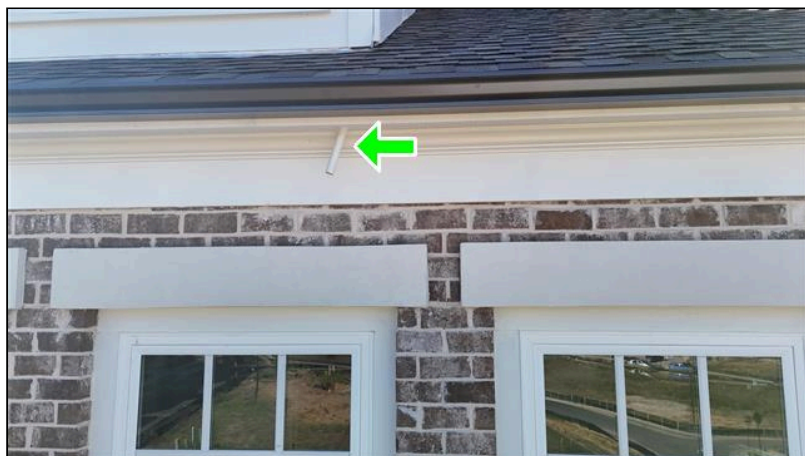
(3) FYI, The picture shown is the location of the auxiliary condensation drain line from the air conditioning system. The drain line is installed in a conspicuous place so that you can be alerted if water is dripping from the pipe. If there is water draining from the pipe, the A/C should be serviced ASAP by a licensed HVAC contractor. The primary drain could be blocked which can cause an overflow.

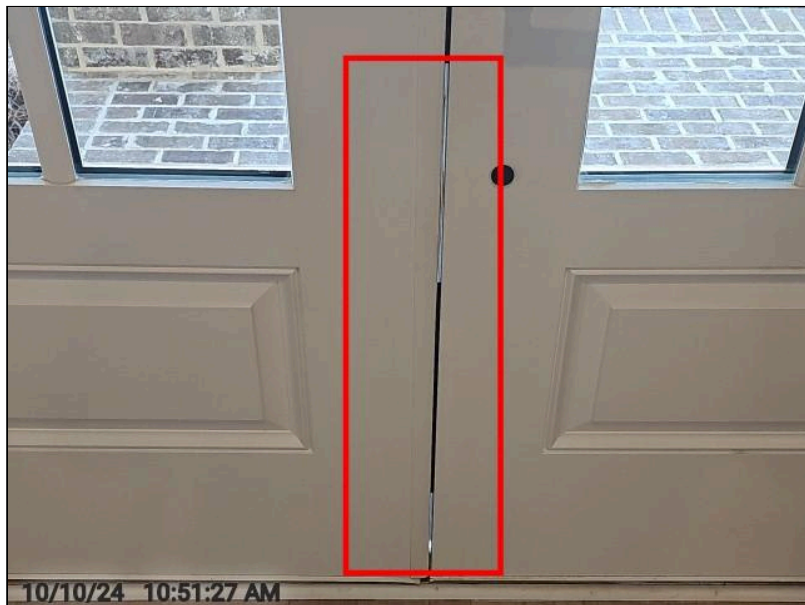
- 🏠 Door reveals daylight when the door is closed. A qualified contractor needs to weatherstrip door to provide a tight seal. Location(s): front door

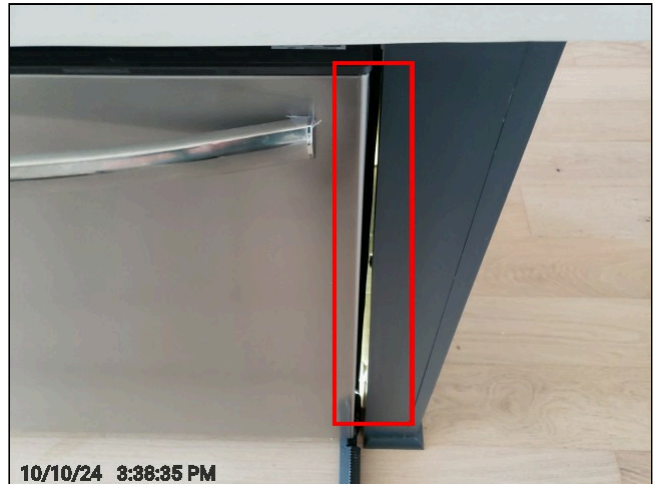
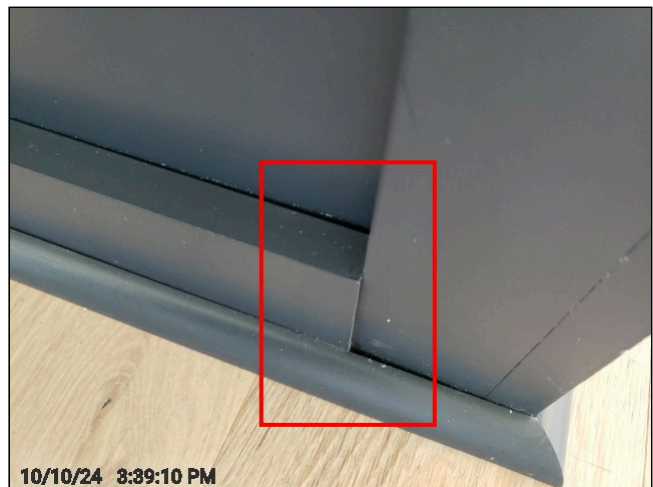
(2) Kitchen cabinet end wall by the dishwasher is not plumb. There is a gap between the dishwasher and cabinet. A qualified contractor needs to repair.

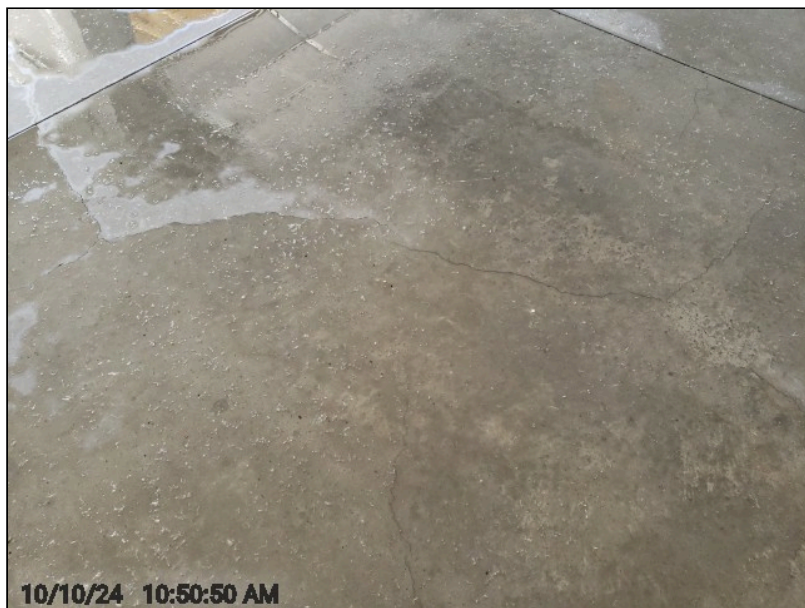
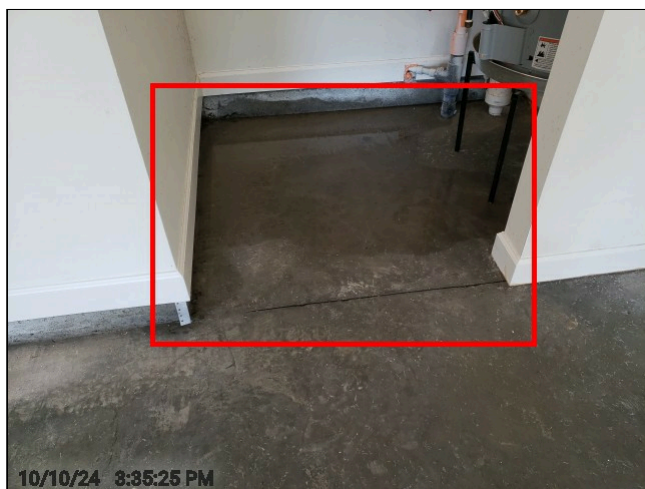
Shrinkage cracks were noted in the garage slab. Shrinkage cracks are usually a result of the curing process of concrete, expansion, and contraction.

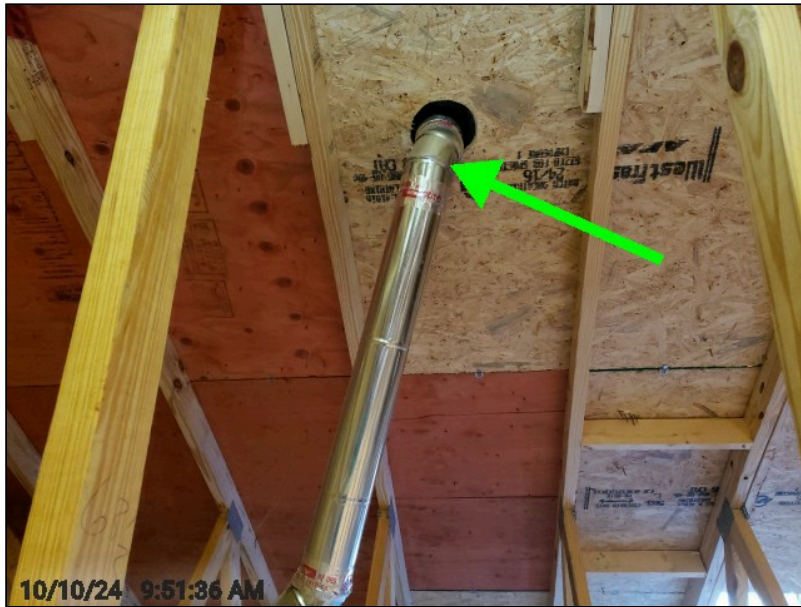
(1) FYI, The dryer is vented through the roof. The vent pipe should be cleaned once a year.

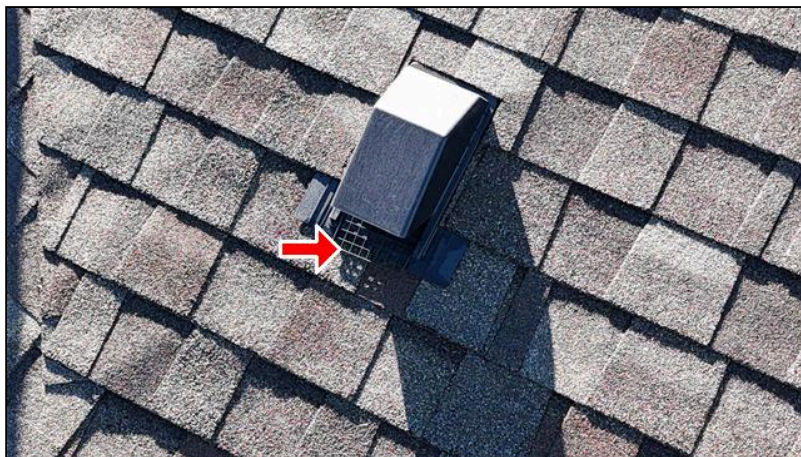
(2) The termination of the dryer duct on the exterior of house is screened. The screen will catch lint and clog the duct pipe. The end of a dryer duct should not be screened but should have a backdraft damper that closes when the dryer is not in use. A back draft damper needs to be added if one is not installed, the screen removed, and the dryer duct pipe cleaned out all the way to the dryer as needed. A qualified contractor needs to repair.

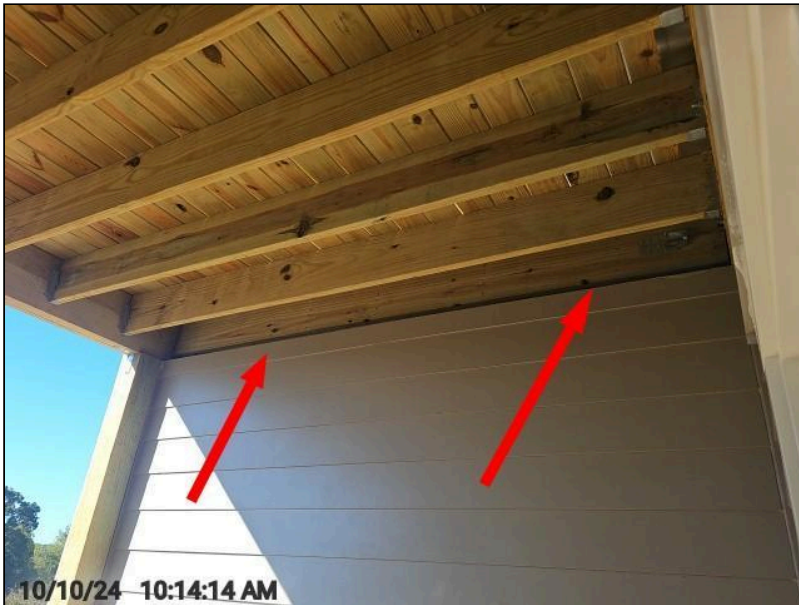
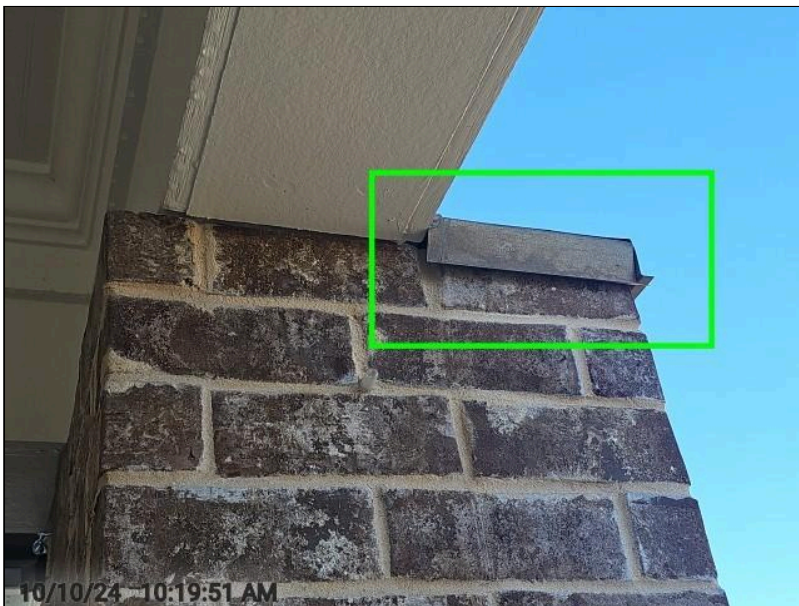
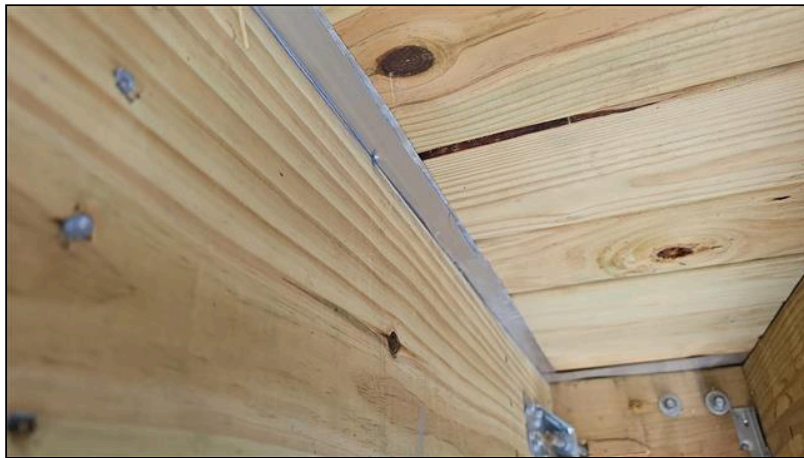
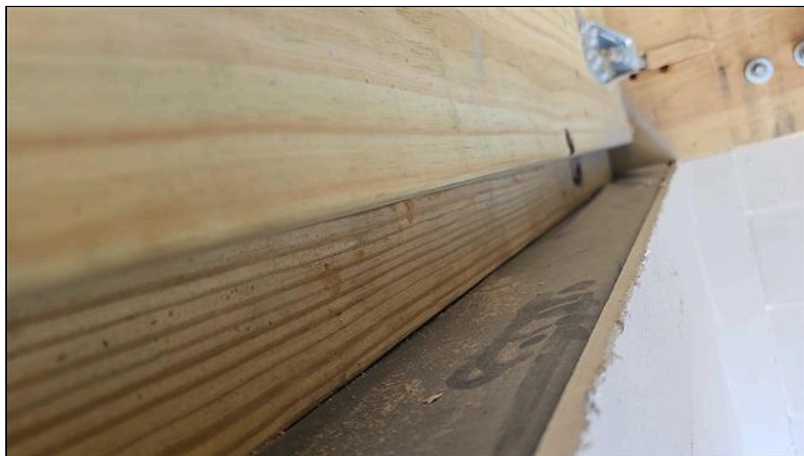
- 🏠 (1) The flashing at the top of the right side wall on main level deck is lower than the top of the siding. The flashing above does not extend out past the wall below. Water will not drain out and could drain into concealed wall space. Water was observed in garage next door on the other side of the wall. Flashing needs to be at top of wall, turned down, and drain water down the front of the wall, Builder needs to evaluate further and repair.

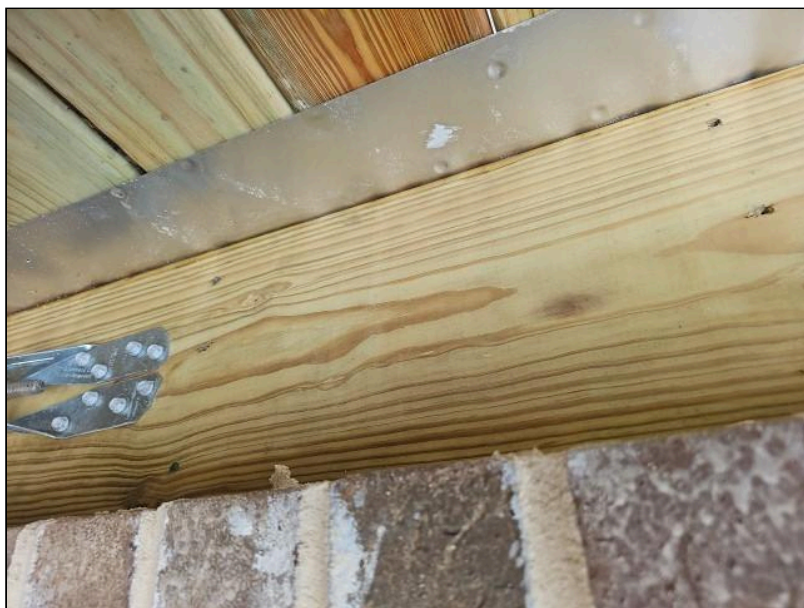
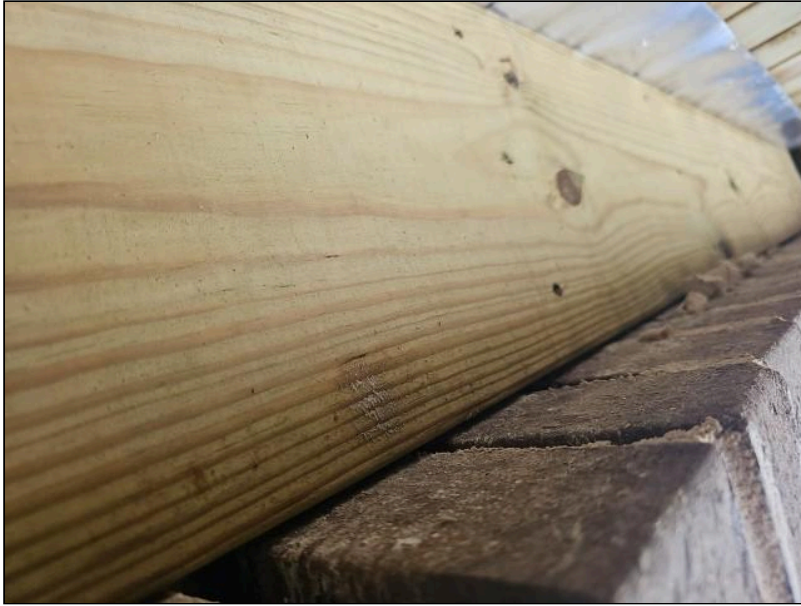
- 🏠 (2) The flashing at the top of the left side wall on main level deck extends out about equal distance as the roll lock brick on top of the wall. The roll lock brick are sloped water will run off. The joint between brick and band needs to be caulked to prevent any leaks into the wall. Builder needs to evaluate and repair.

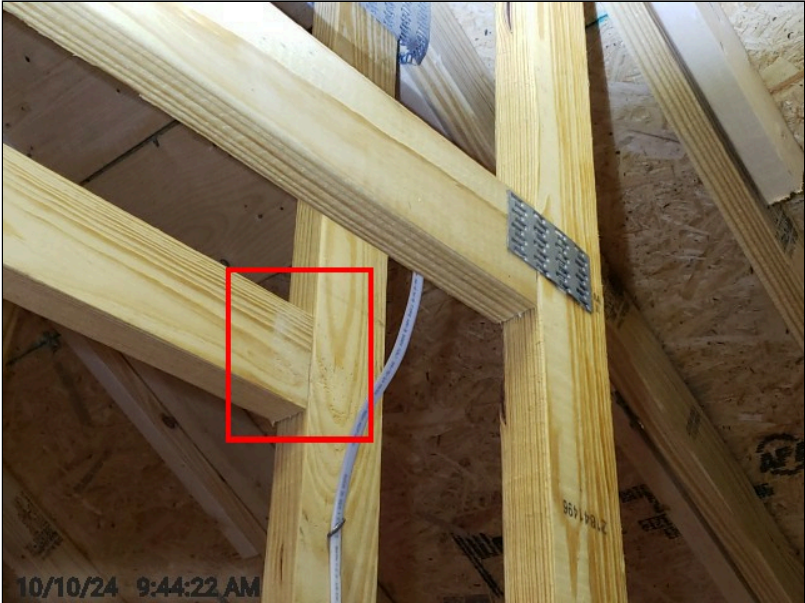
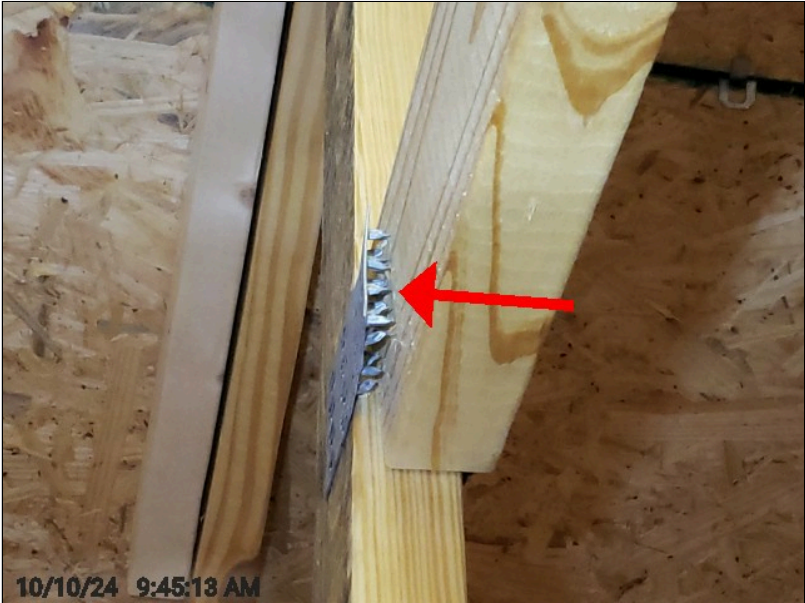
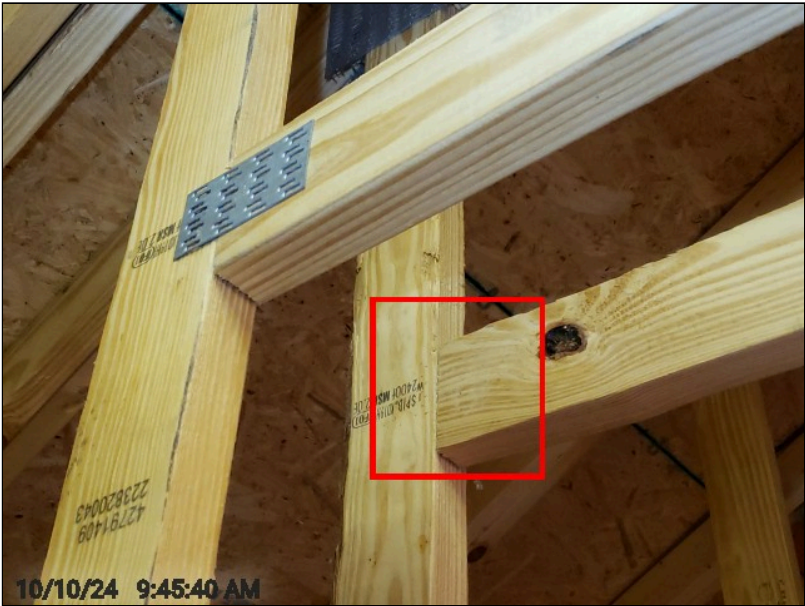
(1) Broken/loose and/or missing gusset connection on truss(es) were observed in the attic. Gusset connections are part of the structural components of a truss. A licensed structural engineer needs to

inspect further and design a repair plan. A qualified contractor needs to make repairs. A letter for the completed repairs needs to be provided to the buyer for their records.

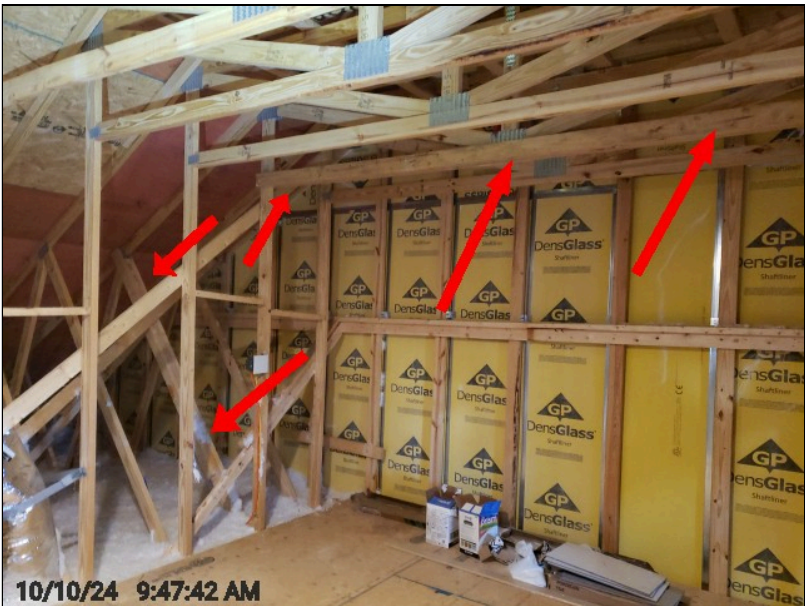
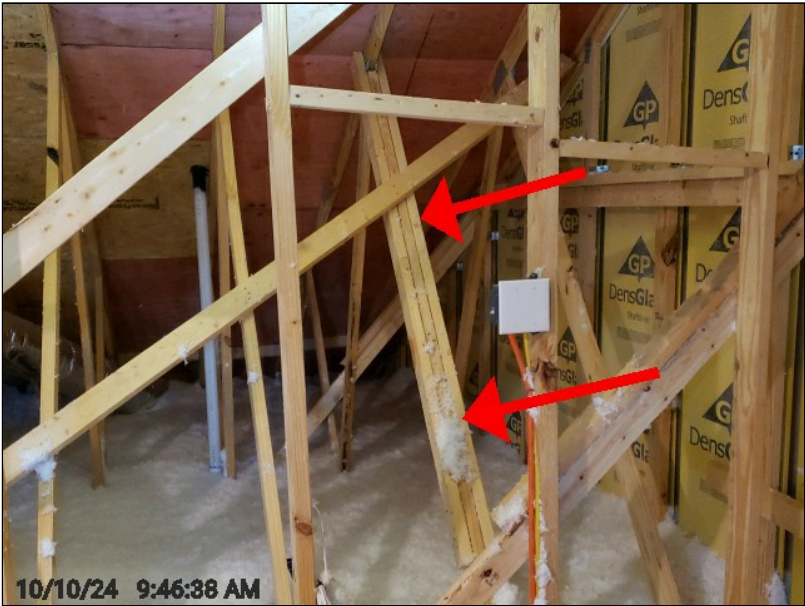
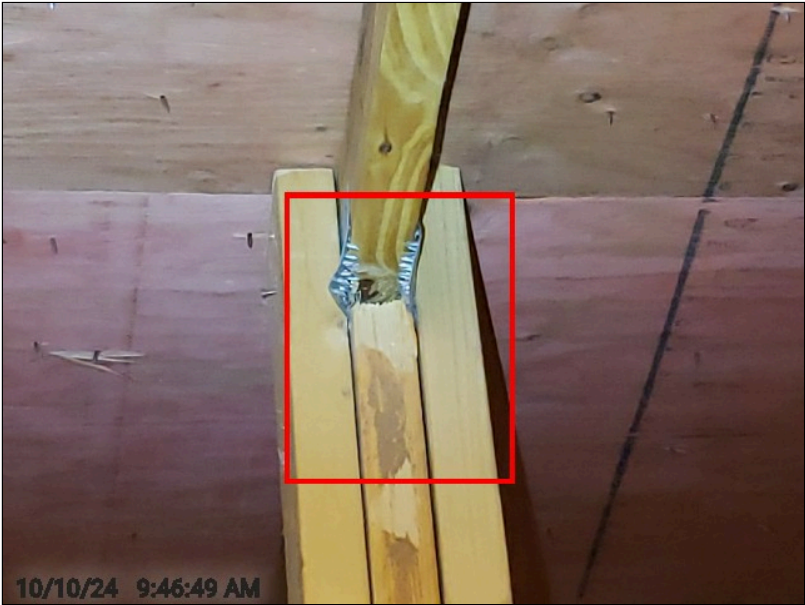
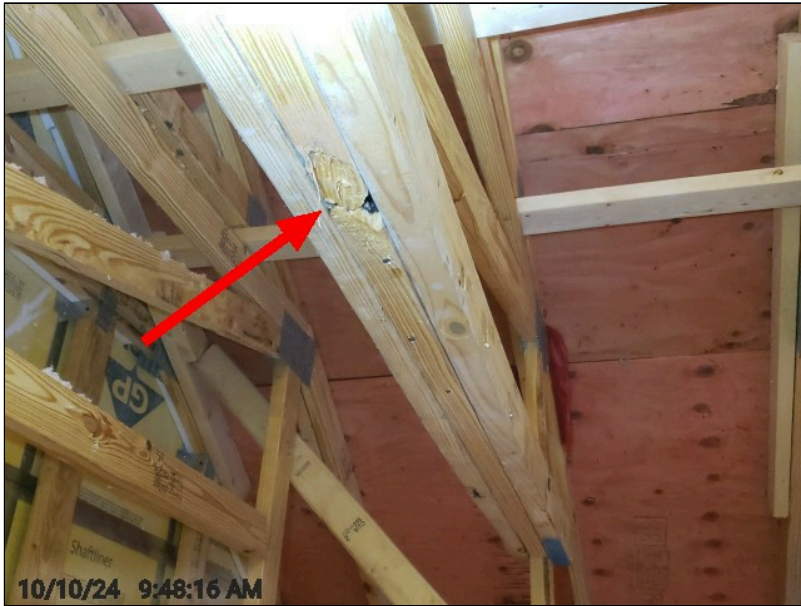
(2) Roof truss component has been altered/cut. Trusses are structural components. A licensed structural engineer needs to inspect further and design a repair plan. A qualified contractor needs to make repairs. A letter for the completed repairs needs to be provided to the buyer for their records.

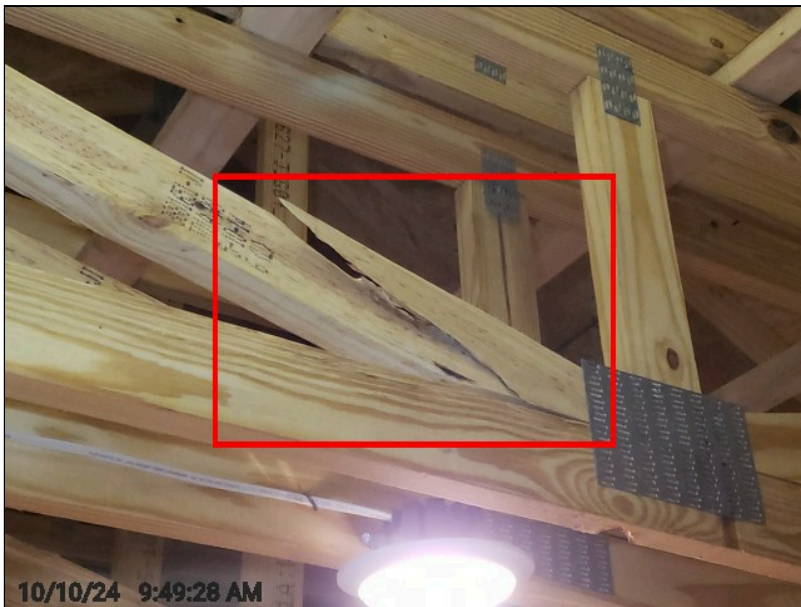
(3) Broken truss was observed in the attic. When a truss is broken the structural integrity of the truss is compromised. A licensed structural engineer needs to inspect further and design a repair plan. A qualified contractor needs to make repairs. A letter for the completed repairs needs to be provided to the buyer for their records.

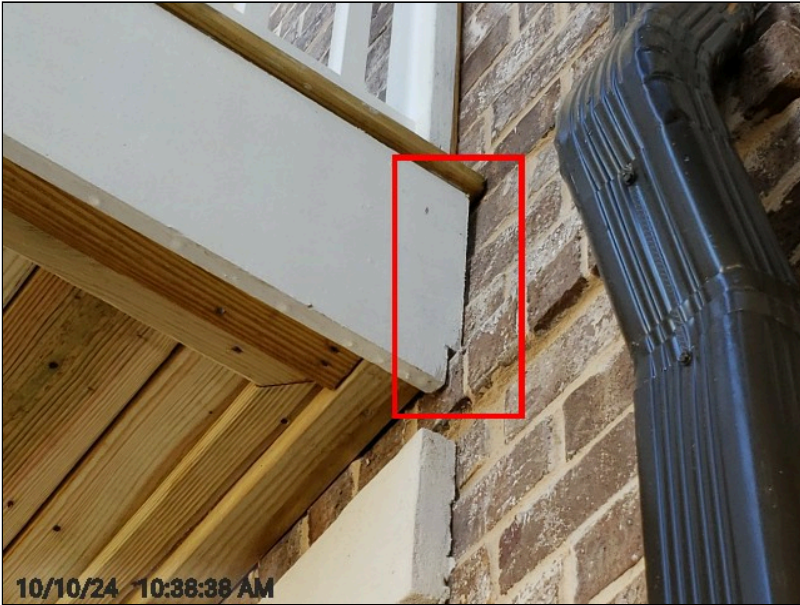
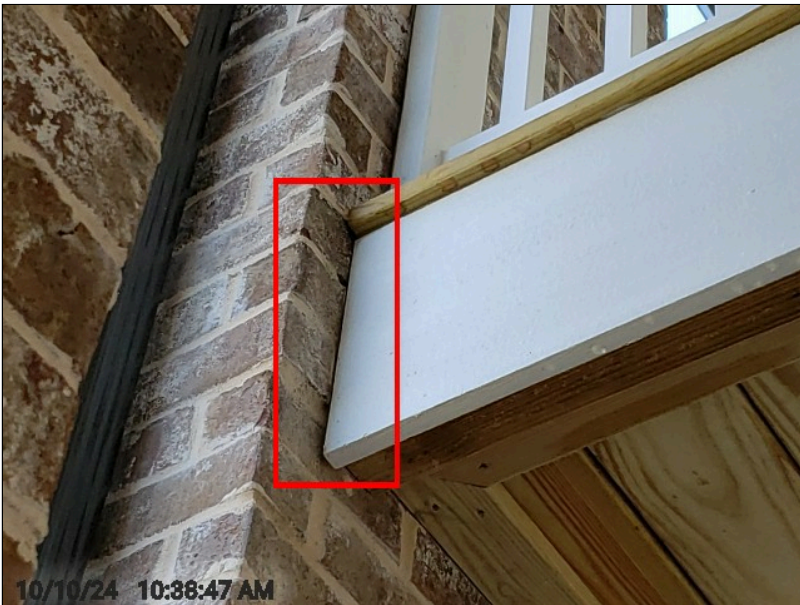
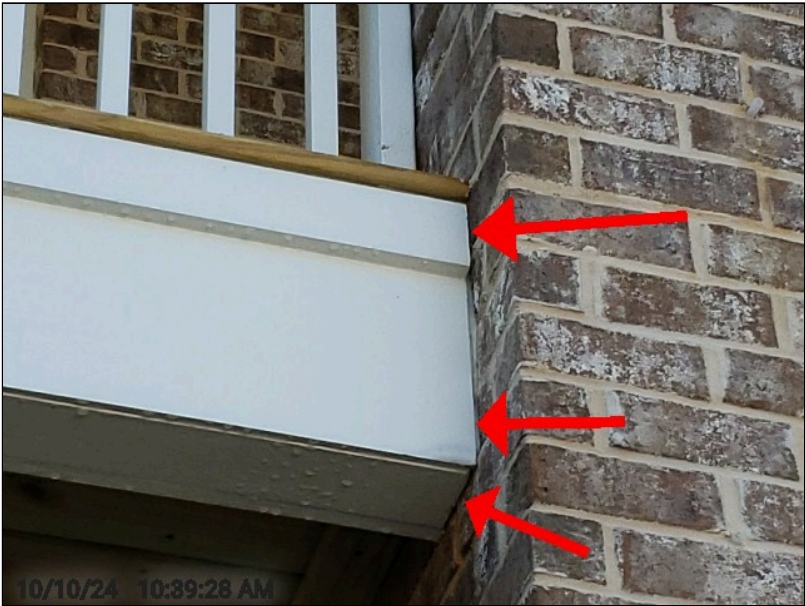
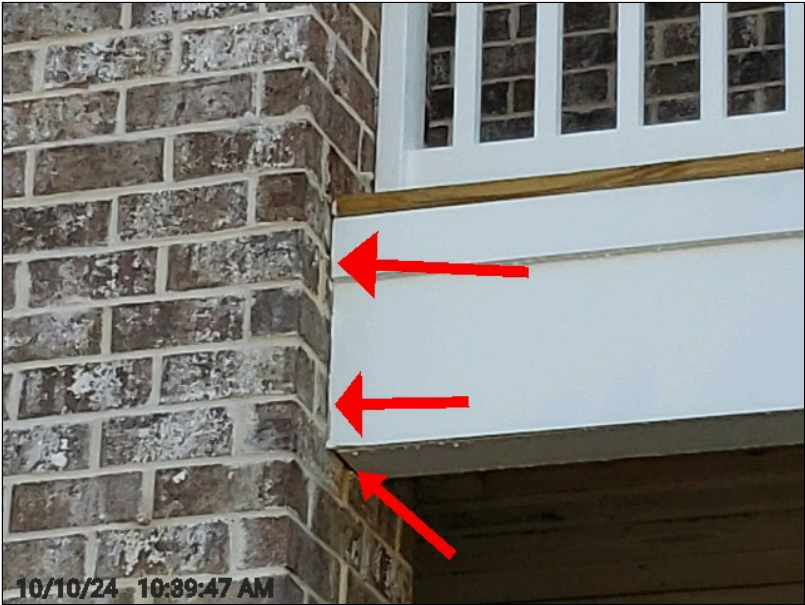
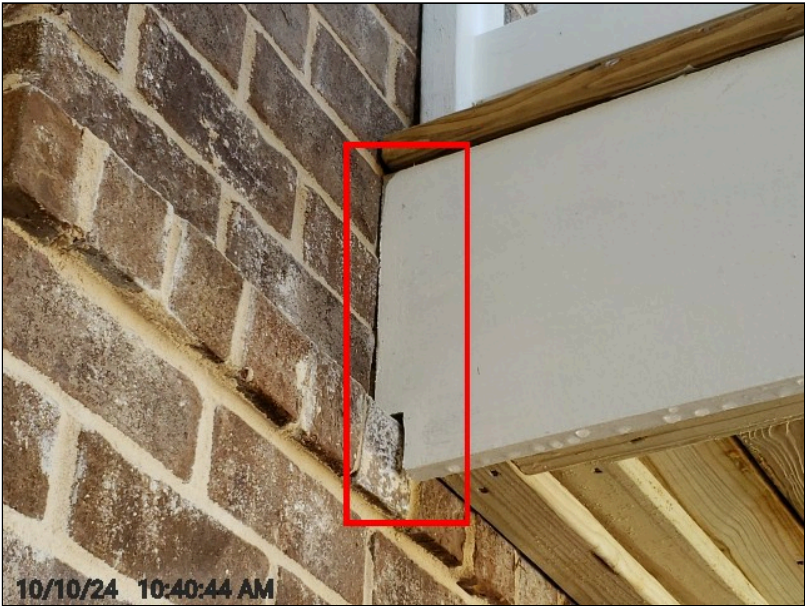
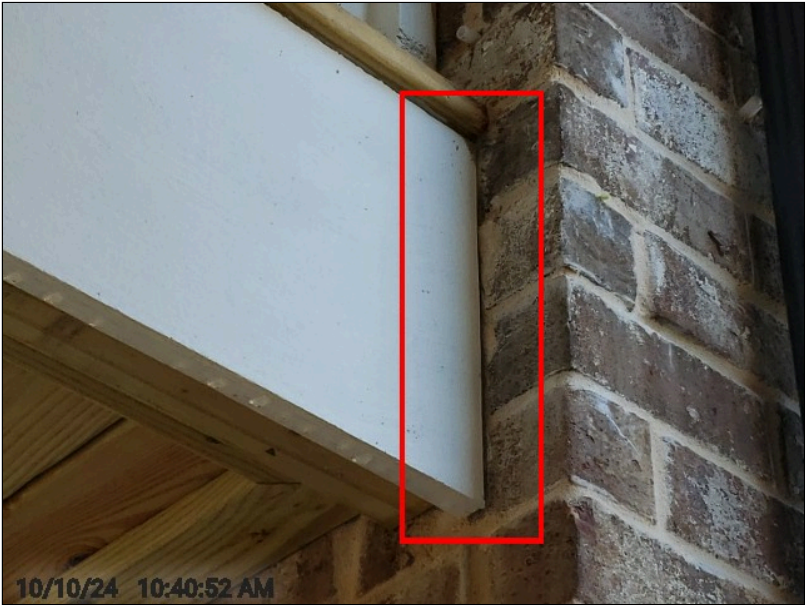
🏠 (1) Trim needs to be caulked. A qualified needs to repair. Location(s): front of the house

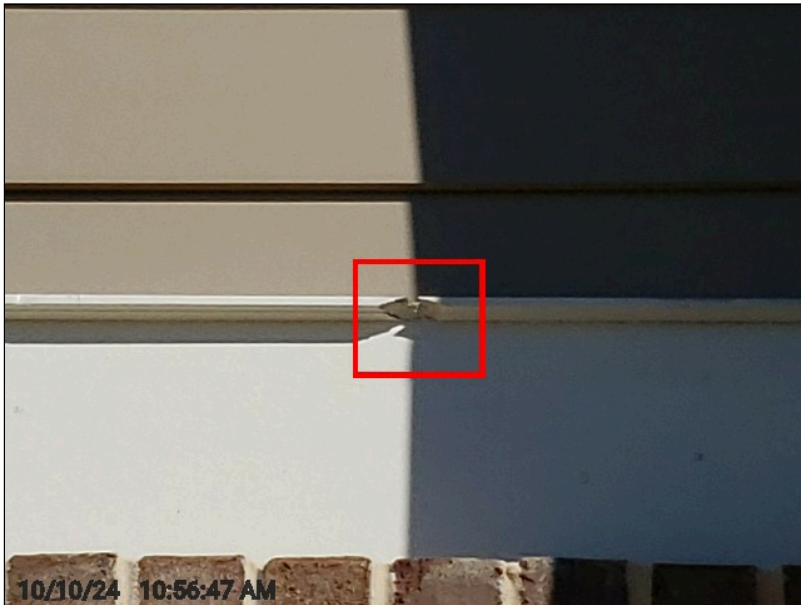
- 🏠 (2) Trim is damaged. A qualified contractor needs to replace trim. Location(s): back of the house

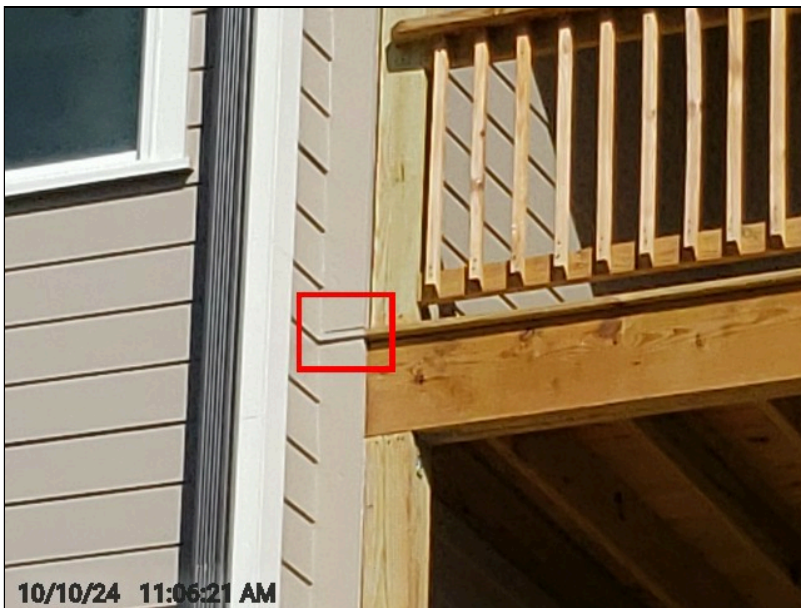
- 🏠 (3) Corner boards need to be caulked and painted. A qualified contractor needs to repair. Location(s): back of the house

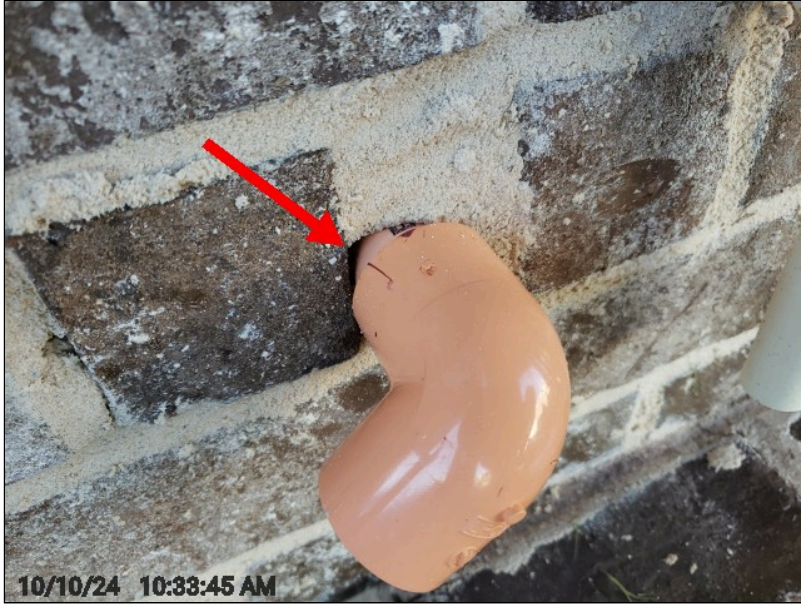
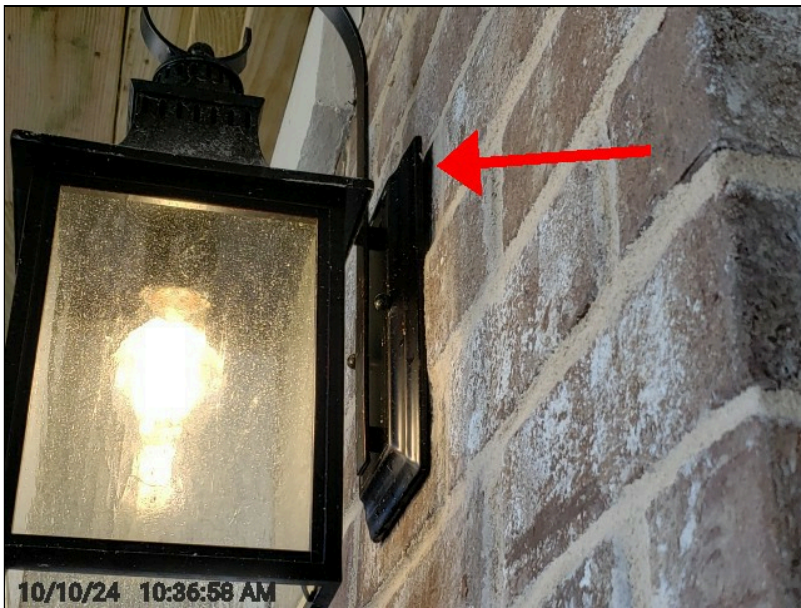
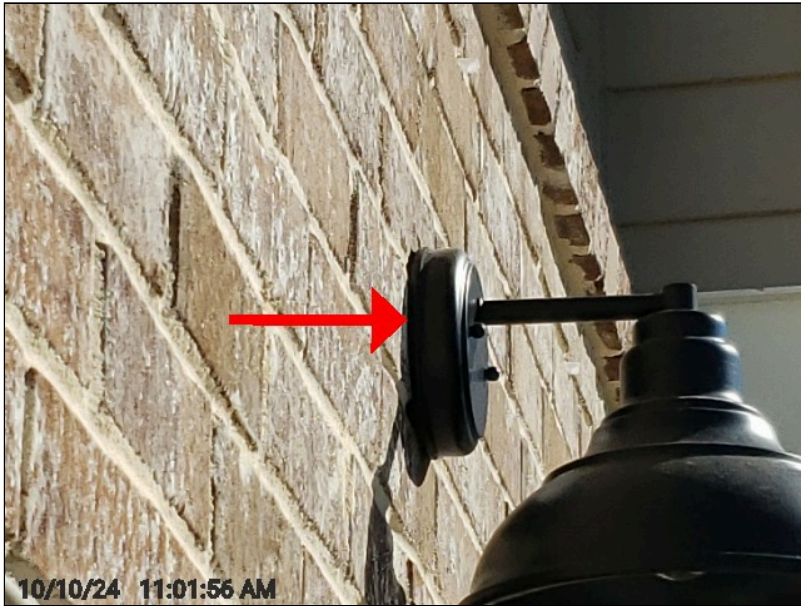
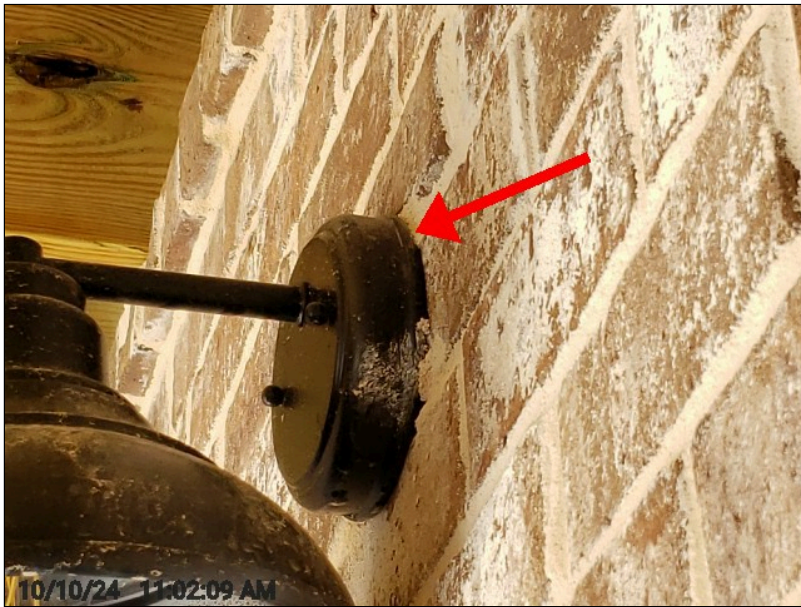
- 🏠 All utility penetrations through the exterior wall should be caulked or filled with foam. The following utility penetrations should be caulked or filled with foam to limit air infiltration: drain on front of the house, front light fixture, back light fixture
