Inspection Report

Marion Hodges Home Inspection Services

6731
GA

Single Family (2 story)

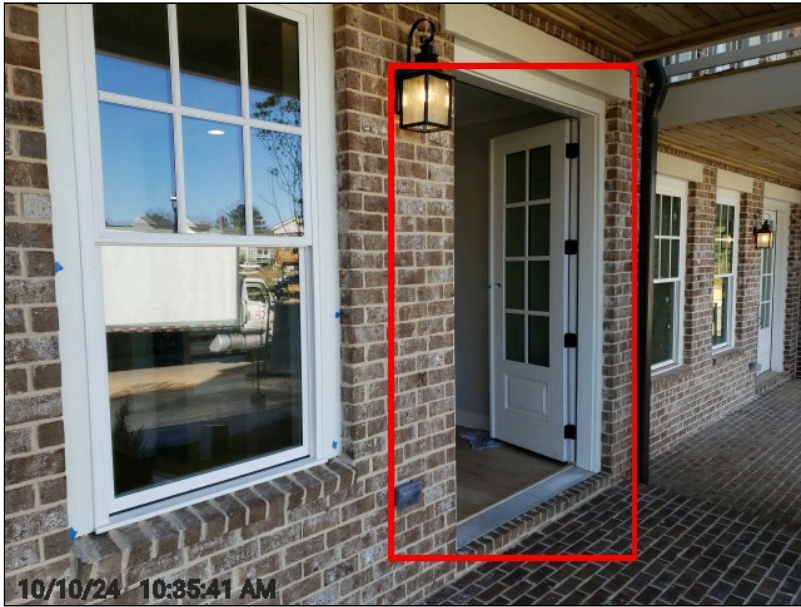
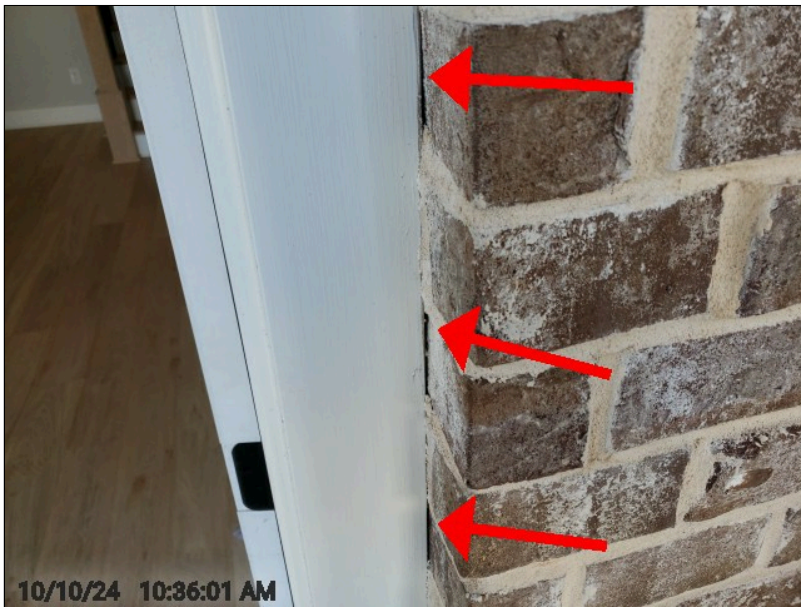
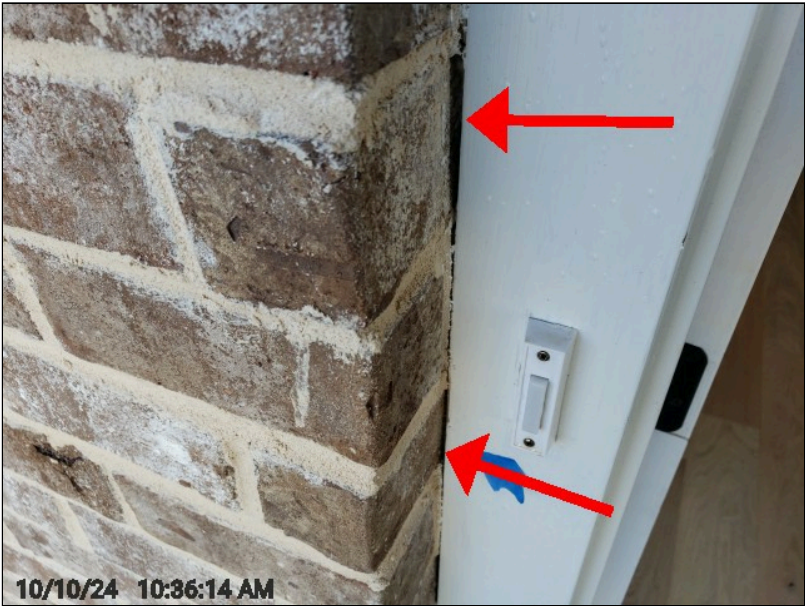
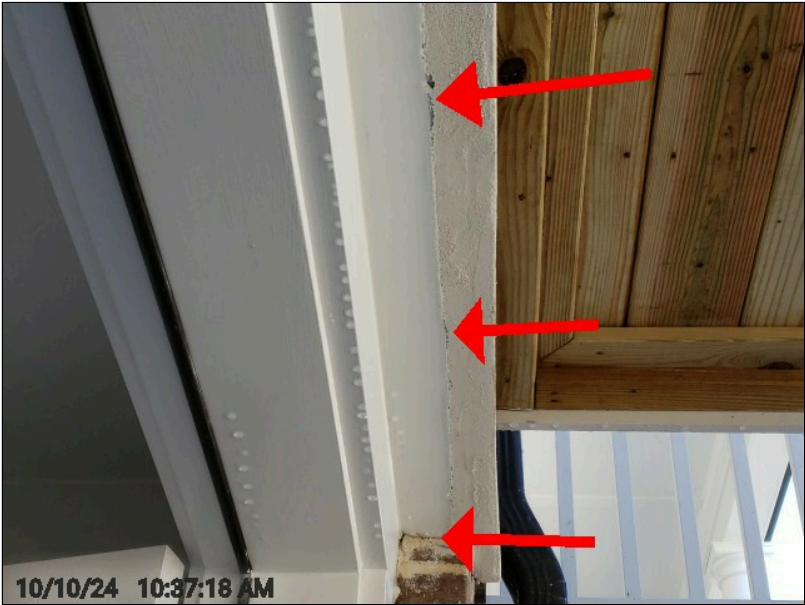
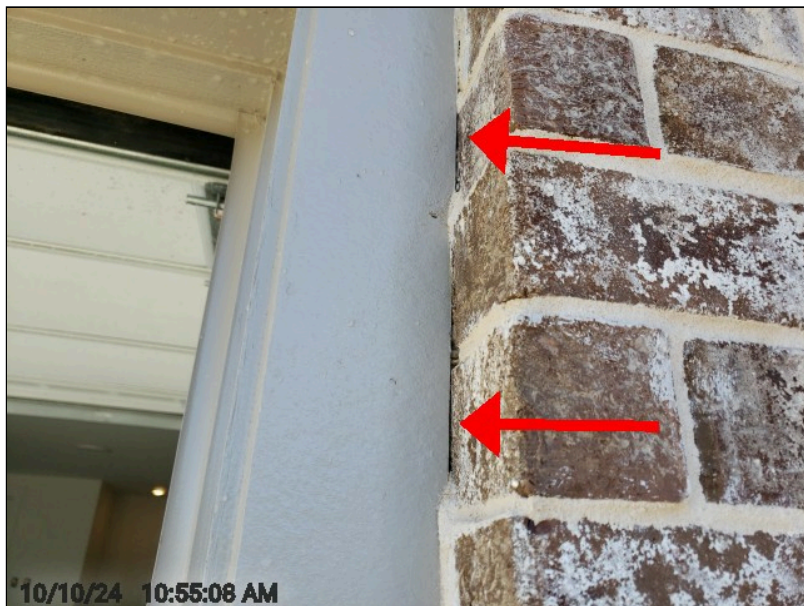
- 🏠 (1) Door trim needs to be caulked. A qualified contractor needs to caulk trim to prevent air intrusion or moisture penetration. Location(s): front door, garage door casings

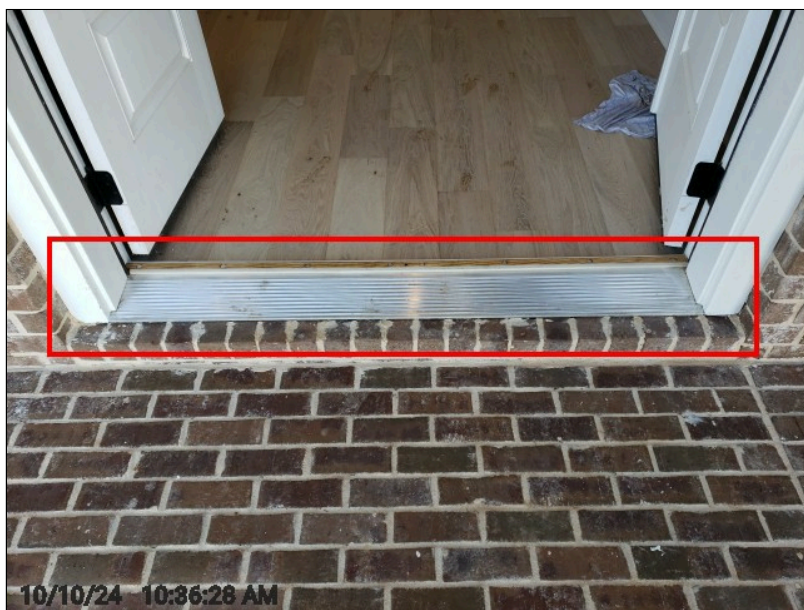
(2) Joint between the door jambs and threshold needs to be caulked. A qualified contractor needs to caulk door jambs and threshold to prevent air intrusion or moisture penetration. Location(s): front door

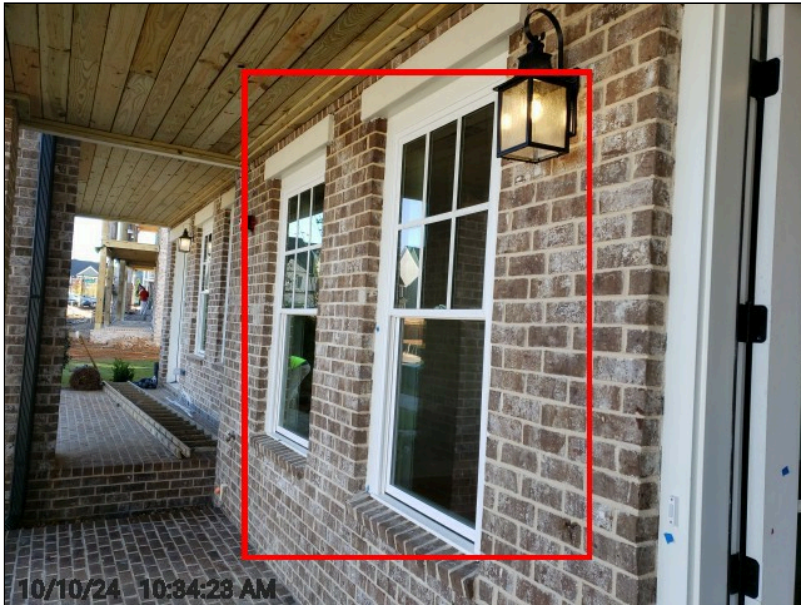
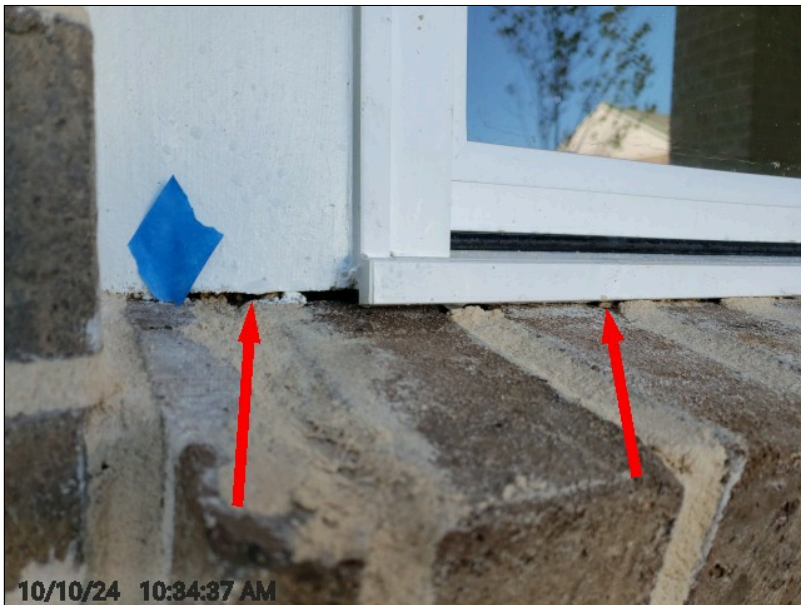
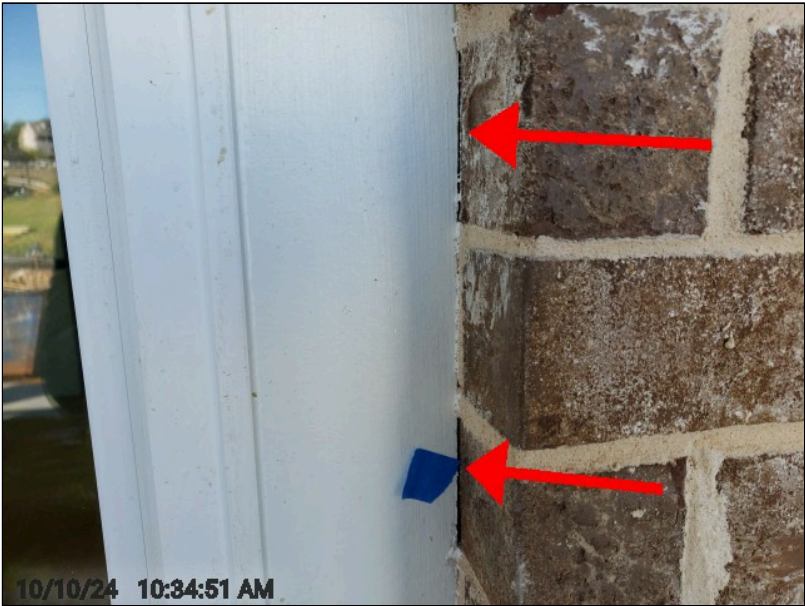
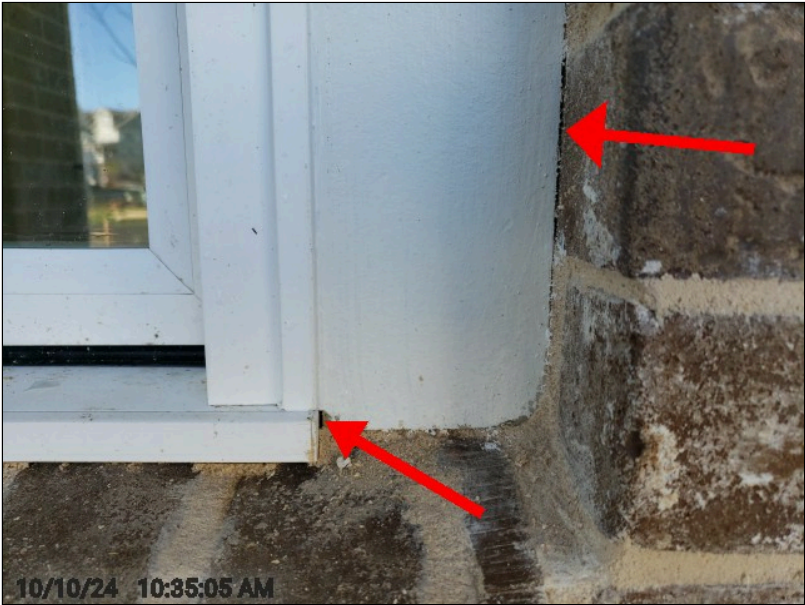
- 🏠 Windows need to be caulked. A qualified contractor needs to caulk windows to prevent air intrusion or moisture penetration. Location(s): front of house

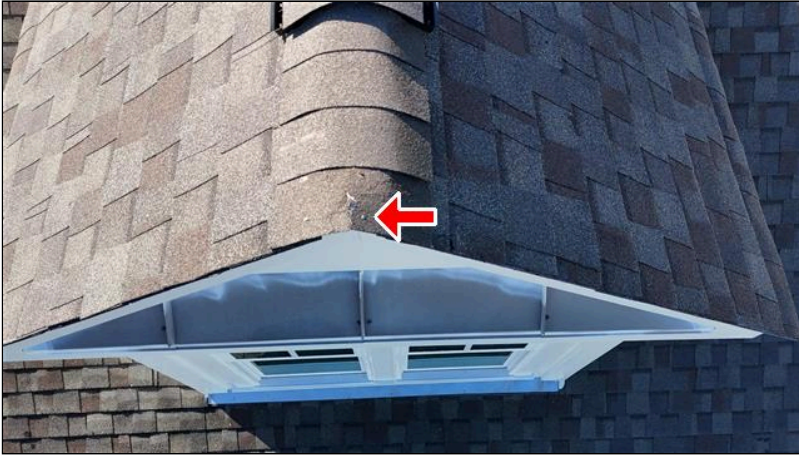
- 🏠 (1) There are cracked ridge shingles on the roof. Picture(s) are examples. A qualified roofer needs to repair or replace cracked shingles.

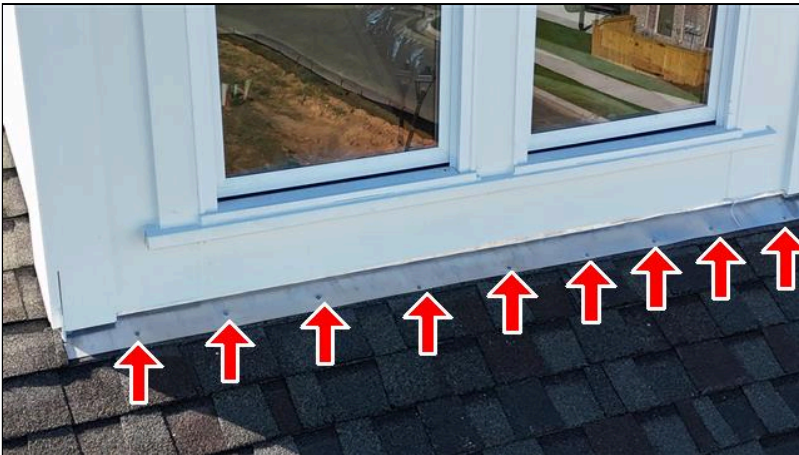
- 🏠 (2) Roofing nails are not sealed. A qualified roofer needs to seal all nails with a roofing sealant. Location(s): front of house on dormer

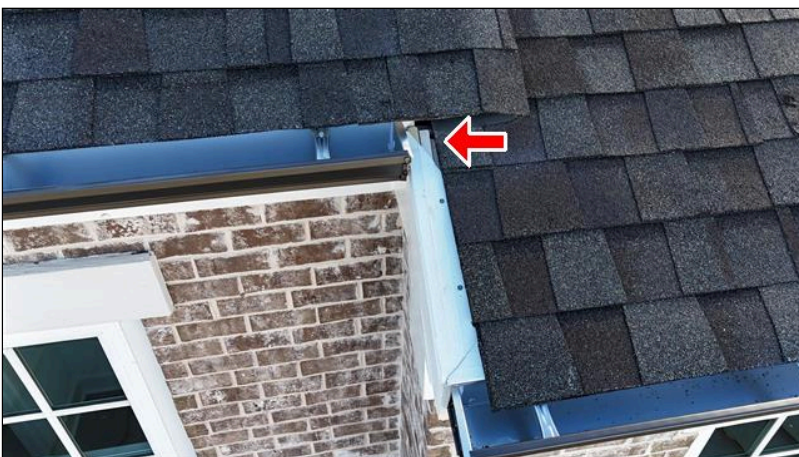
- 🏠 (3) Roof decking is visible on the front of the house. Shingles do not extend past the fascia. A qualified roofer needs to inspect further and repair.

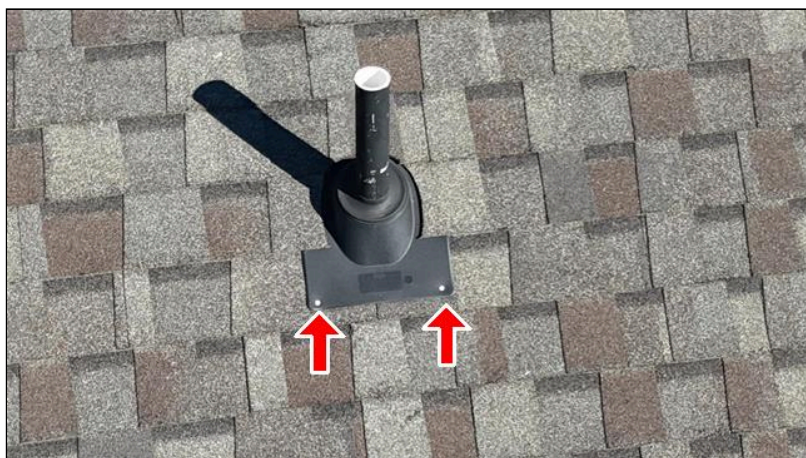
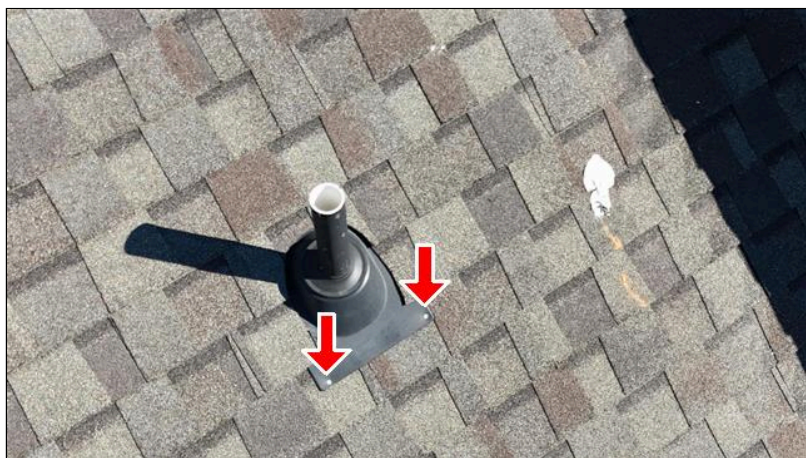
roofing sealant. A qualified roofer needs to repair. Location(s): plumbing boot

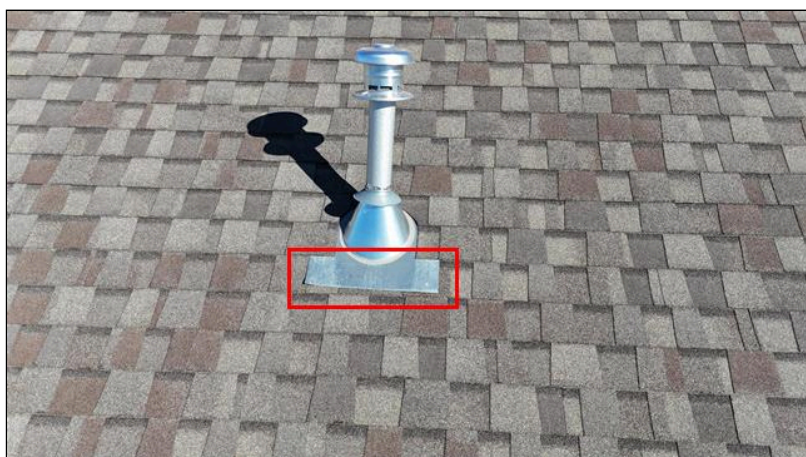
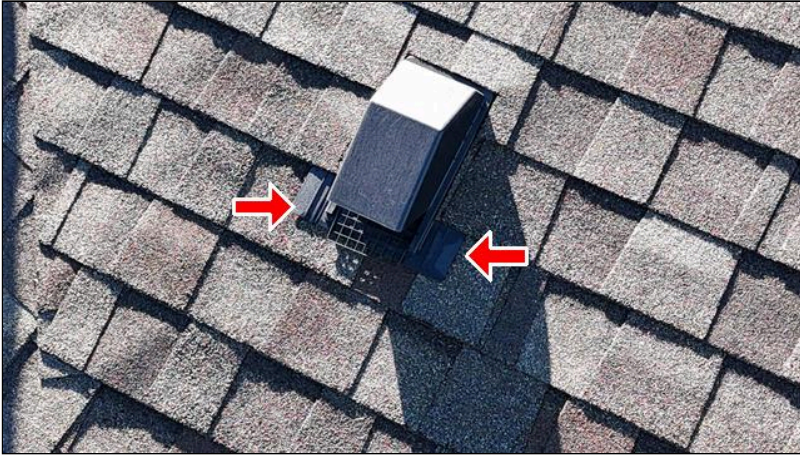
(2) Vent flashing is not secured to the roof. A qualified roofer needs to screw down or replace the flashing as needed. All screw heads need to be sealed with roofing sealant. Location(s): water heater vent flashing, dryer vent flashing

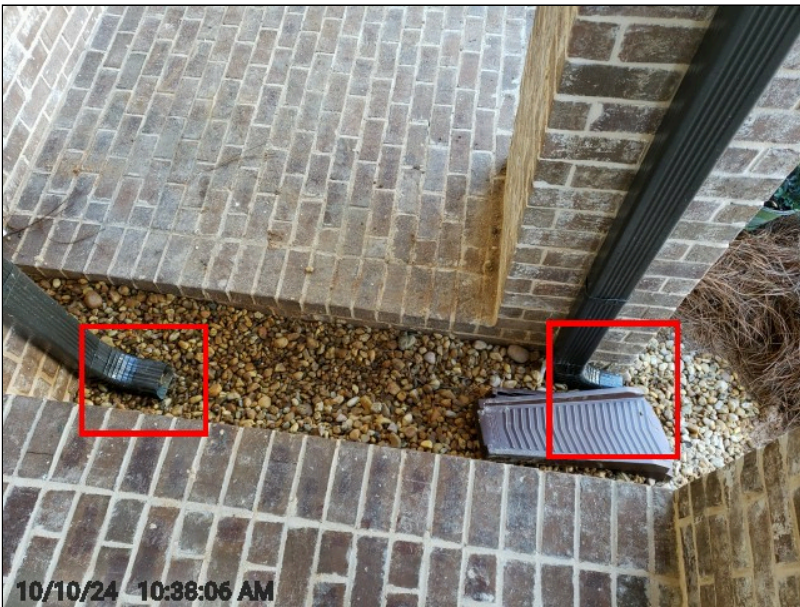
- 🏠 (1) Add splash blocks or downspout extensions at all downspouts that do not drain onto a concrete surface.

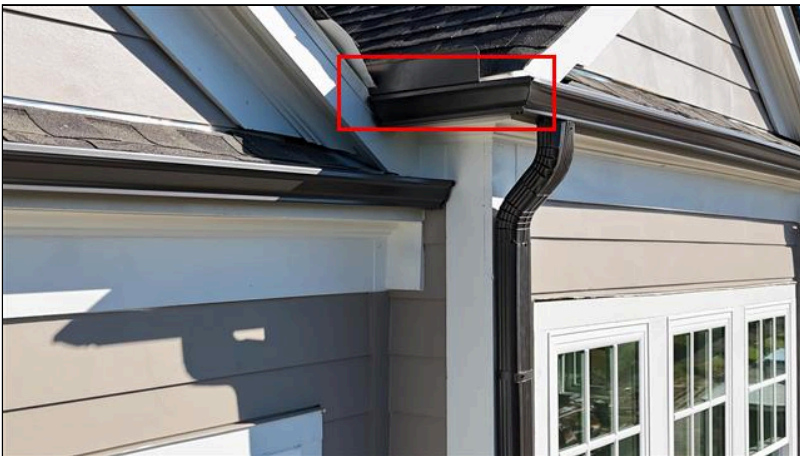
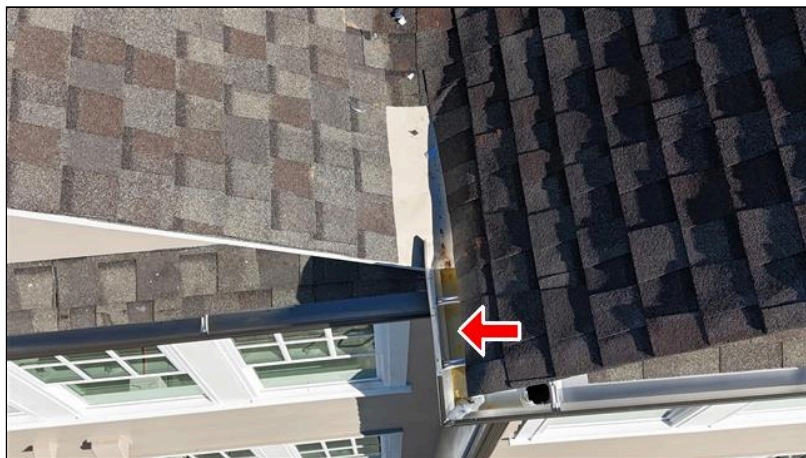
- 🏠 (2) Standing water was observed in the gutter. The gutter does not flow to the downspout. Picture(s) are examples. A qualified contractor needs to re-slope gutter to have a flow to the downspout. Location(s): back of the house

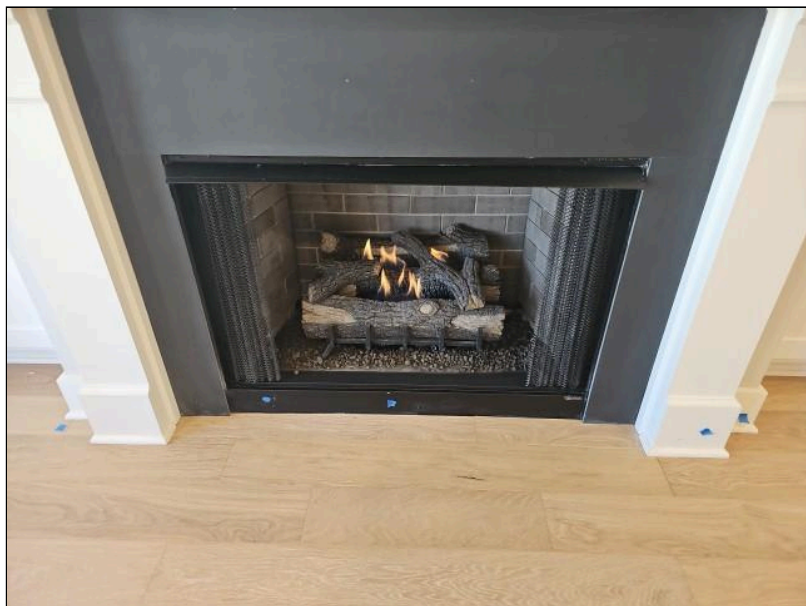
The gas logs were operational at the time of the inspection.
