# **Inspection Report**

# **Property Address:** 8765 Main St

# **Marion Hodges Home Inspection Services**

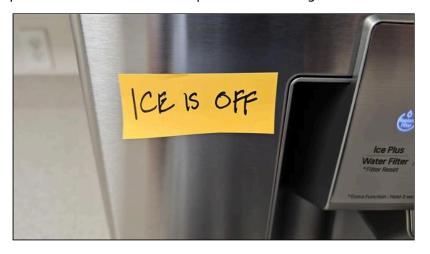
(1) The ice maker and water dispenser were not operational. The seller or a qualified contractor needs to put ice maker and water dispenser in working order.

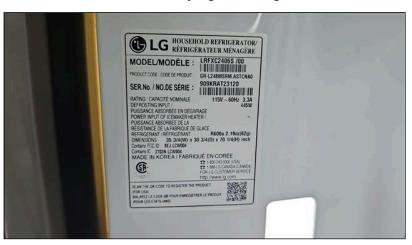
(2) Either have seller identify age of refrigerator or call LG.

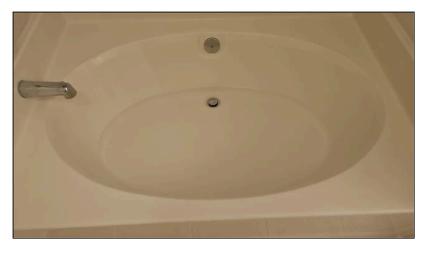
The tub is slow draining. A licensed plumbing contractor needs to inspect further and repair. Location(s): hall bath

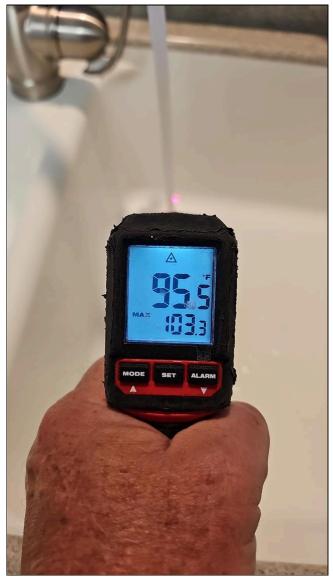
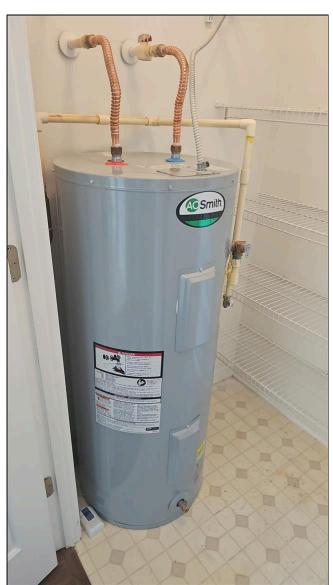
Water Heater

Sulphur/rotten egg smell from the water was observed. This is generally due to water staying in a water heater for a long period of time and creating hydrogen sulfide gas. A licensed plumbing contractor needs to inspect further and repair.

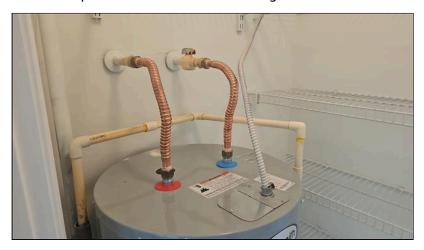
There is not a thermal expansion tank or a thermal expansion device installed on the cold water line. Water heater manufacturers require a thermal expansion tank or thermal expansion device as part of a water heater installation. Some hi-rise condominiums have thermal expansion devices built into the buildings cold water system. A licensed plumbing contractor needs to add a thermal expansion tank or a thermal expansion device if the building is not covered with an expansion system.

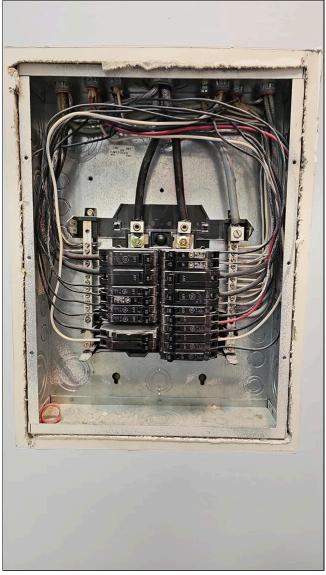
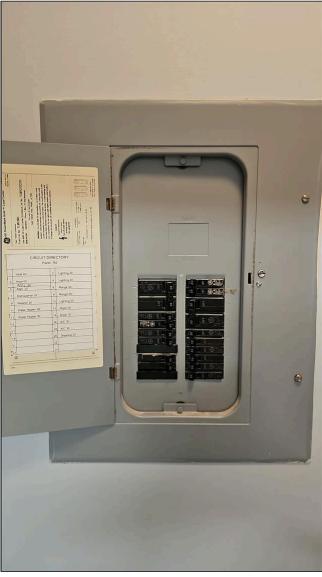
**Distribution Panel**

Labeled Panel Front

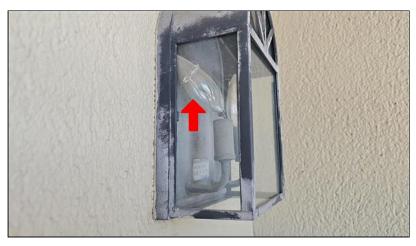
The broken bulb needs to be replaced in the exterior light fixture at the primary bedroom balcony door.

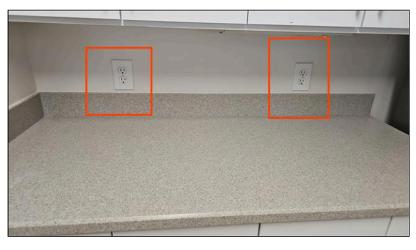
Not all of the receptacles in the kitchen that serve the countertops are GFCI protected. A licensed electrician needs to put all kitchen countertop receptacles on a GFCI protected circuit.

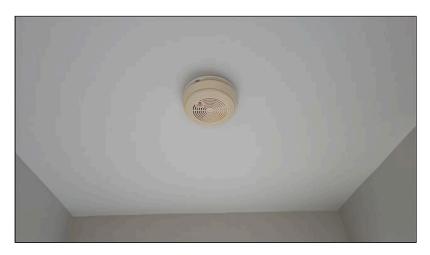
The installed smoke detector is older and needs to be replaced. To bring smoke detectors up to current code, there should be one smoke detector in each bedroom and one smoke detector in the hall outside of the bedrooms. A licensed electrician needs to install smoke detectors as needed.

The purchaser needs to test all smoke detectors for operation prior to someone sleeping in the condo. Batteries need to be replaced every 6 months. Smoke detectors tested every month. Smoke detectors last 7 to 10 years.

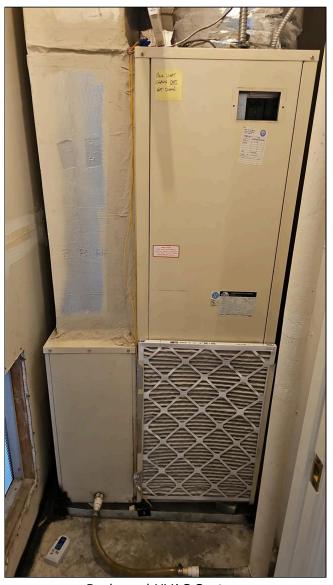
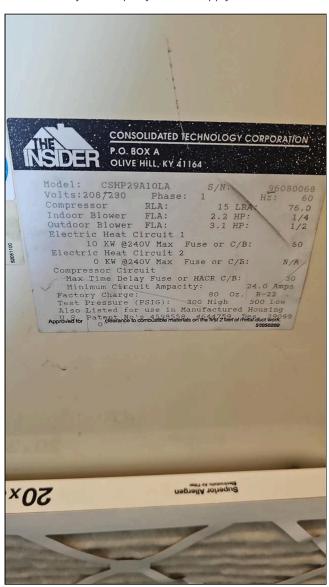
Packaged HVAC System

The heating system was operational. The 1996 equipment is beyond life expectancy. A licensed heating and air contractor needs to do a thorough inspection and cleaning of the equipment based on manufacturers specs. Future replacement of the equipment should be anticipated. The inspector makes no warranties or guarantees as to how long the air conditioning equipment will last.

The 1996 air conditioning was operational. The supply air temperature was 52 degrees and the return air temperature was 69 degrees. The 1996 equipment is beyond life expectancy. A licensed heating and air contractor needs to do a thorough inspection and cleaning of the equipment based on manufacturers specs. Future replacement of the equipment should be anticipated. The inspector makes no warranties

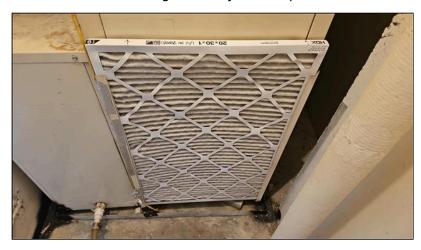
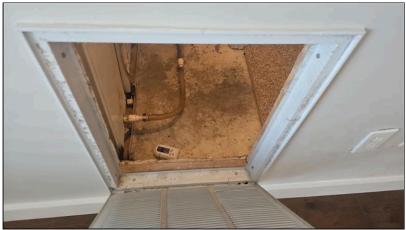
Location of return air filters (see photo). Filters should be changed every 60 to 90 days. Recommend that the filters be changed once you take possession of the house.

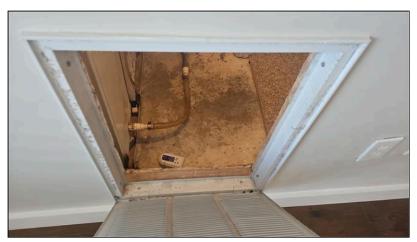
The filter is not installed in the return vent in the living room.

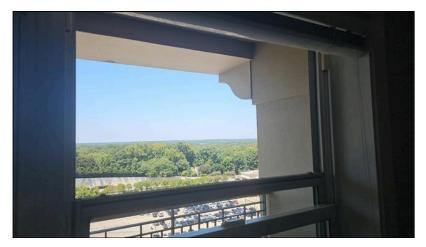
Tension spring are disconnected. A qualified contractor needs to put the window in working order.

Location(s): living room The contractor that repairs the living room window needs to check the windows in the sitting room and secondary bedroom. These windows were not tested because inspector would not be able to close top sash if sash drops. Inspector had to close living room window from balcony.

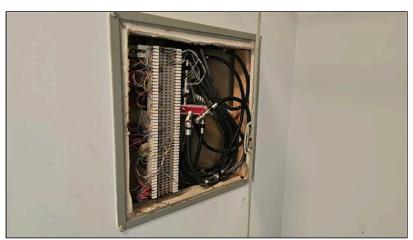
**Comments:** Inspected, Repair or Replace (1) FYI, Low voltage access panel in laundry

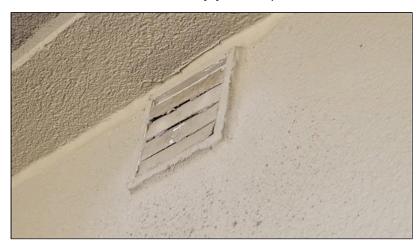
The dryer duct pipe needs to be cleaned out from duct termination back to the dryer. Dryer duct pipe needs to be cleaned out every year. A qualified contractor needs to repair.
